**DEVELOPMENT OF A MULTIPLANE-MULTISPEED
BALANCING SYSTEM FOR TURBINE ENGINES**

by Michael R. Martin

MECHANICAL TECHNOLOGY INCORPORATED

**NASA Lewis Research Center
Contract NAS3-20609**

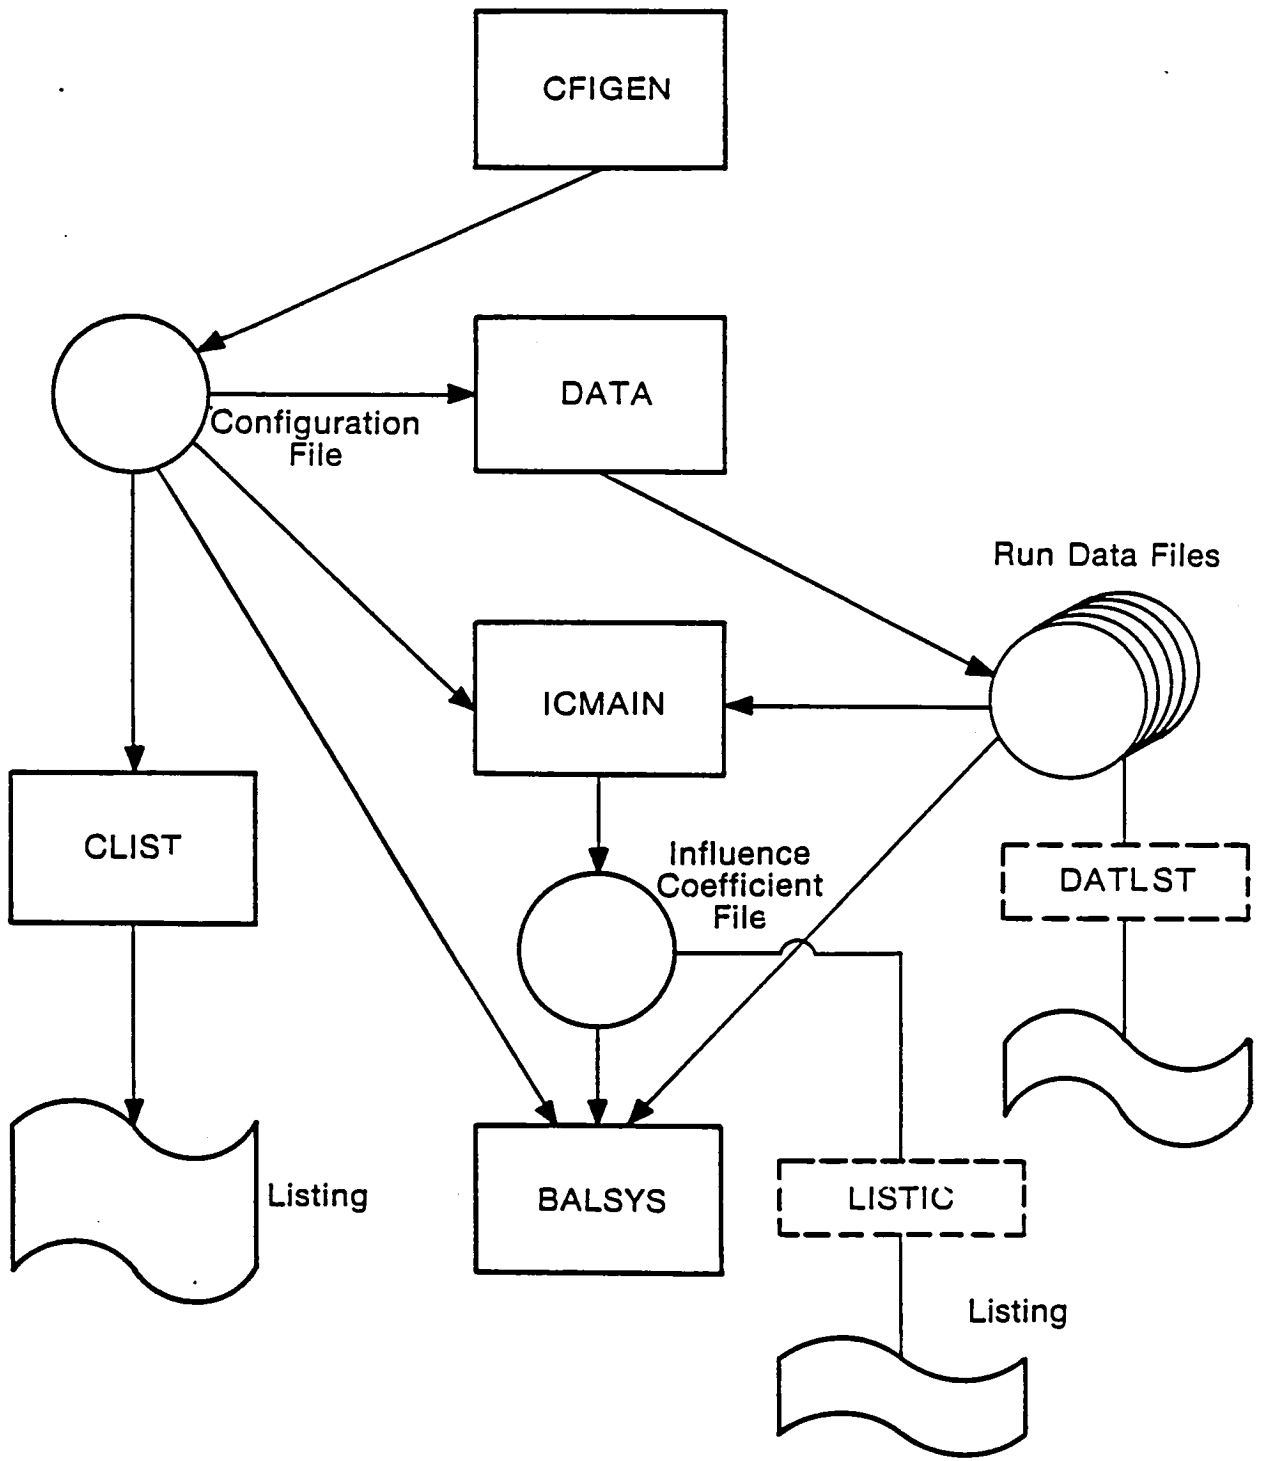
Figure 2 MTI Balancing System - Software Data File Overview

These definitions show the clean organization and modularity of the system. The configuration file is set up by the balancing engineer to control the balancing process for a particular type of rotor. Whenever data are acquired by an operator, synchronous amplitude and phase information is stored as a function of probe number and speed in the run file. Each run has a separate file and the system keeps track of file numbers. The influence coefficient file is filled by the influence coefficient subsystem and is accessed by the balancing subsystem to perform balancing calculations.

Subsystem CFIGEN creates the configuration file which includes information such as the number of correction planes, number of sensors, balancing speeds, speed tolerance, angular relationships between sensors, etc. Subsystem DATA acquires the vibration data and fills the run file. Subsystem ICMAN processes run file data to generate influence coefficients and subsystem BALSYS uses configuration file, run file, and influence coefficient file to determine correction weights to reduce the vibrations measured in a particular run.

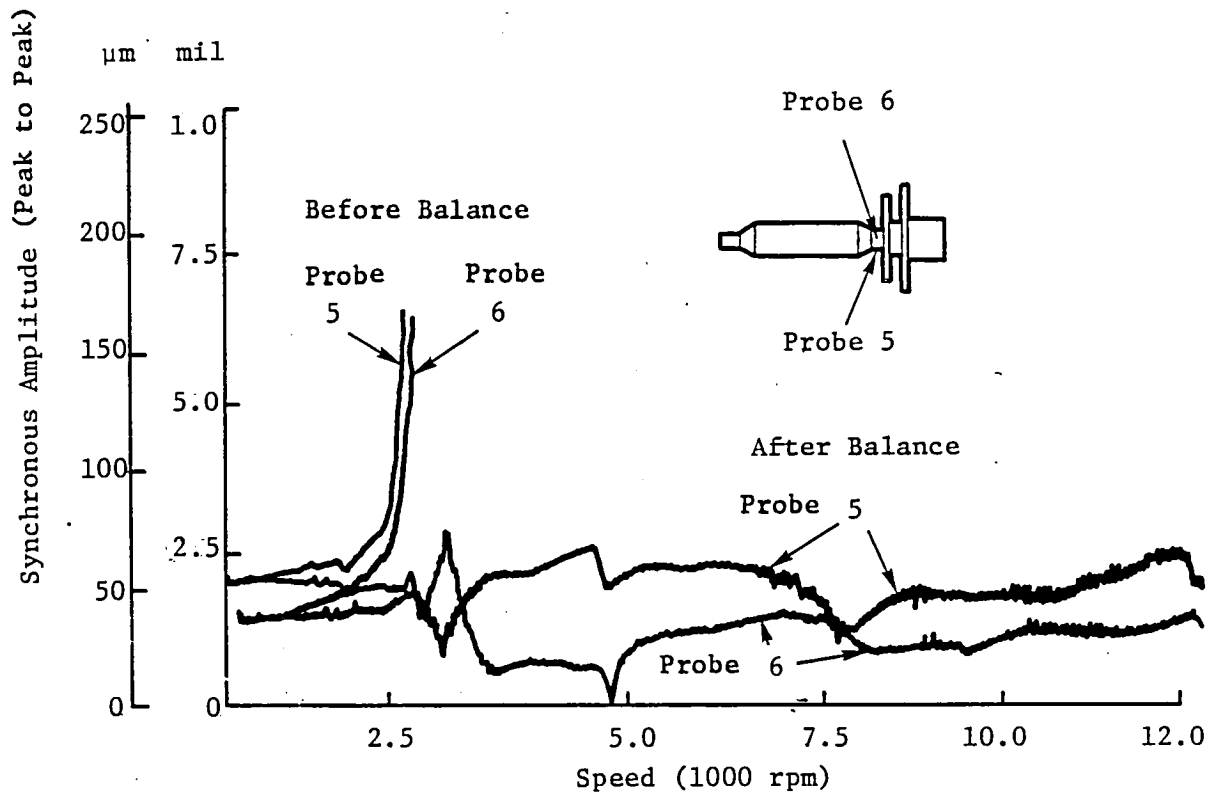
Figure 6 Response of T53 Before and After Balance at 2750 rpm

Figure 6 represents synchronous vibration amplitude for the first T53 power turbine operated in the HSBS. The as-installed amplitudes for the turbine and

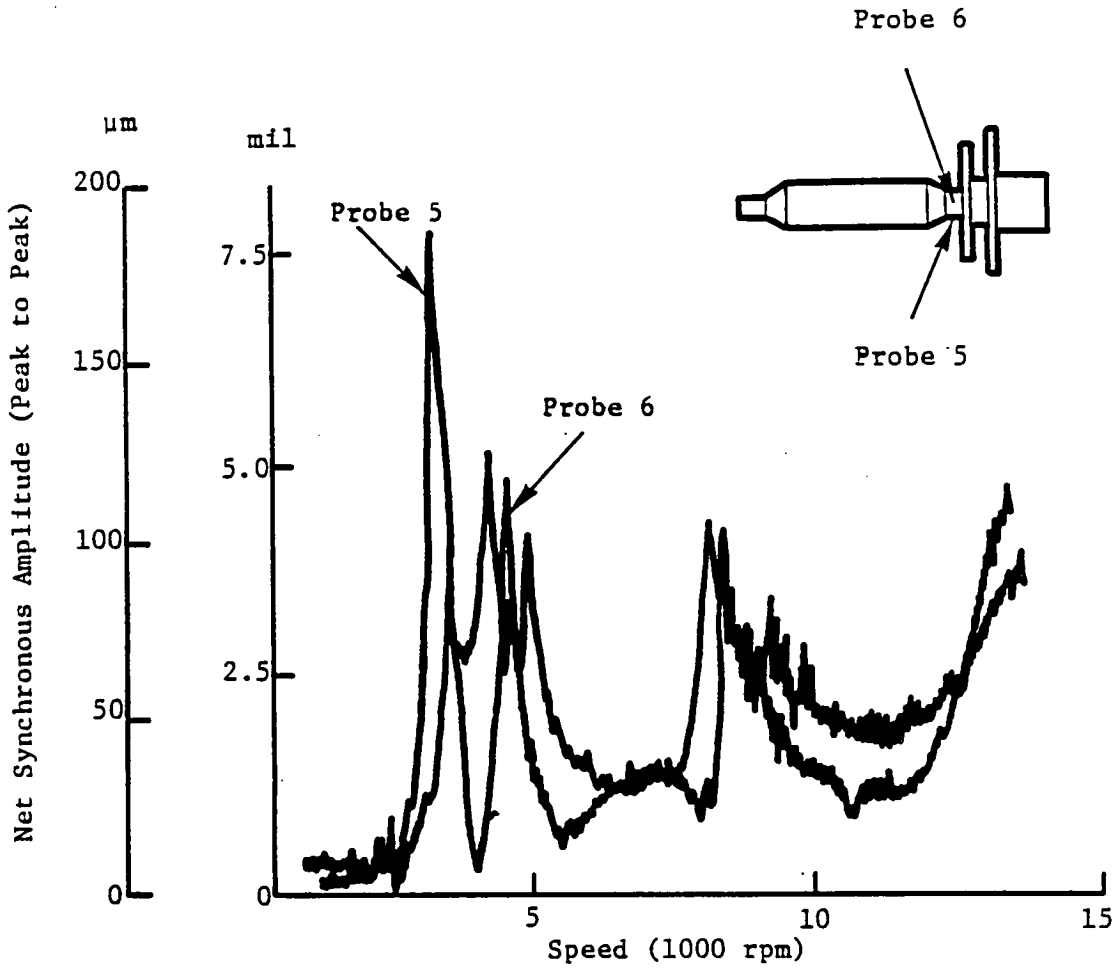
Figure 7 T53 Rotor Amplitudes for As-Installed Condition

Figure 7 shows the as-installed condition from the test run following the rebuild in which the first critical was traversed. The buildup in amplitude at 13,000 rpm also agrees with the analytical predictions. The peak evident at 8000 rpm is structural and does not respond to balancing. At this point in the testing, a considerable number of trial weight and balance runs were made to develop influence coefficients and to develop the balance plan. Figure 8 shows the results of a two-plane, two-speed balance which allowed operation to 17,400 rpm. Synchronous amplitudes became increasingly unstable in the upper speed range, making it impossible to acquire consistent high speed data. Further testing demonstrated the problem to be twofold, with probe bracket resonance and motion of the machine base both contributing to the oscillating levels. After modifying the probe bracket, the vibration levels were more stable and influence coefficients were developed for 17,200 rpm. Development of the influence coefficients at the higher speeds was hampered by vibration amplitude variations caused by shifting of the spline.

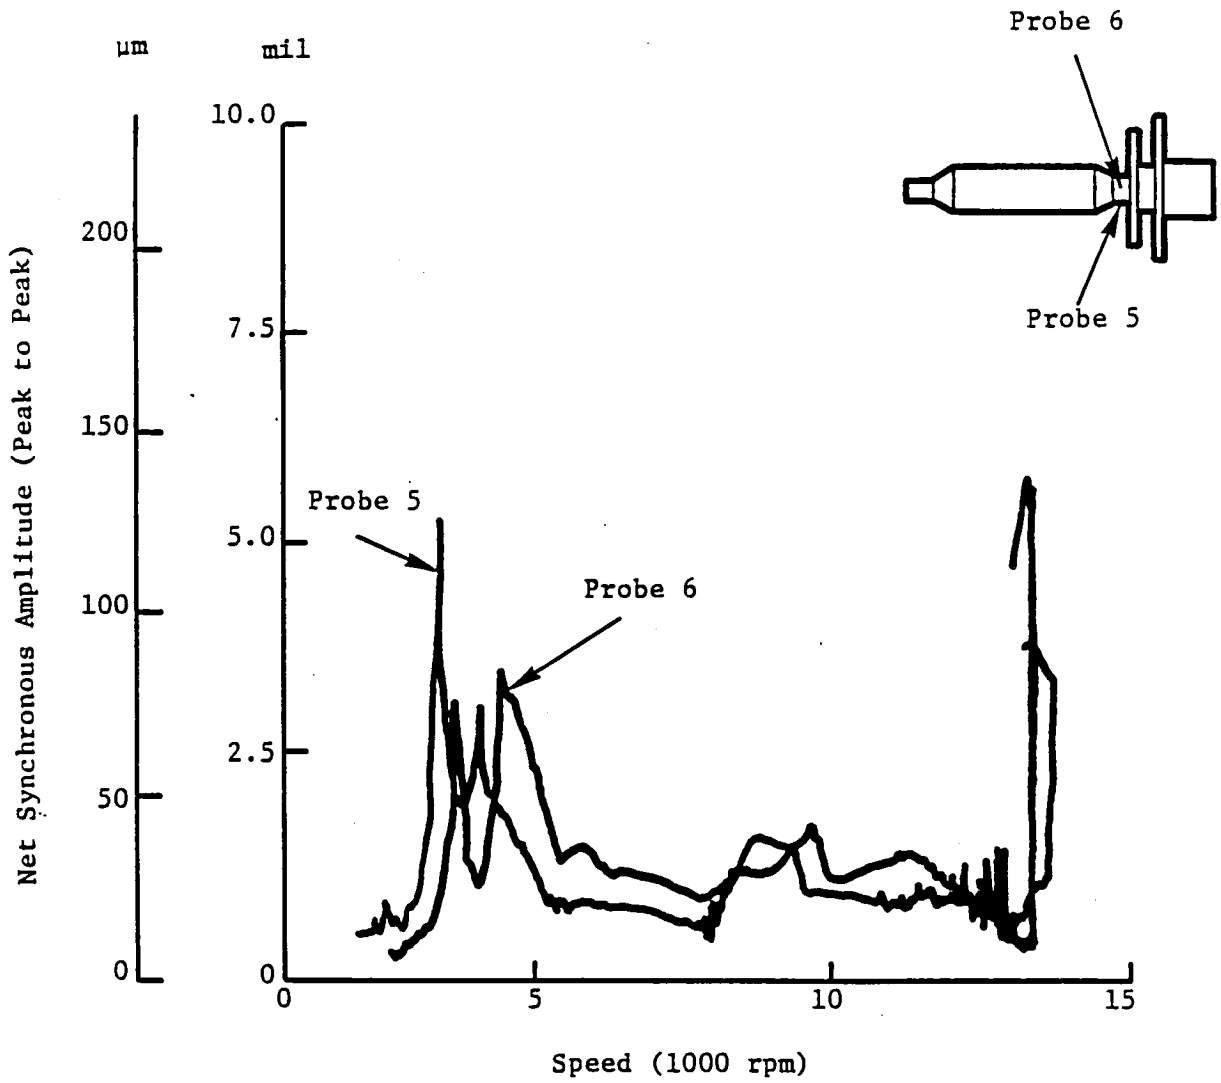
Figure 9 T53 Rotor Response Showing Spline Shift

Figure 9 represents vibration amplitude versus speed (measured by the turbine end probes) in a test run that clearly showed a spline shift. Shifts were occurring at both high and low amplitudes and at various rotor speeds indicating the possibility that a destabilizing mechanism might be involved. Instabilities caused by problems with the thrust bearing might provide sufficient excitation to cause a spline shift. Consequently, the grease packed thrust bearing was replaced with an oil fed bearing that could provide more preload. The new thrust bearing resulted in no change in response at the same preload used in the earlier runs. A series of tests was conducted in which the preload on the aft bearing was varied by making changes in the axial load on the thrust bearing.

A lower than nominal preload resulted in no change in response. A higher than normal preload raised the rotor speed at which the shift occurred. The measured vibration at the higher speeds was the lowest observed at this time. The thrust bearing failed at 20,500 rpm due to lack of lubrication (additionally, 18,240 rpm was later determined to be the bearing manufacturers recommended maximum speed). With the sudden loss of preload, rotor amplitudes became excessive and the forward roller bearing was overloaded to failure. Damage was limited to the bearings and bearing support structure.

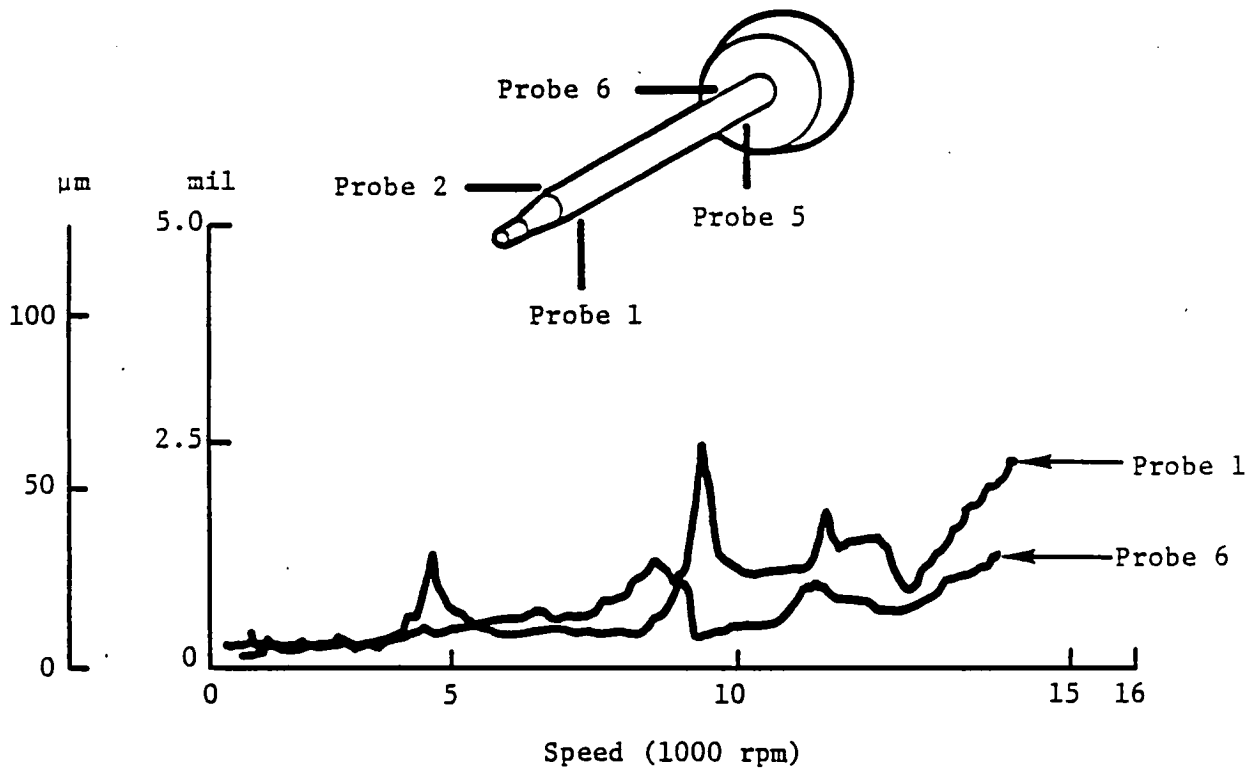
Figure 13 Power Turbine Vibration Before and After Balancing in the HSBS, Serial No. 268922

Rotor 268922 was installed and operated to a speed of 14,100 rpm in the installed condition. A balance calculation based on data at 8,265 and 14,000 rpm followed by a trim calculation at 16,000 rpm reduced the levels as shown in Figure 13. The plots for this rotor show the power turbine first critical speed at approximately 9000 rpm as predicted by analysis.

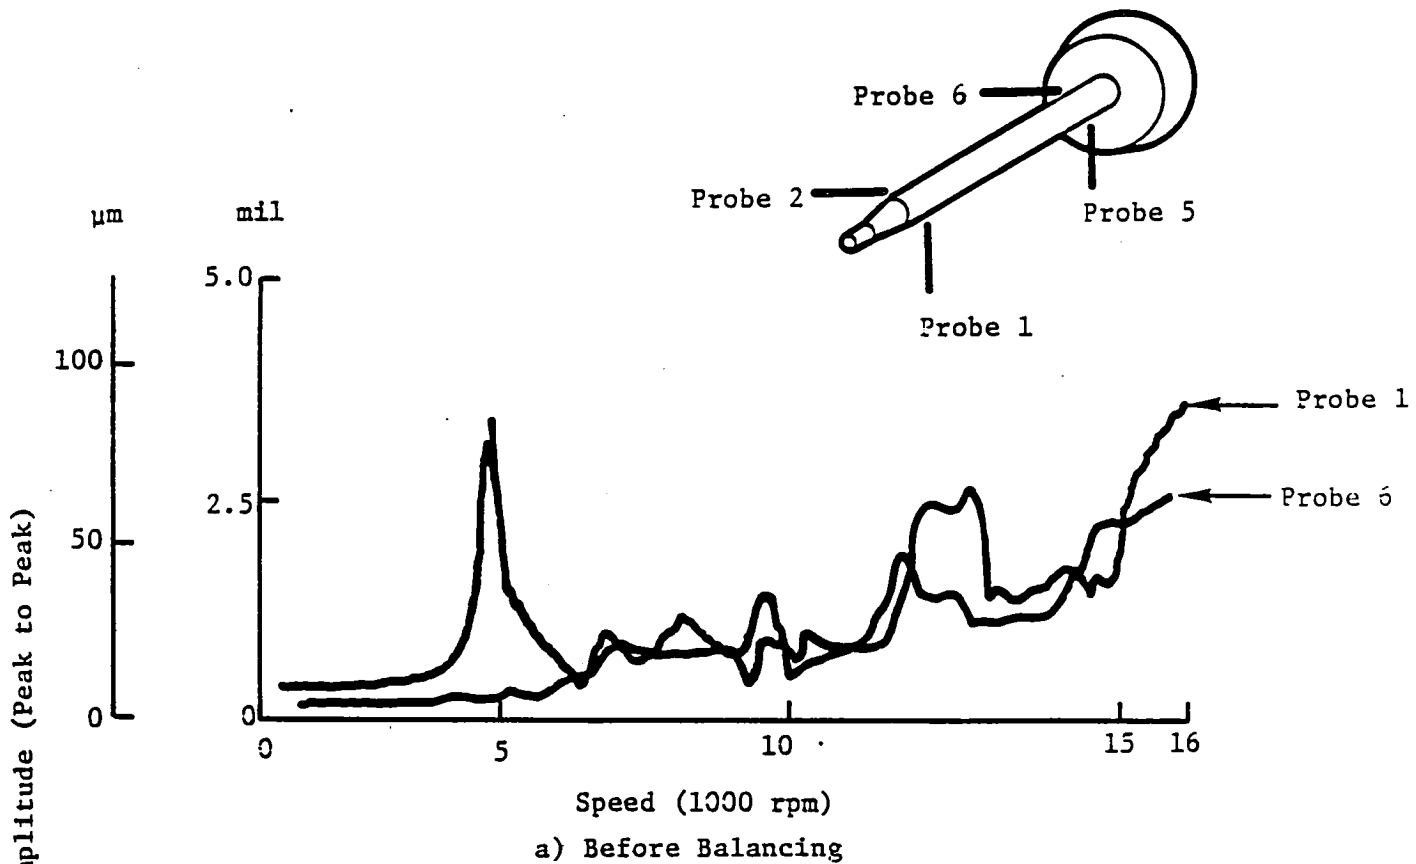
Figure 15 T55 Vibration Level in HSBS (Turbine U00559)

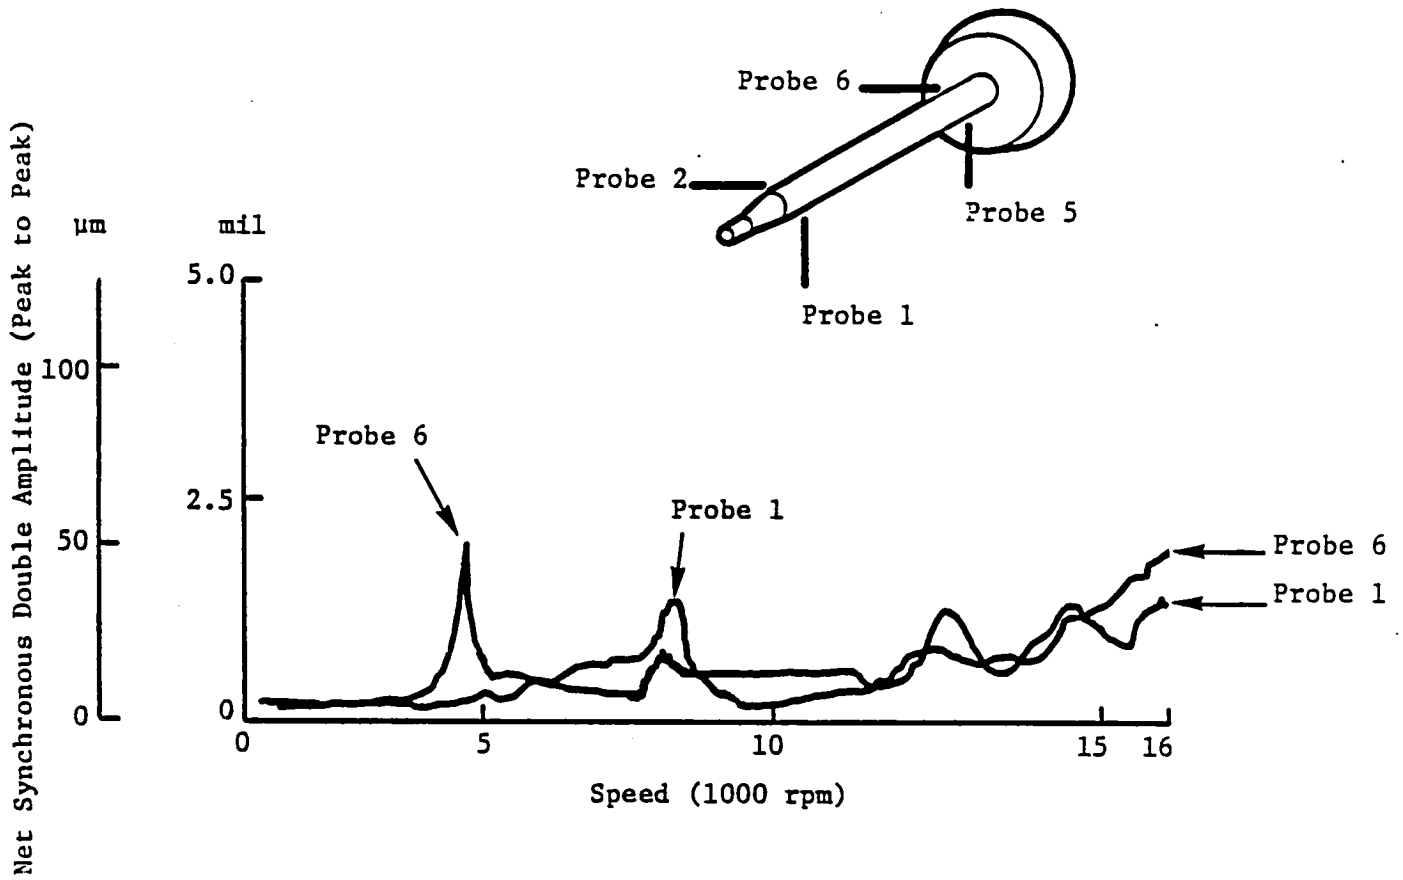
Figure 16 T55 (U00559) Vibration Level After Permanent Balance Weight Grind

The correction weights calculated for rotors U00559 and 268922 were replaced with permanent corrections ground into the rotor. Detailed instructions for material removal are included in the operator's manual. The synchronous amplitude versus speed plots for these two rotors with the permanent correction weights ground in are presented in Figures 16 and 17.

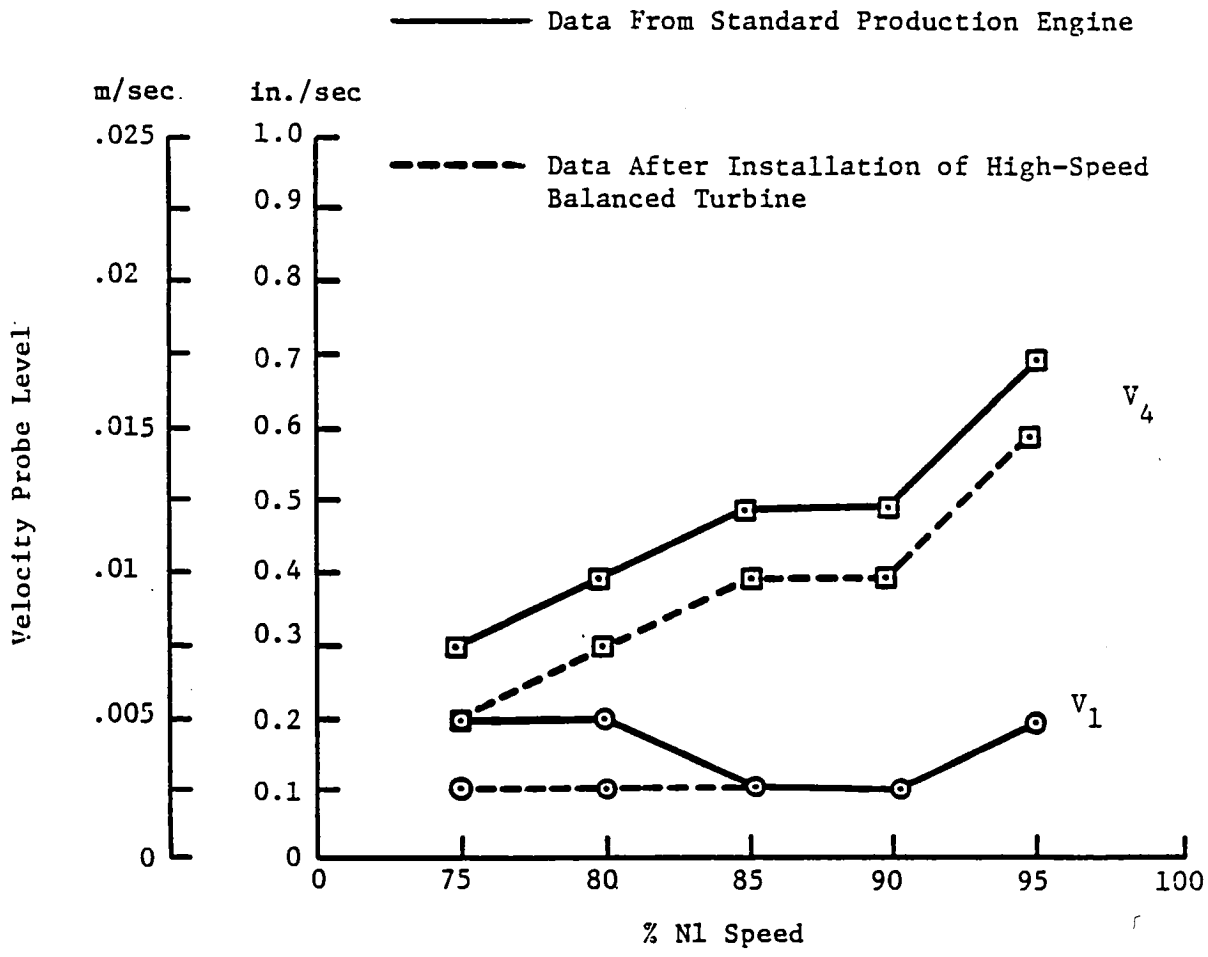
Figure 19 T55 Overall Engine Vibration

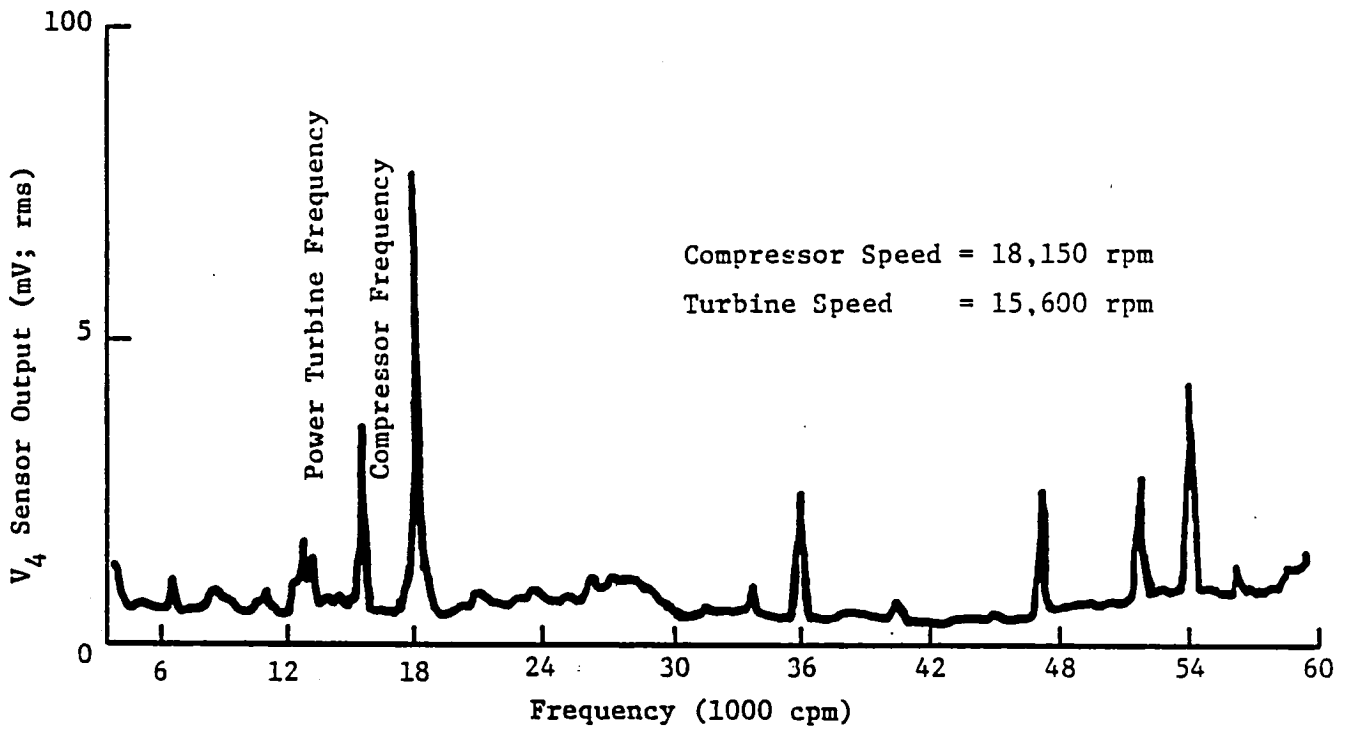
Figure 20 T55 Frequency Spectrum, Serial No. 268922

waterbrake. Even at the lowest power engine setting the V3 sensor has an unacceptable level with all other sensors mounted on the engine reading very low. At the higher speeds there is some transfer of energy to the V4 sensor which is the closest engine sensor to the waterbrake.
