FATIGUE LIFE EXTENSION

D. E. Matejczyk and J. Lin

Rockwell International/Rocketdyne Division
Canoga Park, California

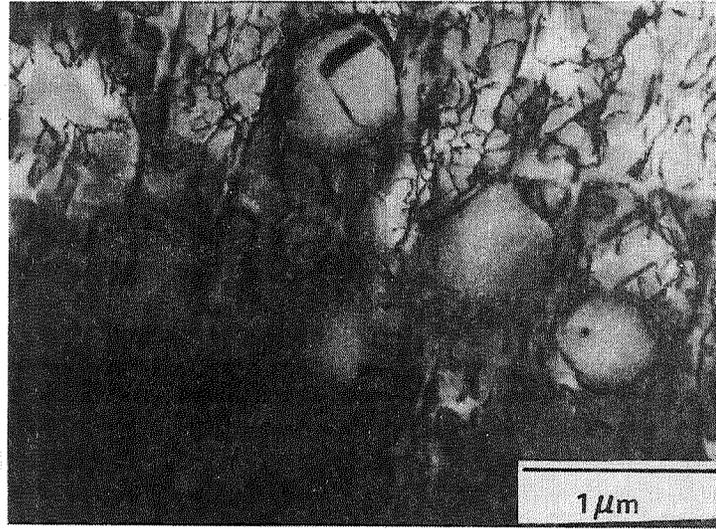
Fig. 9. MAR-M246(Hf) (DS) TEM Micrographs Showing (A) High Dislocation Density Developed During Fatigue Damage and (B) Decreased Dislocation Density and Increase in Stacking Faults and Dislocations at Precipitate Interfaces After Reheat Treatment

Reheat treatment, in this case, was shown to be very effective as a means of rejuvenating the fatigue life of fatigue-damaged MAR-M246(Hf) (DS). Transmission electron microscopy, shown in Fig. 9, revealed that the high dislocation density developed during fatigue exposure is annealed out during reheat treatment. The fatigue damage developed in the vicinity of carbides during fatigue exposure was also evident in the TEM observations (Fig. 10), and further TEM study indicated that some of this localized damage remained following reheat treatment.

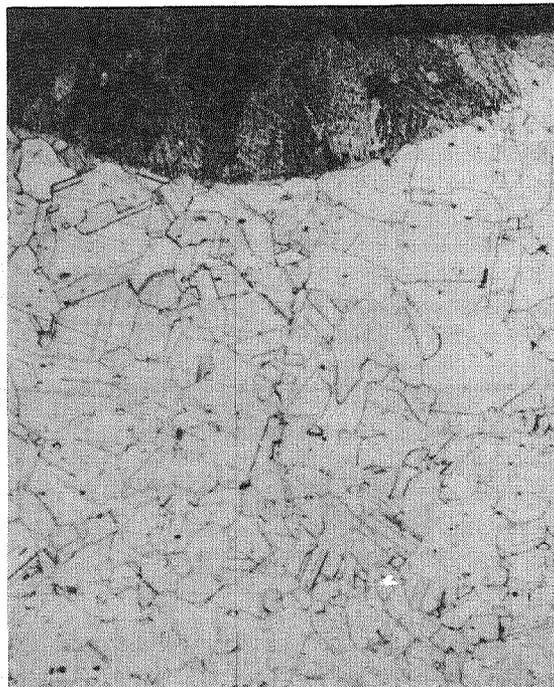
Fig. 12. Inconel 718 that has been Pre-cracked, EB Welded, HIPed, and Reheat Treated. The EB Weld is at the Top of the Photograph. A Trace of the Healed Crack is Evident in the Center.

Specimens were rejuvenated by electron-beam welding to seal the crack opening, HIPing at those conditions listed in Table 2 to heal the crack, and reheat treating to restore the precipitate microstructure (Fig. 12).
