VOYAGER 0.2-lbf THRUSTER VALVE ASSEMBLY SHORT PULSE TEST REPORT

RRC Report No.: 85-R-999

1.0 SUMMARY

The purpose for performing the short pulse width testing on Voyager 0.2-lbf thruster valve assemblies (T/VA's) was to determine the following:

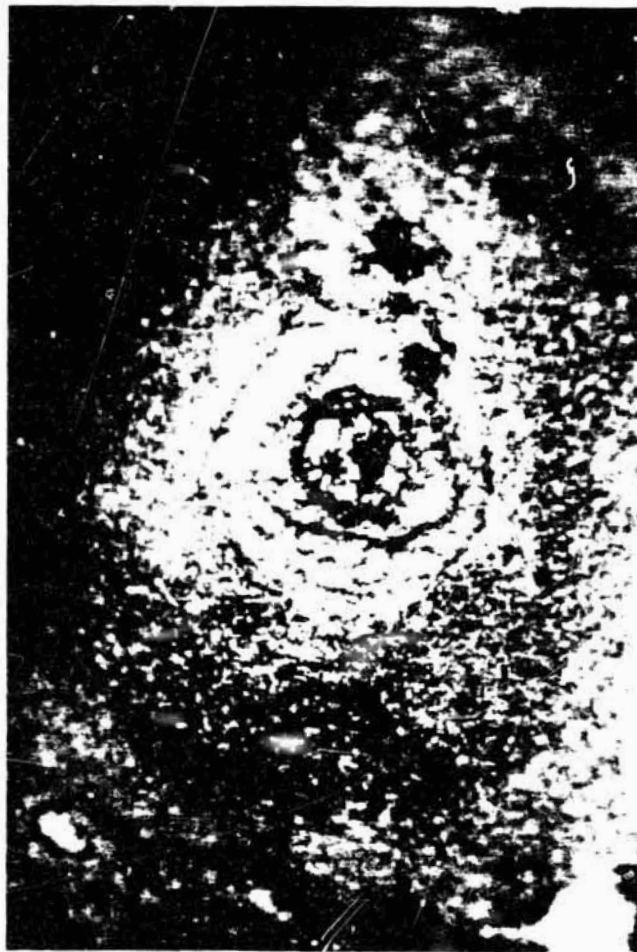
- The downstream injector screens were removed and were observed to have catalyst fines coating the outer edges but the screens were not obstructed. The area in the middle of the screens was very clean.
- The downstream end of the injector was inspected and cause of the partial flow blockage was observed. There was material buildup in the area of the capillary tube. The photograph on Figure 5-1 shows the material buildup causing partial blockage of the capillary tube. Figure 5-2 is a photograph of a section through the downstream end of the injector showing the material buildup in the capillary tube.

0.2 lbf T/A S/N 020 - VIEW OF DOWNSTREAM END OF INJECTOR SHOWING
PARTIAL FLOW BLOCKAGE OF THE CAPILLARY TUBE

- The performance information on T/VA's S/N's 016, 019 and 022 would suggest that none or only minor degradation in thruster life is due to the 25,000 short pulses. The partial flow blockage associated with T/VA S/N 020 suggests that short pulses could seriously reduce thruster life, however, this thruster may have had a substantial buildup of material in the thruster injector capillary tube prior to this short pulse testing. A definite conclusion on the effect of short pulse or thruster life cannot be formulated from the information resulting from this test program.
