NASA Contractor Report 166091

FUEL CONTAINMENT AND DAMAGE TOLERANCE IN LARGE COMPOSITE PRIMARY AIRCRAFT STRUCTURES PHASE I - TESTING

LOCKHEED-CALIFORNIA COMPANY
FATIGUE AND FRACTURE MECHANICS LABORATORY
RYE CANYON RESEARCH LABORATORY
BURBANK, CALIFORNIA

CONTRACT NAS1-16856 March 1983

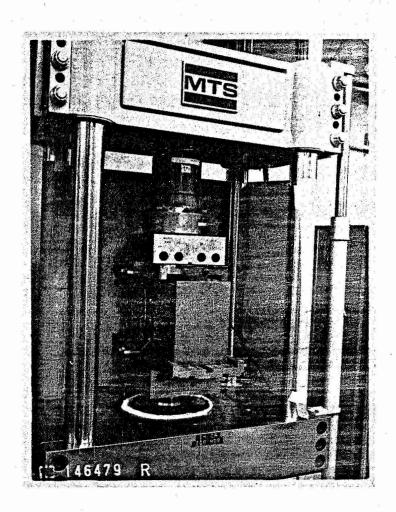
Figure 2-30: Compression Test Fixture Mounted For Test in 200 kip MTS Machine.

An adjustable width compression fixture shown in Figures 2-26 through 2-30 was used for all 5-inch wide tests. Side edges of the specimens were snugly supported by 1/2-inch thick rounded nose plates shown in Figure 2-26. To allow for Poisson expansion in width, 0.020-inch shims were placed on either side of the specimen as shown in Figure 2-26 and then the side supports were brought up into snug contact and bolted down. The shims were then removed. Details of the top loading/support plate are shown in Figure 2-27. This plate was placed on the specimen, and the 1/2-inch thick side support plates were tightened to approximately 20 ft. lbs. Alignment of the top plate was achieved by guide slots on the outboard ends of the plate as seen in Figure 2-28. Likewise bottom width support plates were also tightened. The completed assembly is shown in Figure 2-29, and ready for test in Figure 2-30.

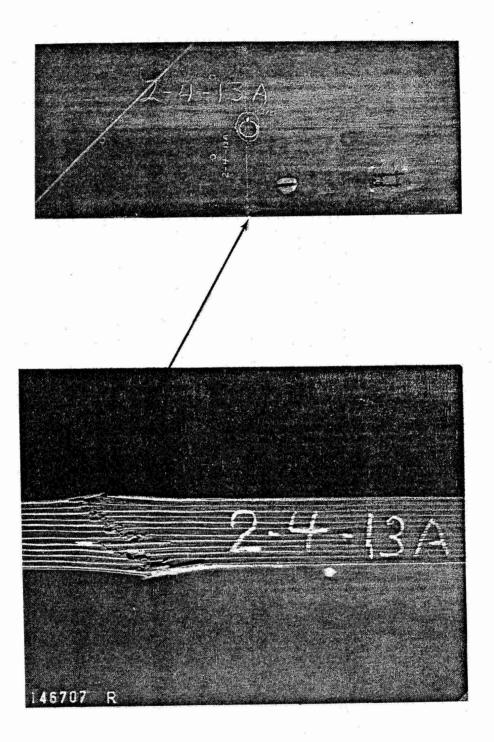
Figure 2-32: Typical Failure of an Impacted Compression Specimen.

Failure is Through the Center of the Impact. The
Bottom Photo Shows a Close-up of the Specimen Edge
in the Failure Zone.

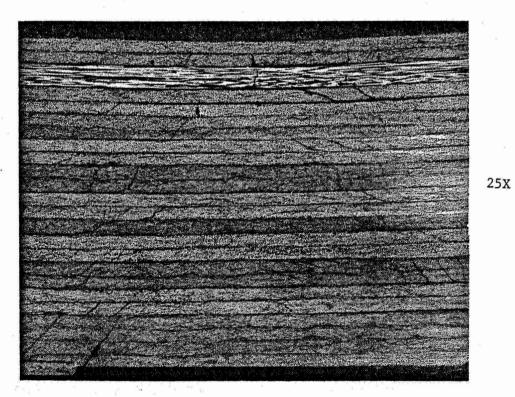
Figure 4-48: Sectional Micrographs of Specimen 14-2 Impacted At 15 Ft.-Lbs.
