MODULE VOLTAGE ISOLATION AND CORROSION RESEARCH

Gordon R. Mon  
Jet Propulsion Laboratory

This paper presents a summary of recent research at JPL on two topics related to achieving long-term reliability of photovoltaic modules: voltage isolation and electrochemical corrosion. Special emphasis is given to similarities and differences in performance between crystalline-silicon modules and amorphous-silicon modules.

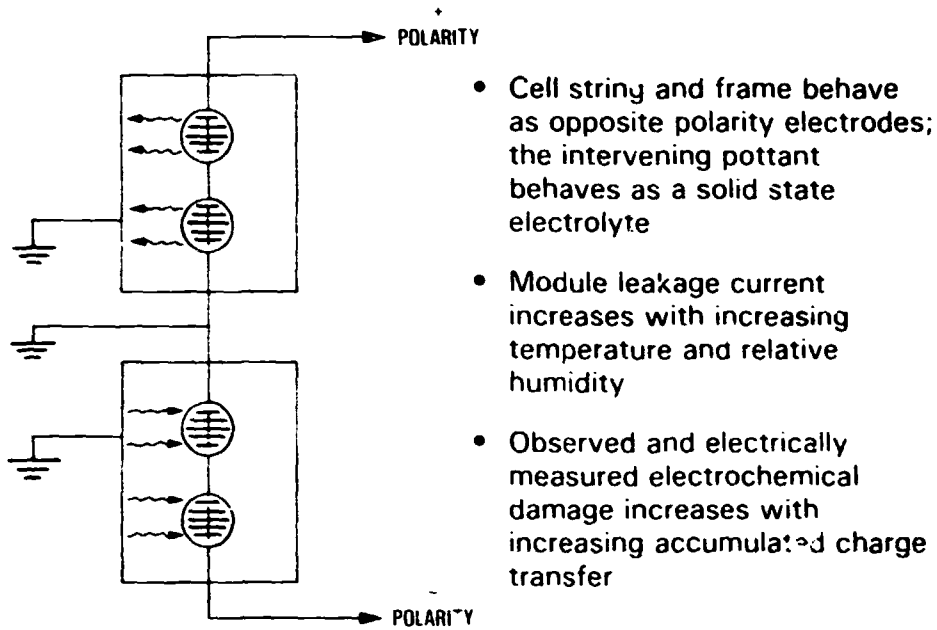
**Figure 4. Relationship Between Leakage Current and Electrochemical Damage**

The fundamental principles of photovoltaic module electrochemical corrosion can be understood with the aid of Figure 4. Leakage current is composed of charge carriers that move under the influence of voltage and concentration gradients through the insulation, reacting with it and with the cell-frame electrodes to produce corrosion products. Leakage current levels are determined in part by the electrical conductivity of the insulation, which varies with changing environmental conditions of temperature, and the relative humidity to which the module is exposed, as indicated for two popular photovoltaic insulations in Figure 5. Note that for the same conditions of temperature and humidity, the conductivity of polyvinyl butyral (PVB) is about three orders of magnitude larger than that of ethylene vinyl acetate (EVA). This will explain in part the higher equilibrium leakage current levels observed in amorphous-silicon modules encapsulated in PVB (Figure 6).

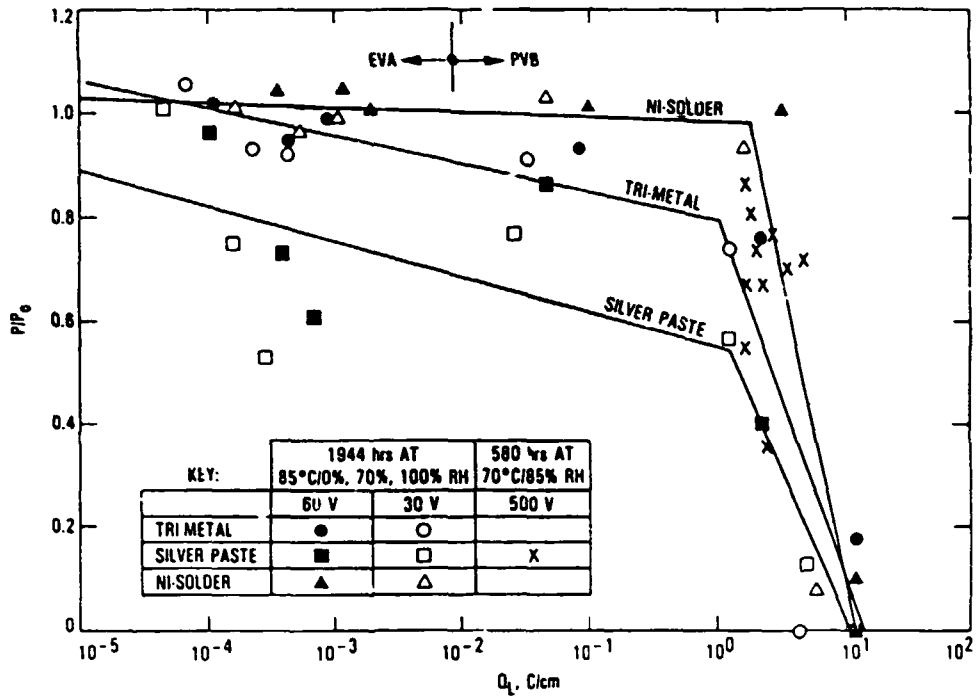
Figure 8. Power Output Reduction vs Accumulated Unit Charge Transfer

Leakage current integrated over time yields charge transferred between the cell-frame electrodes. The quantity of charge transferred is an important measure of the degree of electrochemical corrosion. The cell maximum power output is an important measure of device performance. As environmental exposure continues, the cell power output decreases (Figure 7), as the quantity of charge transferred increases. Quantifying this relationship between total charge transferred and reduction of maximum cell power output for crystalline-silicon modules (Figure 8) and amorphous-silicon modules (Figure 9) reveals similar aging characteristics: 1 to 10 C/cm of charge transferred between cell and frame are required to produce a significant level, say 50%, of cell failures. This observation of a quantitative electrochemical failure threshold enables the prediction of module field life (Reference 2).

It should be emphasized that, although amorphous-silicon module corrosion appears to involve extensive loss of silicon material, the quantitative data of Figures 8 and 9 indicate that corrosion rates are comparable.

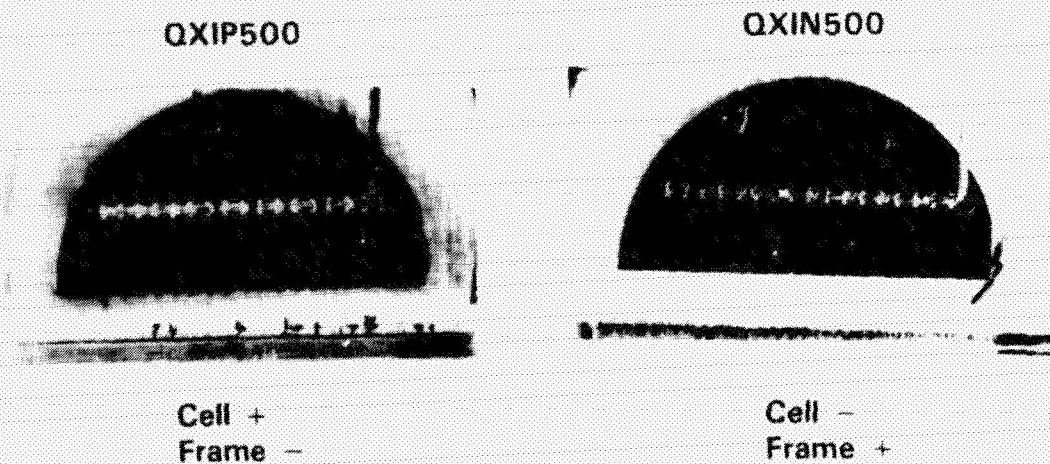
Figure 11. PV Cell Electrochemical Degradation in Two Polarities: 500 V, 580 h at 70°C/85% RH

Typical corrosion observed in crystalline-silicon modules is depicted in Figures 11 through 13. Typical corrosion in positive polarity is characterized by missing cell metallization and the formation of cathodic dendrites; the dissolved metallization ions have migrated to the frame, where they deposit as dendritic crystallites. Typical corrosion in negative polarity exhibits less obvious characteristics to the naked eye, but microscopic examination reveals the formation of anodic corrosion salts and

the evolution of gas bubbles at the metallization-silicon interface, resulting in metallization delamination. Although the corrosion mechanisms in the two polarities differ, the corrosion rates are comparable.

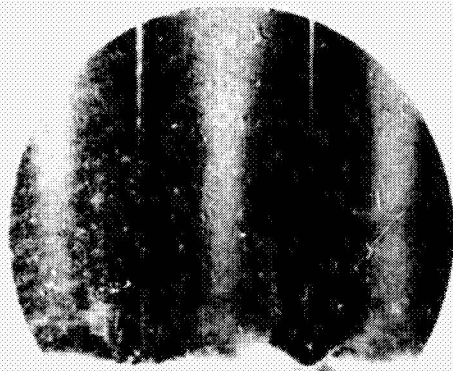
QXIP500

Figure 12. PV Cell Electrochemical Degradation in Two Polarities: 500 V, 580 h at 70°C/85% RH (Cont'd)

Cell +  
showing  
metallization  
dissolution  
and migration

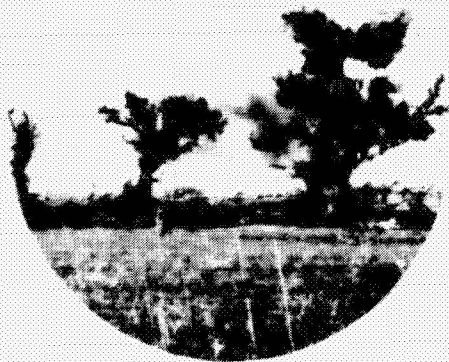
QXIP500

Figure 13. PV Cell Electrochemical Degradation in Two  
Polarities: 500 V, 580 h at 70°C/85% RH  
(Cont'd)

Frame -  
showing  
dendrite  
formation

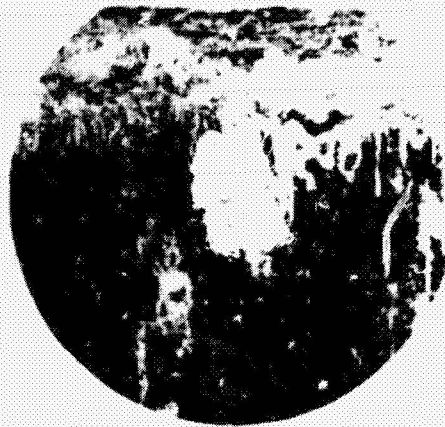
QXIN500

Frame +  
showing  
white "fuzzball"  
corrosion salts

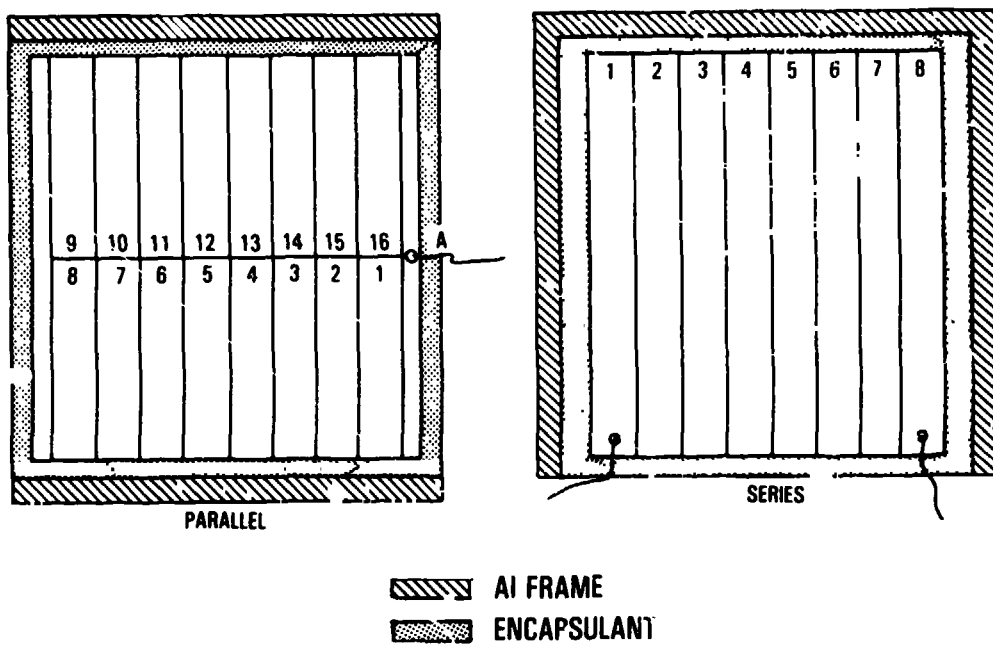
Figure 14. Amorphous Modules: Series and Parallel Configurations

Two amorphous-silicon configurations tested are shown in Figure 14. The parallel modules consist of 16 separate amorphous-silicon cells, all of which share a common electrode--the SnO<sub>2</sub> layer deposited on the underside of the glass superstrate. The series modules consist of eight amorphous-silicon cells interconnected in a series-circuit configuration. The individual module units are encapsulated, together with aluminum bars serving as frames, in either PVB or EVA and are then exposed for more than 300 hours in an environmental chamber held at 85°C and 85% RH, with 500 volts applied between cell and frame. Front and rear views of the actual parallel modules are shown in Figures 15 and 16; front and back views of the actual series modules are shown in Figures 17 and 18. Note that wire attachments to individual cells in Figures 16 and 18 were accomplished with the use of Cho-bond silver epoxy. Note also that the series modules in Figure 18 arrived from the manufacturer with a layer of protective black paint on their rear surfaces; this paint layer was removed from all modules save No. 3 before testing. This negative-polarity series module encapsulated in EVA underwent a chemical reaction at the paint-metallization interface: the metallization extending beyond the paint edge began to disappear after 40 hours of exposure (Figure 19), and had completely disappeared after 130 hours (Figure 20).

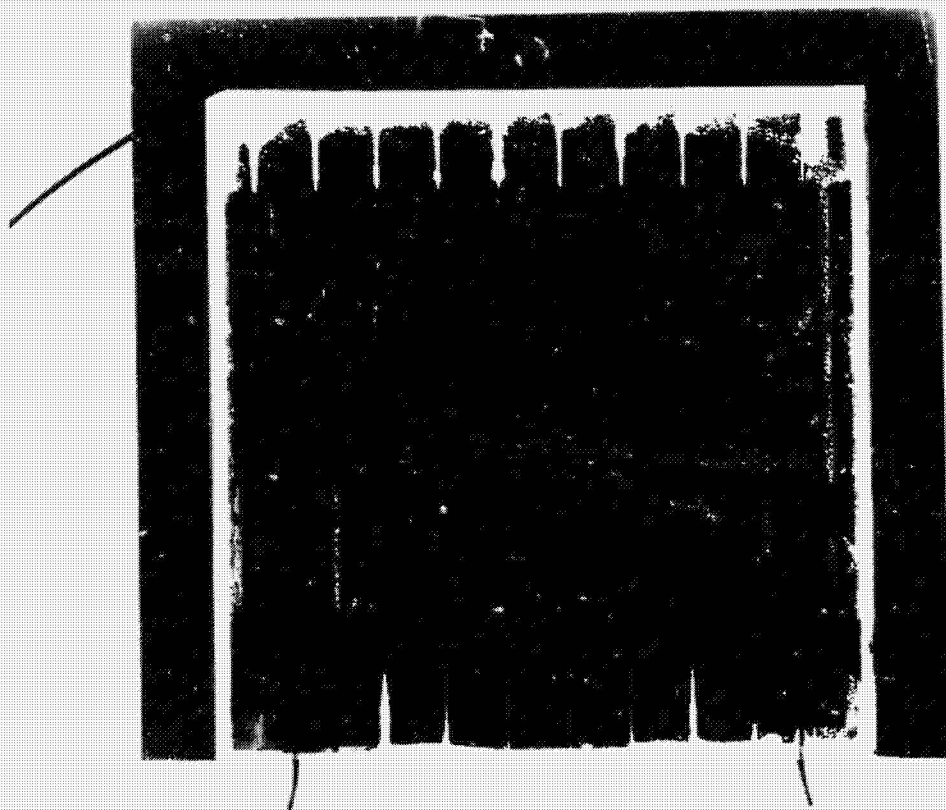
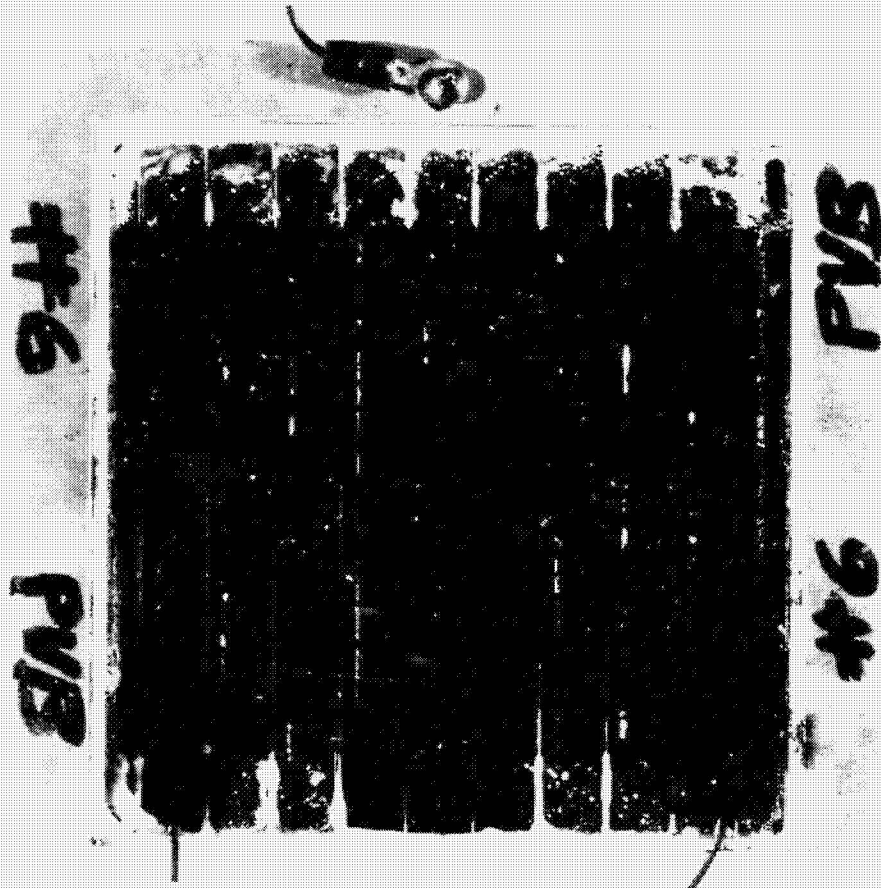
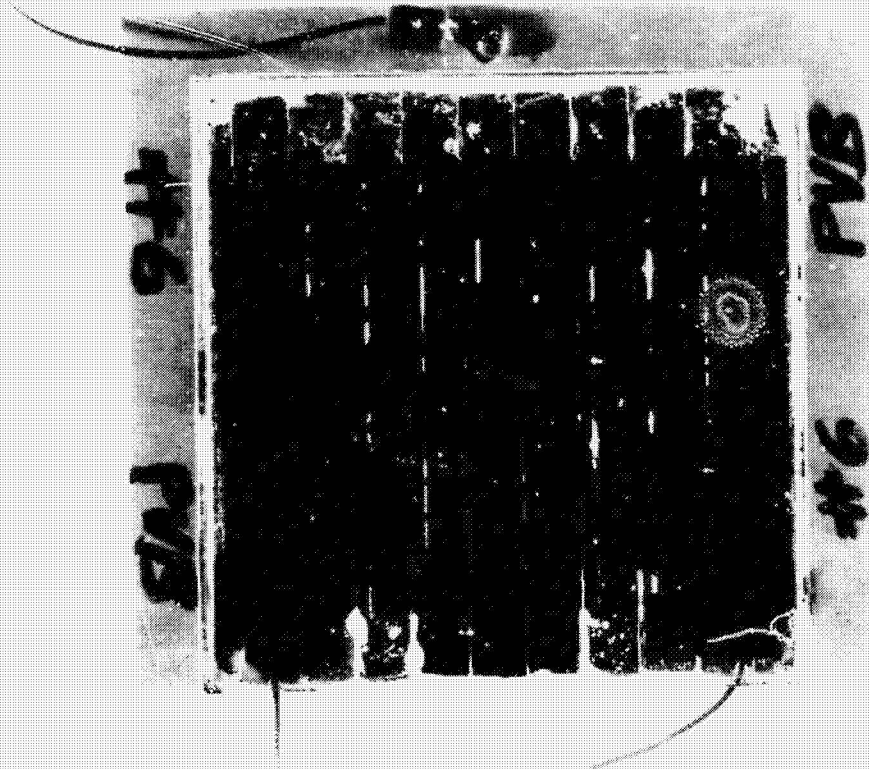
Figures 21 through 23 show a front-face view of progressive corrosion of series module No. 6 (negative polarity, PVB) at 40, 130, and 300 hours, respectively. Note the progressive pinhole-like loss of metallization and amorphous silicon. Note also the squiggly, worm-like configurations generated by the loss of metallization. Figures 24 through 26 show front views of progressive corrosion of the same module. Clearly, some type of ion is moving from the frame toward the center of the module, perhaps an impurity in the PVD.
