NASA TM-86537

CORROSION FATIGUE OF 2219-T87 ALUMINUM ALLOY

By Vernotto C. McMillan

Corrosion Research Branch  
Materials and Processes Laboratory

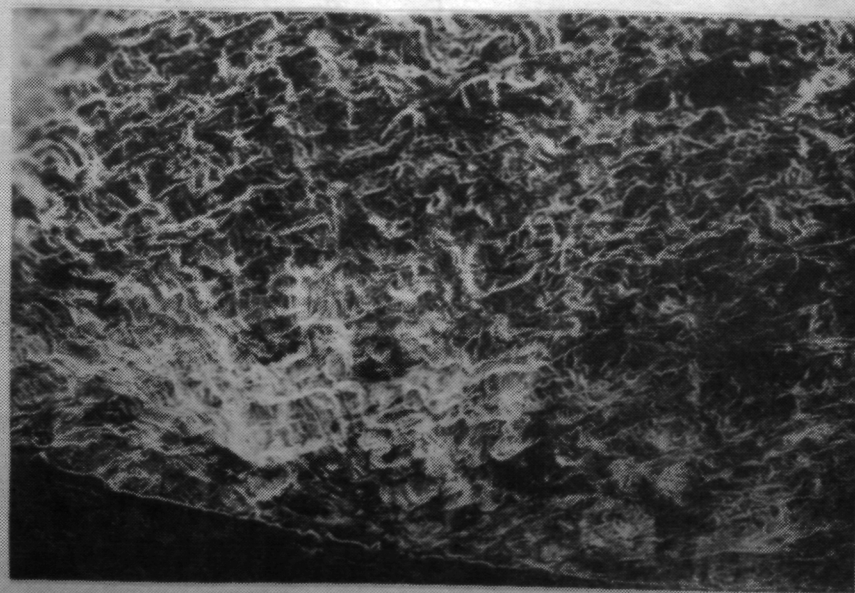
AIR

19,390,000 CYCLES

100 PPM NaCl

1,333,000 CYCLES

Figure 6. SEM micrographs of fractured 2219 Al (Bare).

To determine the relative effect of fatigue strength loss due to the presence of corrosive mediums, ratios of CFS to endurance limits in air were calculated. These results are recorded in Table 4. The corrosion fatigue strength of 2219-T87 aluminum alloy was increasingly reduced as the corrosivity of the environment was increased. A further indication of the effects of corrosion can be seen in Figures 6 through 9 which show SEM fractographs of 2219-T87 aluminum in air and salt water environments. Figure 6 illustrates fatigue fractures of bare 2219 aluminum in air (typical fatigue failure), and 100 ppm NaCl where the predominant failure mode was corrosion. Figures 7, 8, and 9 show corrosion fatigue fractures of bare, conversion coated, and anodized aluminum samples, respectively, all exposed in a 3.5 percent NaCl environment. These fractographs reveal the actual pits that initiated failure.

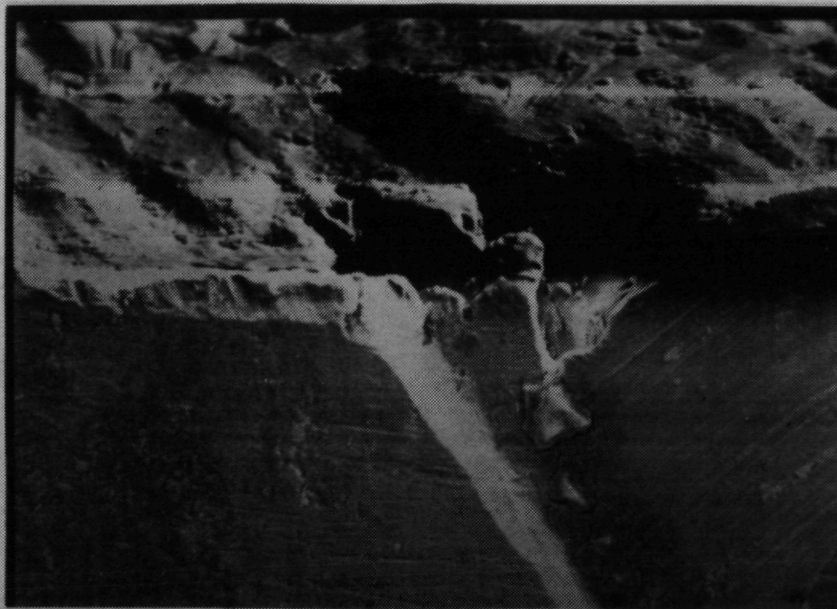
Figure 7. SEM micrograph of fractured bare 2219 Al test sample exposed in 3.5 percent NaCl environment.
