# **THERMAL BARRIER COATING LIFE PREDICTION MODEL**

## **FIRST ANNUAL REPORT**

By  
**R.V. Hillery  
B.H. Pilsner**

**General Electric Company  
Aircraft Engine Business Group  
Cincinnati, Ohio 45215  
April 1985**

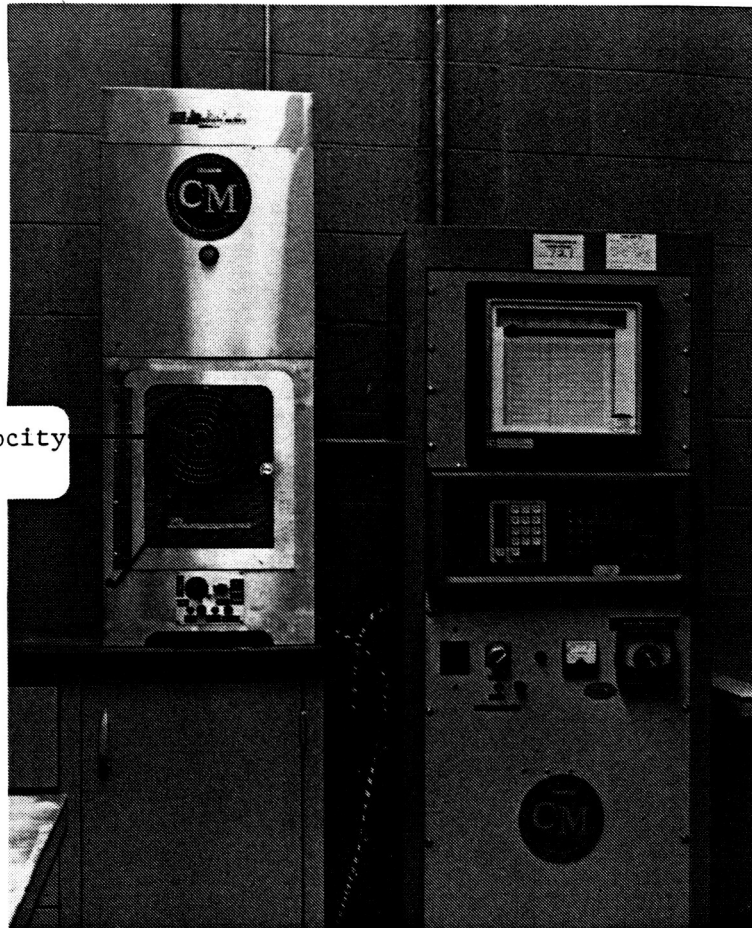
### RAPID TEMPERATURE FURNACE

low velocity  
fan

- 10 minute heat up
- 45 minute exposure at 2000 F
- 15 minute forced air cooling

Thermal cycling of the pre-exposed specimens was accomplished in a programmable, microprocessor controlled, rapid-heating furnace with  $\text{MoSi}_2$  heating elements to a maximum temperature of 1093°C (2000°F) (Figure 4). The complete set of specimens (Table III) was cycled simultaneously. The thermal cycle was approximately 70 minutes long with approximately 10 minutes heat up, 45 minutes at temperature (1093°C), and 15 minutes forced air cooling. Specimens were removed from the test apparatus after every fifth cycle and visually examined for evidence of cracking and loss of the zirconia layer. Each specimen was removed from test when 10 percent of the zirconia layer had spalled. Selected specimens were evaluated metallographically.

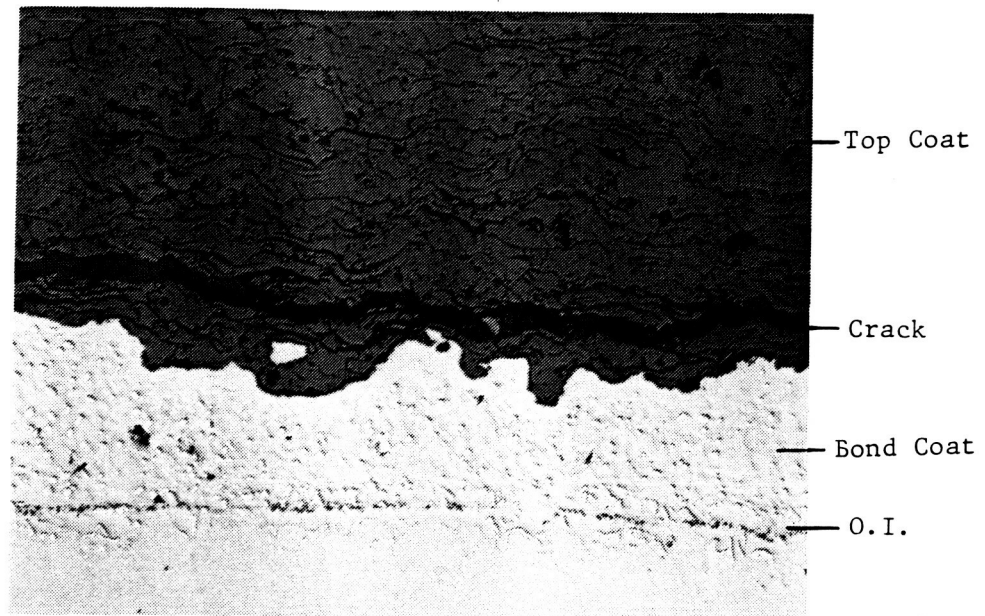
Figure 20 Microstructure of TBC at failure location  
after thermal cycle testing

a) 100 hour argon pre-exposure  
( 50 cycles )

b) 100 hour air pre-exposure  
( 65 cycles)

Unexpectedly, the specimen pre-exposed in argon failed before the specimens pre-exposed in air (Figures 18, 19). Failures in all cases occurred in the ceramic top coat (Figure 20) approximately 0.025 - 0.050 mm (.001 - .002") from the bond coat/top coat interface (normal TBC failure location). Continuous oxide scales of 3-4  $\mu\text{m}$  (excluding the 472 hour pre-exposure (Table VIII and Figures 21, 22) were observed at the bond coat/top coat interface for the as-sprayed and air pre-exposed specimens after thermal cycle testing at failure. This is contrasted with the specimens pre-exposed in argon where oxide scales generally less than 1  $\mu\text{m}$  developed and appeared non-continuous by optical microscopy (Figures 23, 24) after thermal cycle testing.
