# Advanced Powder Metallurgy Aluminum Alloys via Rapid Solidification Technology - Phase II

Ranjan Ray and Sunil C. Jha

MARKO MATERIALS, INC.  
NORTH BILLERICA, MA 01862

CONTRACT NO. NAS1-18001  
April 1987

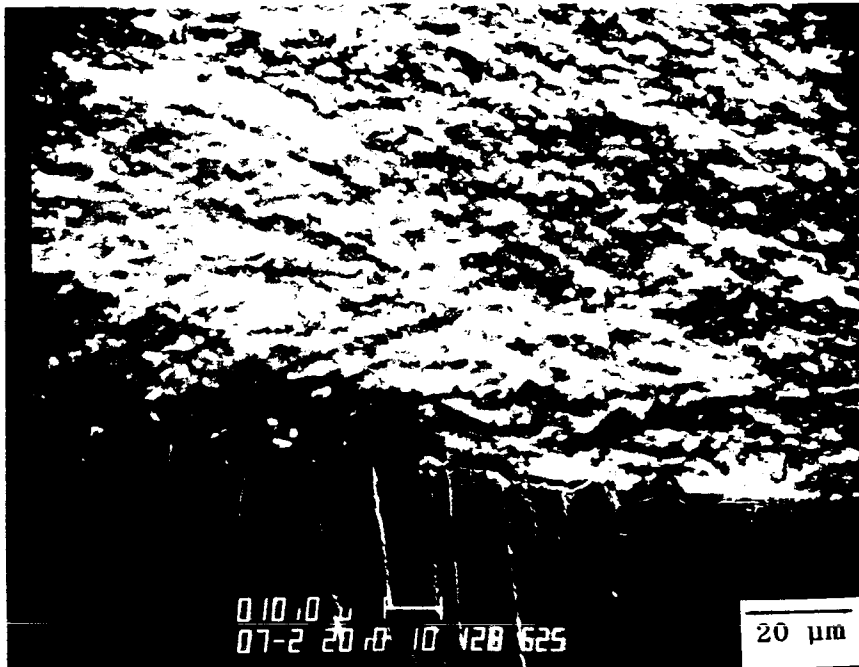
FIGURE 79 SEM and EDXA of the General Fracture Surface in the Propagation Region Near Fracture Origin of the Specimen in Figure 77
