DOT/FAA/CT-87/10

Summary Report--Full-Scale Transport Controlled Impact Demonstration Program

September 1987

Final Report

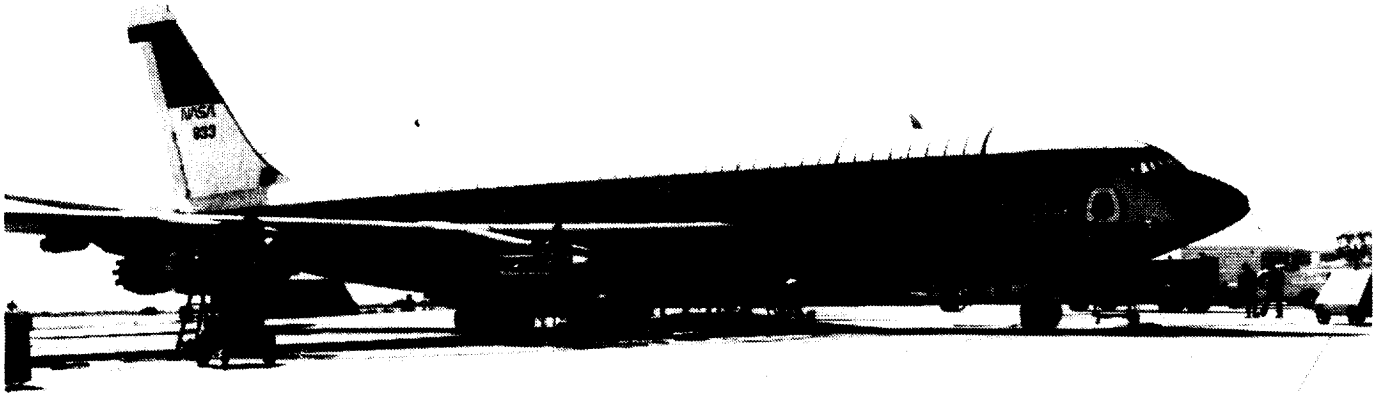
FIGURE 1. CID/BOEING 720

The CID aircraft contained the necessary systems, components, instrumentation, and data acquisition systems to support the AMK, crashworthiness, and fire safety experiments. Current and new generation flight data and cockpit voice recorders were installed. Passive and benign hazardous materials packages were located under the galley area for this test. The RPV/FCS (ground and airborne) were integrated in the B720 to provide remote controlled air-to-surface impact.

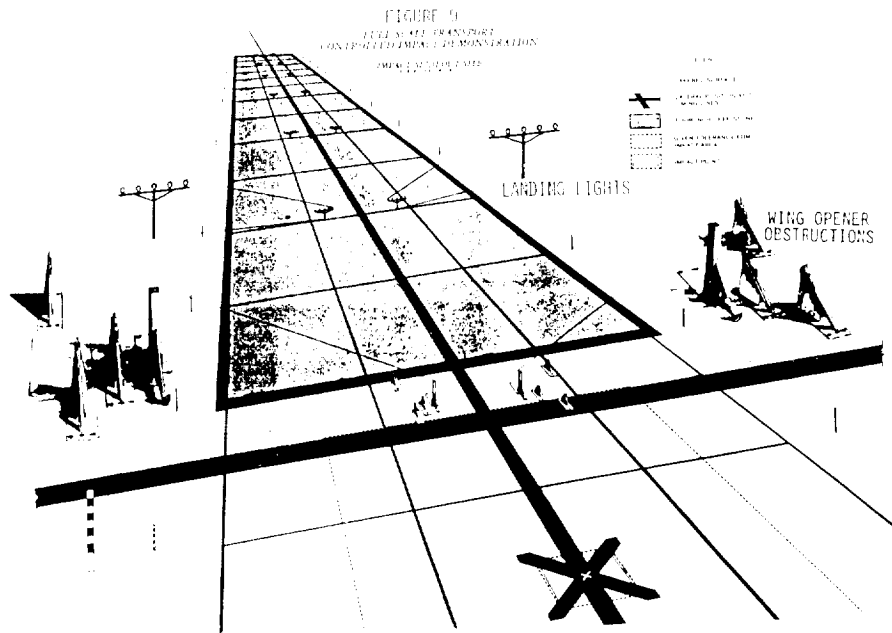
FIGURE 2. IMPACT/SLIDEOUT SITE

Impact Site. The CID test area was located on Rogers Dry Lake immediately adjacent to the Edwards Air Force Base Precision Active Impact Range Area (PAIRA). The impact site (figures 2 and 3) was covered with a 4- to 6-inch deep layer of 1-1/2 inch diameter hard rock for a distance of 1,200 feet by 300 feet wide.

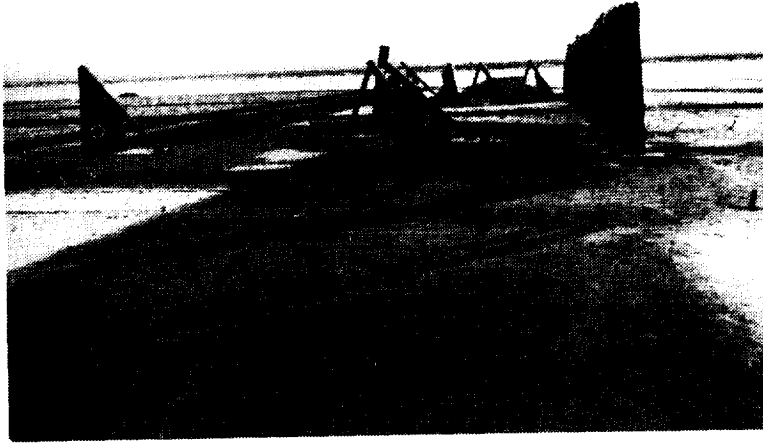
FIGURE 4. WING OPENERS

Eight wing openers (figure 4) were located between 50 and 100 feet past the planned impact point. Contact by the leading edge of the wing will cause the lower half of the wing opener to rotate upwards and cut into the lower portion of the wing, rupturing the fuel tanks. Each wing opener weighs approximately 400 pounds and is 8 feet by 7 feet long (blade part) by 2 feet wide. For RPV pilot visual target alignment and aiming, a black fence (figure 5) with an international orange center was installed in front of the wing openers.

As described in the previous section, "Impact Scenario--Actual," instead of hitting the impact site symmetrical, the aircraft was yawed to the left when it struck the ground. This yaw resulted in one of the steel wing openers at the impact site hitting and destroying the right inboard engine prior to cutting and severing the right wing. A large fire occurred as a result of severing pressurized degraded AMK fuel, oil, and hydraulic lines in the engine and strut compartments. Simultaneously, the wing failed, pouring fuel onto the ruptured combustor area. Other wing openers penetrated the lower right fuselage enabling burning fuel to enter the aircraft.

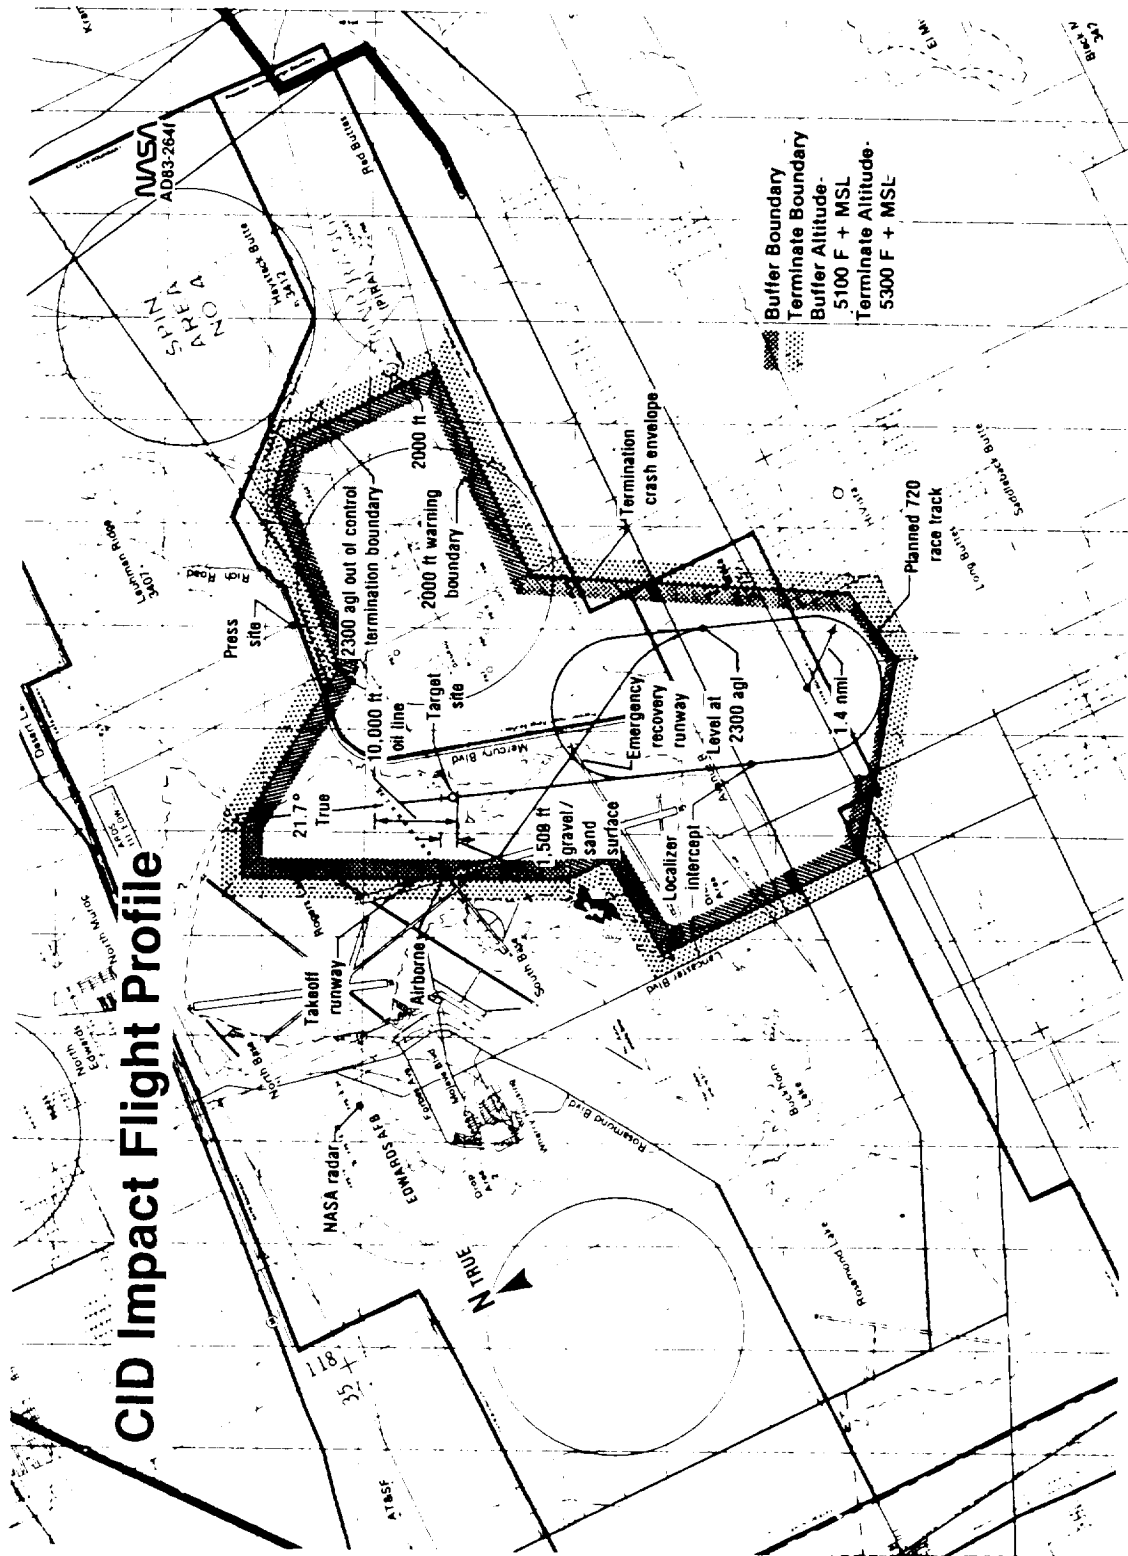
FIGURE 8. CID IMPACT FLIGHT PROFILES

The final "unmanned" CID was to fly the flight profile (figure 8) after a series of engine/systems/experiments ground checks. The final flight time was to last less than 9 minutes. The aircraft will takeoff from the lakebed, climb to 2,300 feet, and circle the dry lakebed to intercept a simulated instrument landing system beam. At the intercept, the remote pilot on the ground sets up an approach speed, altitude and sink rate, and begins the descent.

The aircraft will descend along a glide slope at a controlled sink rate. It will strike the prepared impact area in a nose-up attitude with the wheels retracted and wing flaps set at 30 degrees. Almost immediately after impact, the wings will strike a series of wing openers for the purpose of rupturing the fuel tanks allowing fuel to be released into the airstream and creating potential fire situation.

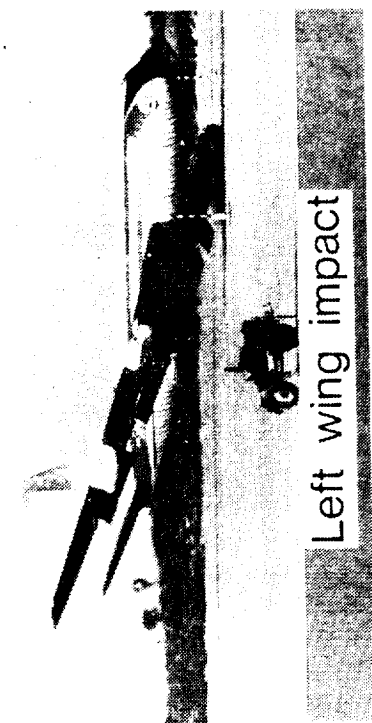
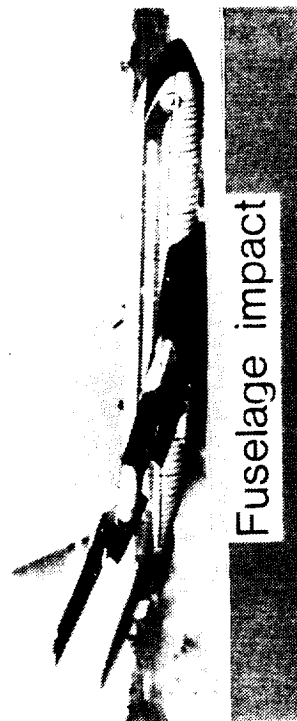
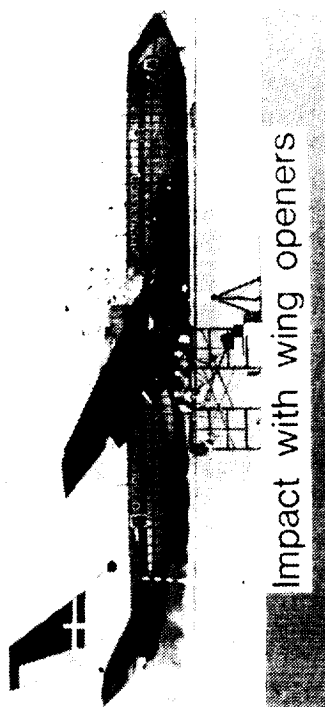
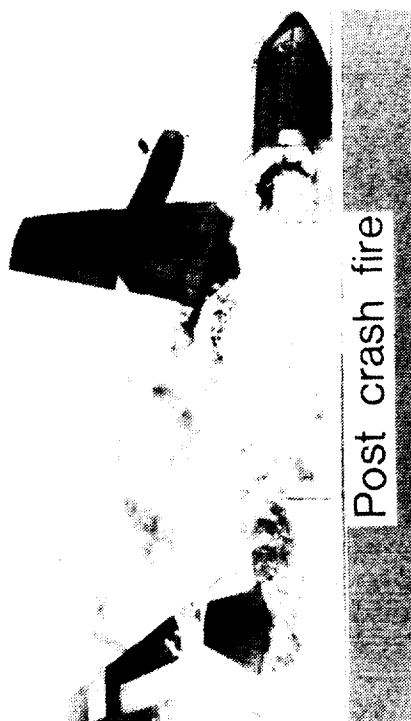
FIGURE 9. CID IMPACT SEQUENCE

The innermost cutter entered the wing leading edge passing through and slashing diagonally through the lower skin and the Number 3 main fuel tank inboard end rib. Part of this cutter was found in the aft lower cargo compartment.

The flame which initiated at Number 3 engine continued to burn with the fire flowing over the fuselage as the aircraft continued its slide-out with the yaw angle constantly increasing until the aircraft came to rest. The initial fire was the result of ignited degraded fuel lubricating oil, and hydraulic fluid. This, added to the heat released from the destructing engine, was fed fuel through the ruptured fuel inlet line to the degrader (for as long as the wing was unseparated). Once the wing did separate, the fuel to the fire was still fed through the cross-feed fuel line in the wing from the override boost pump in the left "cheek" tank. All engines on the aircraft were operating off this tank and boost pump during the CID.

The total time from initial contact of the Number 1 engine until the aircraft came to rest was 11 seconds. The fire, as the aircraft came to rest, diminished greatly. The total time of the fire at its fuselage-involving state was 9 seconds. At the time the fire diminished, the fuselage exterior was not visually damaged to any degree by the flame. All paint instrumentation lines and aircraft markings were plainly visible.

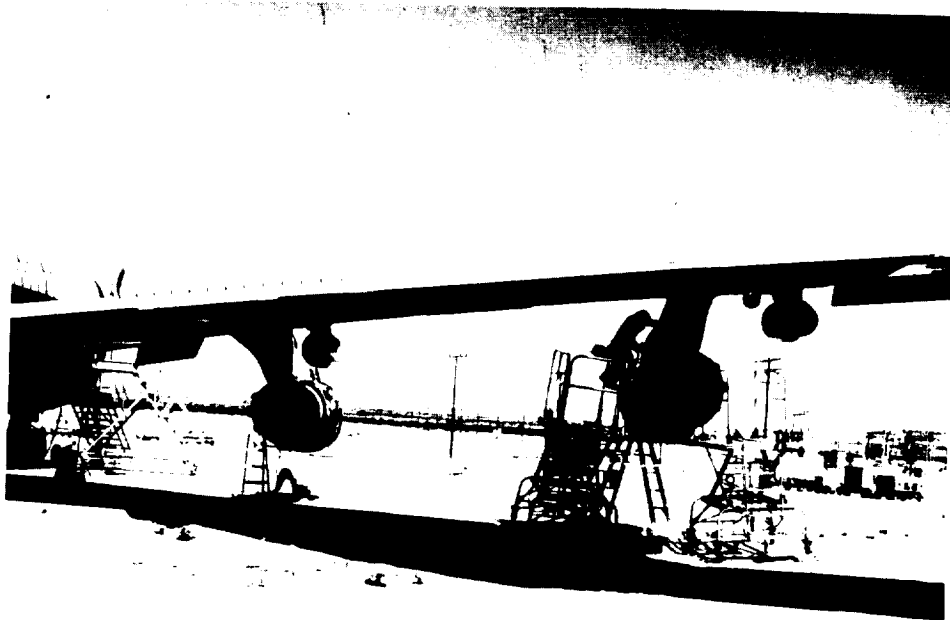
FIGURE 11. ENGINE/DEGRADER SYSTEM INSTALLATION

Engine/degrader system (figure 11) operation was as planned with no anomalies. Up to the DOF, the degrader (figures 12 and 13) operational experience was as follows:

The degraders were each started first and then the companion engine brought up to idle. Degrader operation was a nominal 21K RPM and engine(s) idle at ≈ 66 to 67 percent N₂. At impact, degrader speed was ≈ 21K RPM and engine speed at 74 to 77 percent N₂. All degrader/engine systems performed flawlessly. Total fuel consumed estimated at 1,191 gallons.

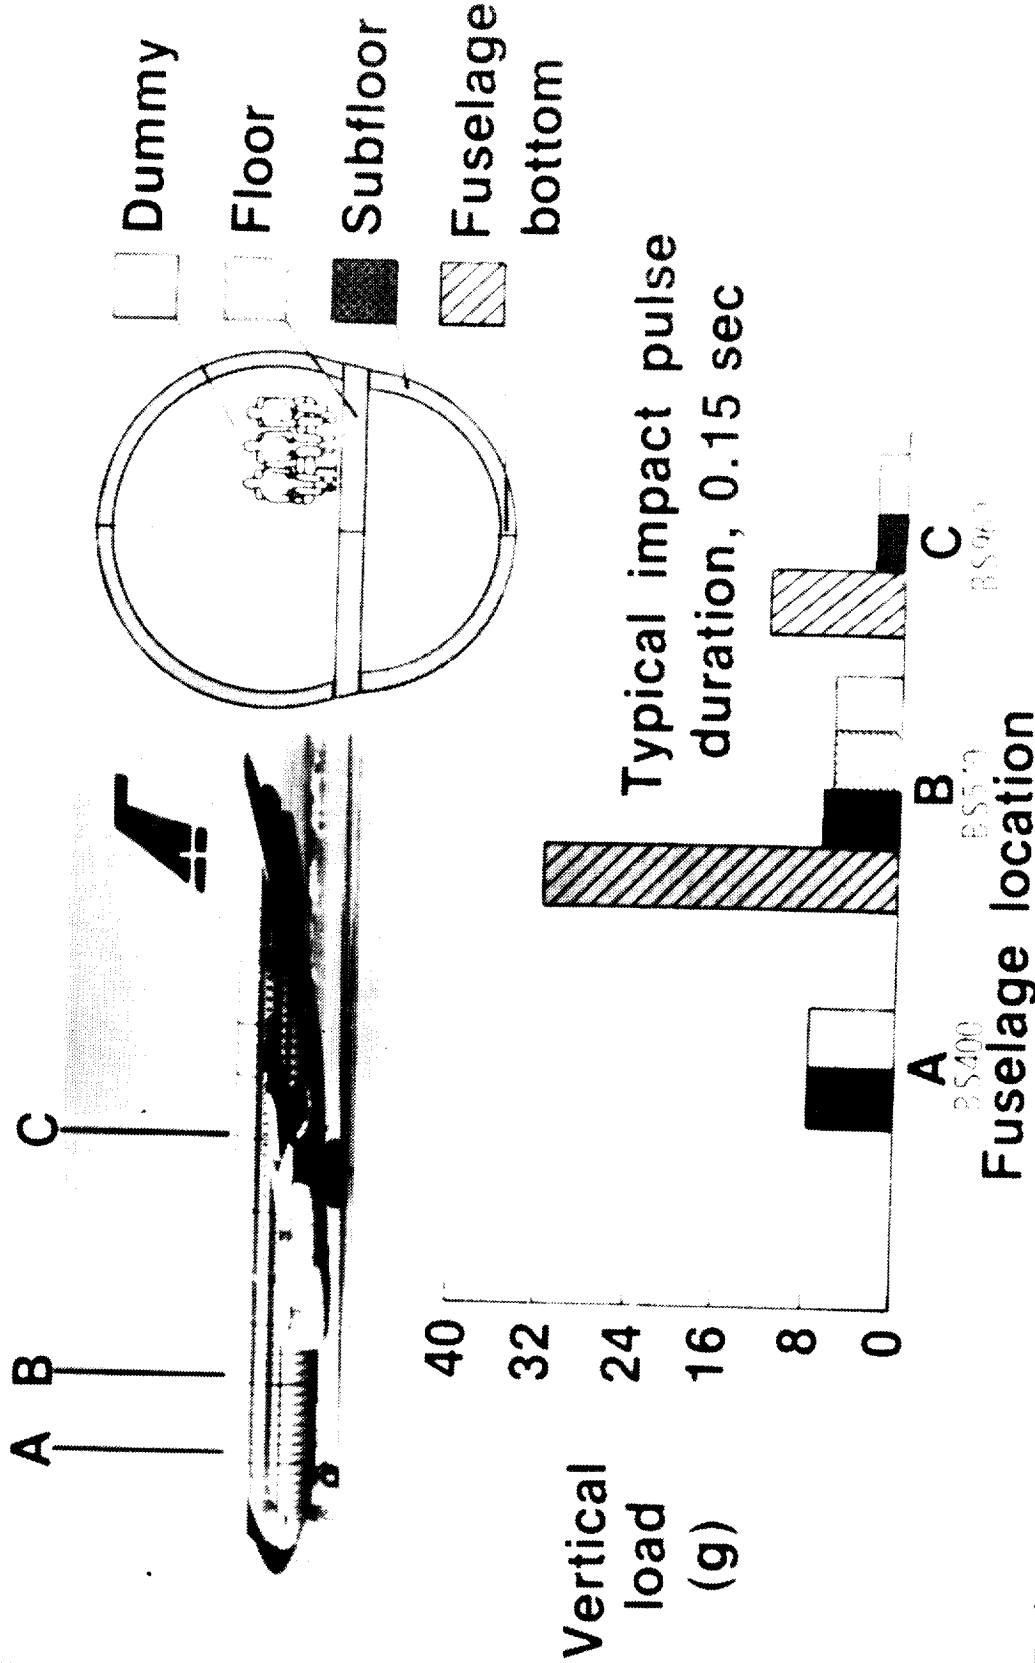
FIGURE 16. AIRCRAFT STRUCTURAL RESPONSE

Vertical	3.0 for 0.10 seconds
Longitudinal	5.0 for 0.14 seconds
Lateral	2.0 for 0.09 seconds

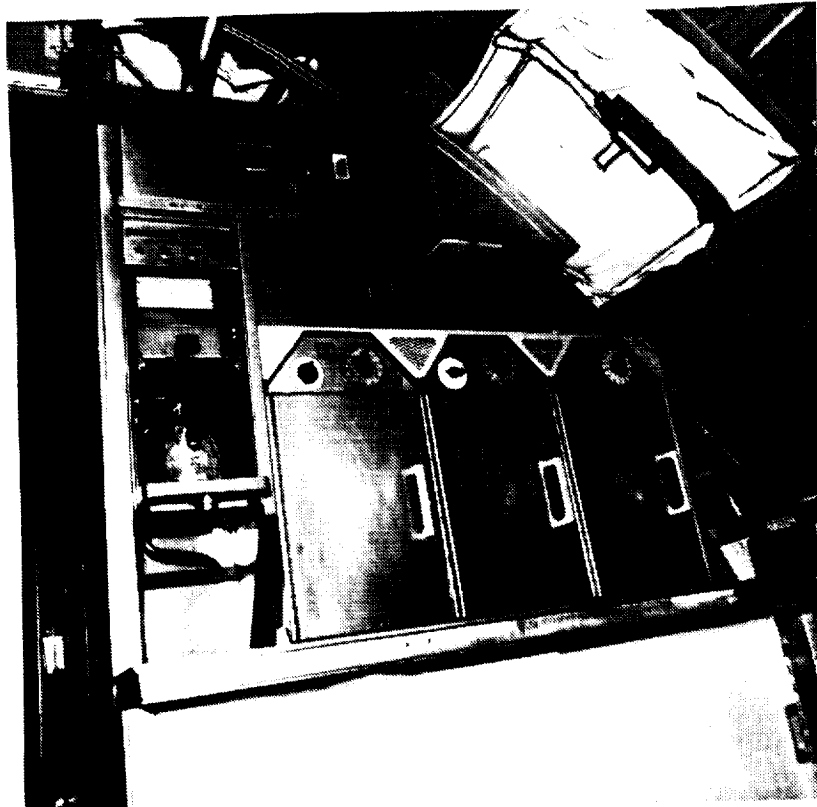
FIGURE 17. FORWARD GALLEY INSTALLATION

The CID stowage and galley compartment experiments consisted of two galley modules (filled to volume capacity) located in the forward starboard side of the aircraft and two overhead stowage compartments (filled to capacity weight) mounted aft the galley modules. While the galleys were not instrumented, accelerometers were installed at nearby structural support areas. The overhead occupant compartment supports were instrumented with three load cells and a traix accelerometer installed on one of two 75-pound test weights.

As observed on film, during the initial ground impact, one overhead compartment door opened while both the galley modules stayed intact, including their internal contents. Post-impact examination showed that fire had destroyed one overhead compartment and partially destroyed the other. The forward galley showed partial fire damage while the aft galley, including contents, showed minor damage (mainly soot).

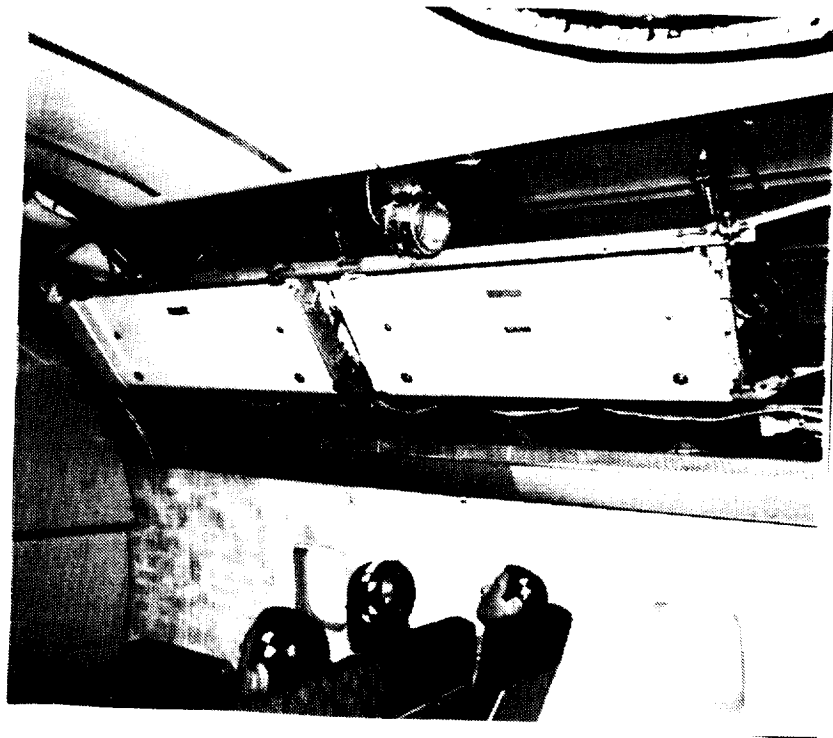
FIGURE 19. OVERHEAD COMPARTMENTS

Based upon the observed film and posttest examination, the CID impact loads appeared to be less than the design strengths of both the galleys and overhead compartment restraint means. The inadvertent opening of the overhead compartment doors must be further assessed.

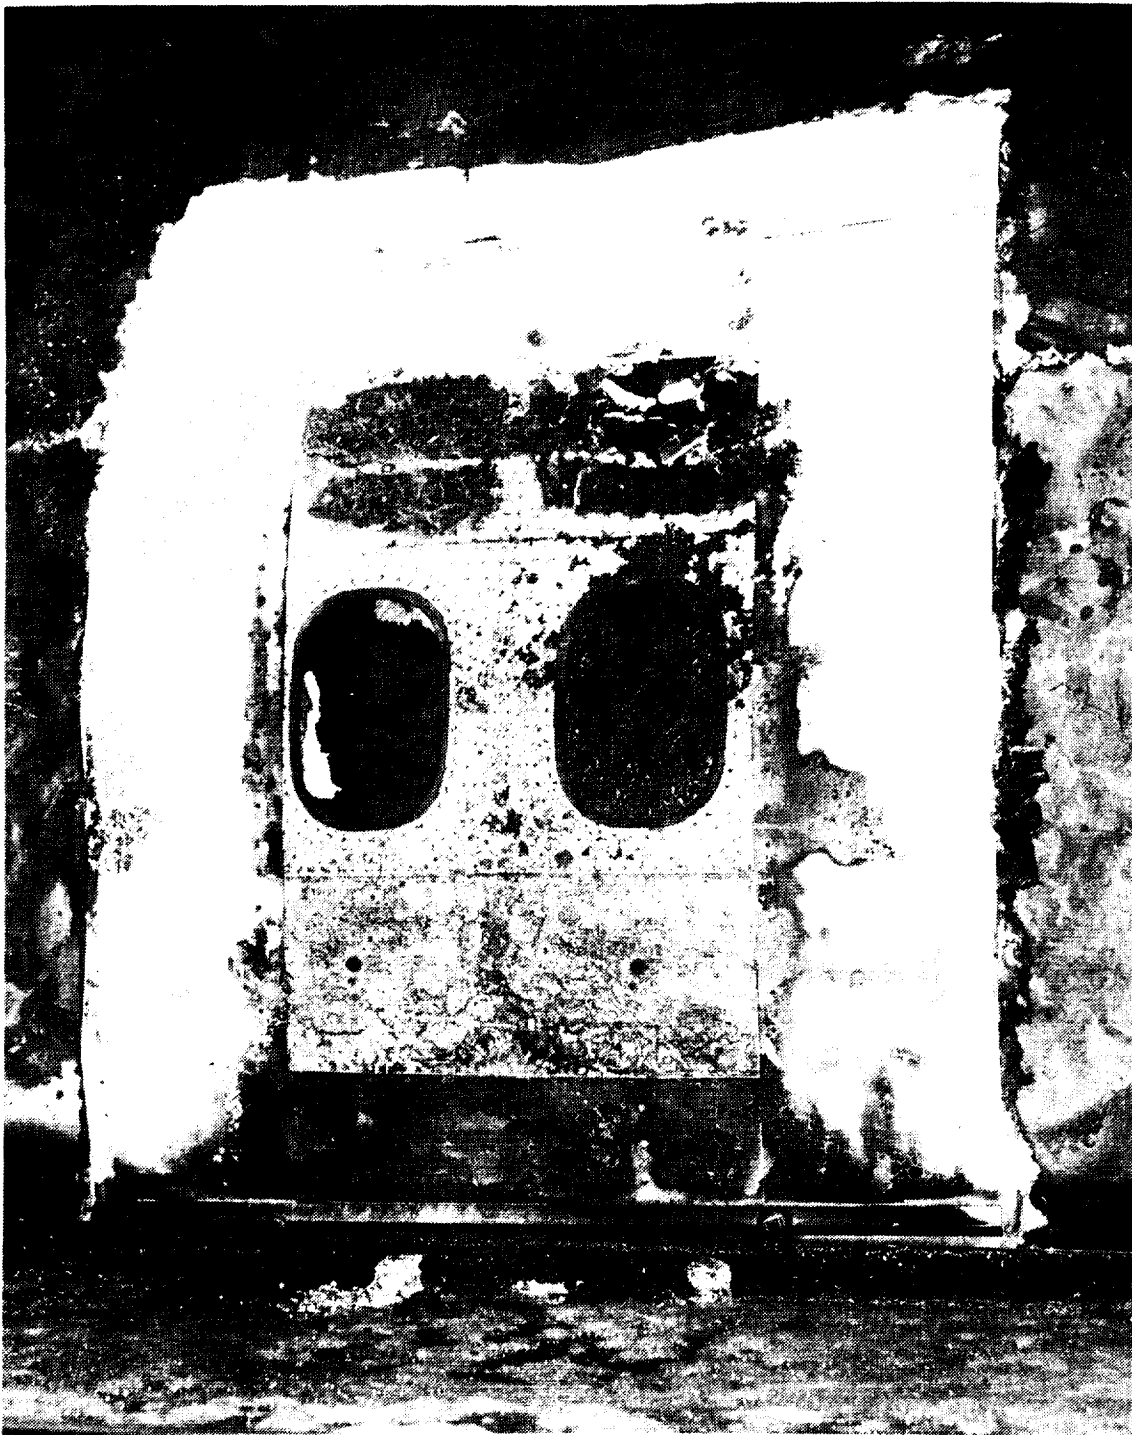
FIGURE 21. BURN-THROUGH RESISTANT EPOXY WINDOWS (WITH FRAME)

The second experiment was the selective use of burn-through resistant epoxy windows (figures 21 and 22).

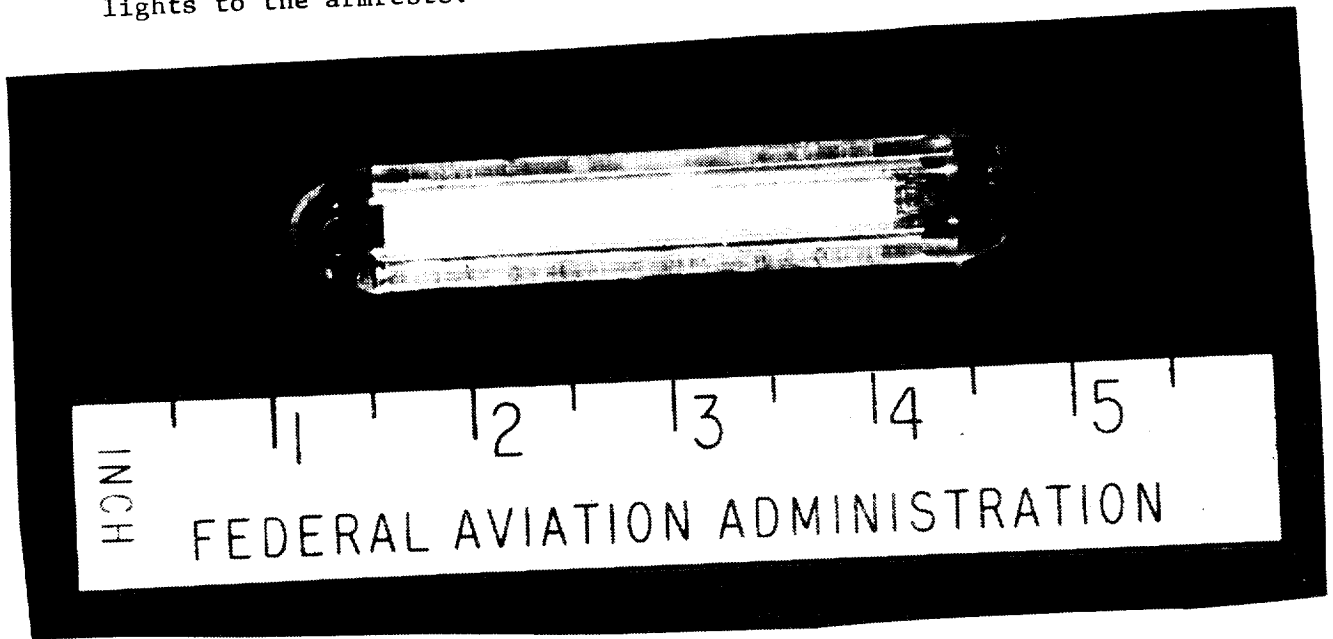
FIGURE 23. TRITIUM LIGHT DEVICE

Twenty-five Tritium lights (figure 23) were installed on the aircraft. A total of 8 aisle seats were selected throughout the cabin, and a light was installed on the top of the armrest, the side, and the rear. An additional light was installed on a ninth armrest. Two different types of two-part adhesives were used in mounting the lights to the armrests.

Only three tritium lights remained bonded to two seats (two on one seat and one on another). No additional lights were found on the floor or in the floor debris. Fire consumed the missing lights in an environment beyond the point of occupant survivability.

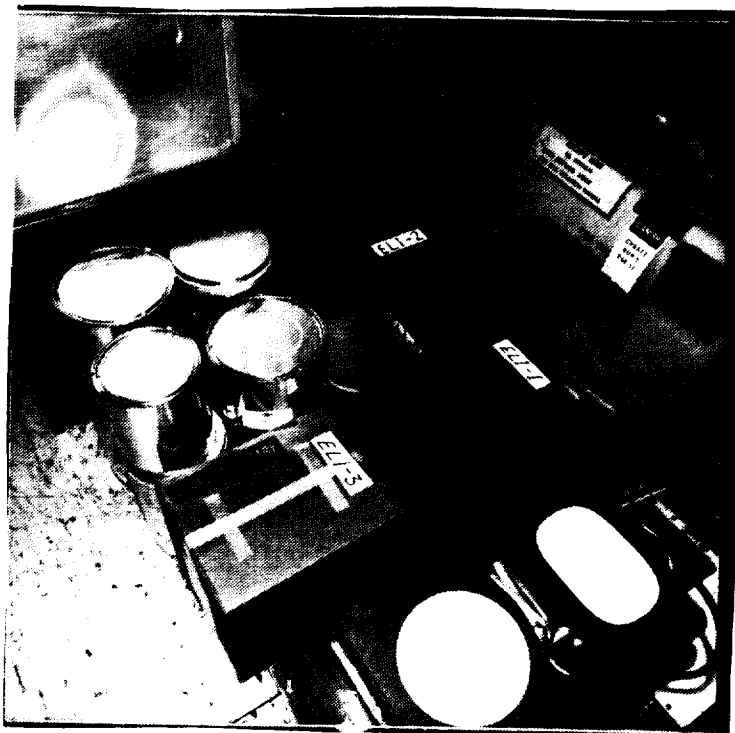
FIGURE 27. SIMULATED HAZARDOUS CARGO

Dow Chemical and Lawrence Packing (figure 27) provided pint and quart packages which had been filled with a scent jelled water material--nonrunning (the jelling material was an inert acrylic copolymer). These packages were located in the forward lower cargo galley near floor positioned accelerometers in order to acquire load data. No special instrumentation was provided.

The experiment represented a series of 15 hazardous material packages (filled with multiple metal containers of nonhazardous jelled water) placed within the lower forward galley compartment.

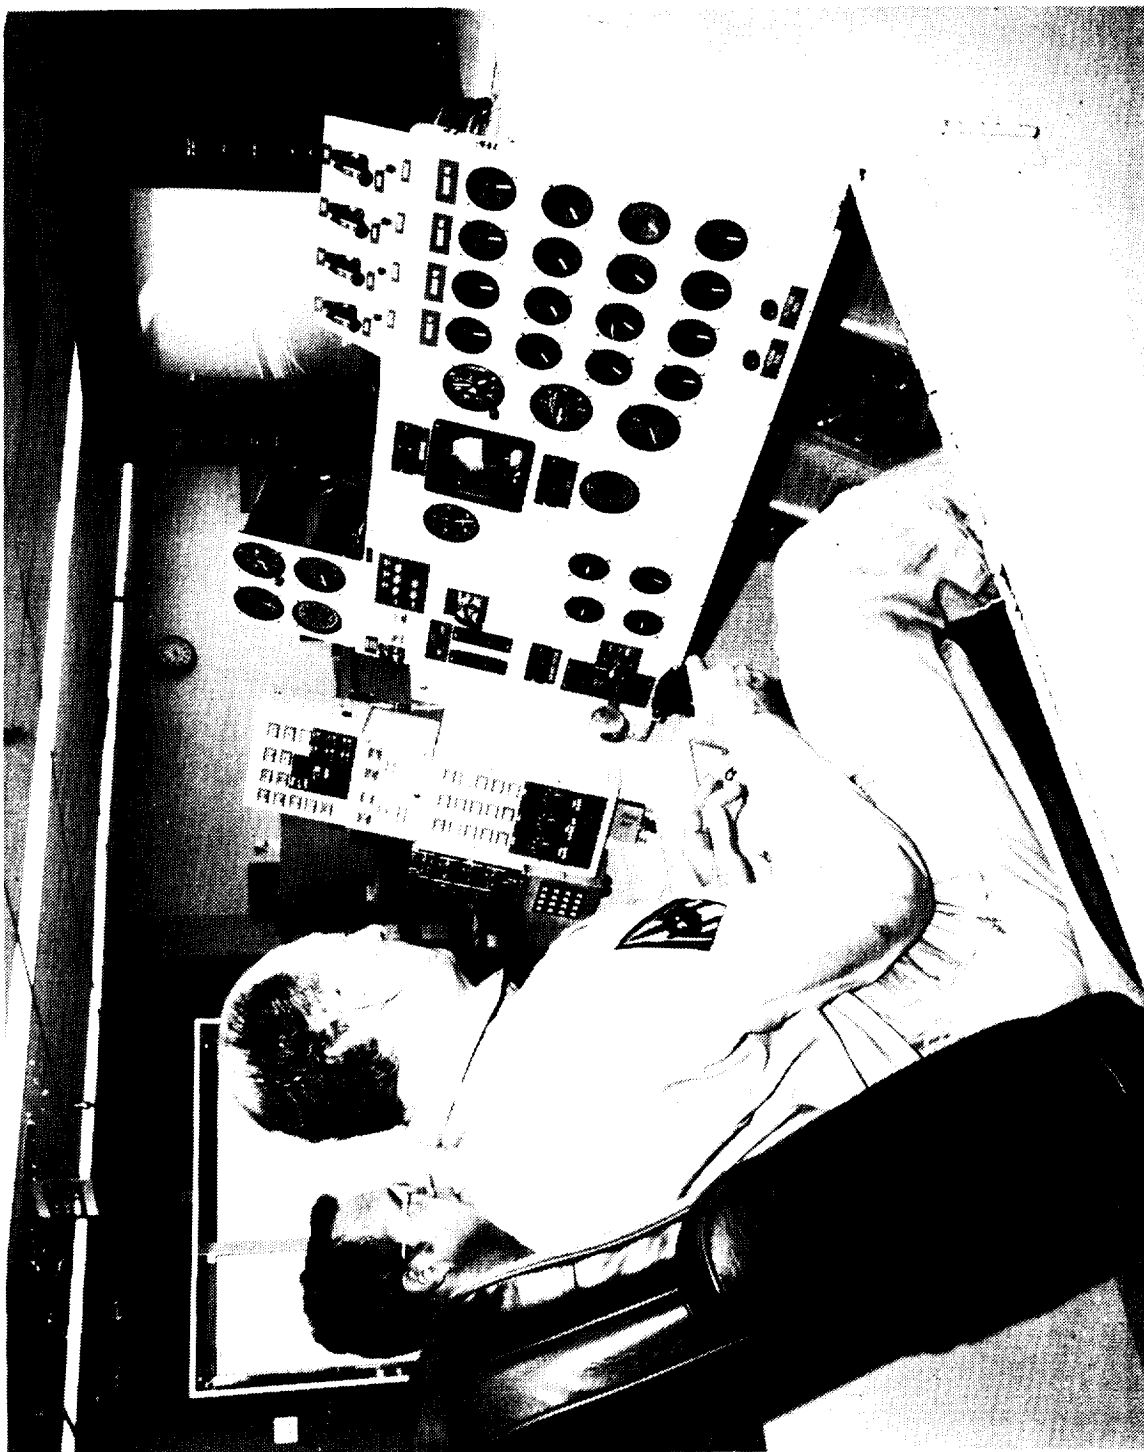
FIGURE 32. RPV GROUND COCKPIT

(figure 32) to fly an airplane using telemetry and radar. Flight control commands are sent electronically from the ground cockpit to the aircraft (figure 33), and flight information is returned in the same manner.

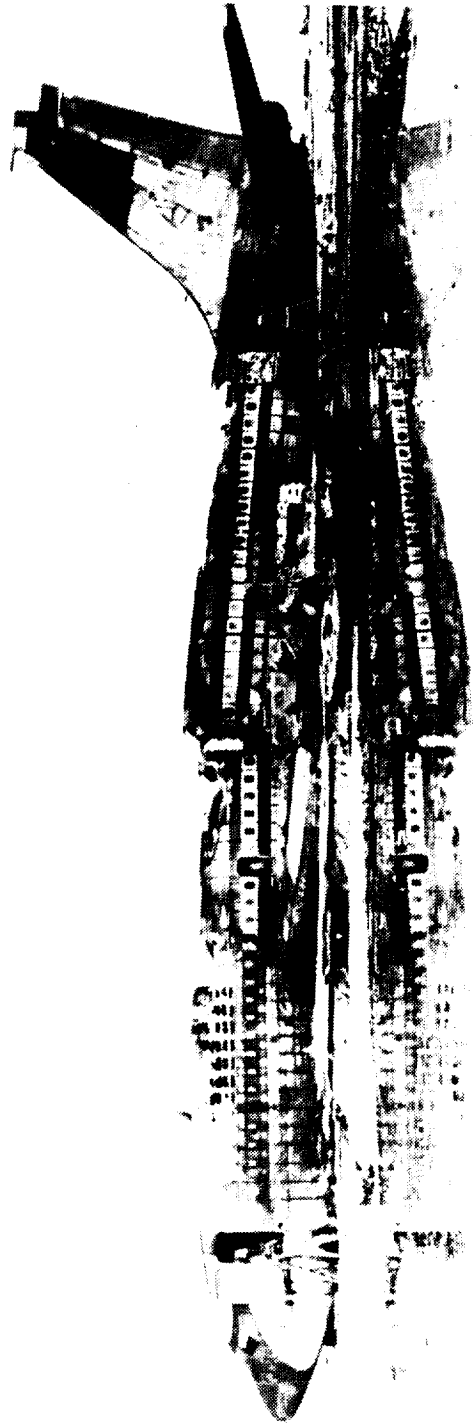
FIGURE 41. CID FIRE DAMAGE

How many additional people could have survived and escaped through dense smoke is highly speculative. Unfortunately, no instrumentation was installed on the aircraft to measure temperature, smoke density, or toxic gas concentration. Therefore, no estimate can be made as to when the cabin fire environment became untenable.
