DOE/NASA/0167-12  
NASA CR-180891  
GARRETT NO. 31-3725(12)

**ADVANCED GAS TURBINE (AGT)  
TECHNOLOGY DEVELOPMENT PROJECT**  
FINAL REPORT

Engineering Staff of  
Garrett Auxiliary Power Division  
A Unit of Allied-Signal Aerospace Company

March 1988

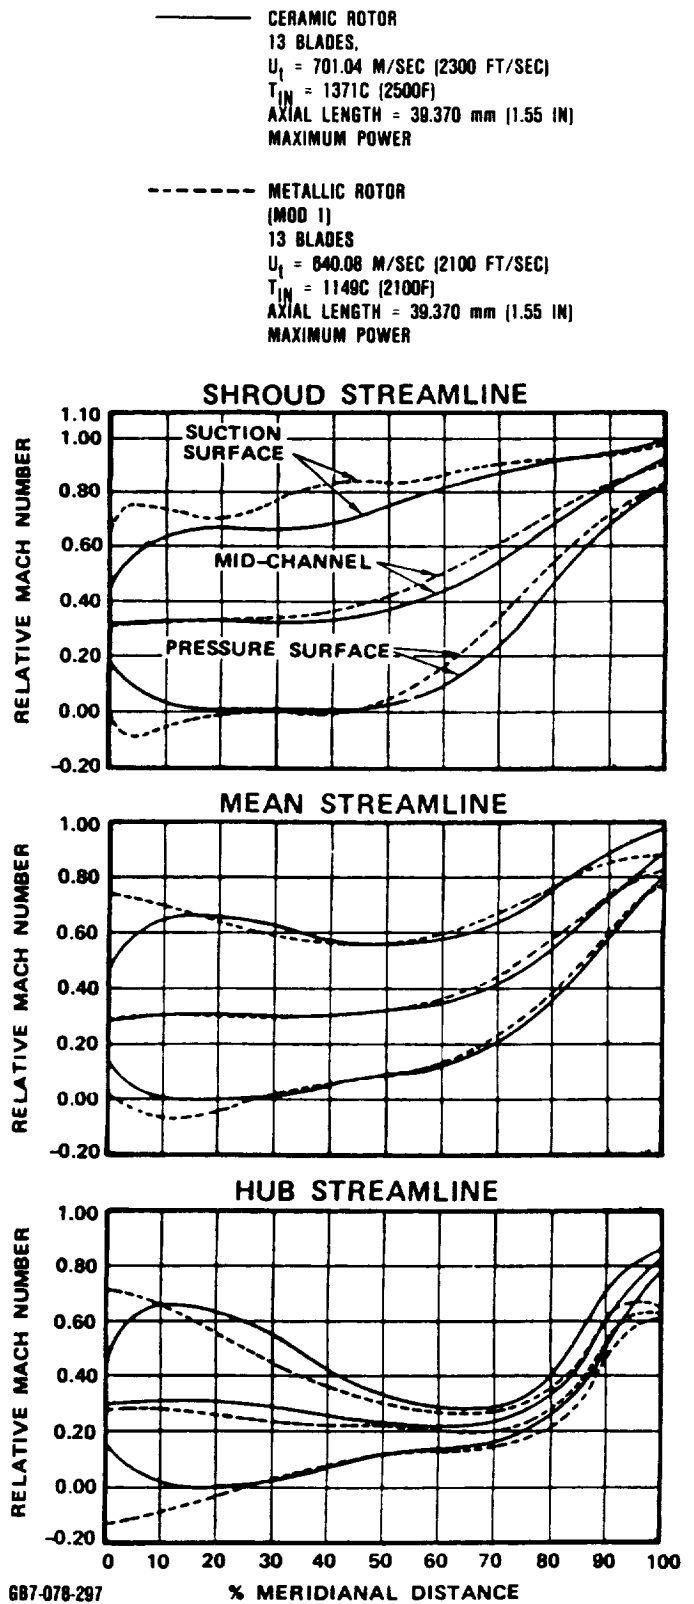
Figure 117. Turbine Rotor Velocity Distribution.

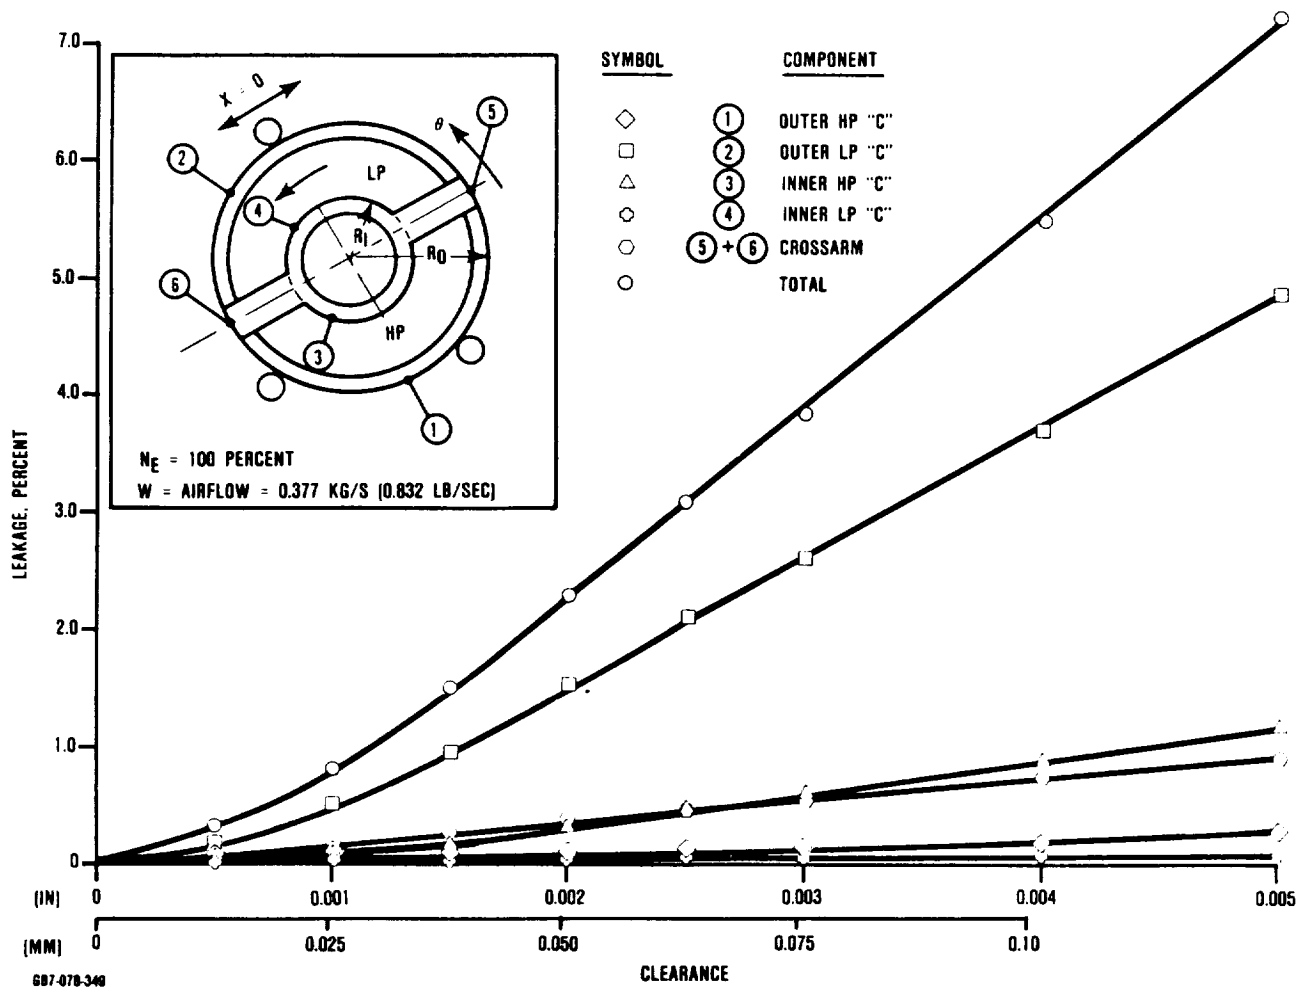
Figure 170. Non-Diaphragm Seal Leakage Versus Uniform Clearance.

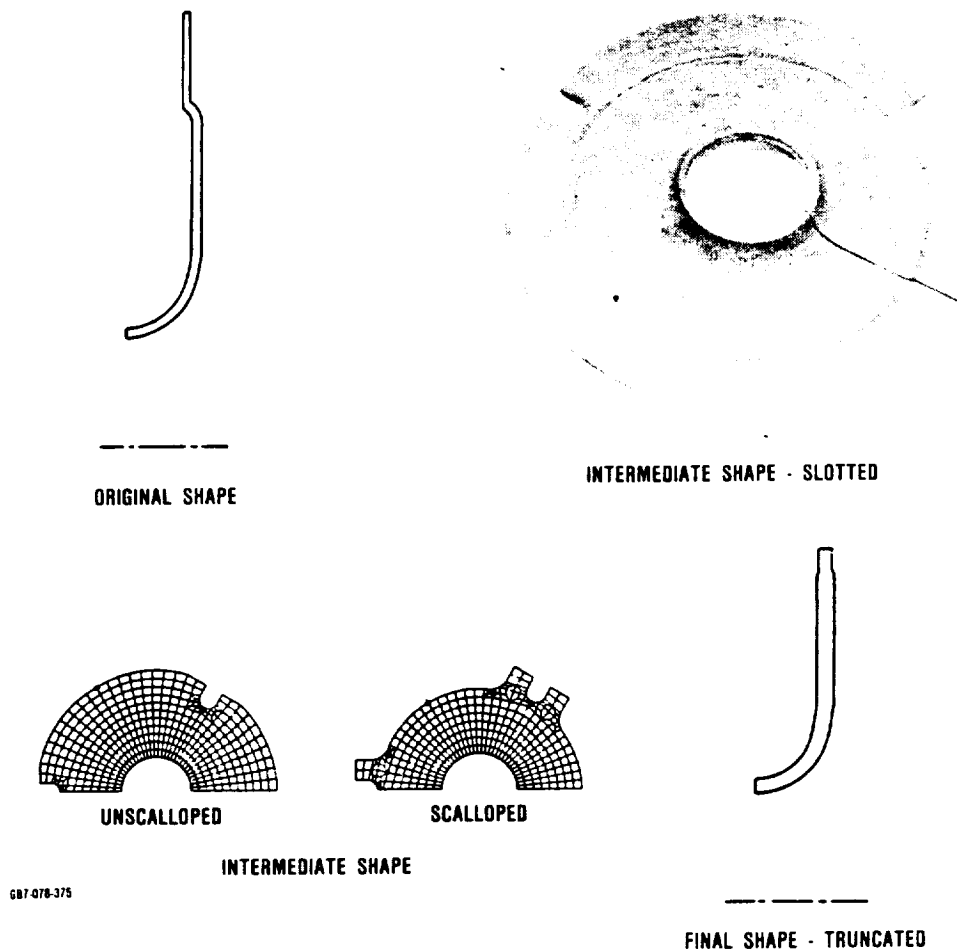
Figure 328. Outer Diffuser Housing Design Evolution.
