# In-Flight Rain Damage Tests of the Shuttle Thermal Protection System

Robert R. Meyer, Jr. and Jack Barneburg

(NASA-TM-100438) IN-FLIGHT RAIN DAMAGE  
TESTS OF THE SHUTTLE THERMAL PROTECTION  
SYSTEM (NASA) 16 p CSCL 22B

May 1988

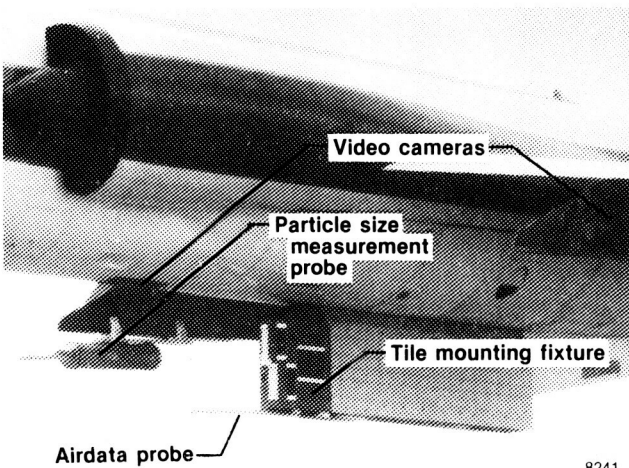
8241

*Fig. 2 In-flight photo of F-104 flight test fixture used for rain damage tests.*

Shuttle TPS coupons were mounted on the nose-cap of a flight test fixture (FTF) carried beneath an instrumented F-104 aircraft (Fig. 2). The F-104 airplane was capable of test airspeeds of 250 to 550 knots indicated airspeed (KIAS) or 1.5 Mach with this test hardware installed.

Instrumentation consisted primarily of a particle measurement probe, airdata probes, and video camera (Fig. 2). The particle measurement probe optically detected and measured particle size, distribution, and concentration. The device used on the F-104 aircraft was a one-dimensional optical array droplet probe (model PMS OAP-260Y) capable of detecting particles between 0.050 to 3.000 mm with a resolution of 0.050 mm. Airdata were determined from two sources — one was a probe mounted on the lower leading edge of the TPS flight test fixture, and the other was the pilot's standard airspeed system. Two video cameras were used to determine when damage occurred to the various TPS test coupons. One video camera was mounted on the lower forward fuselage providing aft viewing of the forward portion of the flight test fixture. This camera provided coverage of the 90°, 60°, and two 30° TPS test samples. Another video camera was mounted on a left wing pylon and provided a view of the left side of the flight test fixture. This camera primarily viewed the 15° and 0° TPS test samples.

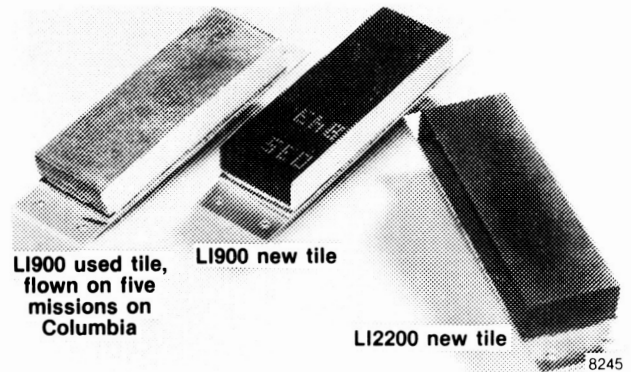
8245

Fig. 7 Typical tiles prior to flight test in rain.

The F-104 tile test coupons consisted primarily of 2 by 6 in. pieces cut from 6 by 6 in. tiles. The 2 by 6 in. LI900 test coupons were cut from flight worthy 6 by 6 in. tiles, saving the two edge pieces and discarding the centerpiece. The cut edge was treated using a standard TPS repair, and the cut edge was installed facing aft in the test fixture. The 2 by 6 in. LI2200 and tufi tile were specifically constructed for these tests. The tiles were bonded to an aluminum plate using a strain isolation pad (standard shuttle installation) mechanically attached to the test fixture. Examples of LI900 and LI2200 tiles prior to testing are shown in Fig. 7.

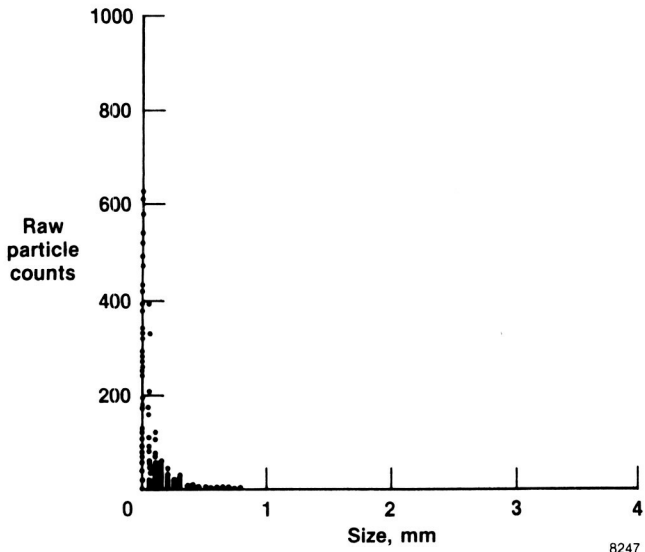
(a) 275 knots.

(b) 550 knots.

Fig. 11 Particle count histogram from a cloud measured by particle measurement probe.

During flight in natural clouds, a comparison of a different sort was made. In this case, a series of calibration runs were made at increasing speeds through a nonprecipitating cloud that did not change visually. The evaluation in this case was to compare the output from the particle measurement probe at different speeds in a relatively constant cloud. A comparison of the raw count histogram from 275 and 550 KIAS runs through the cloud is shown in Fig. 11. The figure clearly shows a marked difference in the distribution and maximum particle size at the two speeds through the cloud. For example, at 275 KIAS the maximum particle size was about 0.7 mm, while at 550 KIAS the maximum indicated particle size was about 2.0 mm. These differences were believed to be much too large to be accounted for by changes in the cloud character with time and are thought to be attributable to problems associated with the probe's ability to accurately measure or process the extremely large number of particles encountered in clouds at high speeds. Consequently, particle measurement probe results from nonprecipitating clouds will not be presented in this report.

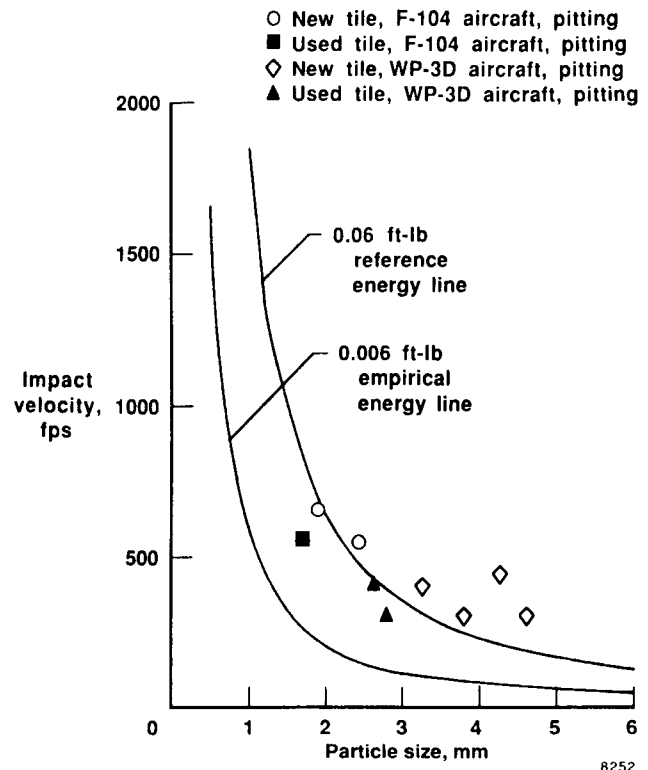
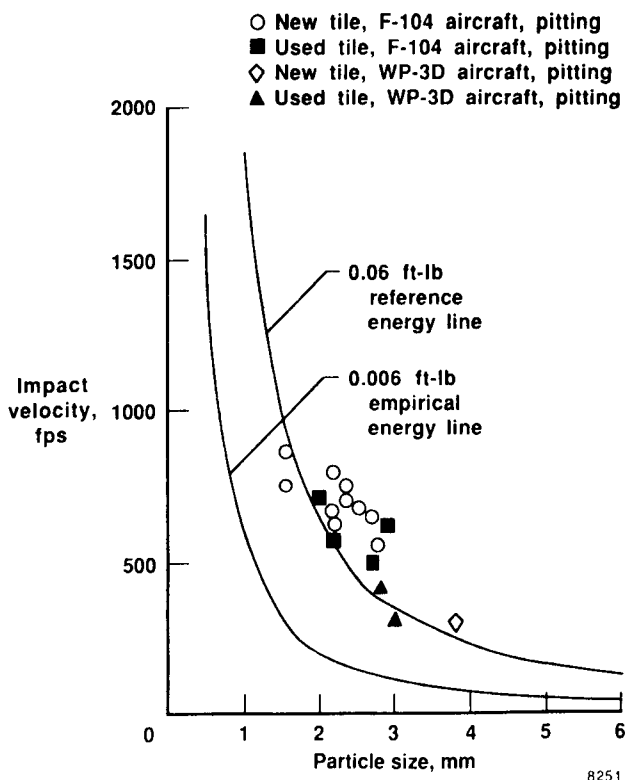
(a) 15° to free-stream flow.

(c) 60° to free-stream flow.

(b) 30° to free-stream flow.

(d) 90° to free-stream flow.

Fig. 13 In-flight exposure of LI900 tile to rain.

The tile damage data are plotted in terms of velocity and drop diameter on Figs. 13 to 16, which have lines of constant kinetic energy shown for reference in later discussions. The 0.006 ft-lb energy line represents an empirically derived surface fracture energy for failure from an impact with a solid, such as a metal sphere, at 90° to the surface. The 0.06 ft-lb energy line is shown for reference.

Figures 13 and 14 present results of the LI900 and LI2200 tile flights through rain. The figures present the velocity and maximum raindrop diameter (detected by the particle measurement probe) for damage threshold or pitting of the surface. The F-104 aircraft results are summarized in Table 1, and the WP-3D results are summarized in Table 2.

For the LI900 tile, the damage threshold data indicate a higher failure energy for the large particle sizes and a lower failure energy for the small particle sizes relative to the 0.06 ft-lb reference energy line (the slope of the plotted failures is flatter than the 0.06 ft-lb reference energy line). This is particularly noticeable for the high incidence angles (Figs. 13c and 13d). The same trend seems to exist for the LI2200 tile, for an incidence angle of 60° (Fig. 14a); however, the change in energy with particle size does not seem as definite as with the LI900 tiles, especially for the 90° incidence angle (Fig. 14b). It is unclear whether this trend is due to the tile failure mechanism or lack of data points to accurately define the trend.

Figures 13b and 13c include data for tiles that were first flown or used on the orbiter Columbia for five missions (five launches and entries) before being exposed to rain during F-104 aircraft flights. In both cases, the used tile failure data tended to occur at the low edge of the scatter in the data, indicating that the used tiles fail at a slightly lower energy than new or unused tiles.

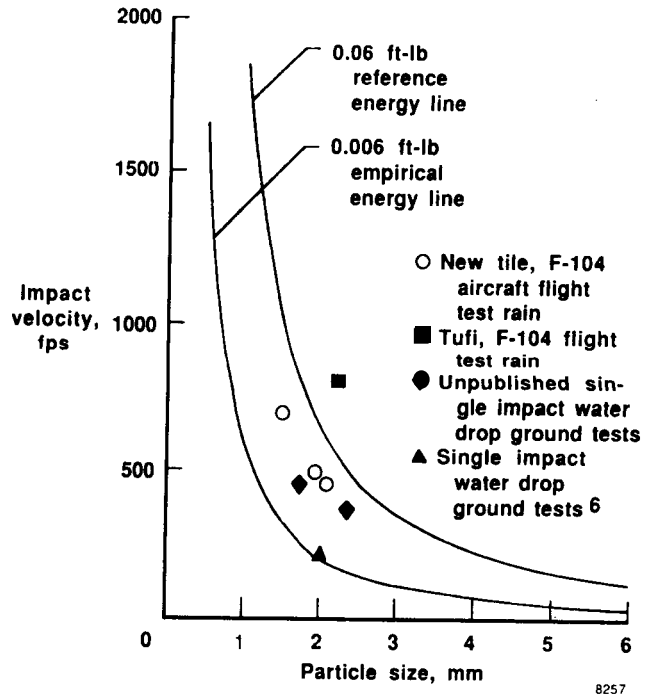
Fig. 16 Damage threshold for LI2200 tile from flight and ground tests and tufi mounted at 90° to free-stream flow.

The LI2200 tile damage threshold data at 90° and one data point from the so-called tuff tile<sup>5</sup> are shown in Fig. 16. Also included are published<sup>6</sup> and unpublished single impact water drop failure data obtained from ground tests. The data for the LI2200 tile indicate closer agreement between the unpublished ground and flight test results than for the LI900 tile results, although the published ground tests are still considerably lower.

The tuff tile shows a significant improvement over the existing LI2200 tile. The damage to the tuff tile was different than the previously described damage to LI900 and LI2200 tile. The face coat on the tuff tile is considerably thicker than either the LI900 or the LI2200 tile. The data point for the tuff tile represents pitting of the face coat only and does not represent exposure of the white substrate under the face coat.
