NASA Technical Memorandum 100942
AIAA-88-3106

An Extended Life and Performance Test of a Low-Power Arcjet

Francis M. Curran and Thomas W. Haag
Lewis Research Center
Cleveland, Ohio

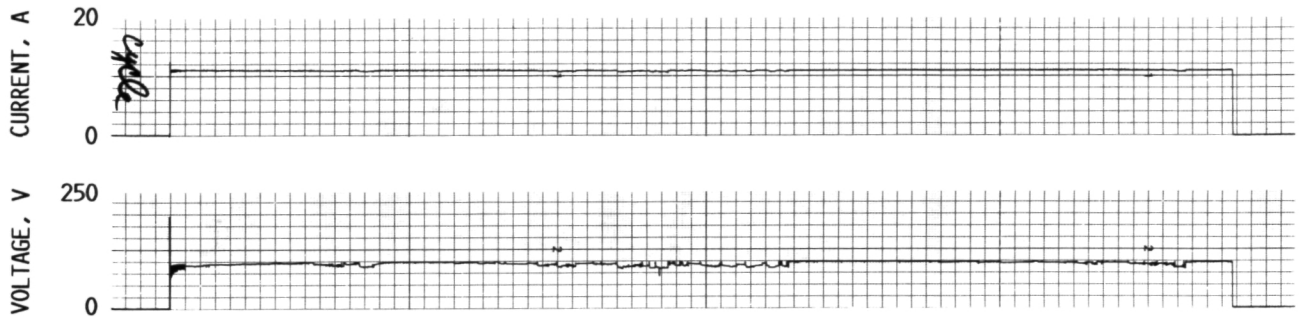
(A) CYCLE 9 - RAPID ARC VOLTAGE EXCURSIONS.

(B) CYCLE 13 - STEP CHANGES IN ARC VOLTAGE.

FIGURE 6. - VOLTAGE AND CURRENT TRACES SHOWING VOLTAGE EXCURSIONS DURING BURN-IN PERIODS.

Prior experience with arcjet thrusters has shown that operational stability is manifested in the steadiness of the plume and smoothness of the voltage trace. After a brief performance check once the thruster was assembled, a 14 cycle burn-in period was found to be necessary for this thruster before consistent operation was obtained. A few of the cycles during this period showed stable voltage readings, but others were characterized by fluctuations in the voltage trace. Some of these voltage excursions were very rapid, as shown in figure 6(a), while others took the form of step changes in voltage as shown in figure 6(b). All of these excursions were accompanied by plume motion in the form of rotation and/or lengthening. While no positive explanation for these

observations has been verified, it is the authors' opinion that they are caused by motion of the arc spot at the cathode tip. The largest of the observed excursions was 15 V. Fluctuations in the voltage due to low mode attachment at the anode are typically greater than 40 V and accompanied by extreme changes in the plume geometry, as the attachment region moves upstream into the constrictor. This phenomena was not observed. Rather, the data suggests that the arc attachment point does not stabilize and become repeatable until a near-steady state cathode shape has developed. At the start of one cycle during the burn-in, low mode attachment did occur. In this mode the operating voltage was between 50 and 60 V at the end of the first minute. This violated the low voltage limit and shut down the test before any apparent damage was done to the thruster. A system reset resulted in a normal starting sequence. The steady state operating voltage increased from 96 V to about 101 V over the course of the burn-in period. The above suggests that somewhat erratic thruster behavior can be expected until the cathode nears a steady state shape.

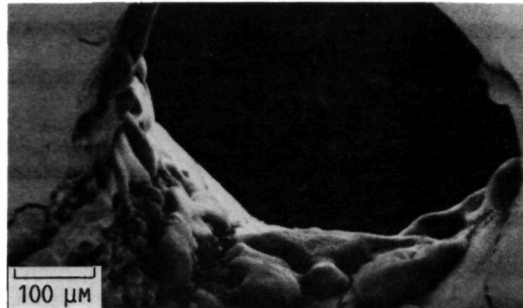
(A) CONVERGING SIDE OF NOZZLE.

(B) DIVERGING SIDE OF NOZZLE.

(C) DIVERGING SIDE OF NOZZLE.

FIGURE 15. - POST-TEST ANODE CONDITION.

The post-test condition of the anode is illustrated by the series of photomicrographs shown in figure 15. As in the case of the cathode, the degradation shown is very similar to that described in the previous report on arcjet components run for a much shorter period of time. Figure 15(a) shows a network of stress cracking and discoloration near the constrictor entrance. Some areas of the converging side of the nozzle upstream of the constrictor were covered with a thin raised layer of crystalline material indicating some surface melting. As suggested in the previous report (ref. 16), it is likely

that the arc initially strikes upstream of the constrictor between the cathode and the converging side of the anode/nozzle and is quickly pushed out to its equilibrium position by the flow field. Some of the observed melting probably occurs during this period as the anode attachment zone in the high pressure region is expected to be in a concentrated spot mode. Melting could also have occurred during the two brief periods of low mode operation previously discussed. A view taken at higher magnification from the diverging side (fig. 15(b)) shows that molten material had resolidified in the constrictor, and that less melting had occurred downstream near the exit of the constrictor. A magnified view of the exit from the diverging side (fig. 15(c)) shows that some molten material migrated to the nozzle side, but that the exit itself was essentially intact. The microcracks traversing the length of the constrictor have also been previously reported (refs. 13 to 16). While the changes in the anode appear to be extensive, it must be noted that they did not lead to any gross performance changes during the testing. That similar changes have been documented after much shorter periods of testing indicates that much of the stress cracking and melting probably occurred early in the test. This damage has been unavoidable in testing to date, but seems to have little effect on the reliability or performance of the arcjet.
