NASA Contractor Report 180807

Thermal Barrier Coating Life Prediction Model Development

Final Report

R.V. Hillery, B.H. Pilsner, R.L. McKnight,
T.S. Cook, and M.S. Hartle
GE Aircraft Engines
Cincinnati, Ohio 45215

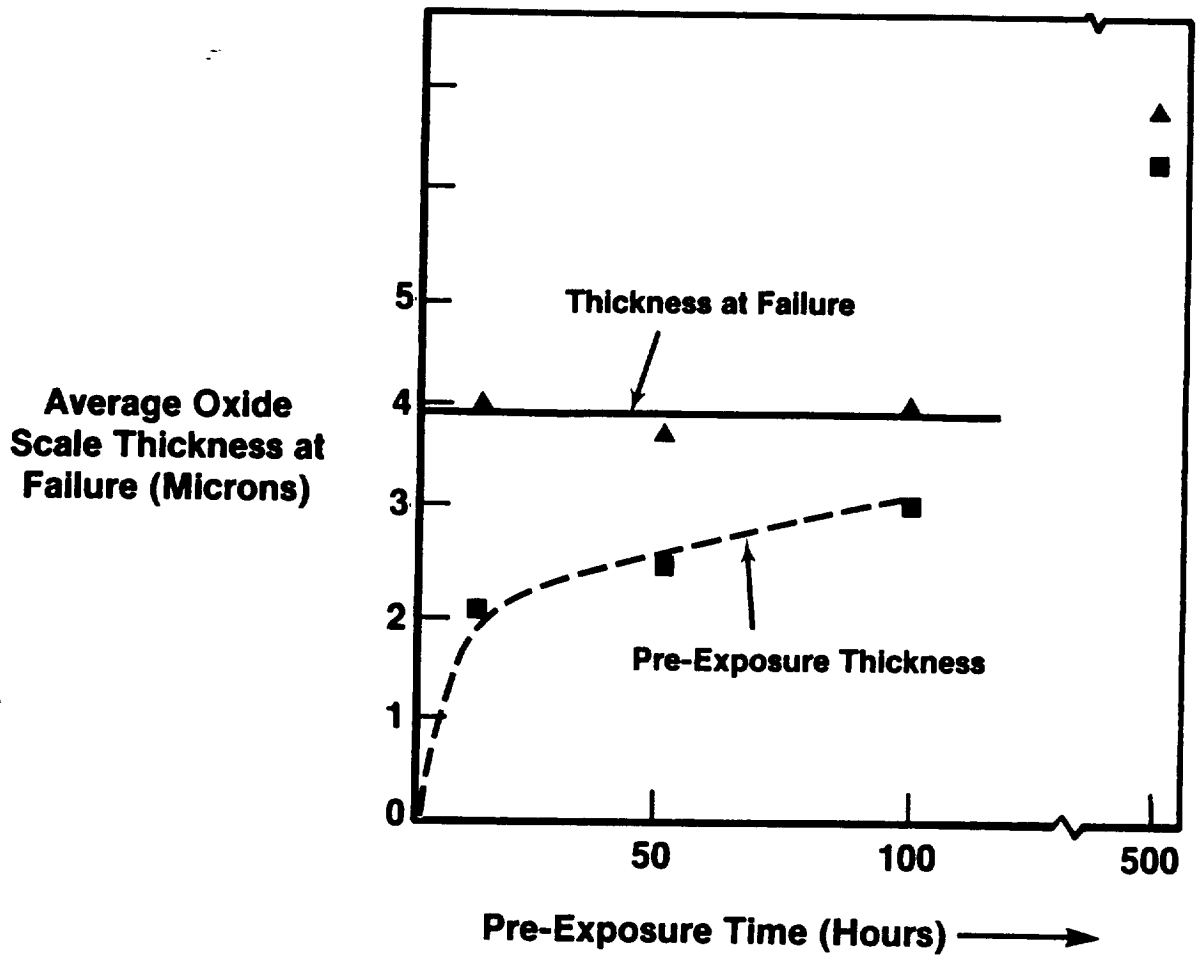
Figure 8. Oxide Scale Thickness at the Bond Coat/Top Coat Interface After Thermal Cycle Testing at 1093°C (First Experiment).

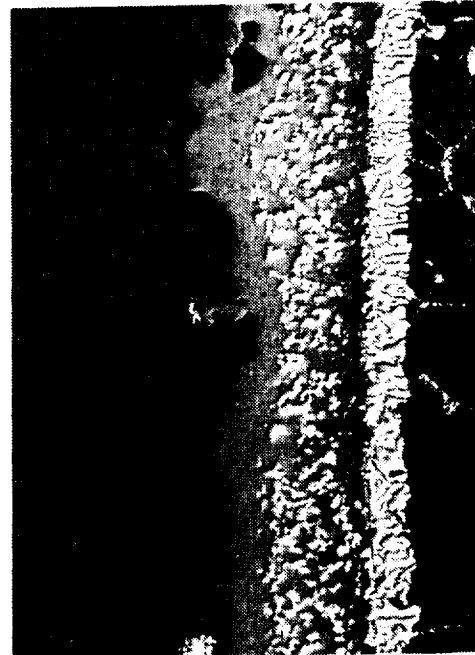
a. 10 Hour Pre-Exposure

Figure 9. Microstructures of Specimens Pre-Exposed in Air at 1093°C (2000°F).

microstructures of pre-exposed specimens are shown in Figures 9 and 10). The observation that, at failure, the bond coat oxide scale thicknesses were essentially identical for the specimens that were not pre-exposed or were pre-exposed in air is consistent with the work of Miller (35), who noted similar weight gains (oxidation) at failure of specimens with a $\text{CaSiO}_4/\text{MCrAlY}$ TBC regardless of test temperature.

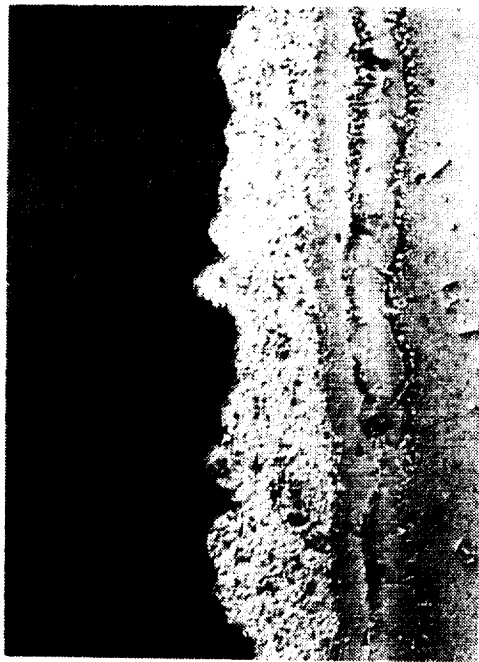
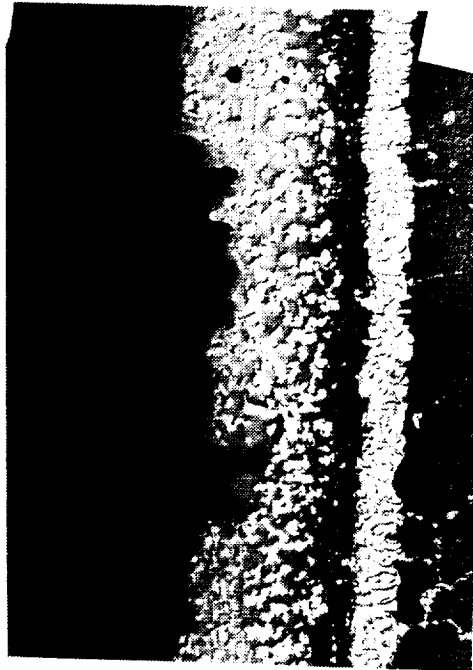
a. 10 Hour Pre-Exposure

b. 50 Hour Pre-Exposure

c. 100 Hour Pre-Exposure

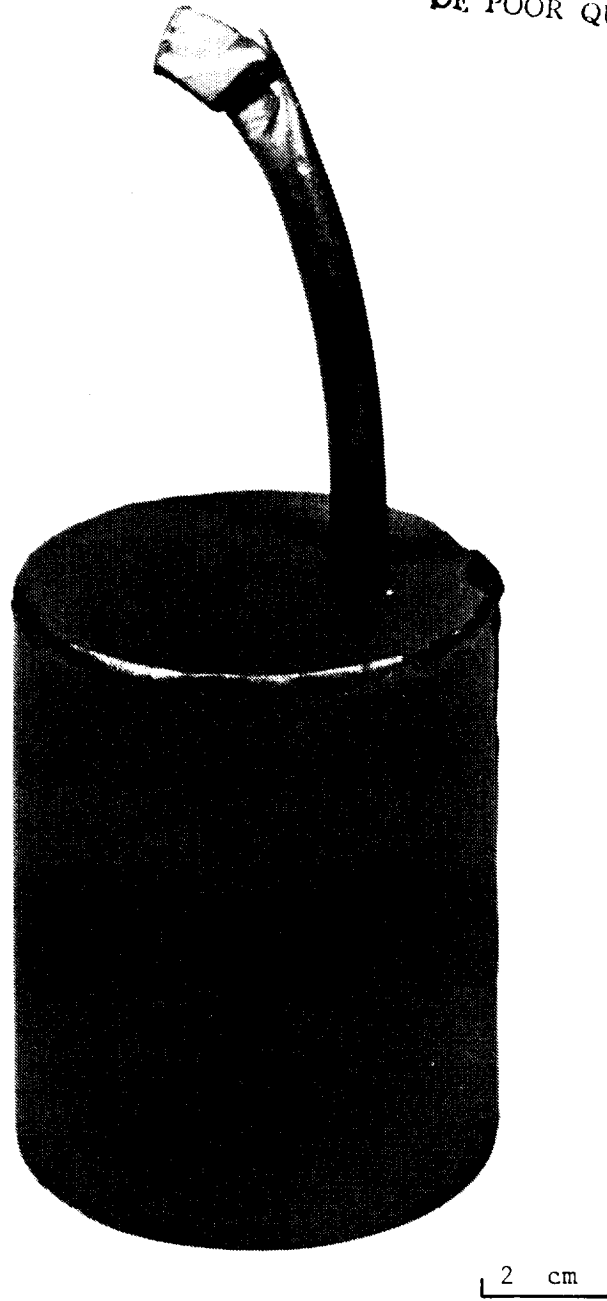
Figure 11. Inconel 718 Canister Utilized for Thermal Cycle Testing in Argon.

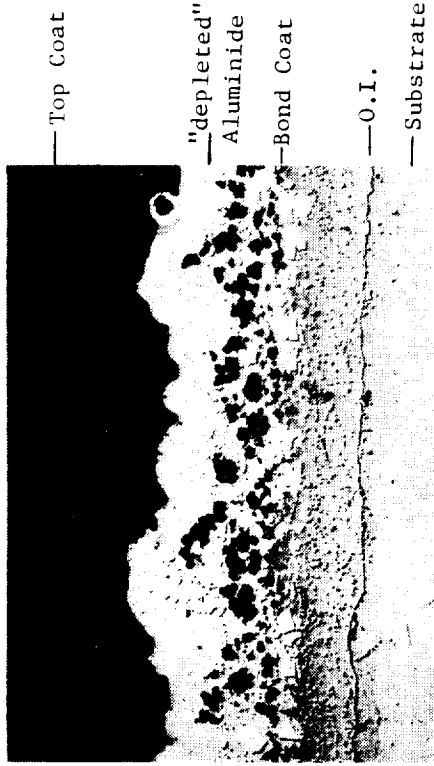
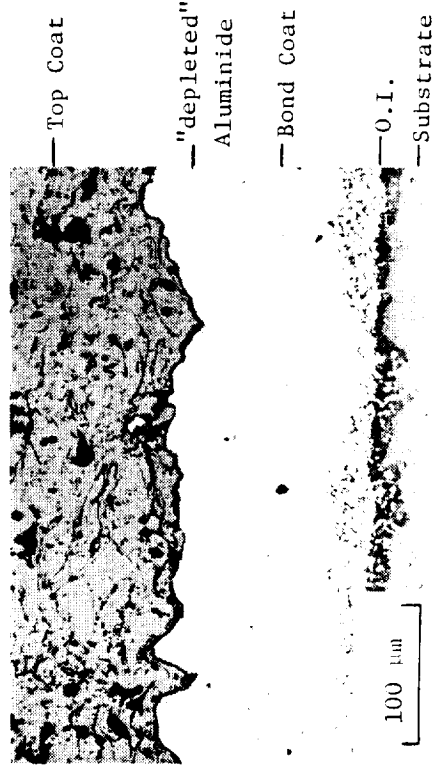
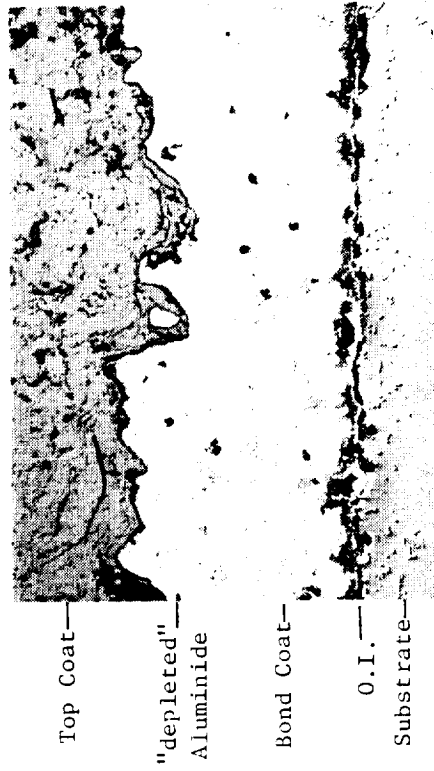
Figure 18. Microstructure of Four Bond Coat Creep Effect TBC Systems (René 80/Bond Coat/Aluminide/ZrO₂-Y₂O₃) After 100 Hour Pre-Exposure in Air at 1093°C.

In all cases, a continuous Al₂O₃ scale formed at the bond coat/top coat interface in specimens that were pre-exposed in air for 100 hours at 1093°C (2000°F) (Figure 18)*, and the oxide scale thickness varied from 3 to 5 μ m for the four different bond coat systems. The presence of a continuous carbide layer (presumably M₂₃C₆ [9]) was also noted at the bond coat/substrate interface for the NiCrAlY + aluminide system (TBC System No. 1). The aluminide in all cases was significantly depleted due to bond coat oxidation and bond coat/substrate interdiffusion. Bond coat No. 3 also developed blocky carbides during the pre-exposure. Unique changes in structure and morphology for each bond coat were expected due to the significant differences in bond coat compositions.

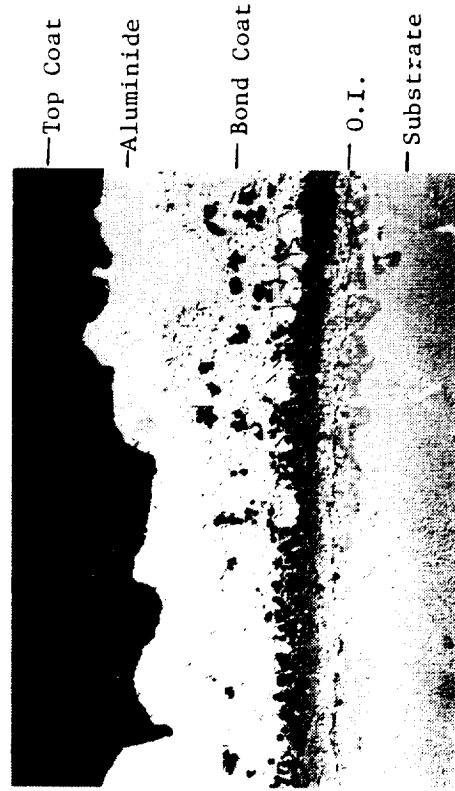
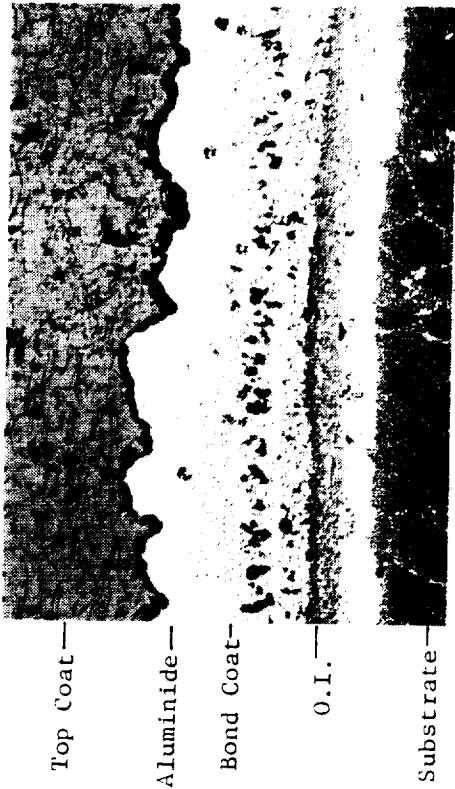
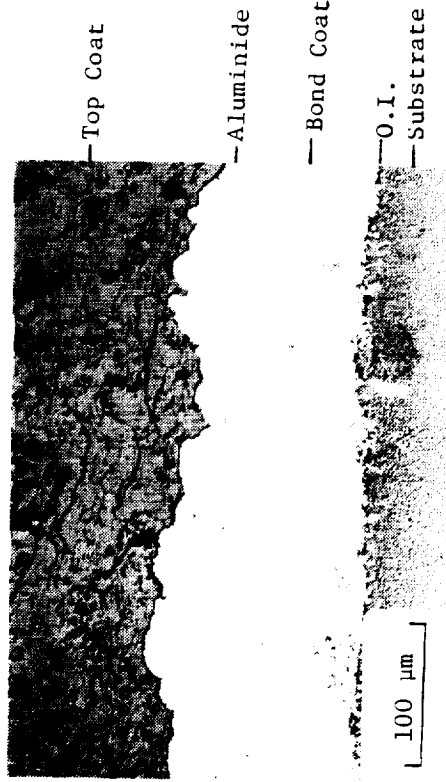
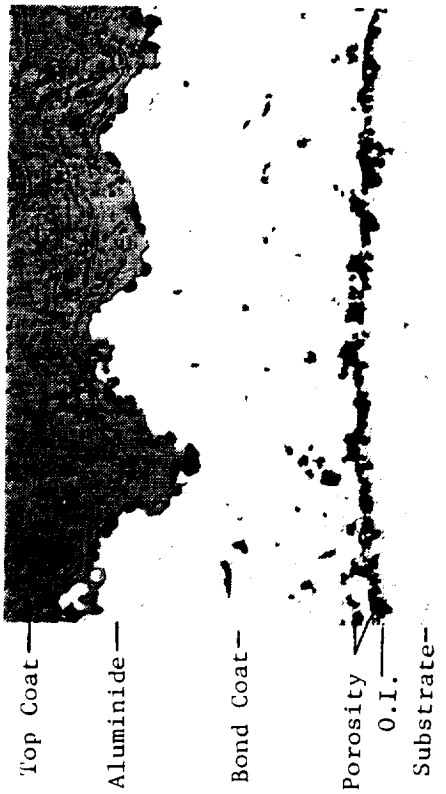
Figure 19. Microstructure of Four Bond Coat Creep Effect TBC Systems (René 80/Bond Coat/Aluminide/ZrO₂-Y₂O₃) After 100 Hour Pre-Exposure in Argon at 1093°C.

In assessing the effect of argon pre-exposure on these specimens, canisters were again used successfully to retard oxidation at 1093°C (2000°F). In all cases, essentially no Al₂O₃ scale was detected at the bond coat/top coat interface by optical microscopy after pre-exposure (Figure 19). The aluminide in all systems did not appear depleted since little bond coat oxidation had occurred. Interestingly, a continuous carbide layer was not present at the bond coat/substrate interface in bond coat No. 1 although the presence of significant quantities of (presumably) M₂₃C₆ carbides were noted at this interface following air pre-exposure. The presence of blocky carbides was again noted in bond coat No. 3 following the argon exposure.

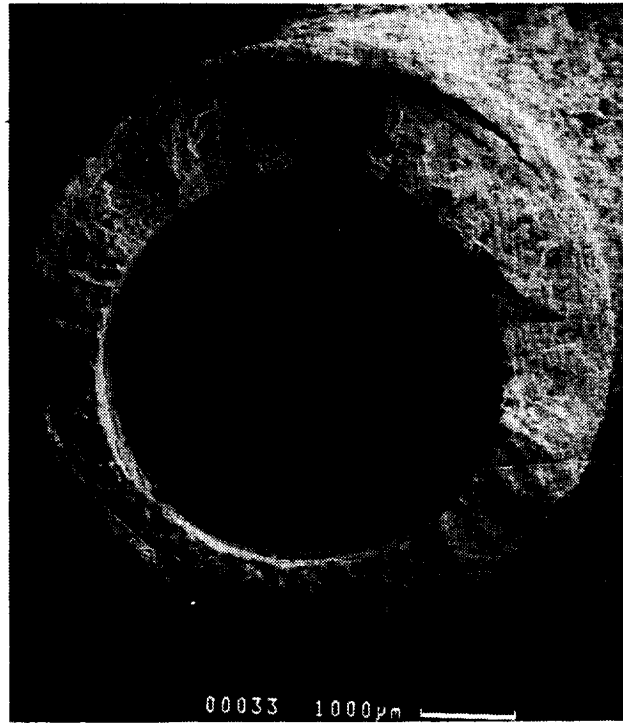
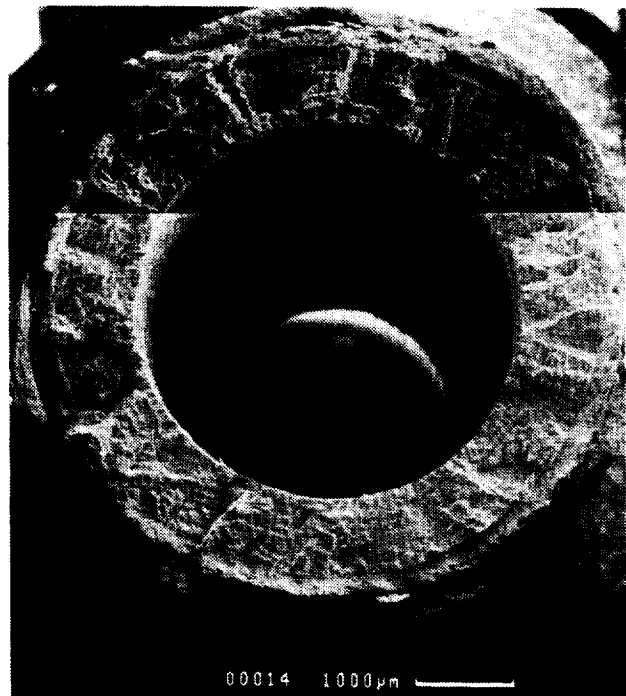
a. Specimen from First TMF Test

c. Specimen from Third TMF Test

Figure 46. Fracture Surface of Test Specimens from TMF Test.

The fracture surfaces of the three TMF specimens were examined to determine the role of each of the materials in the failure process. A typical portion of the fracture surface of each specimen is shown in Figure 46. Specimens from the first and third tests show that fracture surface in the René 80 is dominated by interdendritic features. The fracture surface of the specimen from the second test, which failed monotonically, is quite different from the other two. The failure surface is more faceted, displaying the features of fast fracture. In none of the three specimens was it possible to locate any fatigue markings such as striations. For specimens from tests 1 and 3, Figures 46a and 46c, there were several large, relatively flat areas which at low magnification are reminiscent of elliptical fatigue cracks. These areas, however, when examined at high magnification, showed no striation markings, so it is speculation to interpret these planar features as fatigue cracks growing inward from the bond line. There was no evidence that the ceramic top coat played any role in the fatigue fracture; there were no fatigue markings or signs of an origin in the ceramic. Figure 47 shows a small section of the top coat of the specimen from the third TMF test. The fracture surface is very crystallographic and shows numerous secondary cracks. There are a number of lines on some facets but these lines are perpendicular to the direction of crack propagation and are more likely to be splat boundaries than fatigue striations. From the different heights of the fracture surface, it appears that the failure origin was in the René 80 or the bond coat and the ceramic fracture was a terminal event.
