## MICROSTRUCTURAL ASPECTS OF ZIRCONIA THERMAL BARRIER COATINGS

T.E. Mitchell, D.S. Suhr, R.J. Keller, V. Lanteri, and A.H. Heuer
Department of Metallurgy & Materials Science
Case Western Reserve University
Cleveland, Ohio 44106

Various combinations of plasma-sprayed bond coatings and zirconia ceramic coatings on a nickel-based superalloy substrate were tested by static thermal exposure at 1200°C and cyclic thermal exposure to 1000°C. The bond coats were based on Ni-Cr-Al alloys with additions of rare earth elements and Si. The ceramic coats were various  $ZrO_2-Y_2O_3$  compositions, of which the optimum was found to be  $ZrO_2-8.9$ wt.  $x_{2}^{2}0_{3}^{3}$ . Microstructural analysis showed that resistance to crackiñg during thermal exposure is strongly related to deleterious phase changes. Zones depleted of Al formed at the bond coat/ceramic coat interface due to oxidation and at the bond coat/substrate interface due to interdiffusion, leading eventually to breakdown of the bond coat. The 8.9%  $Y_2O_3$  coating performed best because the as-sprayed metastable (high- $Y_2O_3$ ) tetragonal phase converted slowly into the low- $Y_2O_3$  tetragonal plus high- $Y_2O_3$  cubic-phas

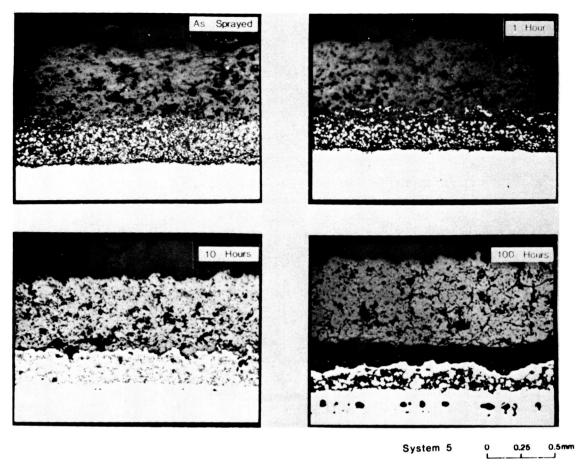
Fig. 1. Optical microstructures of an 8.9%  $Y_2O_3$  system, as-sprayed and after static thermal exposure for 1, 10, and 100 h at 1200°C.

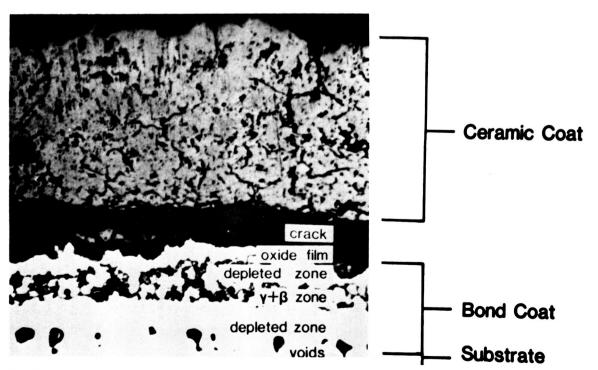
Fig. 2. General optical microstructure of an 8.9%  $Y_2O_3$  system after 100 h static thermal exposure at 1200°C.

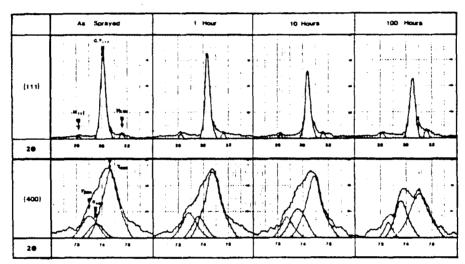
Fig. 3. Experimental X-ray diffraction patterns and deconvoluted peaks in the  $\{111\}$  and  $\{400\}$  regions for plasma-sprayed  $ZrO_2$ -8.9%  $Y_2O_3$  after 1, 10, and 100 h static thermal exposure at 1200°C.

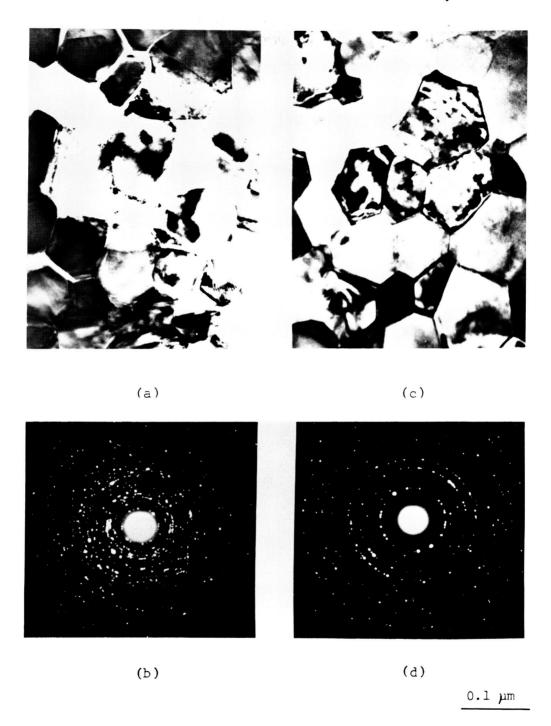
Fig. 4. (a)-(d) TEM micrographs of the as-sprayed  $4.3\% \text{ Y}_2\text{O}_3$  ceramic coating showing the separated regions of monoclinic and tetragonal (T') grains and their SAD ring pattern, (a)-(b) monoclinic; (c)-(d) tetragonal (T')

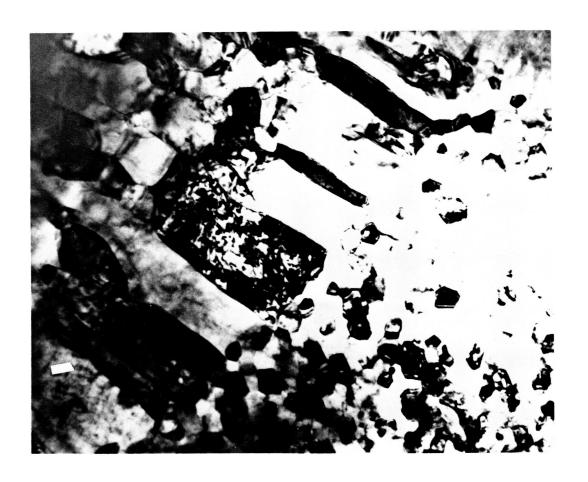
Fig. 5. TEM micrograph of the as-sprayed 6.1%  $\rm Y_2O_3$  ceramic coating showing the non-equilibrium tetragonal (T') columnar grains.

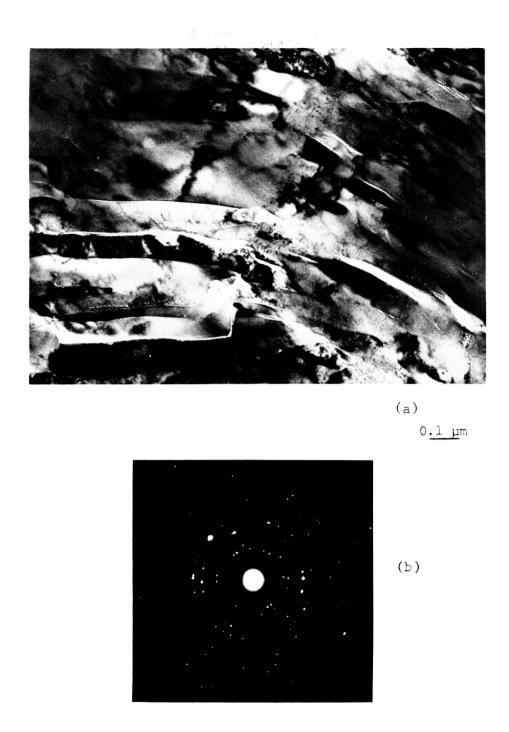
Fig. 7. (a)-(b) TEM micrograph of the columnar cubic grains within as-sprayed 19.6%  $Y_2O_3$  ceramic coating showing intergranular microcracking (a) and the SAD ring pattern (b).

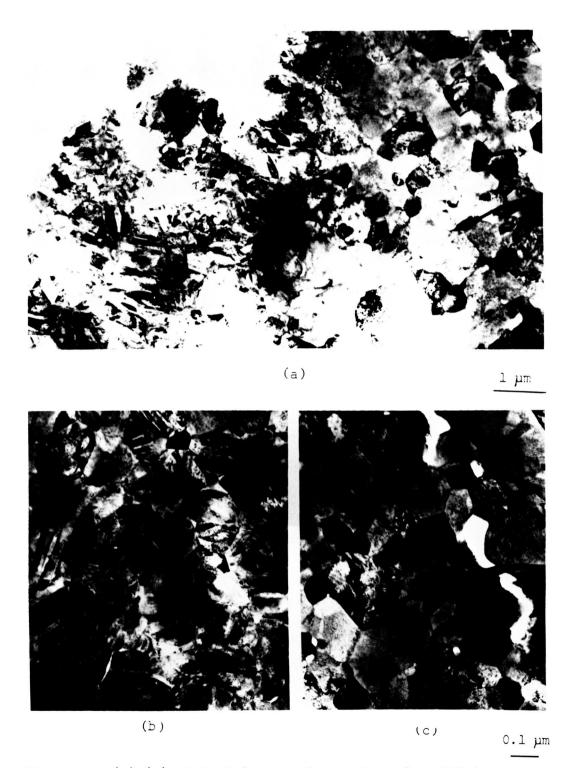
Fig. 9. (a)-(c)  $4.3\%~\rm Y_2O_3$  ceramic coating after 100 hours exposure at  $1200^{\circ}$  C showing separate regions of monoclinic and tetragonal grains.

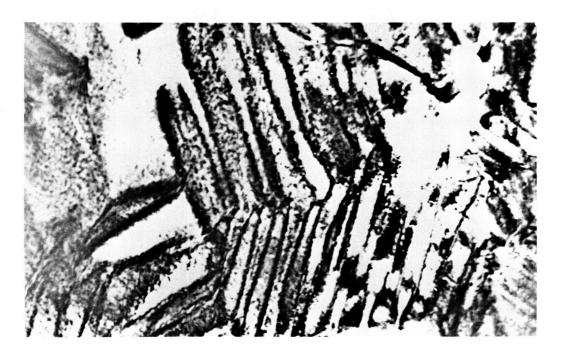
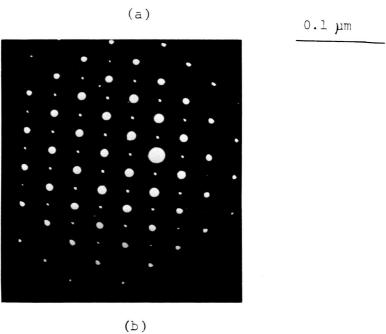
Fig. 10. 4.3% Y 0 ceramic coating after 100 hours at  $1200^{\circ}$  C : (a) TEM micrograph of the tetragonal colony structure within large ( ~ 1.0  $\mu$ m) grain and (b) corresponding [011] diffraction pattern.

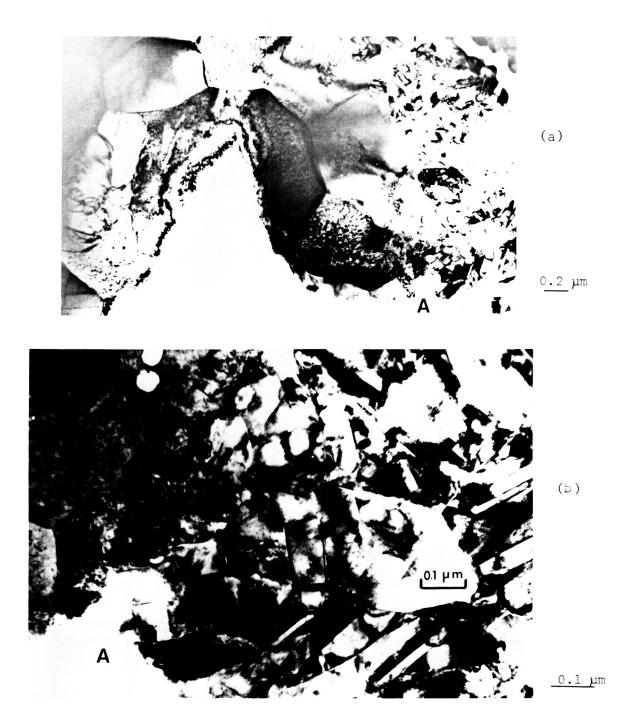
Fig.12. (a)-(b)  $19.6\%~Y_2O_3$  ceramic coating after 100 hours exposure at  $1200^{\circ}$  C (a) monoclinic and cubic grains (b)higher magnification micrograph showing tetragonal grains(A) formed at the interface between monoclinic and cubic grains due to yttrium diffusion.

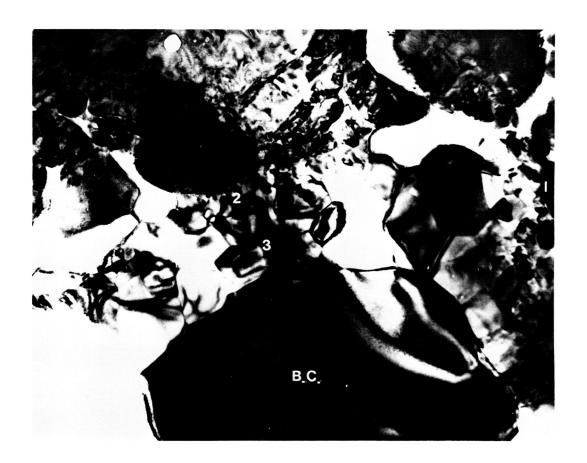
0.25 jun	_
Position	<u>A1203</u>	SiO <sub>2</sub>	Cr <sub>2</sub> 0 <sub>3</sub>	<u>Co0</u>	NiO	
1	2.2	43.1	9.3	4.3	41.1	
2	5.7	55.2	6.9	2.8	29.3	
3	25.0	3.3	65.2	0.6	5.8

Fig. 13. TEM micrograph of oxide scale after 1 hour thermal exposure at 1200°C and the result of point EDAX analyses (system 5). The oxide scale is adherent to the bond coating, however pores are present at the oxide scale/ceramic coating interface.

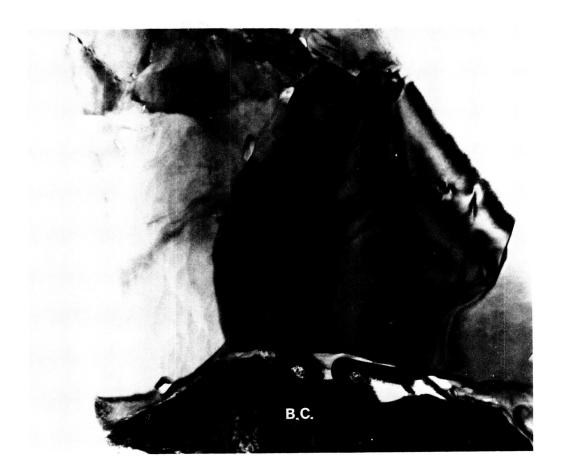
Fig.14. TEM micrograph of oxide film after 10 hours thermal exposure at  $1200^{\circ}$  C showing the columnar grains of Al $_2$ 0 $_3$  and the void formation at the oxide film/bond coating interface.

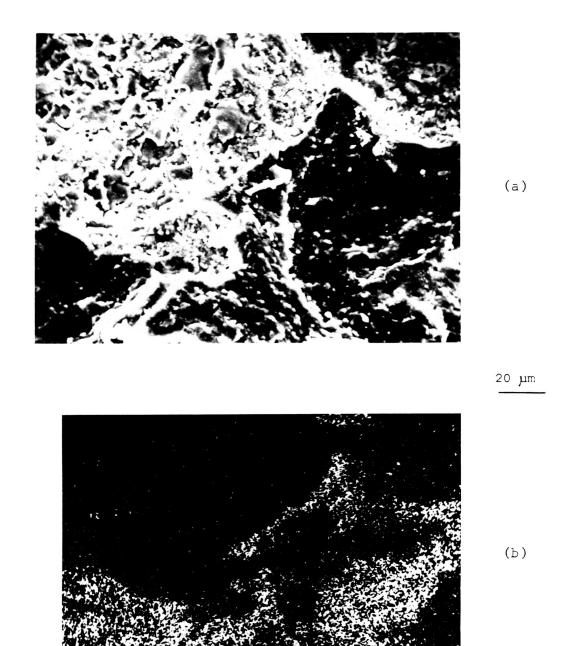
Fig. 15. (a)-(b); (a) SEM micrograph of the bottom-side of ceramic coating (system 10) that had failed after 100 hours exposure and (b) microprobe X-ray map for Al.

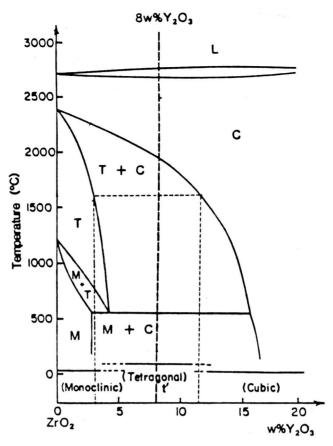
Fig. 16. Phase diagram of the  $ZrO_2$ -rich region of the system  $ZrO_2$ - $Y_2O_3$  (Ref. 4).

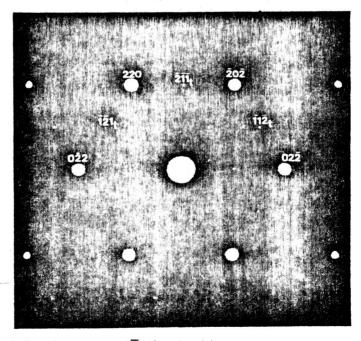
Fig. 17. Diffraction pattern, [111] zone axis.

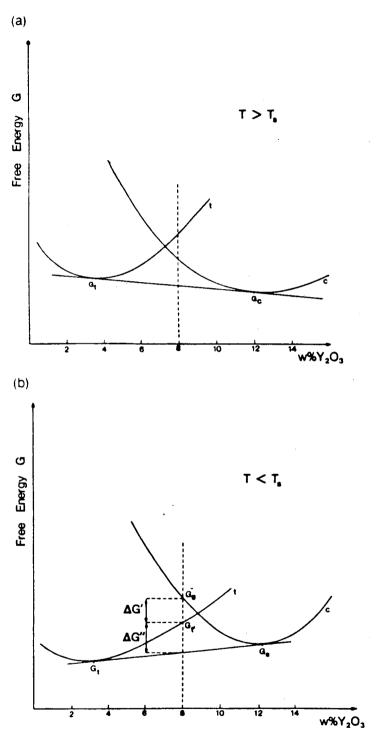
Fig.18. Free energy vs composition curves: (a) above the critical temperature  $\mathcal{T}_0$  and (b) below the critical temperature  $\mathcal{T}_0$ .
