NASA Technical Memorandum 102113
AIAA 89-2739

Liquid Oxygen Cooling of Hydrocarbon Fueled Rocket Thrust Chambers

Elizabeth S. Armstrong
Lewis Research Center
Cleveland, Ohio

Prepared for the
25th Joint Propulsion Conference
cosponsored by the AIAA, ASME, SAE, and ASEE
Monterey, California, July 10-12, 1989

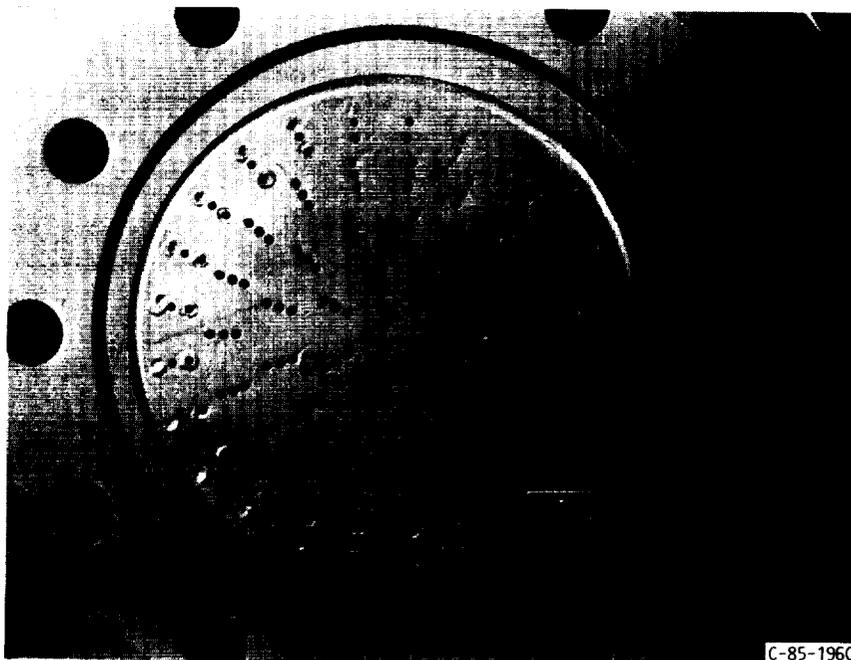
FIGURE 1. - 61 ELEMENT TRIPLET INJECTOR.

Figure 1 shows a 61-element triplet injector with 4 radial rings of elements and a central quad element that provided 3 oxidizer streams impinging on a straight fuel stream. The three innermost radial rings were arranged in an oxidizer-fuel-oxidizer (O-F-O) sequence to provide good propellant mixing, fuel vaporization, and mass flux distribution. The outermost radial ring consisted of F-O doublet showerheads to provide more fuel in the outer zone, which resulted in film cooling of the chamber wall. More details of the injector are given in table I.

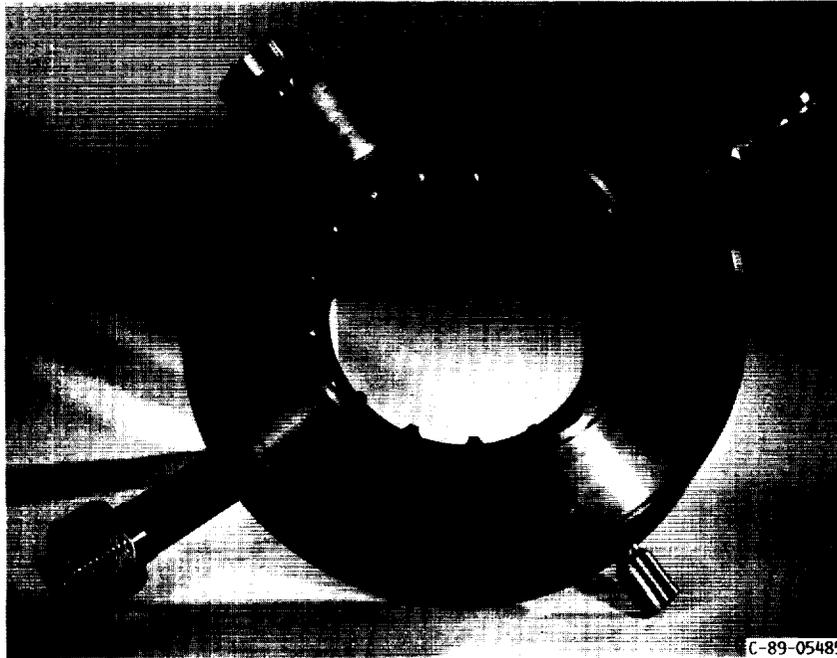
FIGURE 2. - ACOUSTIC RESONATOR.

A water-cooled resonator, as shown in figure 2, was used in this investigation to provide stable combustion. It was composed of 16 acoustic cavities arranged evenly around its inside surface. The resonator was placed between the chamber and the injector. The cavities were in line with the chamber at its edge and were 3.63 cm (1.43 in.) long. The injector formed the inner wall of the cavities which was 2.54 cm (1.0 in.) long. This corresponded to a quarter wave tube to dampen the second tangential frequency of 9700 cycles/sec which was the expected frequency of the combustion oscillations driving the instability. The hydrogen-oxygen spark torch igniter was located in the resonator wall just downstream of the acoustic cavities.

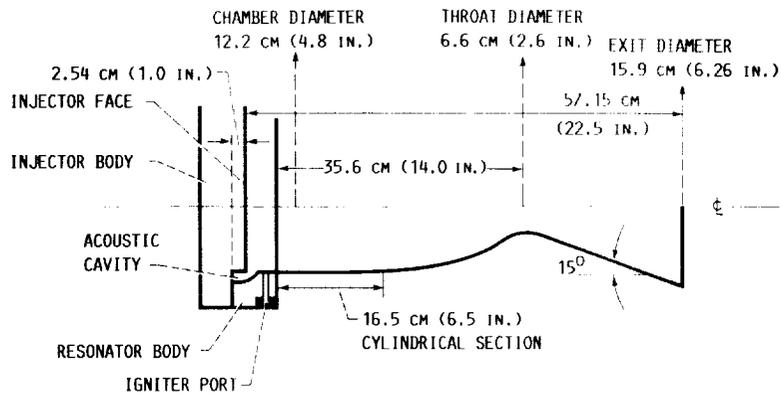
FIGURE 3. - COMBUSTION CHAMBER DIMENSIONS.

Figure 3 shows the dimensions of the combustion chambers used in this test program. The hot gas liners were fabricated from oxygen-free, high conductivity (OFHC) copper and contained 100 axial milled channels for the coolant passages. The passages were closed out with electroformed nickel. The details of the coolant channel dimensions are shown in figure 4.

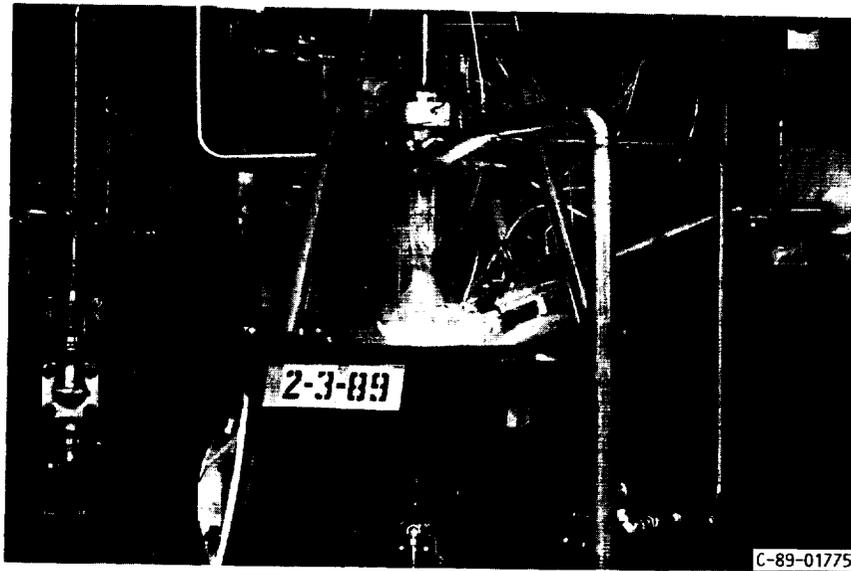
FIGURE 5. - CHAMBER DURING TEST FIRING.

Two combustion chambers were tested in this program. Chamber 702 is shown in figure 5 during a firing. To determine the effects of cracks occurring upstream of the throat, both chambers were fabricated with two machined slots 180° apart. The machined slots were not in the same circumferential location in the two chambers relative to the injector. Instead, the slots in chamber 702 were 45° off from those in chamber 703. The slots were 1.0 cm (.40 in.) long and .0127 cm (.05 in.) wide. On chamber 702, the machined slots were located 7.0 cm (2.75 in.) upstream of the throat, and on chamber 703 they were located 19.0 cm (7.5 in.) upstream of the throat, as shown in figure 6. Figure 7 shows a close-up view of one of the slots in chamber 702. The thrust chambers were instrumented

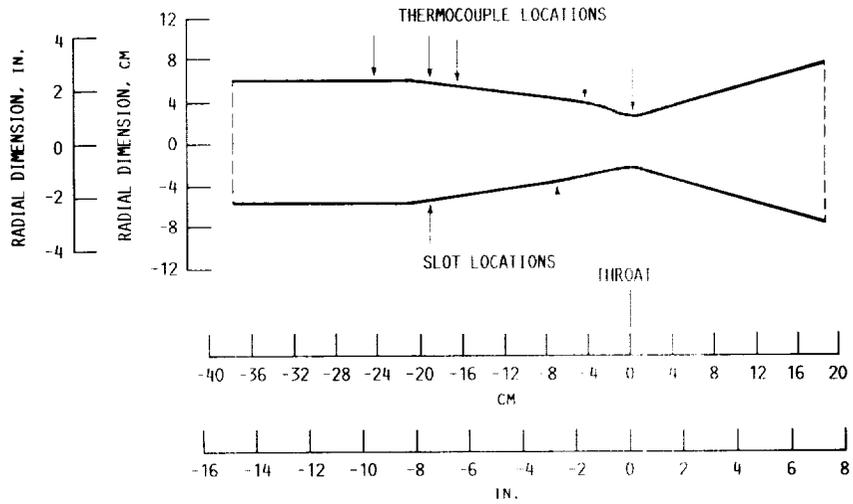
FIGURE 6. - SLOT AND THERMOCOUPLE LOCATIONS.

with Chromel/Constantan thermocouples imbedded in the rib between coolant channels approximately 1.30 mm (.051 in.) from the hot gas wall. Both chambers had 20 thermocouples evenly spaced at 4 circumferential locations in 5 axial positions. As shown in figure 6, the axial positions were 24.13 cm (9.50 in.) upstream of the throat, 16.50 cm (6.50 in.) upstream of the throat, 4.44 cm (1.75 in.) upstream of the throat, at the throat, and at the machined slots. The LOX in the coolant passages used a separate feed system from the LOX flowing through the injector. The LOX coolant was countercurrent to the combustion gases and flowed at approximately the same flowrate as the LOX used as the oxidizer.

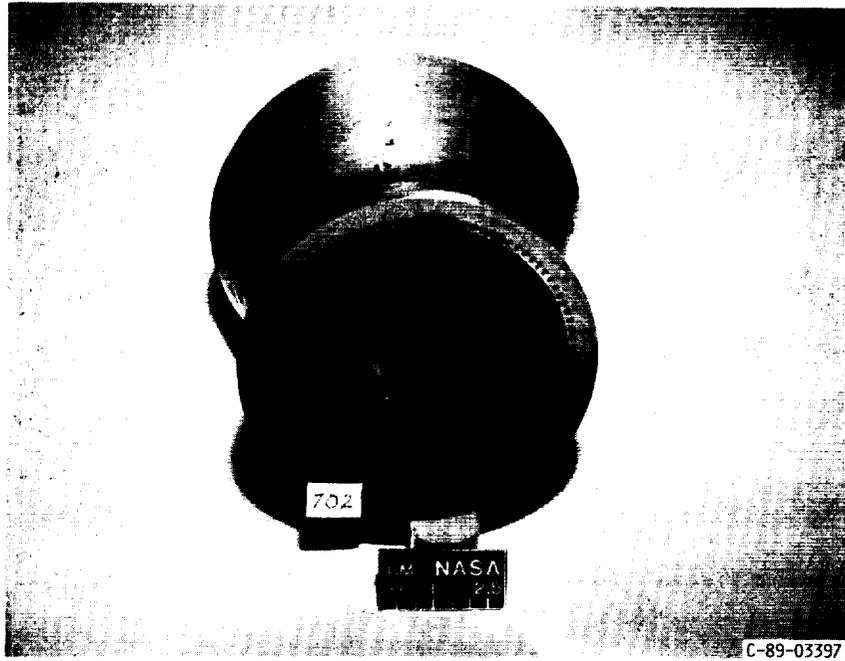
FIGURE 8. - CHAMBER 702 THROAT AREA.

Chamber 702 was fired twice. The chamber was inspected after one run and a melted region was detected just upstream of the throat and at the throat. Several oxygen-rich zones were also detected from discoloration of the copper wall. The zones, which appear as streaks, began at the injector face and continued past the throat region. The melted region was in line circumferentially with an oxygen-rich streak from the injector but not in line with either machined slot. During the second run, the RP-1 flow decreased, for reasons not yet determined. As a result, the mixture ratio increased from about 2.39 at the beginning of the test to 3.72 at the end, passing through the stoichiometric mixture ratio of 3.43. The chamber was inspected after the second run and there was indication of more melting in the same location, which opened up several coolant passages (figure 8). The reason for the severe melting is presently

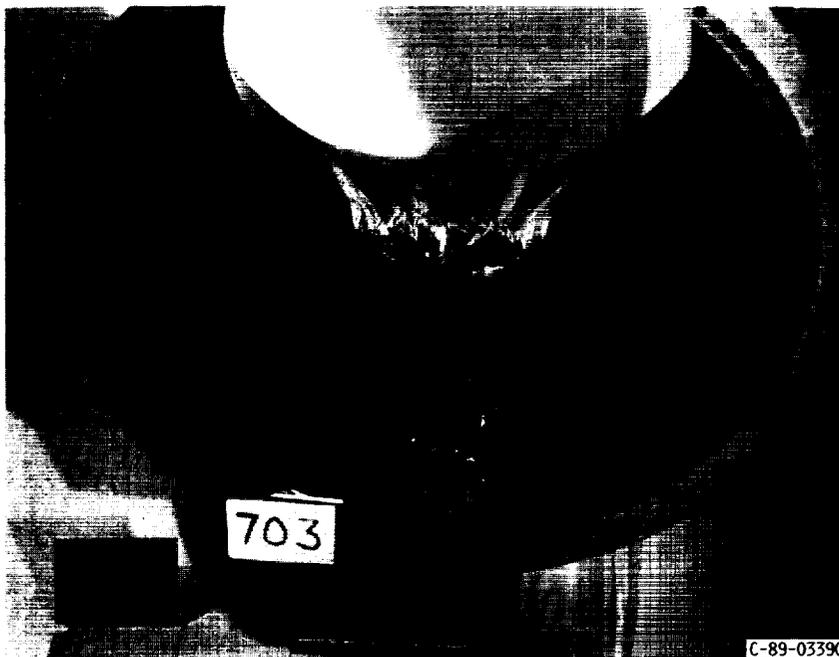
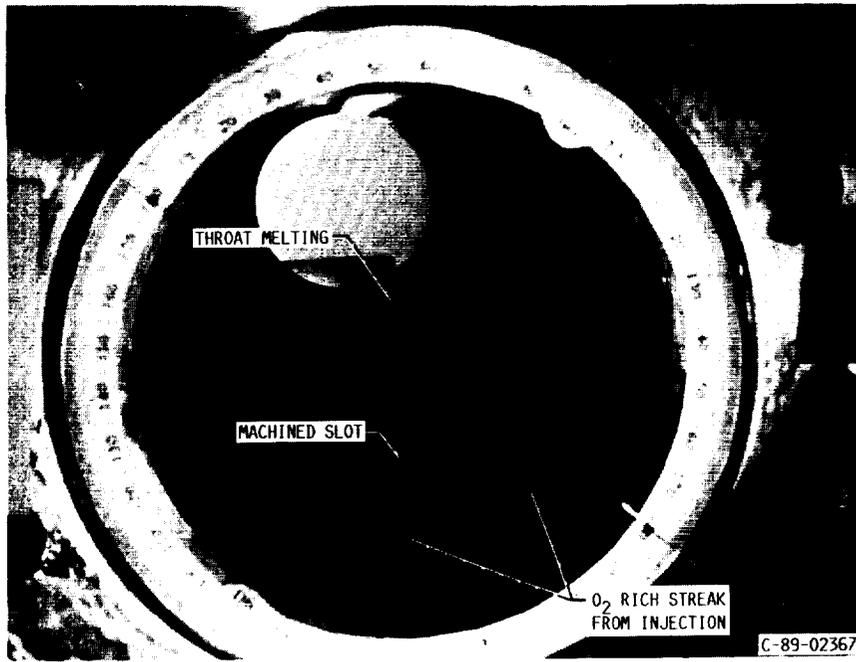
Six complete runs and one partial run were conducted with chamber 703. After the first three runs, the chamber was inspected and no evidence of damage was detected on the liner surface. The chamber was fired four more times and then inspected again. A part of the chamber liner had melted at the throat and just upstream of the throat (figure 11). Several oxygen-rich streaks were also detected from discoloration of the copper wall. The streaks began at the injector face and continued past the throat. The melted region was in line circumferentially with an oxygen-rich streak from the injector but not with either machined slot (figure 12). Again, the reason for the melting is presently undetermined. Chamber 703 was then taken off the test stand and also sectioned. Again, there was no distinguishable effect on the chamber from the leaking LOX at the machined slots.

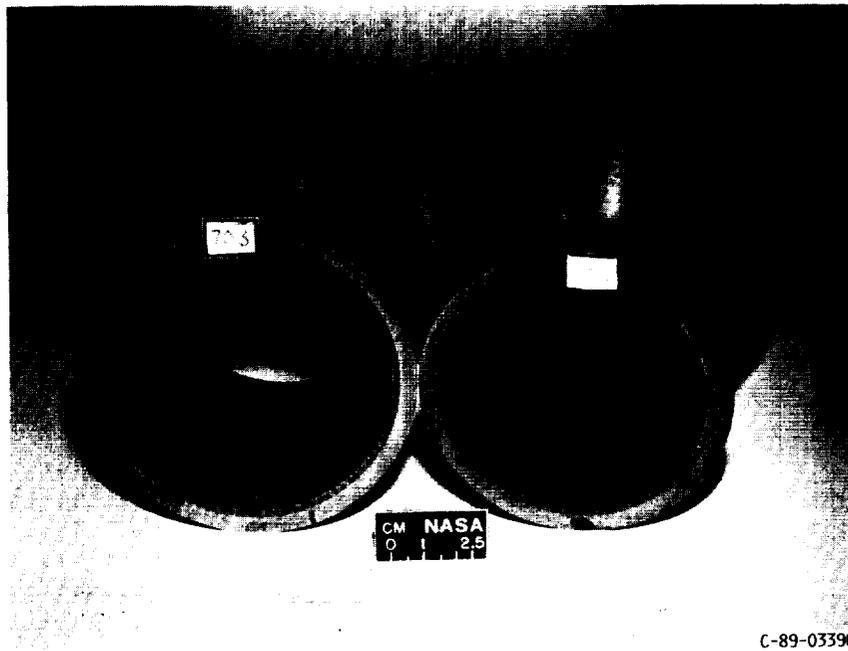
FIGURE 13. - MELTED THROAT REGION OF BOTH CHAMBERS.

Figure 13 shows the melted region at the throat for the two chambers. The line on the outside of each section represents the same circumferential location relative to the injector face. As can be seen, the melted regions were not in the same circumferential location.

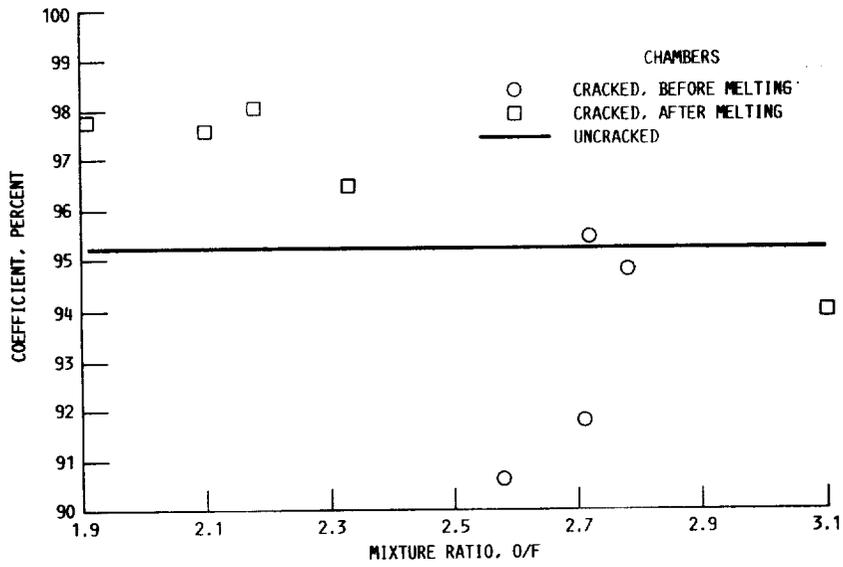
FIGURE 14. - CHARACTERISTIC EXHAUST VELOCITY EFFICIENCY FOR A CHAMBER PRESSURE OF 8.6 MPa.

Figure 14 is a plot of the C^* efficiency (characteristic exhaust velocity efficiency) versus the mixture ratio tested. As expected, the C^* efficiency increased after melting occurred at the throat. The rise in efficiency is a result of the additional mass flow coming into the chamber at the throat that was not accounted for in the C^* calculations. The C^* efficiency for the slotted chambers is generally higher than the C^* efficiency using identical hardware without machined slots⁶ for the same reason. Figure 15 is a plot of the thrust level versus mixture ratio. This figure indicates that the thrust level also increased after melting occurred at the throat due to the increase in mass flow.

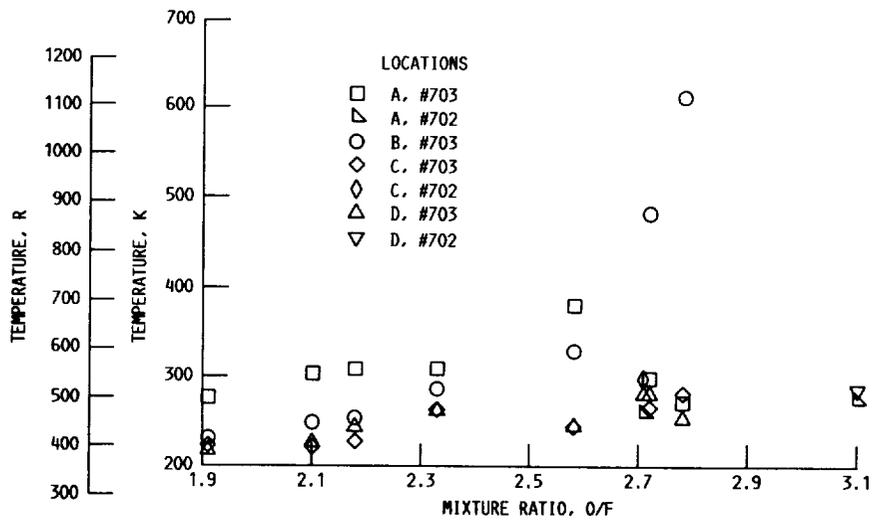
FIGURE 16. - HOT GAS WALL TEMPERATURES, AT $X = 4.44$ CM.

Thermocouples were located on the chambers at the slot locations and 2.54 cm (1.0 in.) downstream of the slots to determine the effect of LOX leaks on wall temperature. The temperatures 2.54 cm (1.0 in.) downstream of the slots in chamber 702 (4.44 cm upstream of the throat) are compared for the two chambers in

figure 16, which shows similar temperatures for the two chambers. Location B on chamber 703 had very high temperatures on runs 33 and 34 although no discernable melting occurred during these runs. The temperatures 2.54 cm downstream of the slots in chamber 703 (16.46 cm upstream of the throat) are compared for the two chambers in figure 18, which shows similar temperatures for the two chambers. Location B on chamber 702 had very high temperatures and was circumferentially near the melted throat region. This axial location, however, is upstream of the slots, indicating that these high temperatures at location B were not caused by the slots, but by the oxygen rich streak which began at the injector face. Figures 16 and 17 do not indicate any increase in temperature due to the slots in the area just downstream of the slots. Also, there was no deleterious effect on the chambers in the region of the slots. However, there were melted regions at the throat but not in line with slots. The cause of the melted regions has not yet been determined.
