Thermal Measurements of Microwave Transmitter Feedhorn Window

R. M. Perez and D. J. Hoppe

Radio Frequency and Microwave Subsystems Section

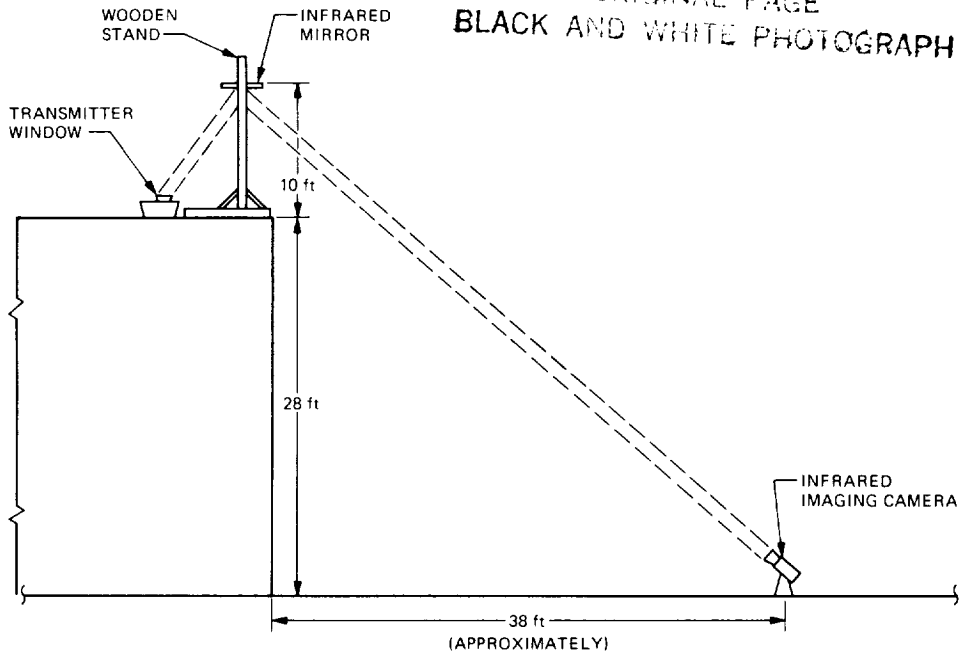
Fig. 1. Microwave window infrared imaging test configuration.

In order to overcome these difficulties, a highly-reflective infrared mirror was erected on a nonmetallic stand parallel to the feedhorn, 14 feet away, at an angle of 45 degrees (see Fig. 1). The mirror was fabricated from a 16-in. by 16-in. by 1-in.-thick soda lime float-glass blank with a highly-reflective gold finish electrodeposited on one side. An Inframetrics 600 infrared radiometer with a 3X telescope lens was placed 54 feet away, allowing viewing of the feedhorn window image on the mirror (see Fig. 2). To ensure the safety of the radiometer operator, the power density was calculated in the vicinity of the radiometer assuming reflection from the mirror surface. Using a worst-case analysis, at no time was a power density greater than 1 mW/cm² calculated. In addition, during the performance of the test, a Narda radiation monitor was used to constantly survey the area about the radiometer.

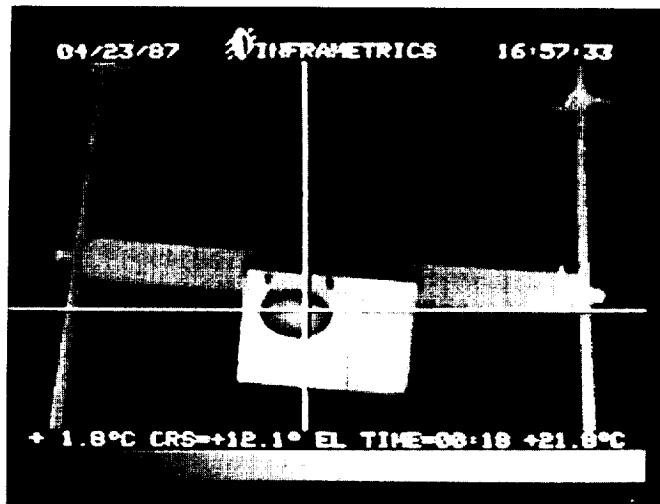
Fig. 2. Infrared image of window in mirror.

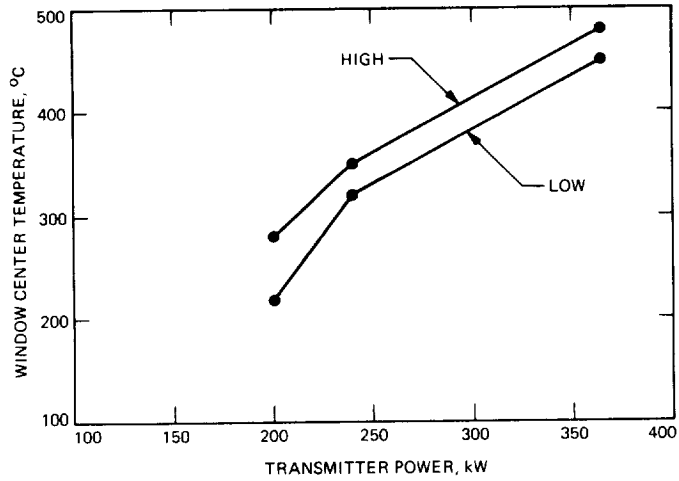
Fig. 3. HTP-6 window temperature versus transmitted power.

More stable temperature data were obtained for the HTP-6 window. A peak operating temperature of 475 degrees C was observed at 365-kW transmitted power. The power-temperature relationship for HTP-6 is shown in Fig. 3. Simple calculations were made of the temperature of a 0.1-in. HTP-6 window at 365 kW using two different models. Assuming a uniformly heated disk model, a temperature of 270 degrees C was predicted. Using a model of a Gaussian temperature distribution over the disk, a temperature of 580 degrees C was predicted. Given the Gaussian distribution of the RF beam passing through the window (see Fig. 4), the second estimate was the better one. The lower measured temperature value was due to neglecting conductive cooling through the window mounting surface in the calculations.

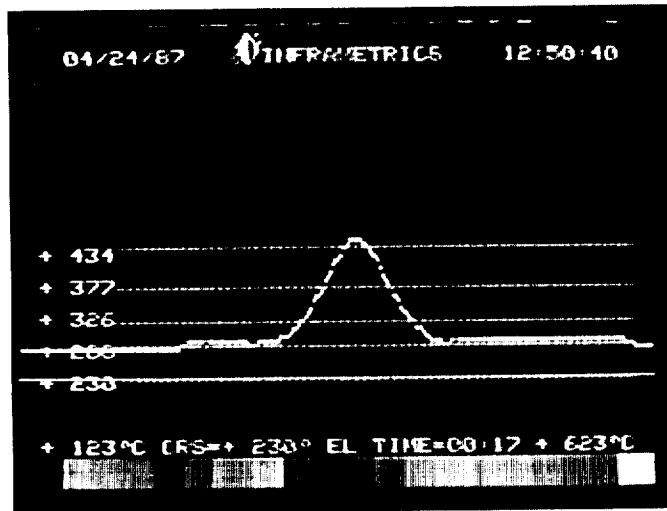
Fig. 4. Temperature distribution across window surface.

Measurements of both peak temperature and the temperature profile across the face of the window were then performed for both Kapton and HPT-6 for transmitted power levels in the range of 200–365 kW.
