# Tribological Properties of Ceramic/Ti<sub>3</sub>Al-Nb Sliding Couples for Use as Candidate Seal Materials to 700 °C

Christopher DellaCorte, Bruce M. Steinetz, and Pamela K. Brindley  
*Lewis Research Center*  
*Cleveland, Ohio*

Prepared for the  
International Conference on Metallurgical Coatings  
sponsored by the American Vacuum Society  
San Diego, California, April 2-6, 1990

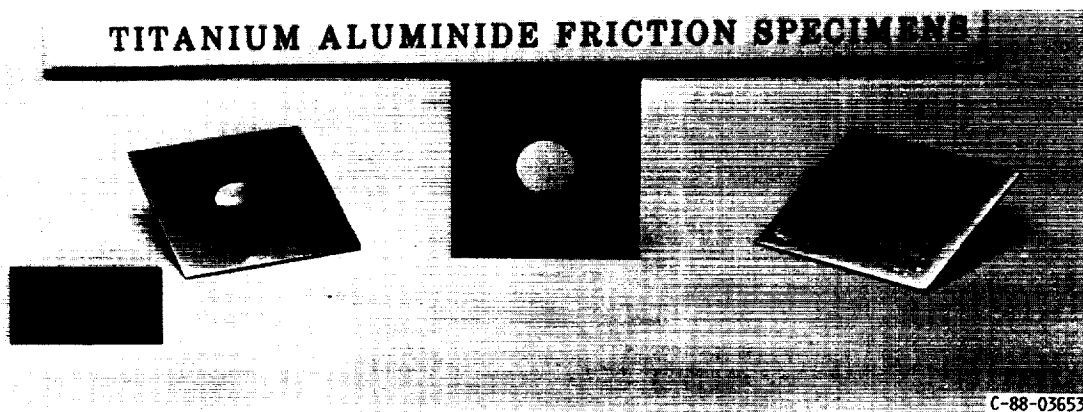
FIGURE 3. -  $\text{Ti}_2\text{Al}$ -Nb INTERMETALLIC TEST DISKS.

The powders are hot pressed into a plate 5.0 mm thick, 150 mm long and 50 mm wide. 50- by 50-mm squares were cut from the plate and polished with silicon carbide sandpaper to make the test disks. A 16 mm diameter hole was cut into the center of the disk by wire electromachining methods. The disk surface was then polished to a 0.1  $\mu\text{m}$  rms surface finish using aluminum oxide polishing powder. Scanning electron microscopy (SEM) and energy dispersive

x-ray spectroscopy (EDS) indicate that the prepared surface was free from contaminants and large scratches. Figure 3 is a photograph of some  $\text{Ti}_3\text{Al-Nb}$  wear disks.
