Strength and Toughness of Monolithic and Composite Silicon Nitrides

Jonathan A. Salem
Lewis Research Center
Cleveland, Ohio

January 1990

Jonathan A. Salem
National Aeronautics and Space Administration
Lewis Research Center
Cleveland, Ohio 44135

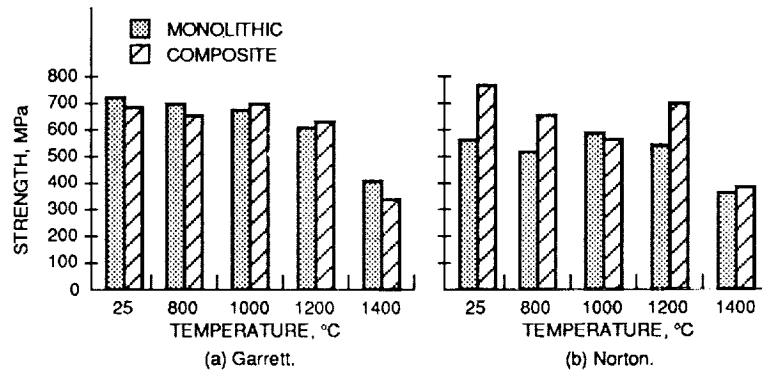
Figure 3. - Four-point bend strength of Si_3N_4 and $\text{SiC}_w/\text{Si}_3\text{N}_4$ materials.

A summary of bend strength and fracture toughness test results is given in table IV. Strength of the Garrett composite and monolithic materials were similar at each test temperature (fig. 3).

In contrast, the Norton composite exhibited higher strength than the corresponding monolithic at 25, 800, and 1200 °C, and similar strength at 1000 and 1400 °C (fig. 3). The low room temperature strength of the monolithic was attributed to the aforementioned density variations.

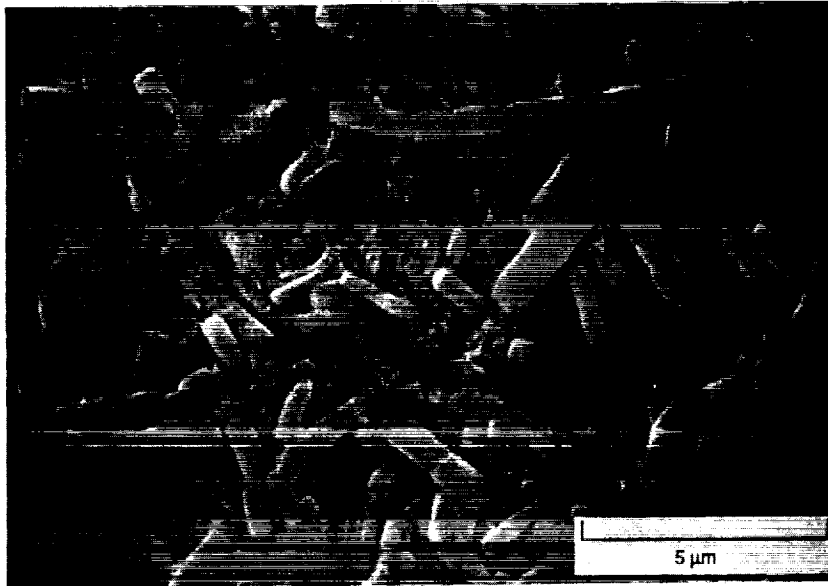
Figure 7. - Whiskers in Garrett SiC_w/Si₃N₄ exposed via plasma etching.

Typical microstructures are illustrated in figures 5 and 6. The whisker distribution in the Garrett composite was somewhat heterogeneous, with the whiskers distributed randomly in some regions and oriented in others. Whiskers, shown in figure 7, were revealed with a modified plasma etching procedure (ref. 6). The procedure did not work well on the Norton material because of the short whisker lengths.
