Robert G. Hoey

X-15 CONTRIBUTIONS TO THE X-30

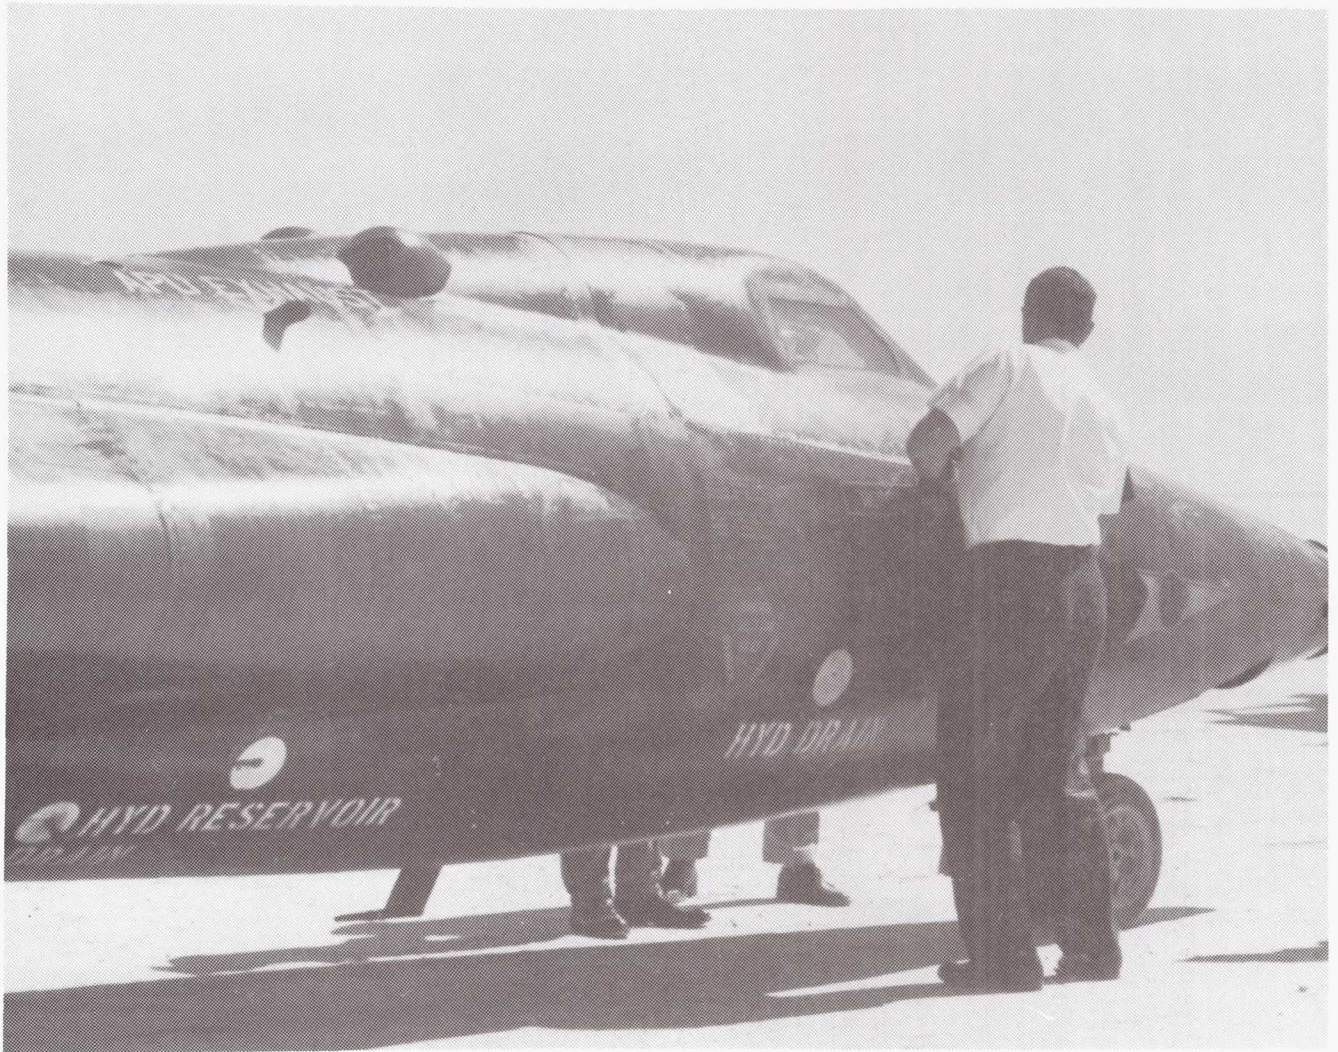
Figure 7. Small spanwise buckles and local scorching observed in X-15's skin.

At about the same time, small spanwise buckles and local scorching were observed in some areas of the thin-skinned side tunnels. The fix was to segment the side tunnels fore and aft and insert expansion slip joints between each segment (fig. 7).

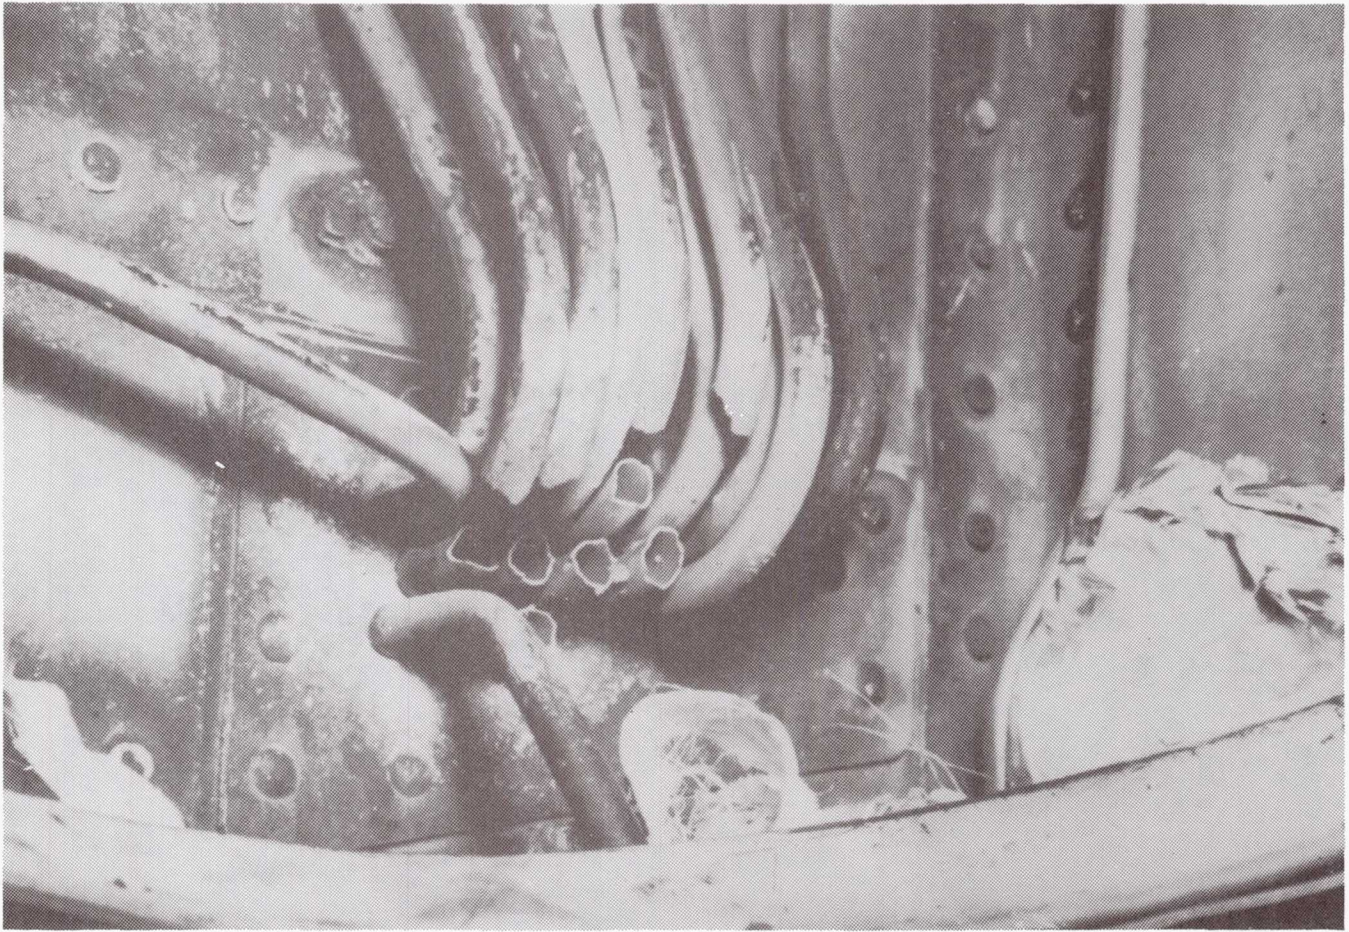
Figure 8. Heat damage to the X-15's aluminum tubing.

After a flight to about 4.5 Mach number, these aluminum instrumentation pressure lines in the nose wheel well (fig. 8) were observed to be melted and severed. The cause was a small gap in the nose wheel door seal which allowed a torchlike stream of hot boundary layer gas to enter the wheel well. The paint on the bulkhead behind the tubes (a cockpit pressure bulkhead) was badly burned and scorched but the bulkhead remained undamaged.
