# Hydrocarbon-Fuel/Combustion- Chamber-Liner Materials Compatibility

Contract NAS 3-25070  
Final Report  
NASA CR-187104  
April 1991

Report No. KBQ-FR-2  
NASA CR-187104

Aerojet Propulsion Division  
P.O. Box 13222  
Sacramento, California

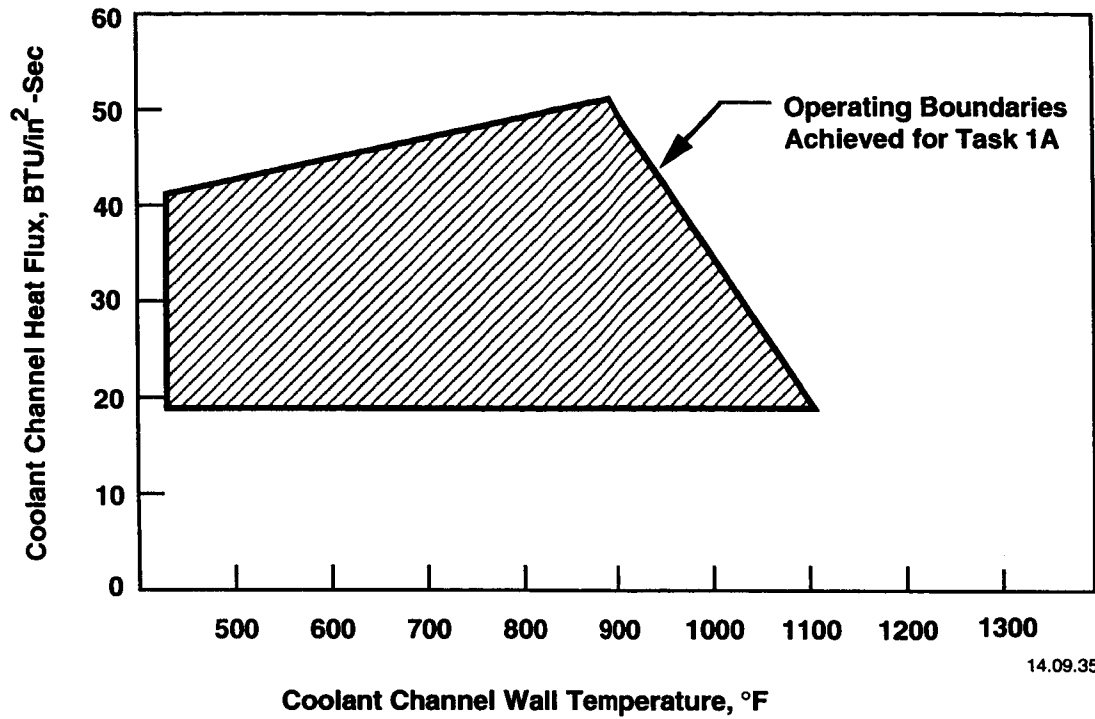
**Figure 1. Actual Operating Boundaries Achieved for Task 1A**

The dynamic test results with low sulfur content methane fuel, i.e., 0.5 ppm isobutyl mercaptan which is approximately equivalent to 0.1 ppm hydrogen sulfide ( $H_2S$ ), showed that neither carbon deposition nor sulfur corrosion were serious enough to lead to measurable losses in cooling channel heat transfer, mass flow rate, and pressure drop across the channel, during the course of 15-25 minute test runs. The Task 1A experimental test matrix actually achieved for low sulfur content methane had the operating boundaries shown in Figure 1. Thus, even at coolant channel wall temperatures as high as 1094 F, cooling channel performance did not deteriorate. However, post dynamic test analysis of the test specimen by optical microscopy, SEM, and EDS did show minor amounts of carbon deposition and moderate amounts of sulfur corrosion under the most severe operating conditions, i.e., 1094 F wall temperature and a low heat flux of 20 BTU/in.<sup>2</sup>-sec. Virtually no carbon deposition was detectable under less severe test conditions, but minor amounts of the sulfur corrosion product cuprous sulfide ( $Cu_2S$ ) were found in all the test specimen. These results clearly show that carbon deposition is never a significant problem and that sulfur corrosion is present even with low sulfur content methane, although the extent of sulfur corrosion was not severe enough to degrade cooling channel performance. Figures 2, 3, and 4 are SEM photomicrographs showing as received cooling channels, minor corrosion, and the moderate corrosion found for  $T_{wall} = 1094$  F at a heat flux of 20 BTU/in.<sup>2</sup>-sec, respectively.

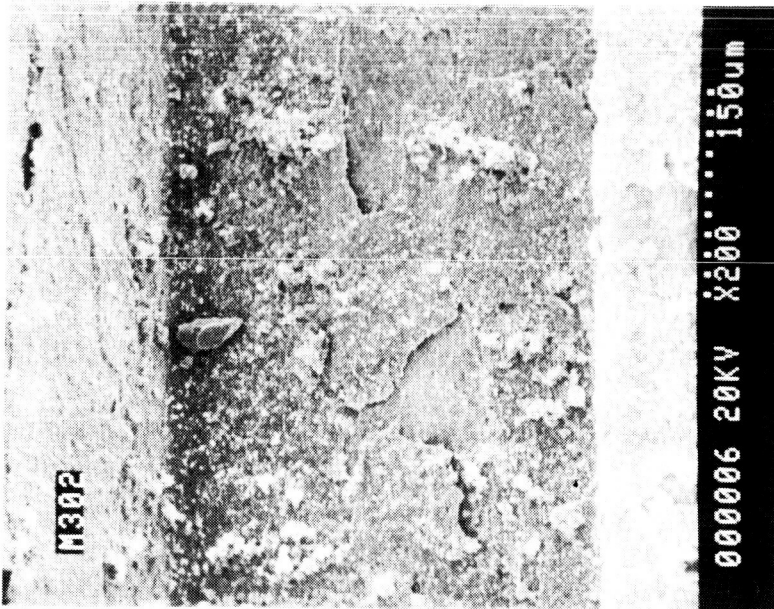
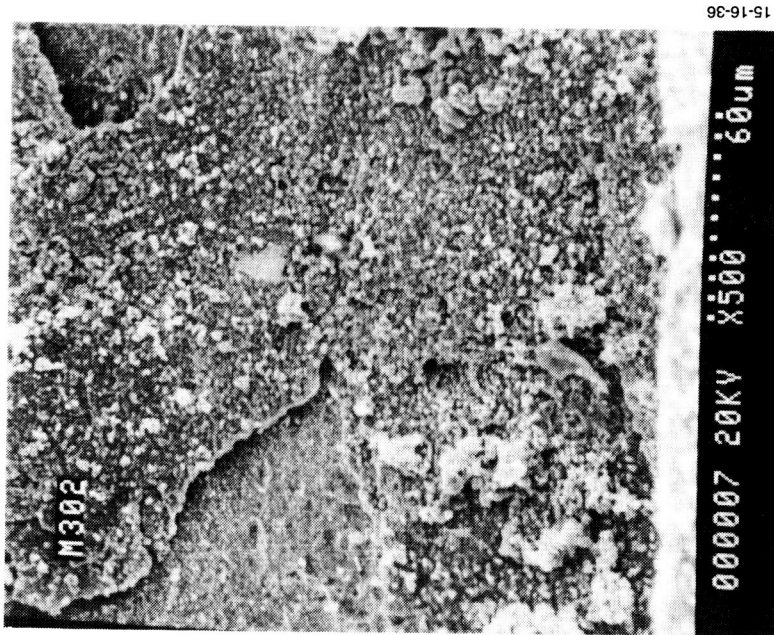
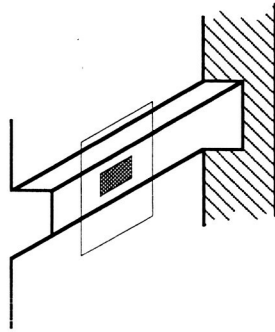
Figure 4. Cooling Channel Showing Moderate Sulfur Corrosion After Exposure to Methane Containing 0.5 ppm Isobutylmercaptan at a Wall Temperature of 1094°F and Heat Flux of 20 Btu/in.<sup>2</sup> -sec. Note, Cu<sub>2</sub>S Deposits Cover Most of Channel Surface

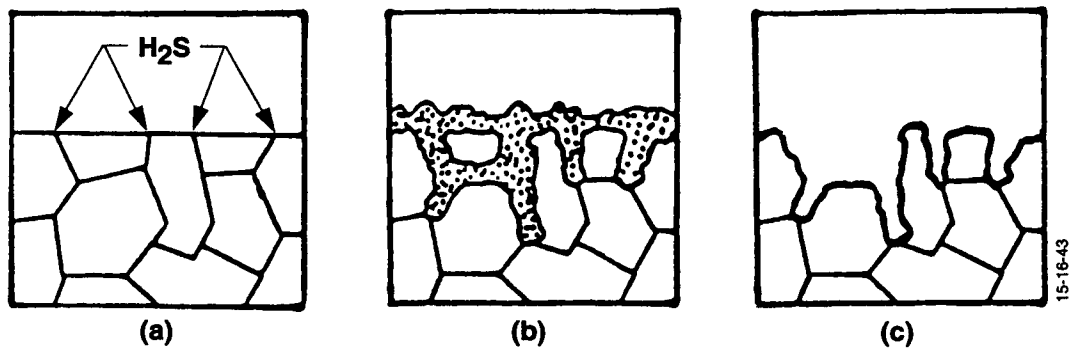
**Figure 6. Pictorial Presentation of Overall Sulfur Corrosion and Cuprous Sulfide Removal Process**

- (a) Preferential Grain Boundary Attack By  $H_2S$  on Cu Alloy**
- (b) Resulting  $Cu_2S$  Corrosion Product, Has Penetrated the Grain Boundaries, Completely Undermining and Isolating Some Surface Grains**
- (c) Removal of the  $Cu_2S$  With Aqueous NaCN Also Leads to the Loss of the Isolated Grains, Leaving a Rough, Highly Pitted Surface**

The static test results identified only one process capable of efficiently removing  $\text{Cu}_2\text{S}$  without attacking the bare copper alloy. This process involves a brief, i.e., less than 5 minutes, treatment with 5% (w/w) aqueous sodium cyanide (NaCN) which dissolves the  $\text{Cu}_2\text{S}$ . The resulting copper surface is highly pitted and rough. This roughening is primarily due to the nature of the initial corrosion process which involves preferential grain boundary attack by the sulfur corrosive. The overall process is graphically illustrated in Figure 6.

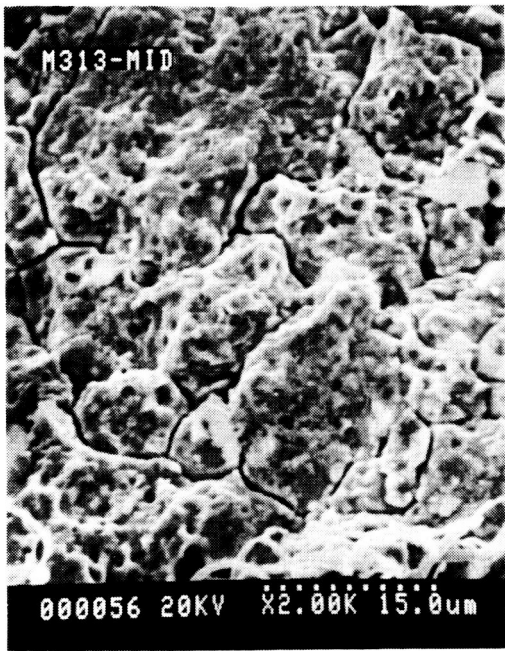
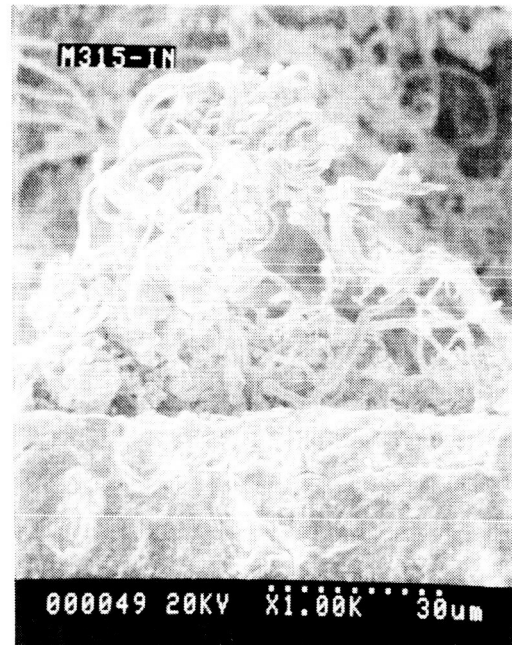
**Figure 7. Cooling Channel Surface Features Resulting From the Overall Sulfur Corrosion/NaCN Refurbishment Process**

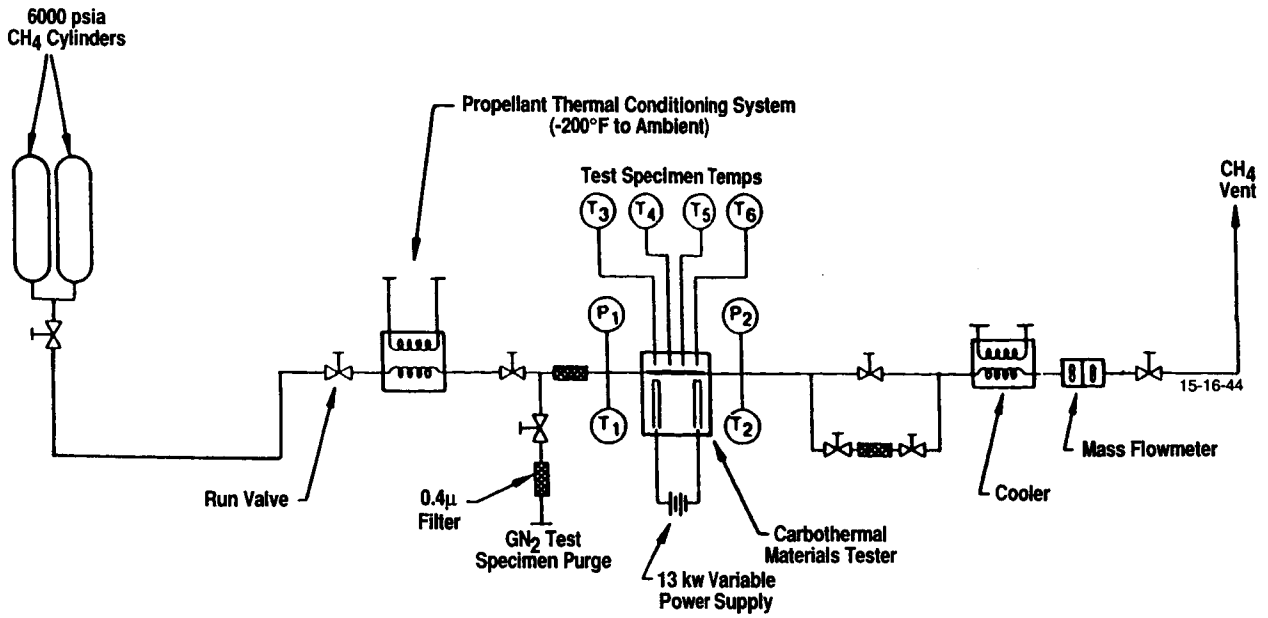
**Figure 8. Schematic of Aerojet Carbothermal Test Facility Set-up for Handling Methane Fuel**

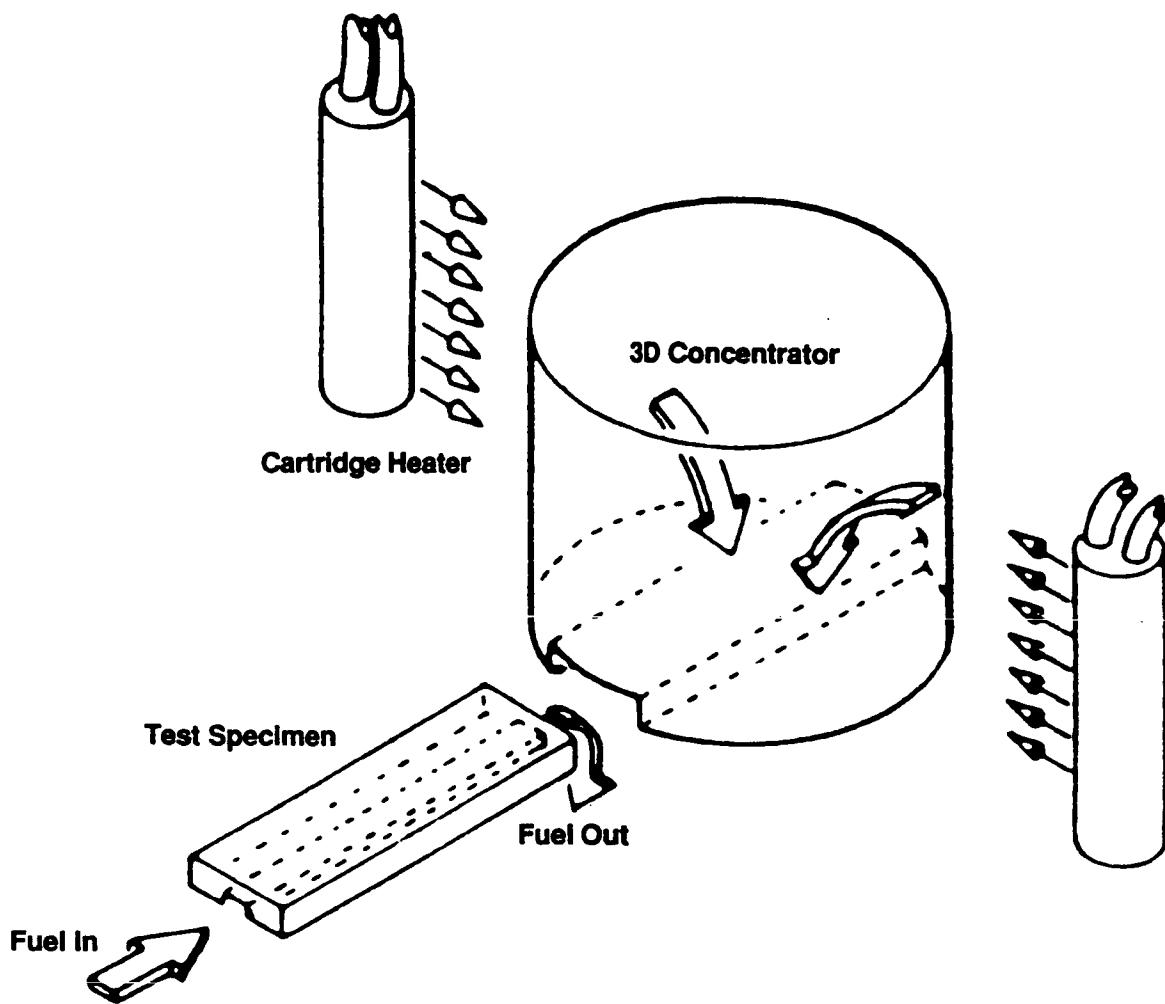
**The Geometric Concentration of Energy is an Alternative to Ohmically Heated Test Specimens**

**Figure 9. Conceptual Design of Aerojet Carbothermal Materials Tester**

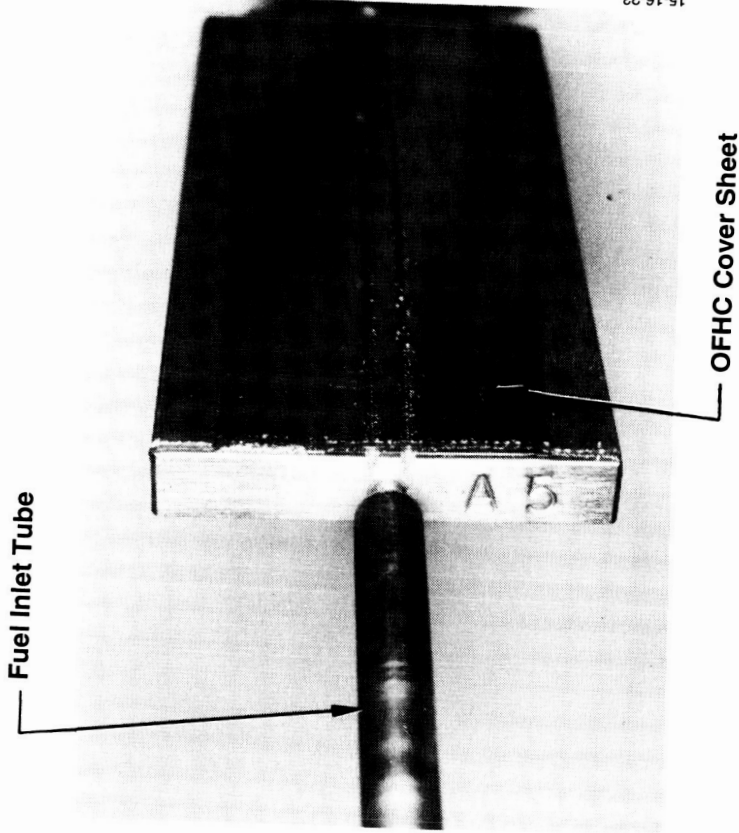
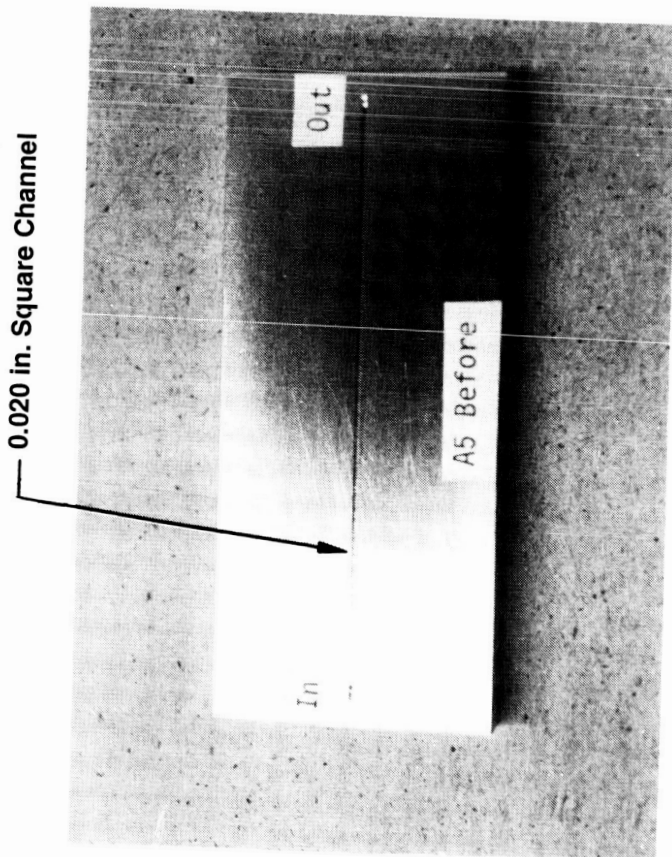
Completed CH<sub>4</sub>/Cu Test Specimen

As Machined NASA-Z Test Specimen

Figure 10. Copper Test Specimen Details

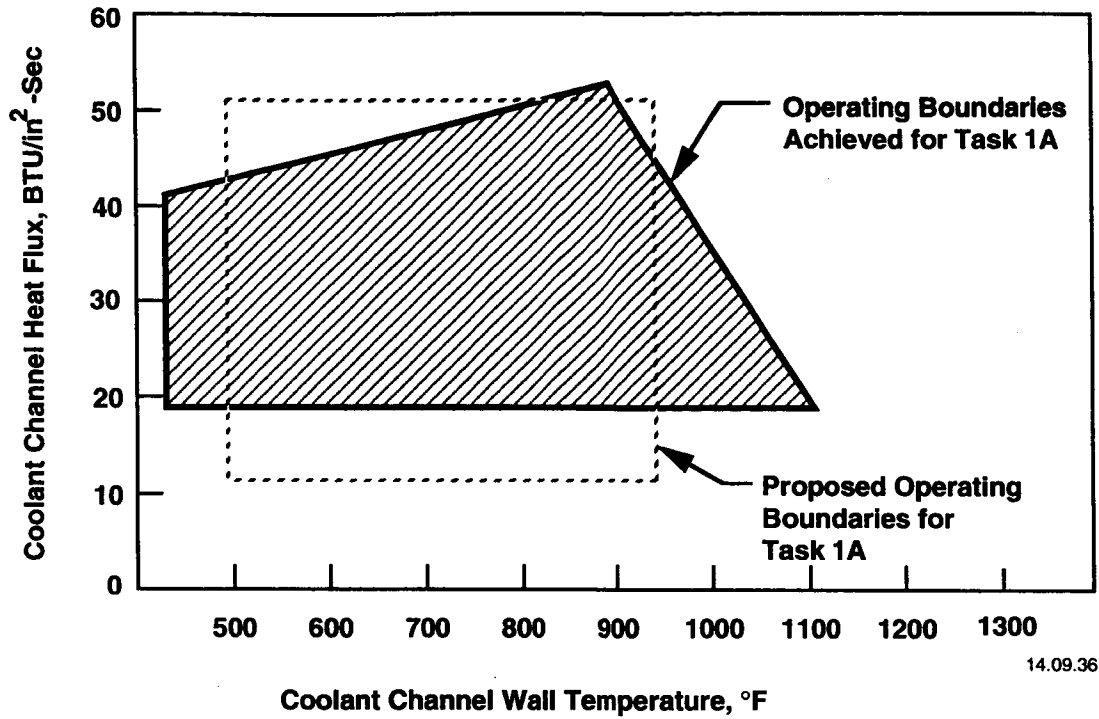
**Figure 11. Actual and Proposed Operating Boundaries for Task 1A**

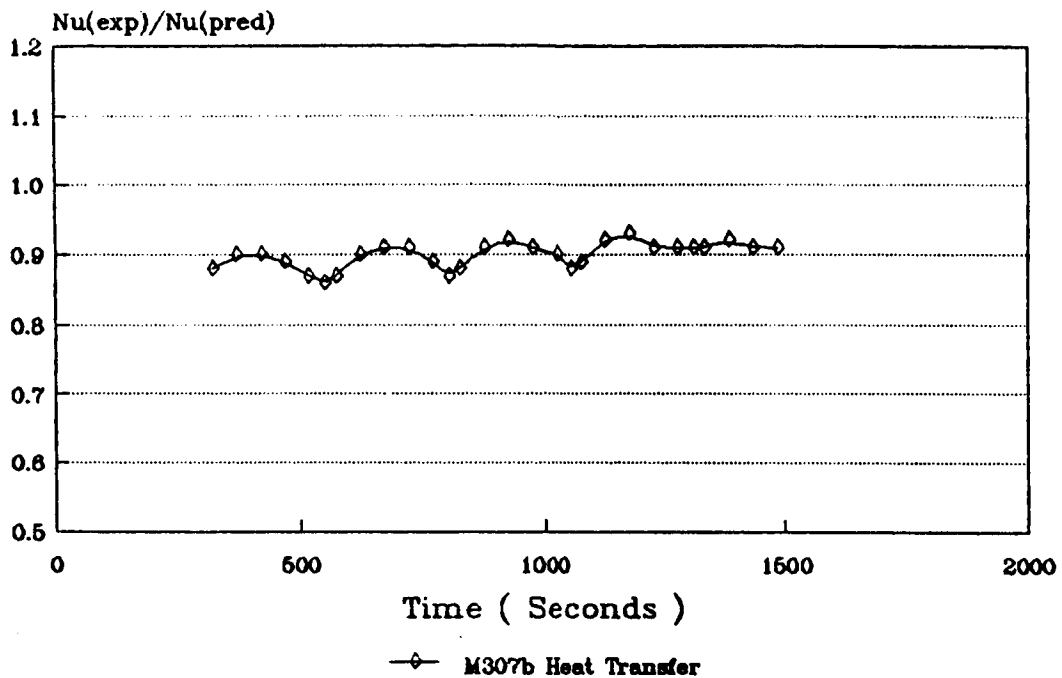
Figure 12. Heat Transfer Efficiency,  $Nu(\text{exp})/Nu(\text{pred})$ , vs Time for Test M307b  
Operating Conditions:  $T_{\text{wall}} = 638^{\circ}\text{F}$ , Mass Flow = 1.23 lbs/min

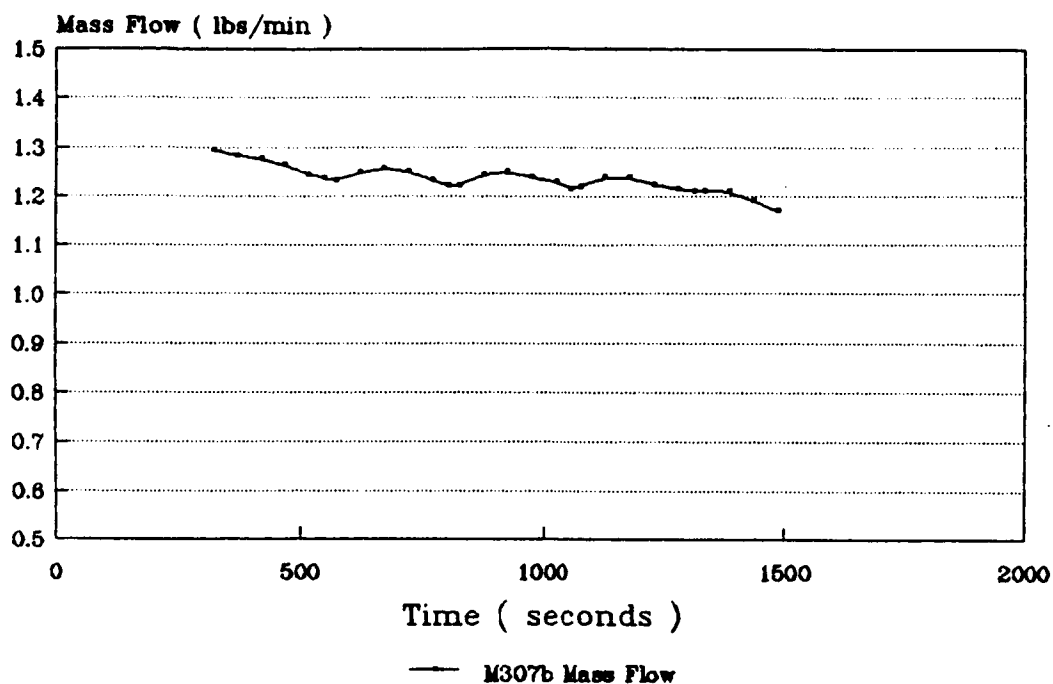
**Figure 13. Mass Flow vs Time for Test M307b**  
**Operating Conditions:  $T_{wall} = 638^{\circ}F$ , Mass Flow = 1.23 lbs/min**

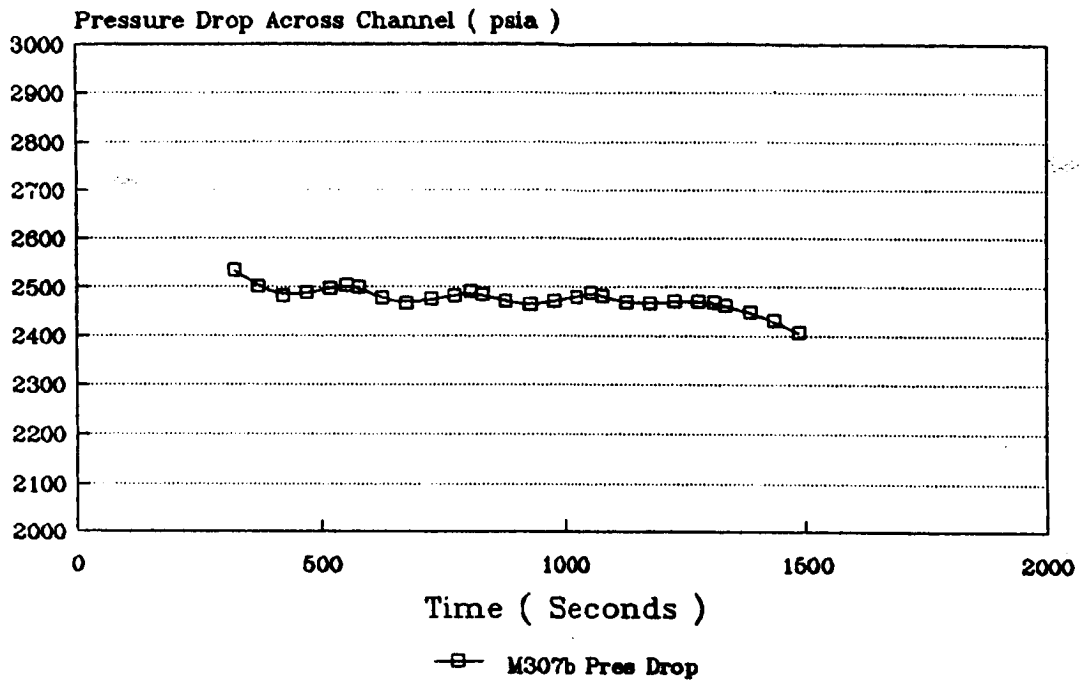
Figure 14. Pressure Drop Across the Cooling Channel vs Time for Test M307b  
Operating Conditions:  $T_{wall} = 638^{\circ}\text{F}$ , Mass Flow = 1.23 lbs/min

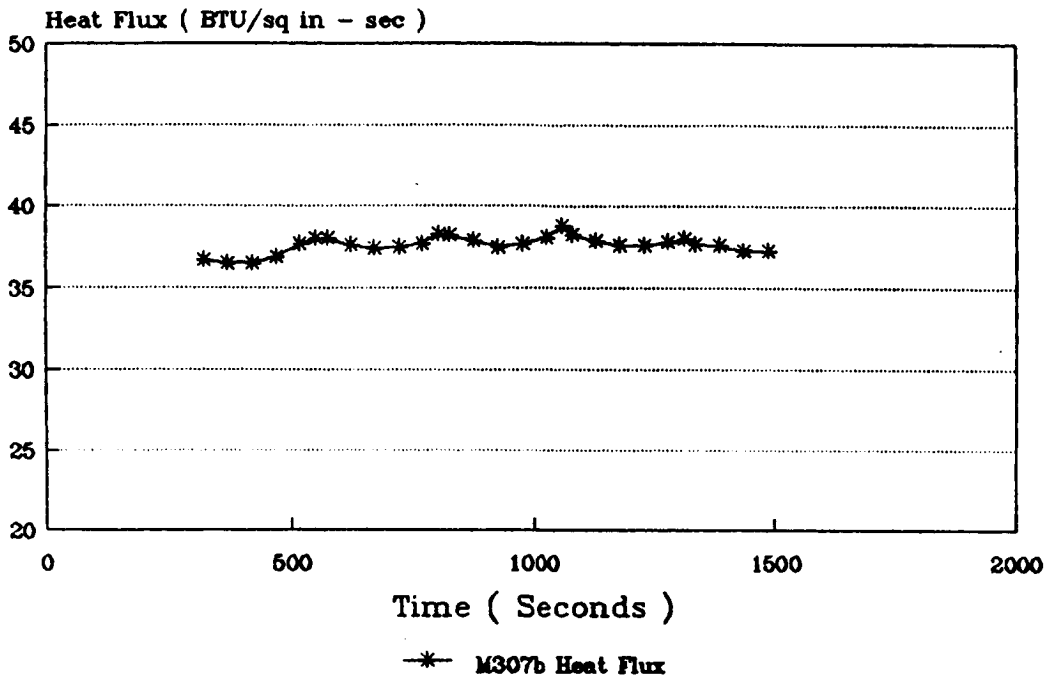
Figure 15. Heat Flux vs Time for Test M307b  
Operating Conditions:  $T_{wall} = 638^{\circ}\text{F}$ , Mass Flow = 1.23 lbs/min

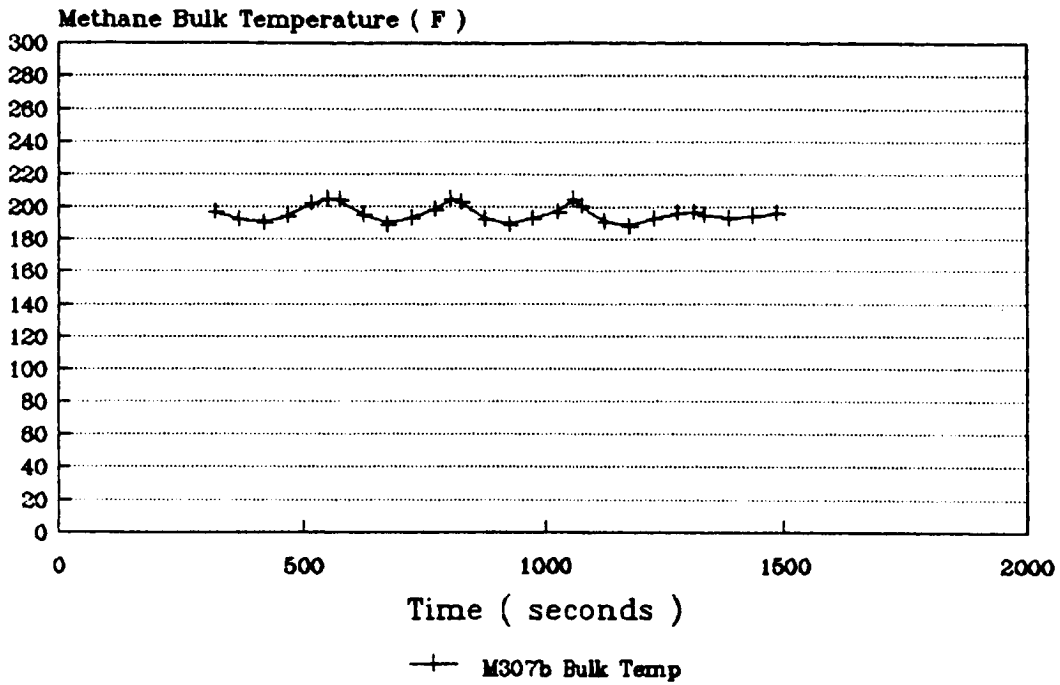
**Figure 16. Methane Bulk Temperature vs Time for Test M307b**  
**Operating Conditions:  $T_{\text{wall}} = 638^{\circ}\text{F}$ , Mass Flow = 1.23 lbs/min**

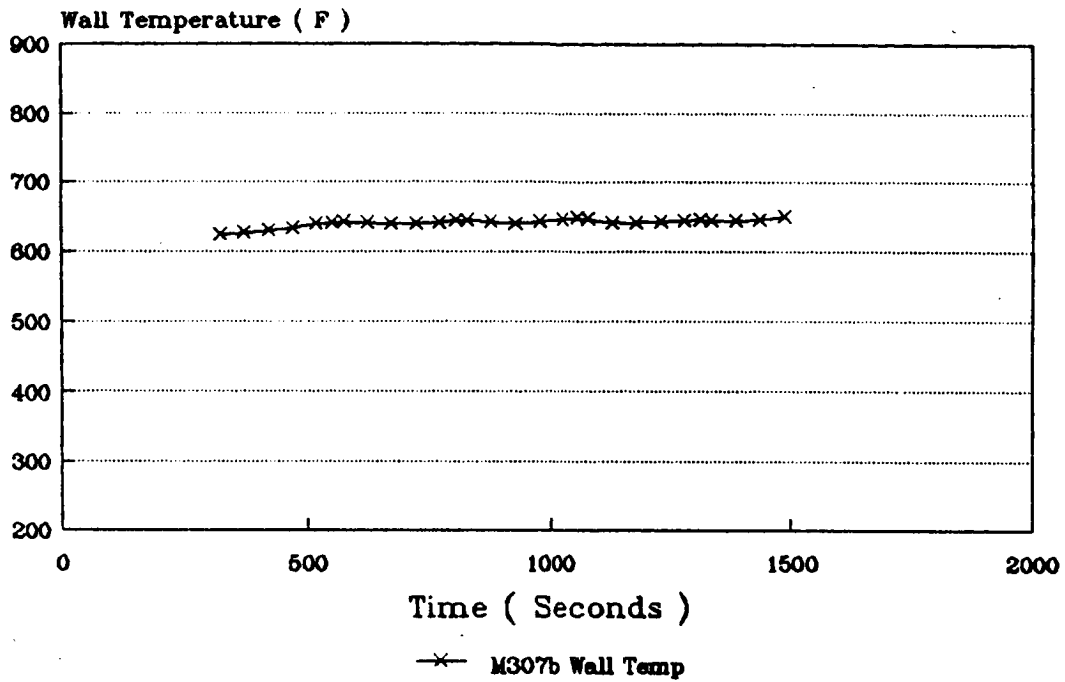
Figure 17. Cooling Channel Wall Temperature vs Time for Test M307b  
Operating Conditions:  $T_{wall} = 638^{\circ}\text{F}$ , Mass Flow = 1.23 lbs/min

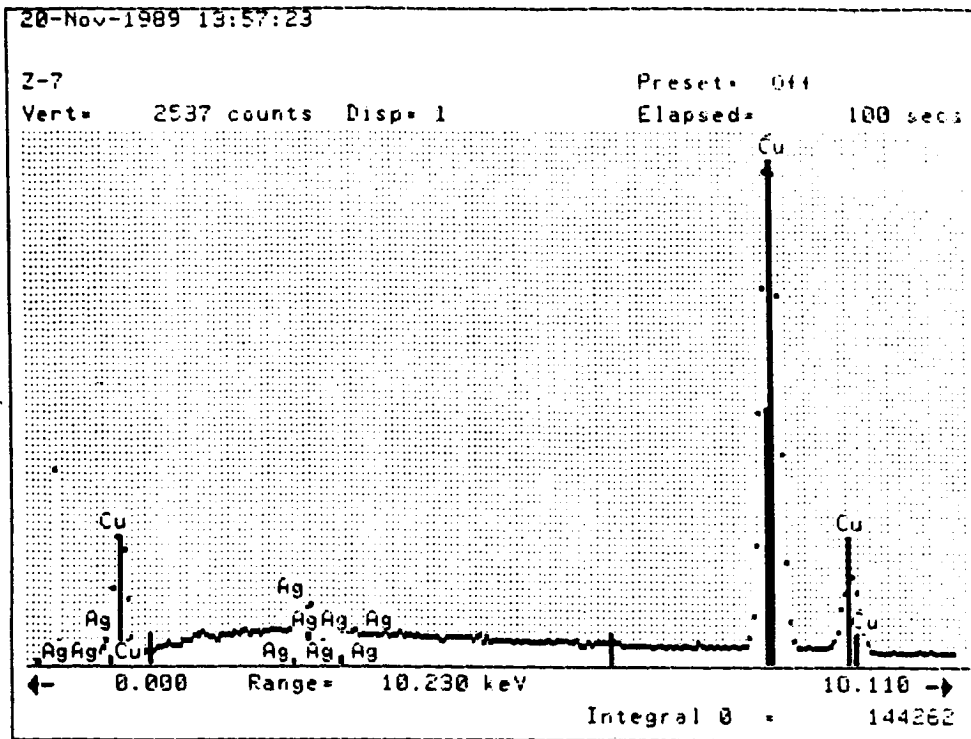
Figure 18. EDS Spectrum of as Received NASA-Z Copper

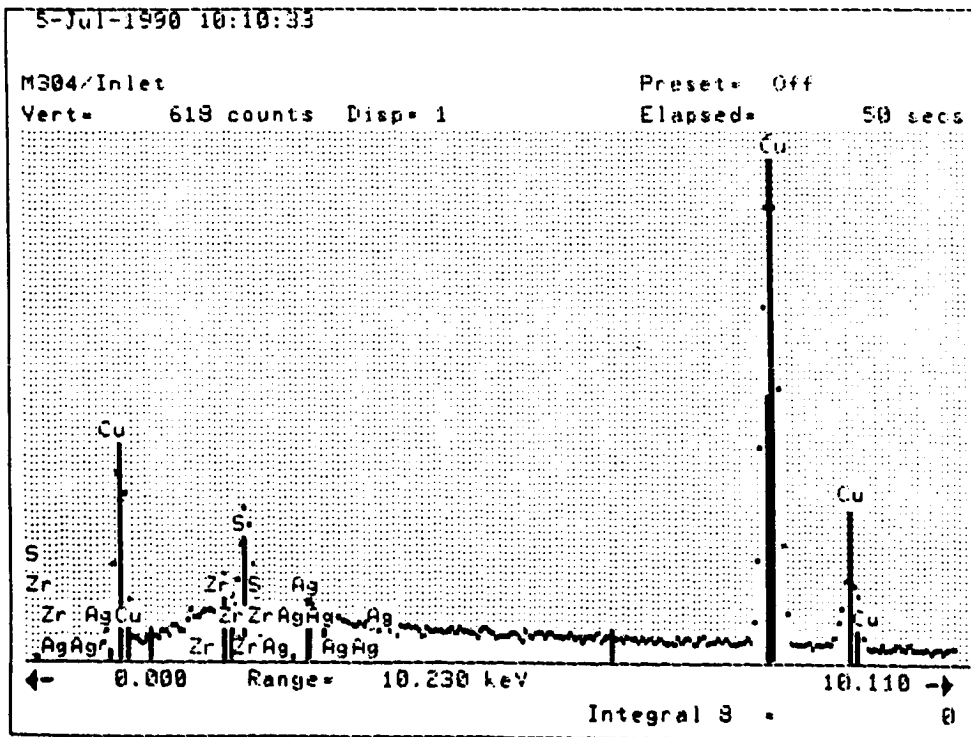
Figure 19. EDS Spectrum of Cooling Channel Surface for Test Specimen Used In Test M304. Note the Presence of Sulfur Which is Absent From the Spectra of as Received NASA-Z Copper

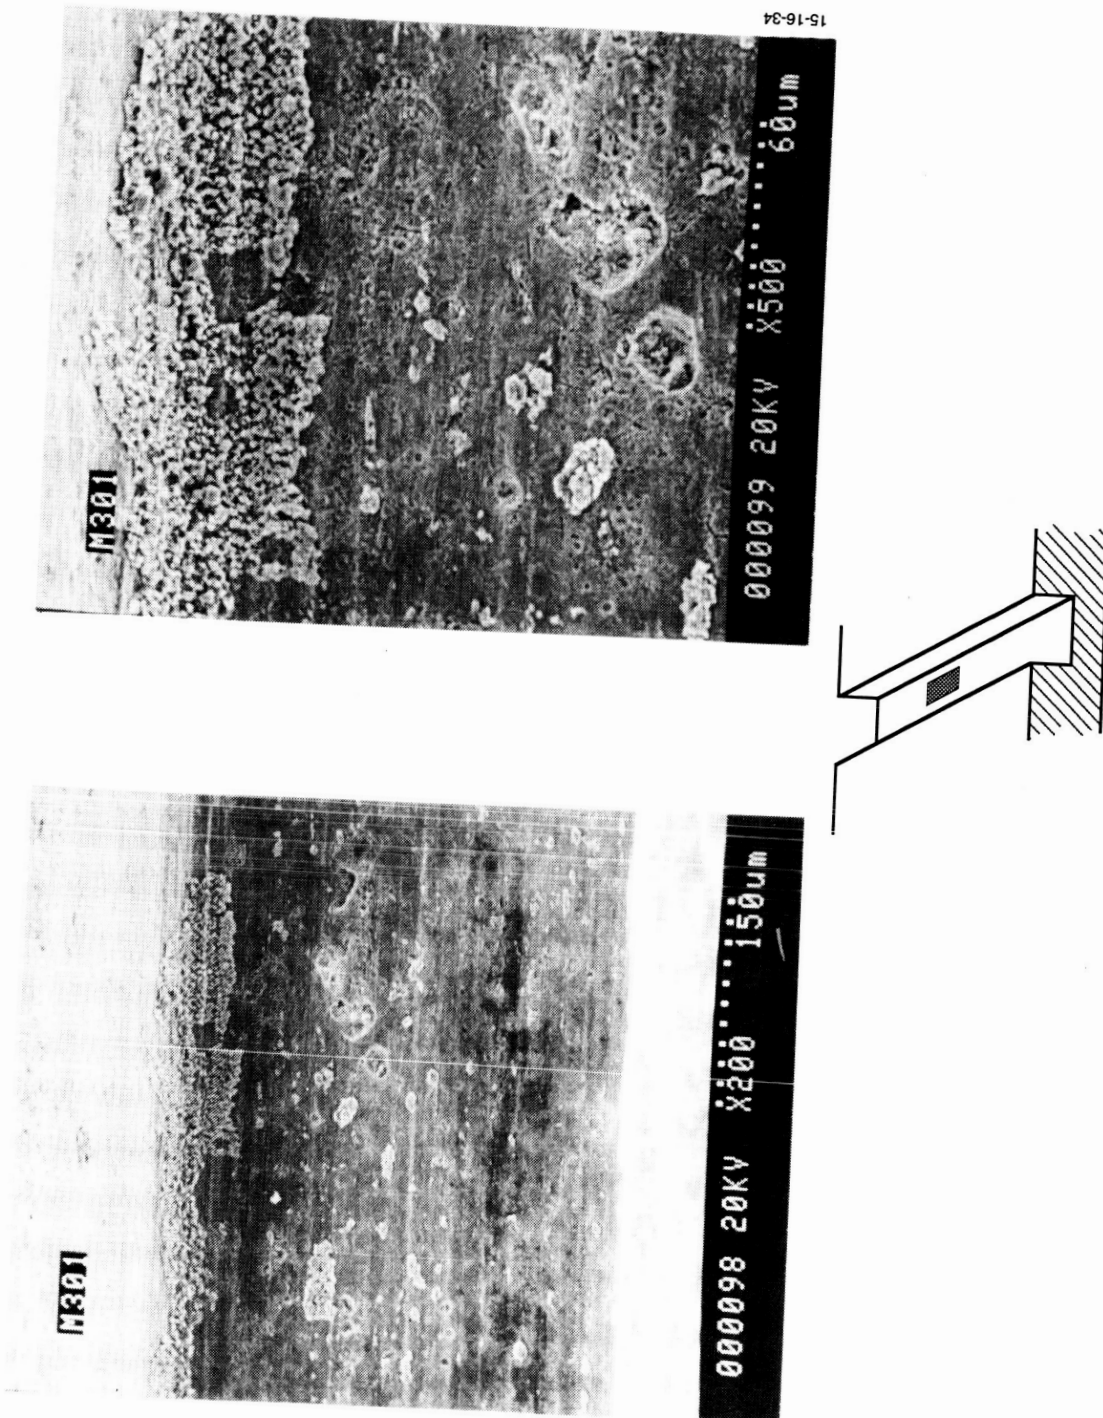
Figure 21. Cooling Channel of Test Specimen After Test M301. Note That Only Small Amounts of Cu<sub>2</sub>S Deposits Are Present as Scattered Patches. Machine Markings Are Subdued, But Still Visible. M301 Test Conditions: T<sub>Wall</sub> = 425°F, Mass Flow = 0.68 lbs/min

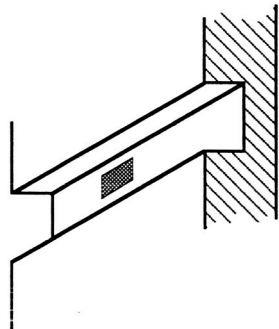
Figure 22. Cooling Channel of Test Specimen After Test M302. Note That Channel Surface Is Almost Completely Covered With a Loosely Bound "Scale" of  $\text{Cu}_2\text{S}$ .  
M302d Test Conditions:  $T_{\text{Wall}} = 1094^\circ\text{F}$ , Mass Flow = 0.41 lbs/min

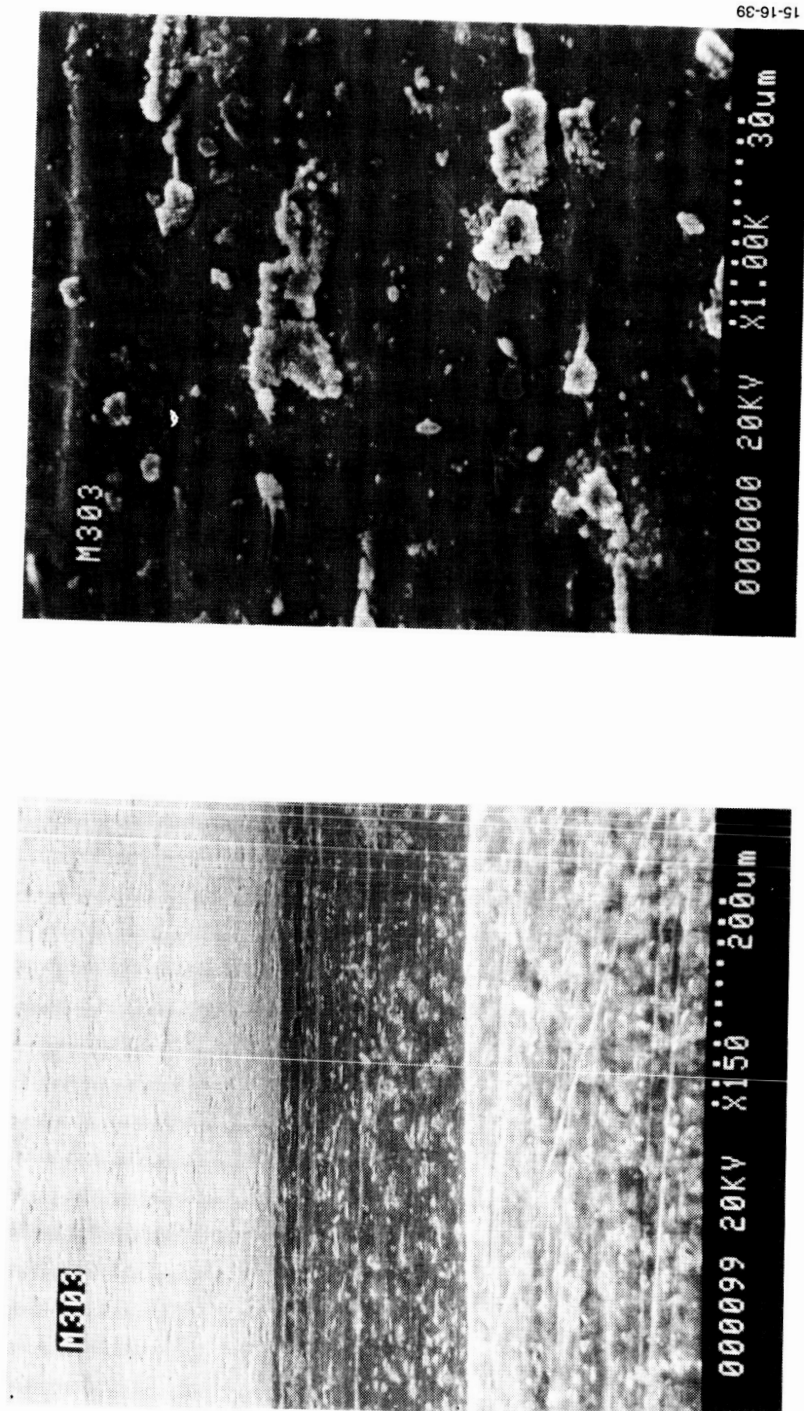
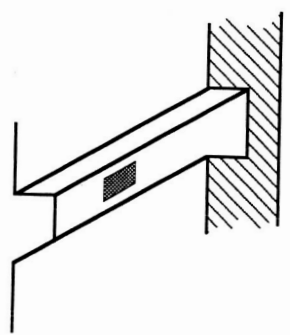
Figure 23. Cooling Channel of Test Specimen After Test M303. Note Very Light Deposits of  $\text{Cu}_2\text{S}$  and That Machine Marks Are Visible. M303 Test Conditions: T Wall = 429°F, Mass Flow = 1.76 lbs/min

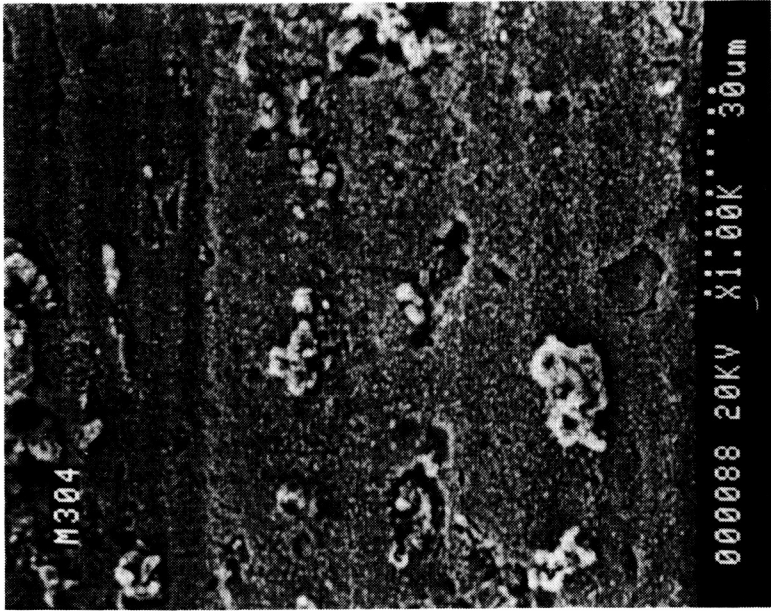
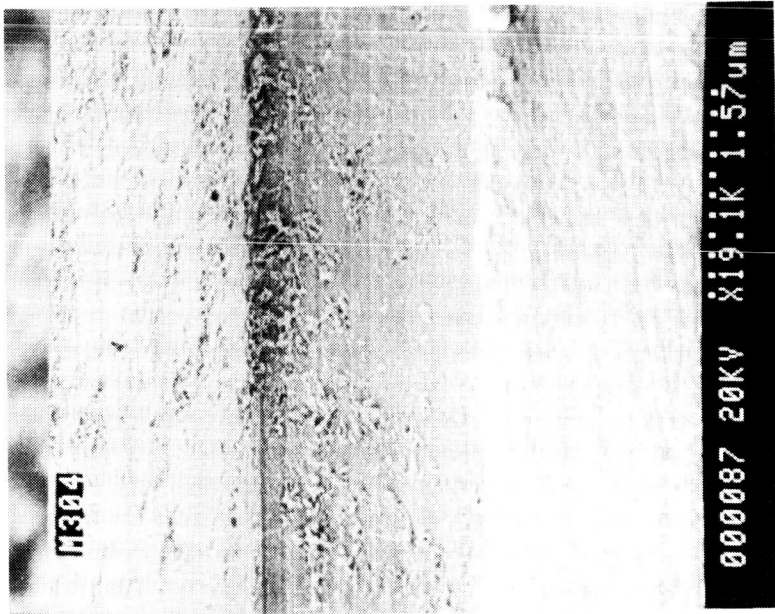
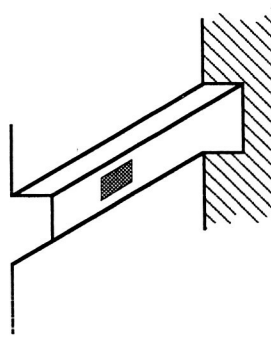
Figure 24. Cooling Channel of Test Specimen After Test M304. Note Scattered Deposits of  $\text{Cu}_2\text{S}$  and That Machine Marks Are Subdued But Still Visible. M304 Test Conditions:  $T_{\text{wall}} = 900^\circ\text{F}$ , Mass Flow = 0.69 lbs/min

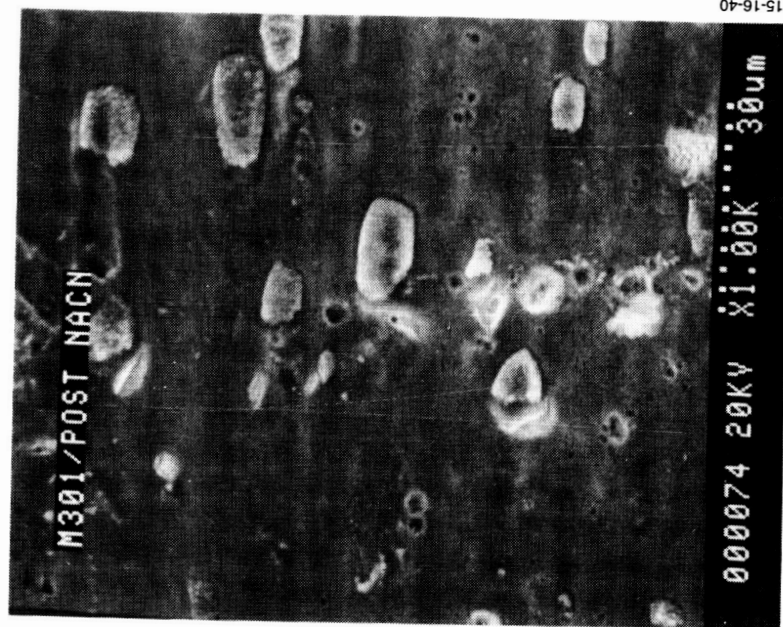
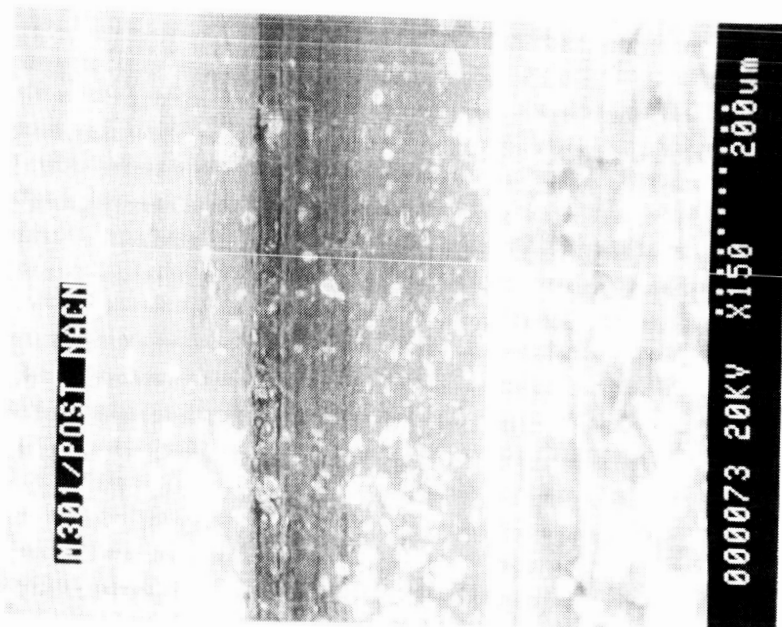
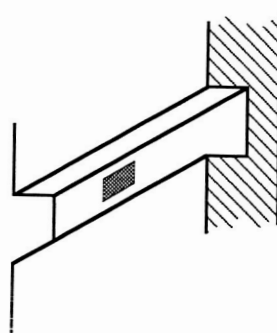
Figure 25. Cooling Channel of M301 Test Specimen After Removal of the  $\text{Cu}_2\text{S}$  Deposits With Aqueous NaCN. Note That Machine Marks Are Clearly Visible Along With Some Shallow Craters and Surface Particles

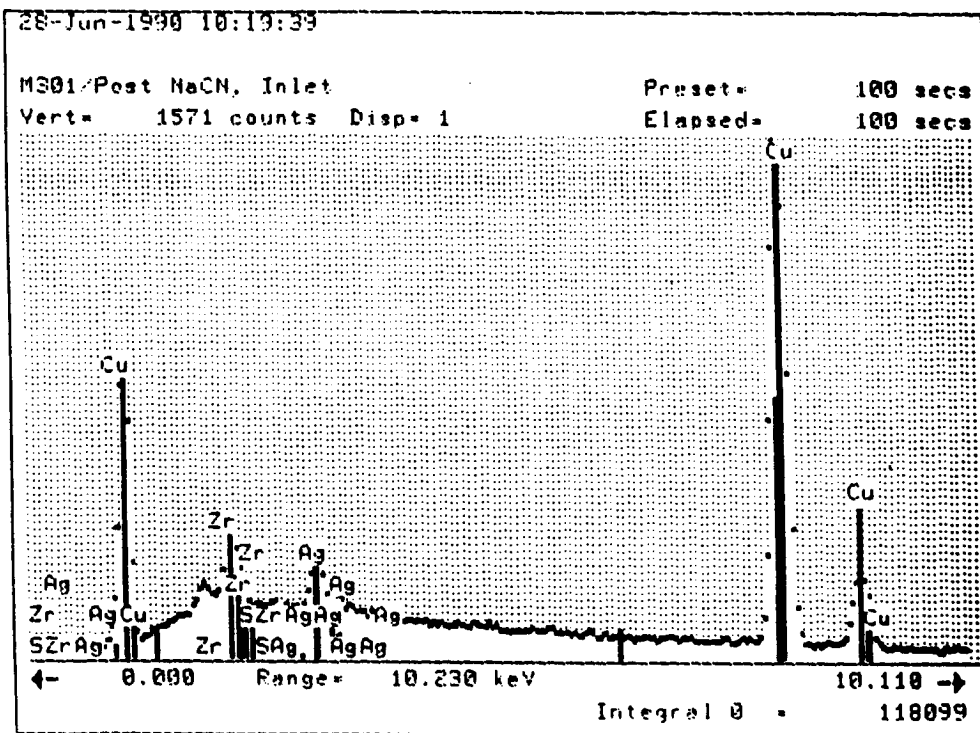
**Figure 26. EDS Spectrum of Cooling Channel Surface of M301 Test Specimen After Removal of Sulfur With Aqueous NaCN. Note, No Sulfur is Detectable and Both Zirconium and Silver Show Measurable Responses**

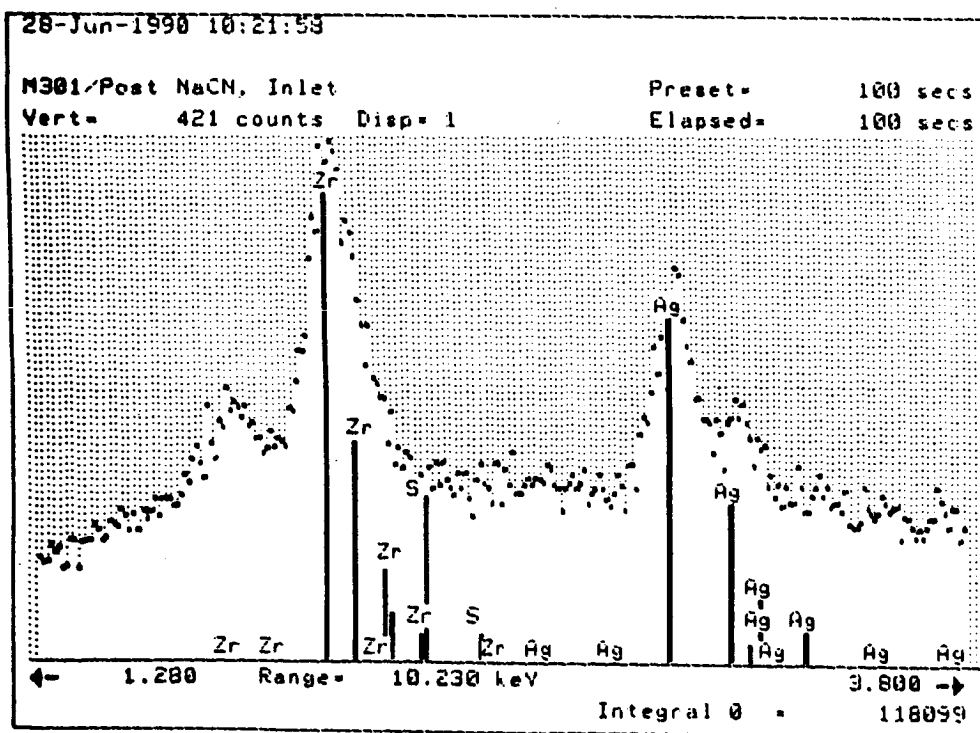
**Figure 27. Expanded View of EDS Spectrum Showing Surface Particles are Grains Enriched in Zirconium and Silver and That Sulfur is completely Absent**

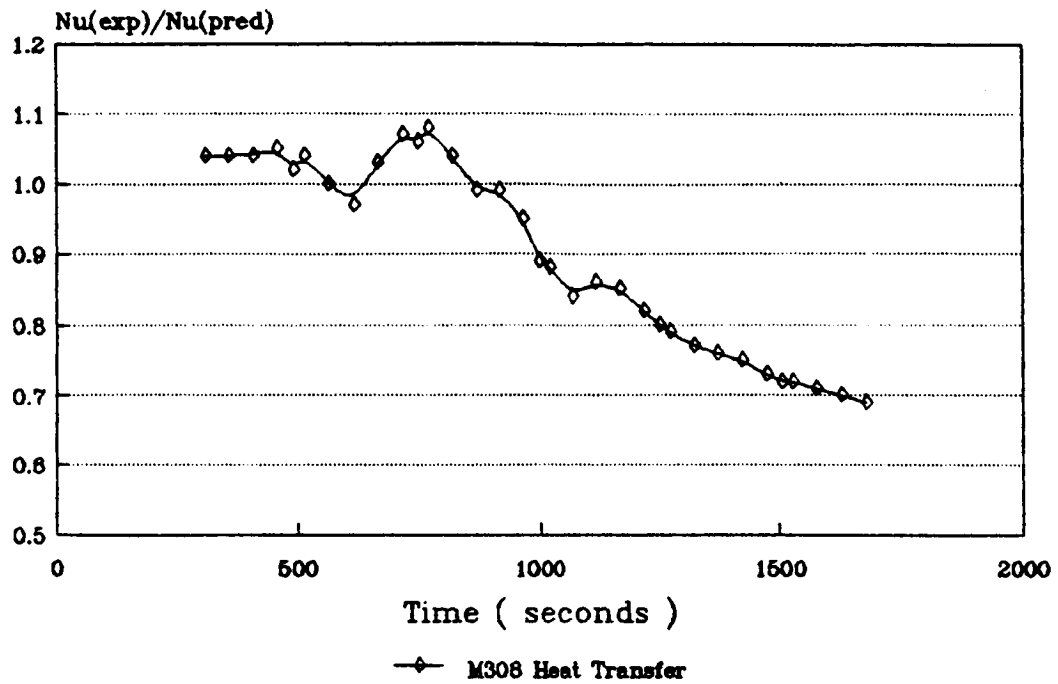
**Figure 29. Heat Transfer Efficiency,  $Nu(\text{exp})/Nu(\text{pred})$ , vs Time for Test M308 (1 ppm  $H_2S$ )**  
**Operating Conditions:  $T_{\text{wall}} = 631^\circ\text{F}$ , Mass Flow = 1.20 lbs/min**

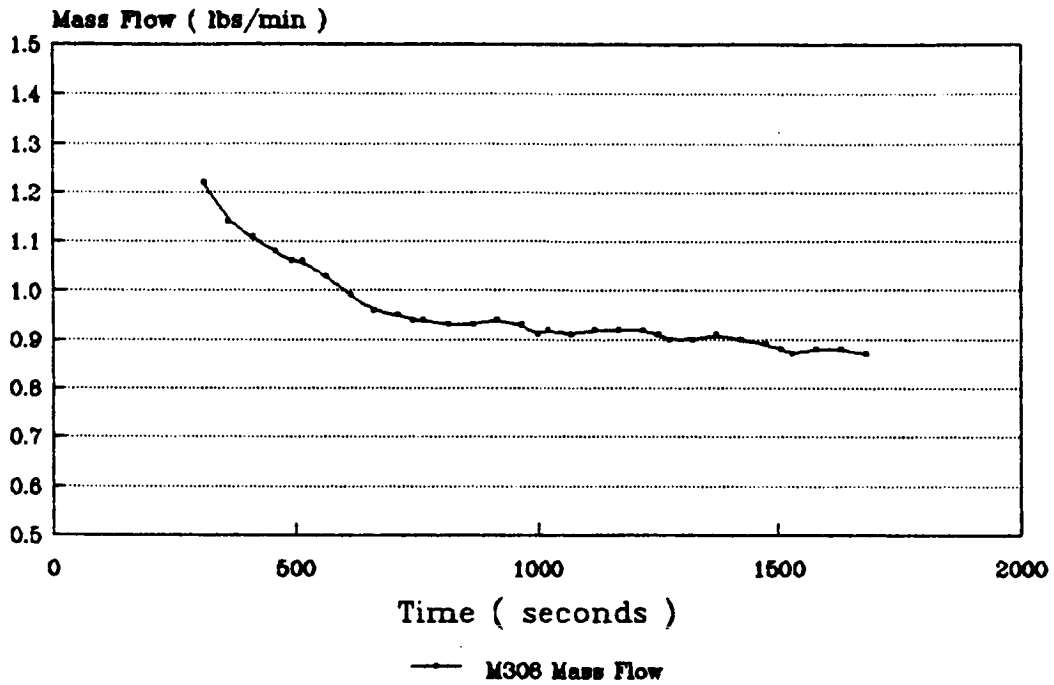
**Figure 30. Mass Flow vs Time for Test M308 (1 ppm H<sub>2</sub>S)**  
Operating Conditions:  $T_{wall} = 631^{\circ}\text{F}$ , Mass Flow = 1.20 lbs/min

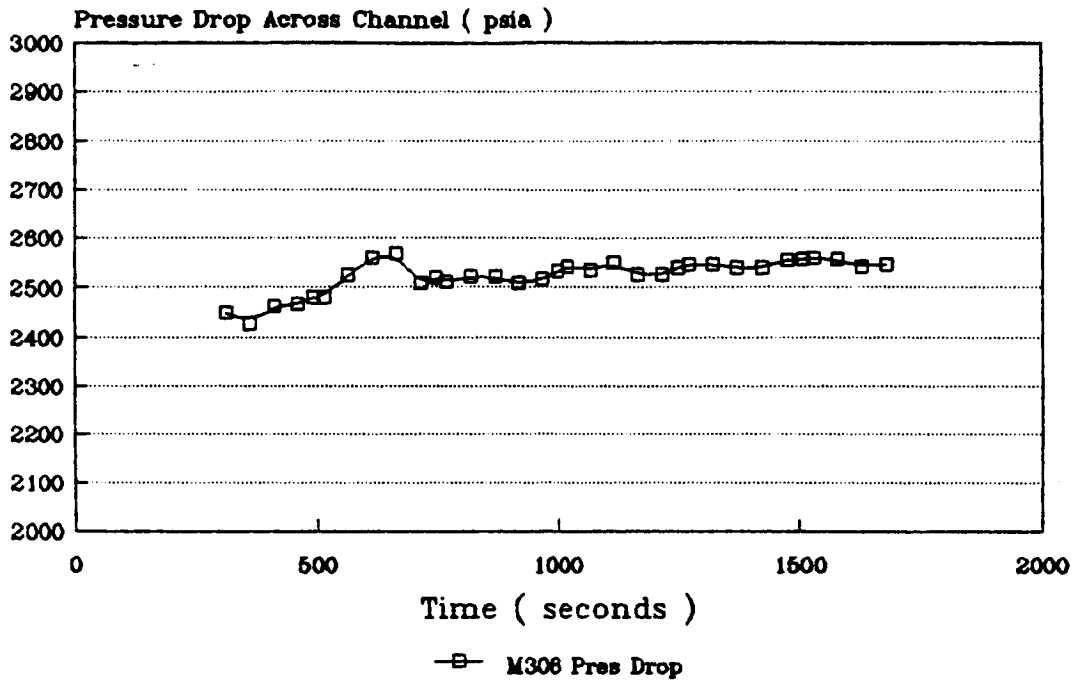
**Figure 31. Pressure Drop Across the Cooling Channel vs Time for Test M308 (1 ppm H<sub>2</sub>S)**  
**Operating Conditions: T<sub>wall</sub> = 631°F, Mass Flow = 1.20 lbs/min**
