# Hydrocarbon-Fuel/Combustion- Chamber-Liner Materials Compatibility

Contract NAS 3-25070  
Final Report  
NASA CR-187104  
April 1991

Report No. KBQ-FR-2  
NASA CR-187104

Aerojet Propulsion Division  
P.O. Box 13222  
Sacramento, California

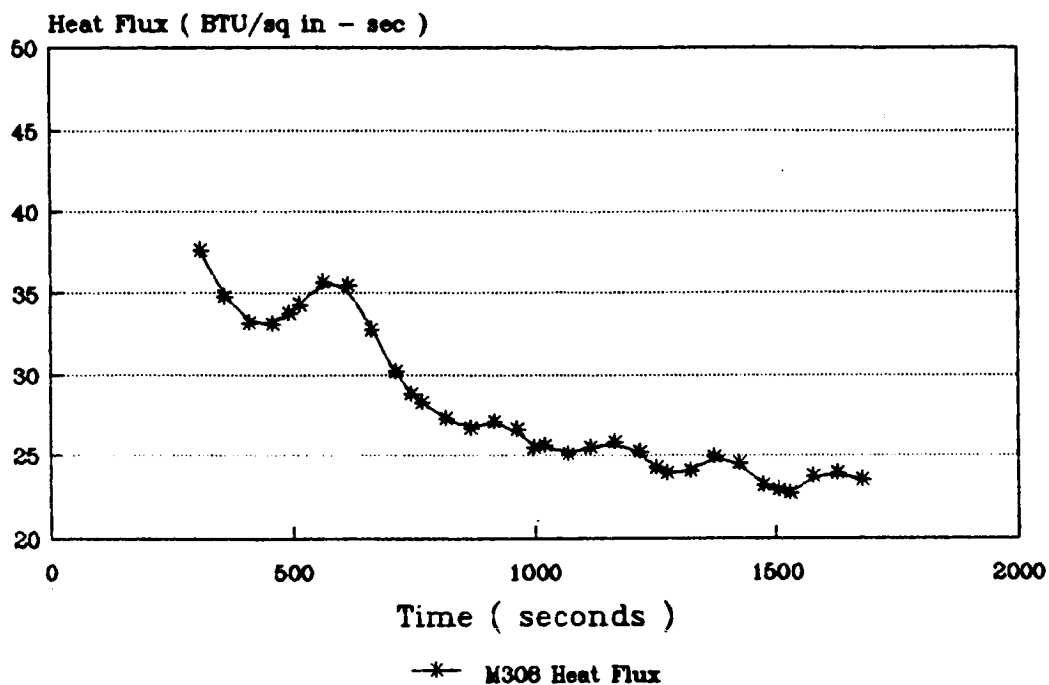
**Figure 32. Heat Flux vs Time for Test M308 (1 ppm H<sub>2</sub>S)**  
**Operating Conditions: T<sub>wall</sub> = 631°F, Mass Flow = 1.20 lbs/min**

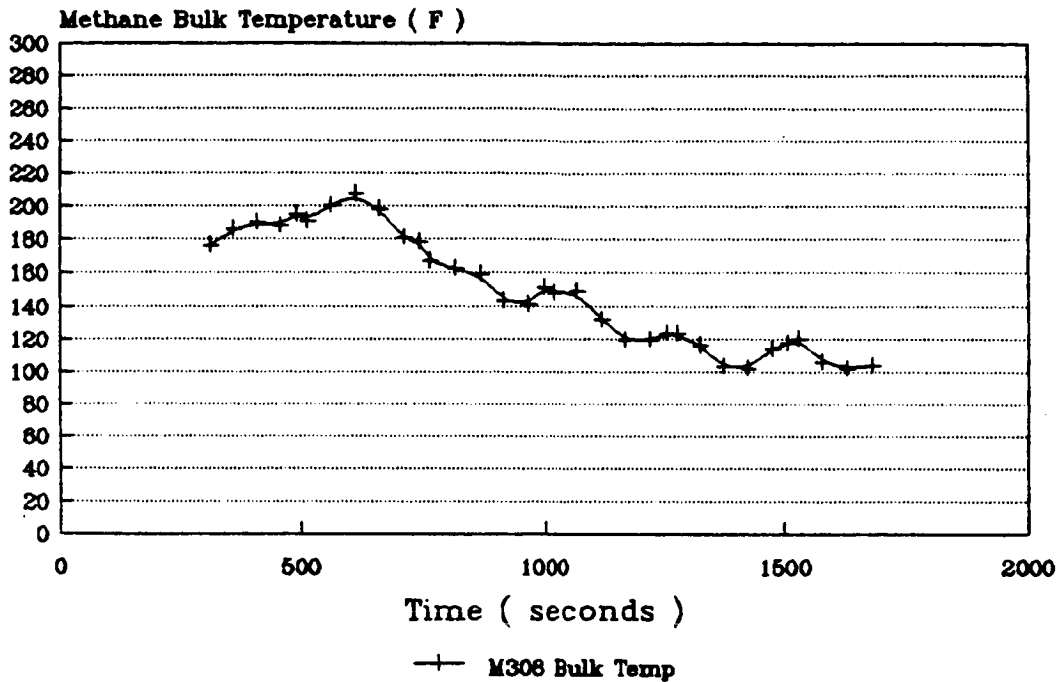
**Figure 33. Methane Bulk Temperature vs Time for Test M308 (1 ppm H<sub>2</sub>S)**  
Operating Conditions:  $T_{wall} = 631^{\circ}\text{F}$ , Mass Flow = 1.20 lbs/min

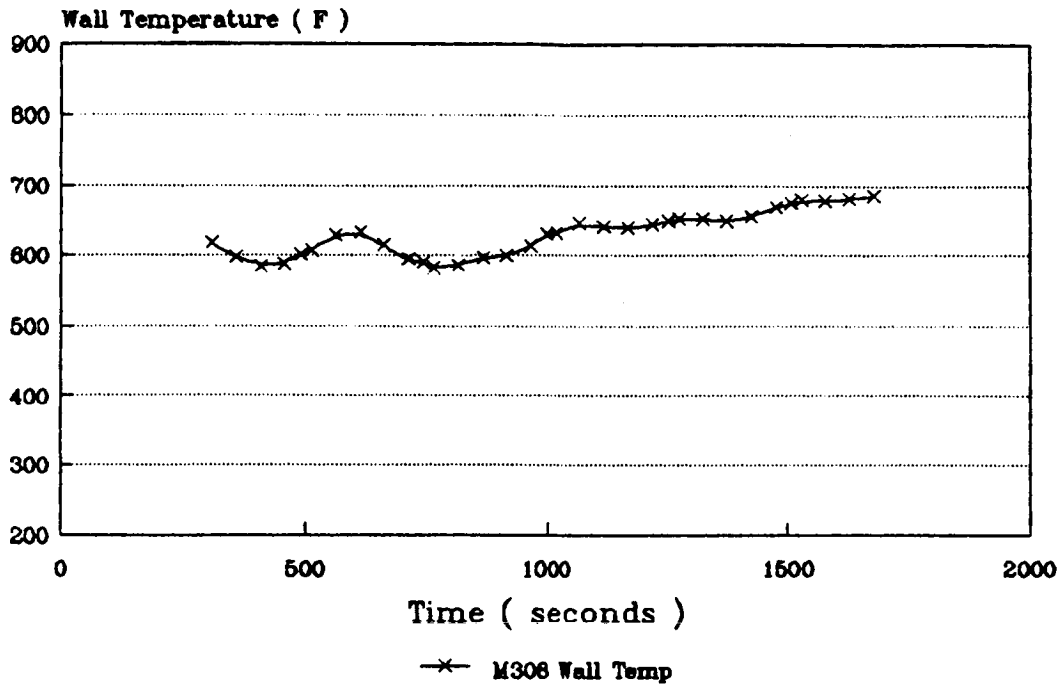
Figure 34. Cooling Channel Wall Temperature vs Time for Test M308 (1ppm H<sub>2</sub>S)  
Operating Conditions: T<sub>wall</sub> = 631°F, Mass Flow = 1.20 lbs/min

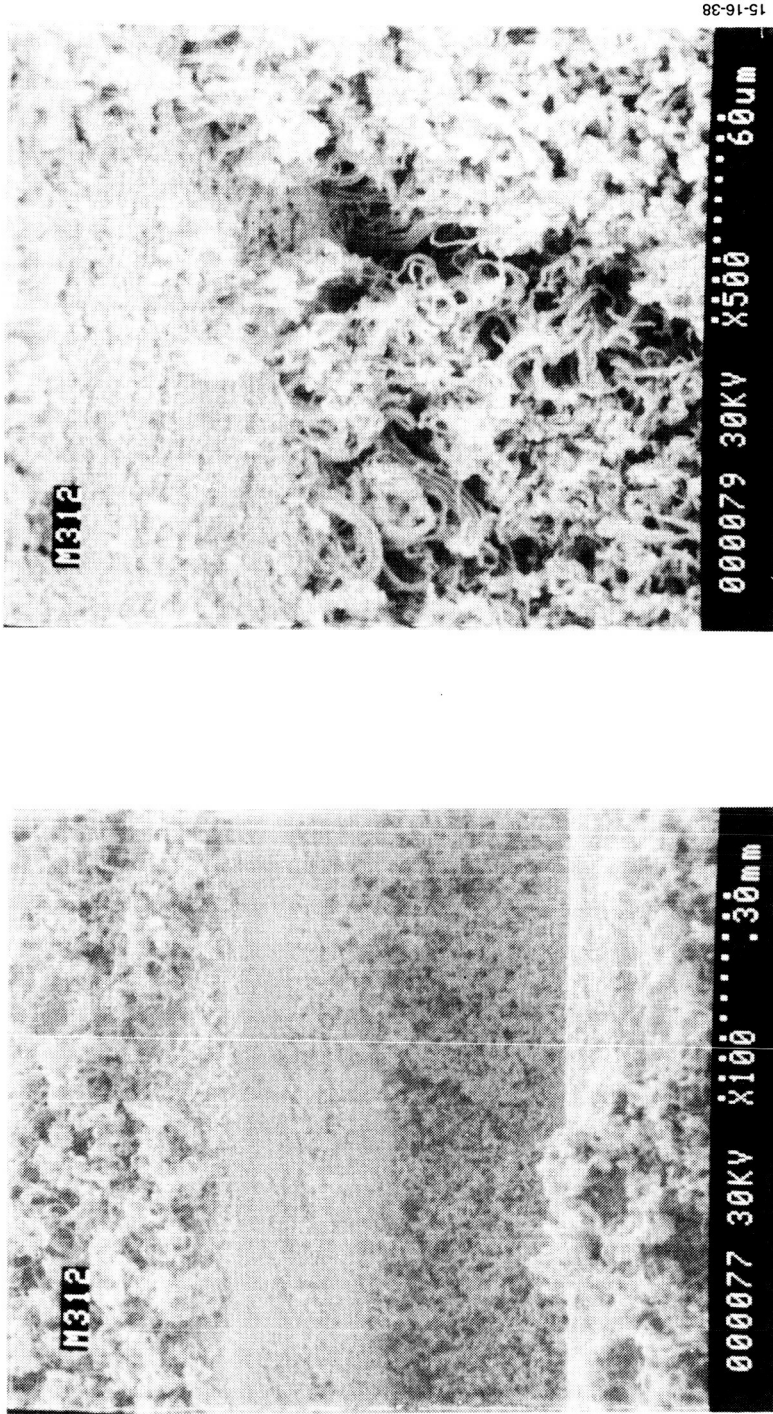
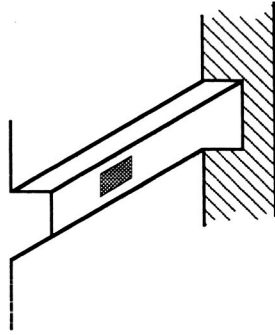
Figure 35. Cooling Channel of Test M312a Test Specimen After Exposure to 6 ppm CH<sub>3</sub>SH at T<sub>Wall</sub> = 631°F and Mass Flow = 1.70 lbs/min. Note, A Fibrous Form of Cu<sub>2</sub>S Covers All the Channel Walls

across the channel. In a test with 10 ppm CH<sub>3</sub>SH the build up of Cu<sub>2</sub>S corrosion products nearly blocked all flow through the channel by the end of a 28 minute run. Figure 5 are SEM photomicrographs showing heavy deposits of a fibrous form of Cu<sub>2</sub>S on all cooling channel surfaces.

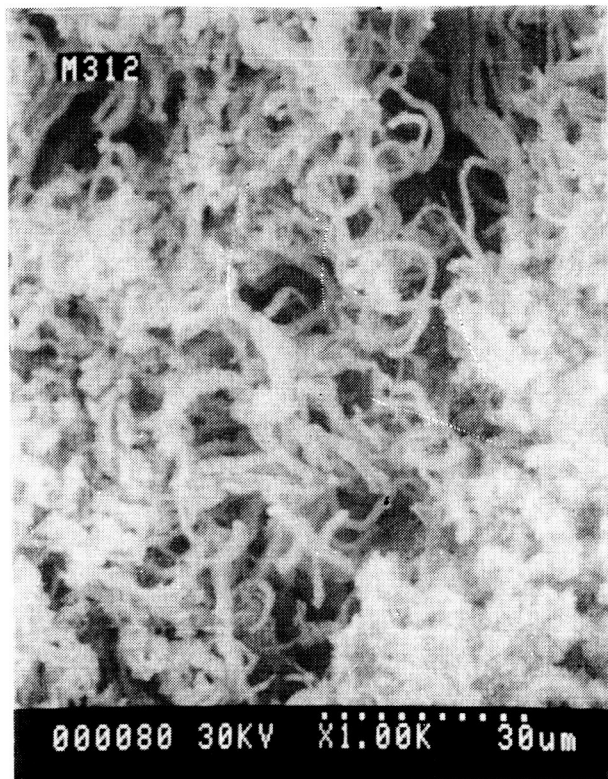
Figure 36. Close-up of the Fibrous Form of  $\text{Cu}_2\text{S}$  on the Test M312a Test Specimen Walls and an EDS Spectrum Showing the Presence of Sulfur

The test specimen from Test M312a (6 ppm CH<sub>3</sub>SH) showed the channel walls to be completely covered with a fibrous or "wool-like" gray-black deposit when viewed under a binocular microscope. SEM photomicrographs shown in Figure 35 illustrate the appearance of these deposits and Figure 36 is a close-up view and its corresponding EDS spectrum that confirms the presence of sulfur. These photographs clearly show that the channel is still largely open, but the walls have been severely roughened by the formation of the Cu<sub>2</sub>S deposits. This appearance is completely consistent with the monitored test parameters shown in Figures 29-34.

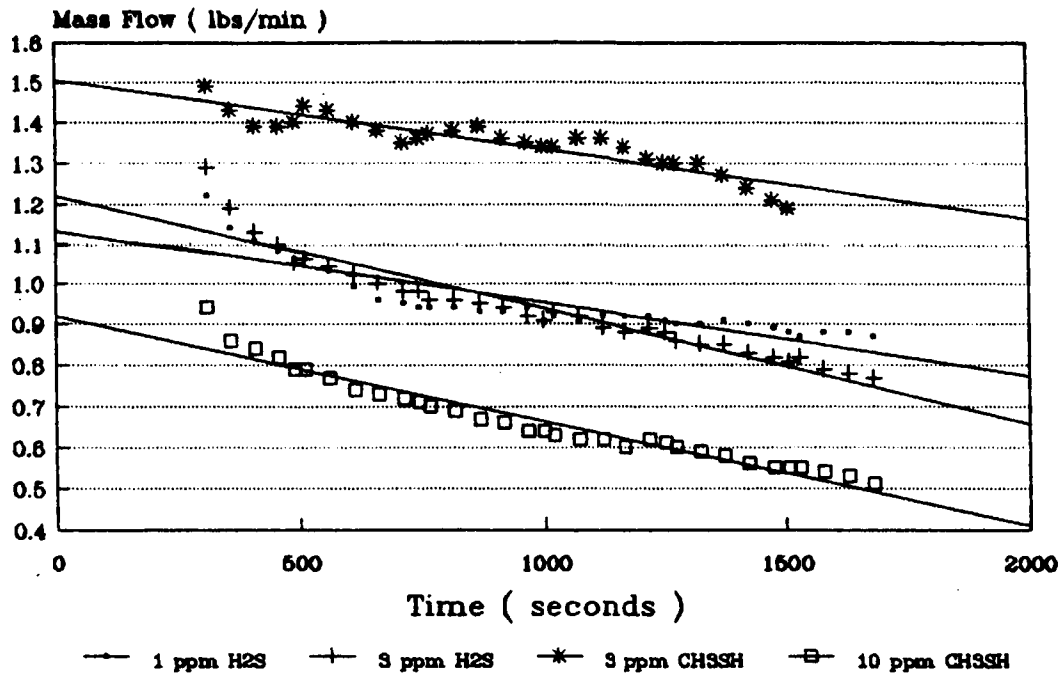
**Figure 37. Comparison of the Average Rate of Decrease in Mass Flow Rate for the Tests With Sulfur Contaminated Methane**

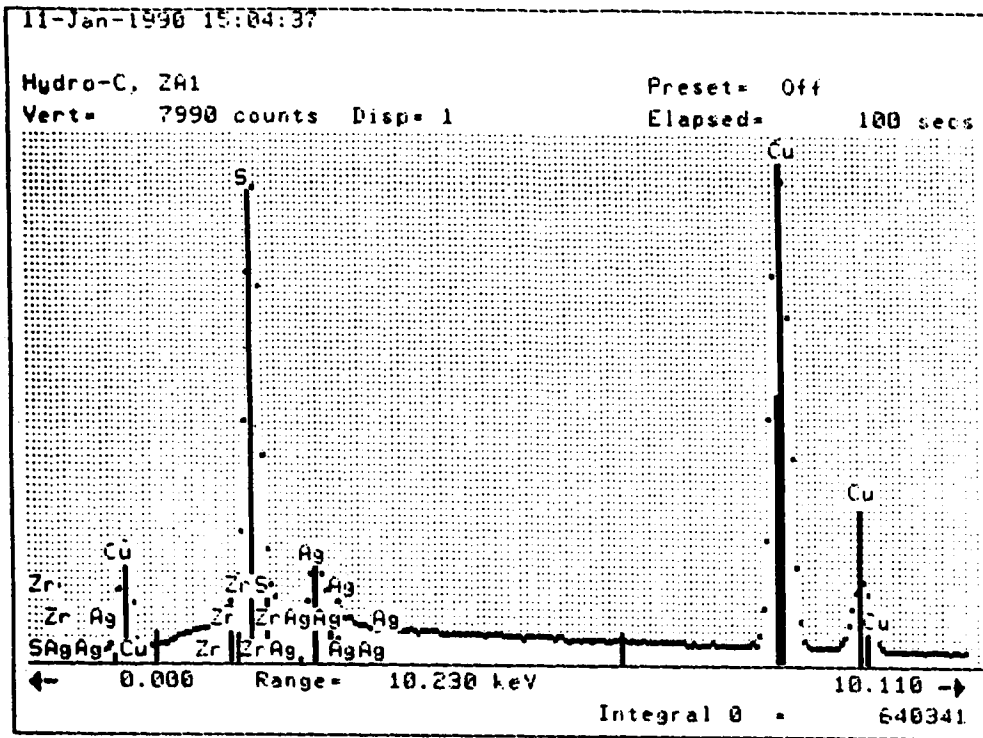
Figure 41. EDS Spectrum of Test Coupon ZA1 Before NaCN Refurbishment. Note, Large Response for Sulfur

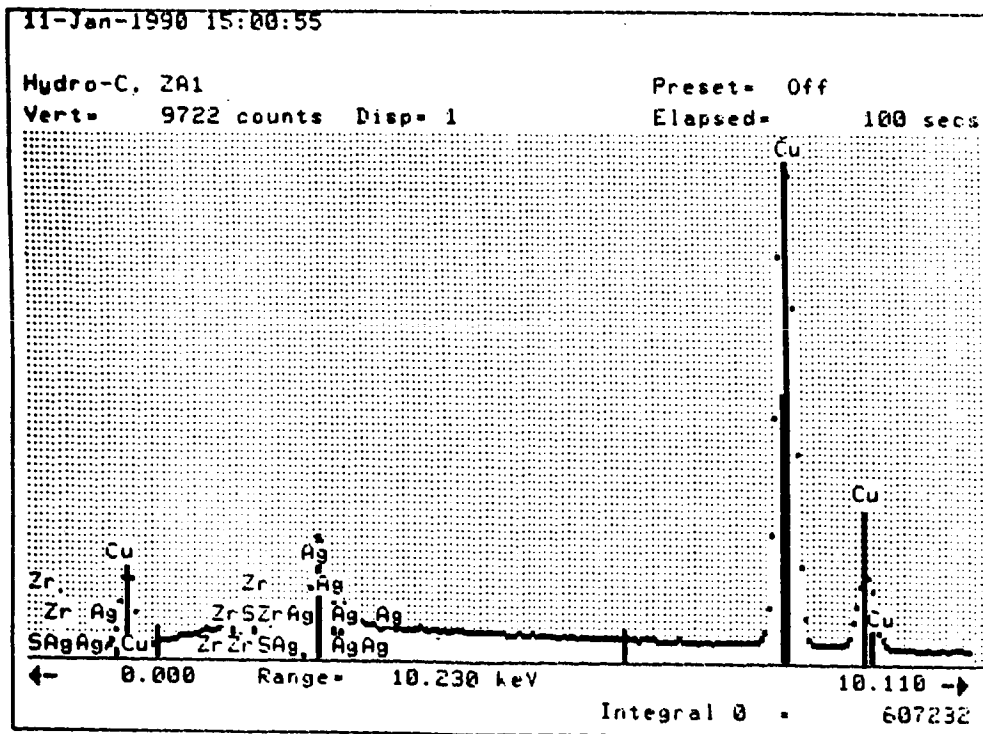
Figure 42. EDS Spectrum of Test Coupon ZA1 After NaCN Refurbishment. Note, the Sulfur has Been Completely Removed

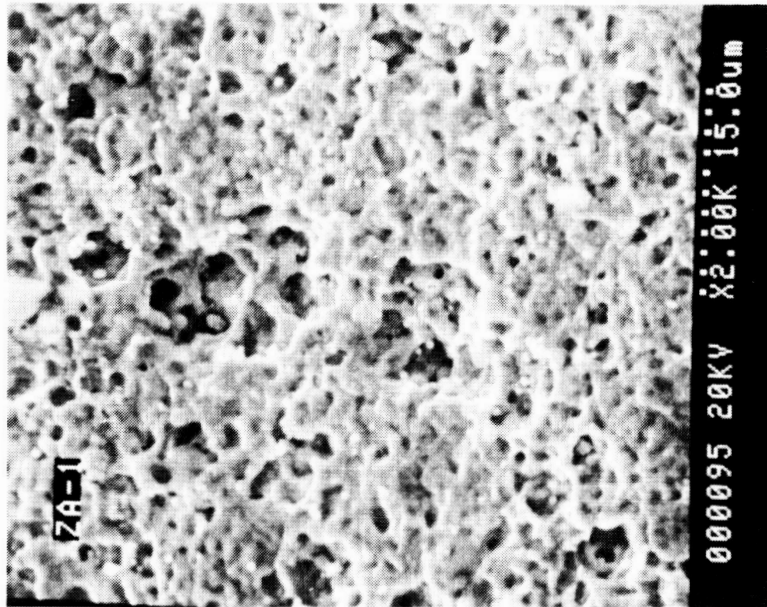
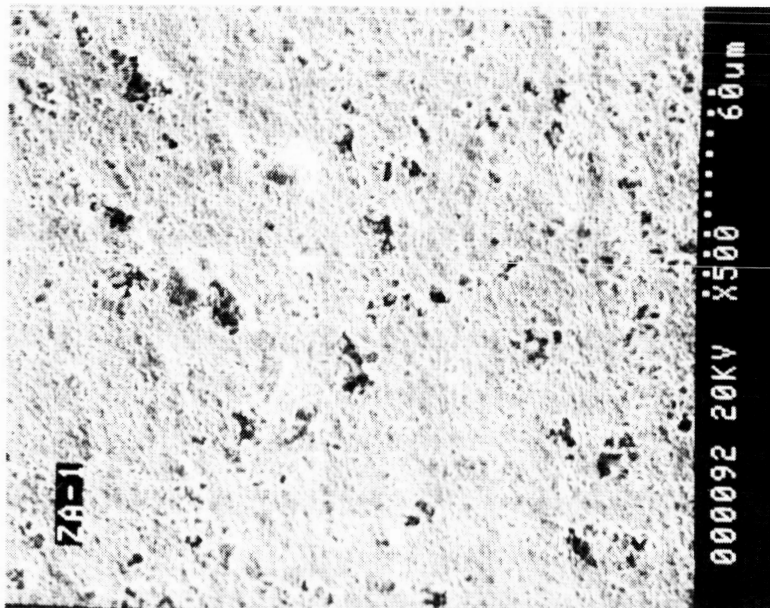
Figure 44. SEM Photomicrograph of Test Coupon ZA1 After Sulfur Corrosion and NaCN Refurbishment. Note, the Extensive Pitting and Overall Roughness of the Surface Compared to the Electropolished Surface Shown in Figure 43

Figures 43, 44, and 45 are SEM photomicrographs showing a freshly electropolished test coupon, a test coupon after sulfur corrosion/NaCN refurbishment, and an electropolished test coupon after exposure to 5% (w/w) NaCN, respectively. Comparing the three figures shows that the sulfur corrosion/NaCN refurbishment process converts a smooth featureless copper surface (Figure 43) into a highly pitted and roughened surface (Figure 44). Furthermore, treatment of an electropolished coupon also roughens the surface (Figure 45), but the effect is minor in comparison to the sulfur corrosion/NaCN refurbishment effect. The surface appearance shown in Figure 44 suggests that the sulfur corrosive preferentially attacks the grain boundaries. If this is true, it is possible that some surface grains are completely undermined and isolated by the corrosion process and that subsequent removal of the Cu<sub>2</sub>S corrosion product with NaCN solution causes the loss of these uncorroded grains as well. This mechanism accounts for the extra weight loss noted in Table 18 and the pitted surface. The proposed mechanism is shown in Figure 46.

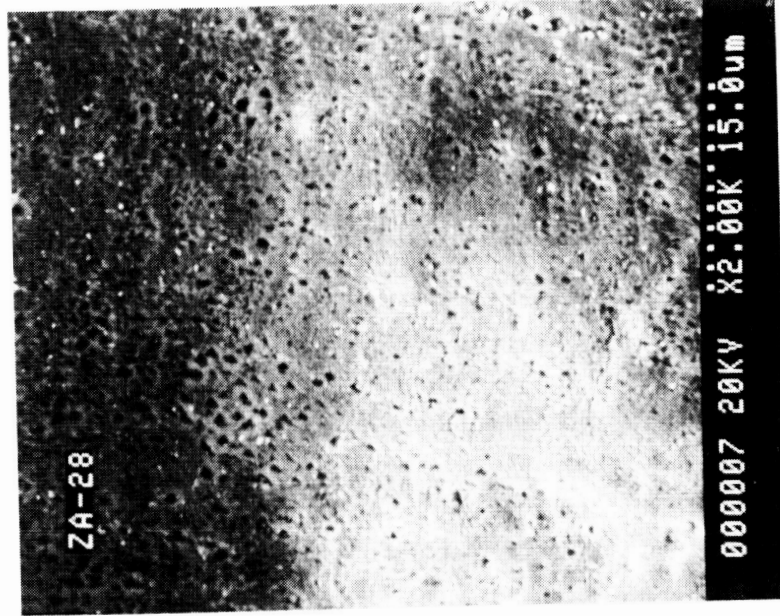
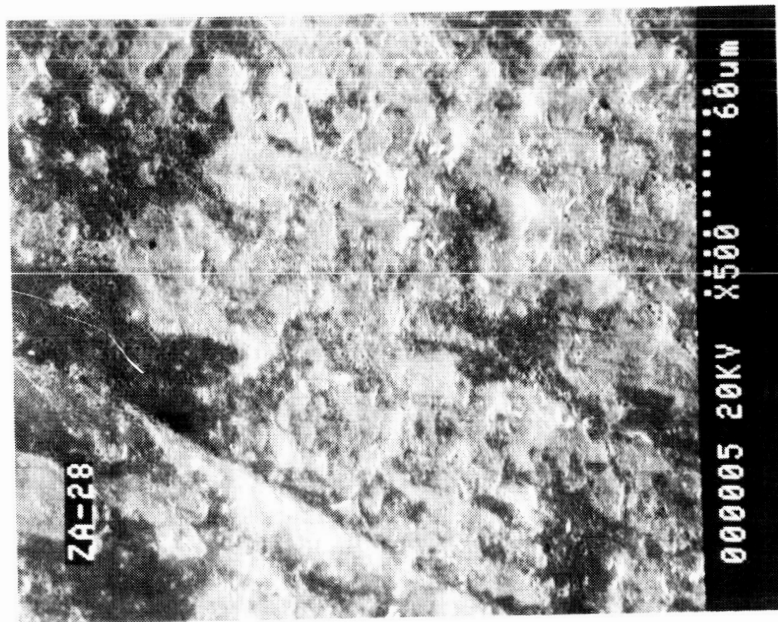
Figure 45. SEM Photomicrograph of Test Coupon ZA28 After Exposure to 5% (w/w) NaCN. Note, A Slight Amount of Pitting is Visual, but the Effect is Less Dramatic Than That Shown in Figure 44

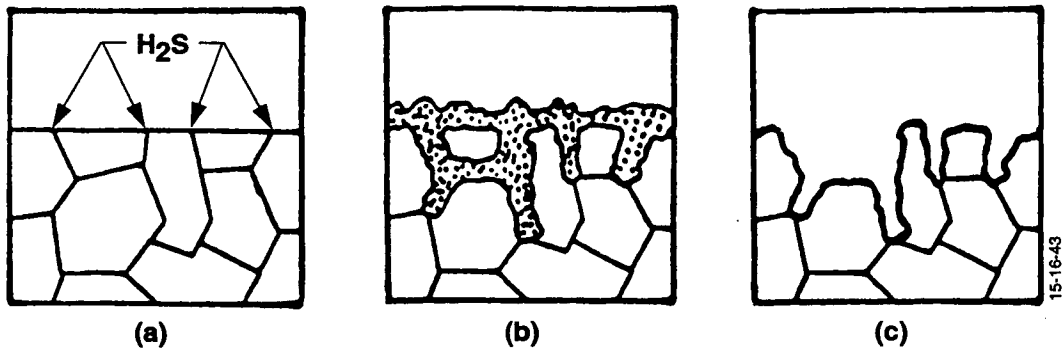
**Figure 46. Pictorial Representation of Overall Sulfur Corrosion and Cuprous Sulfide Removal Process**

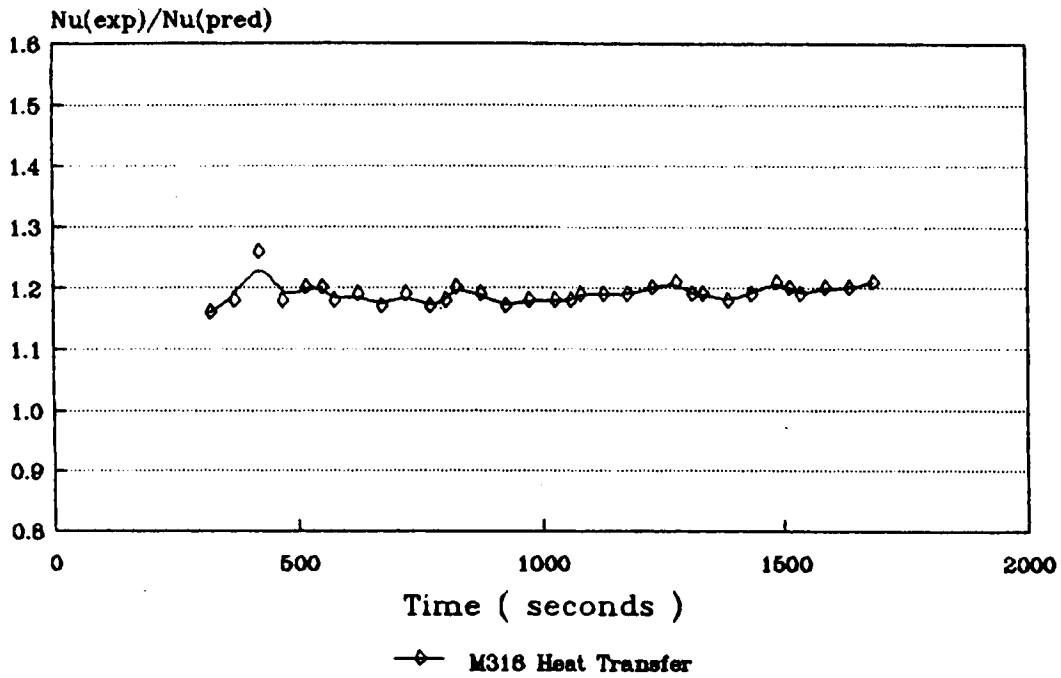
**Figure 47. Heat Transfer Efficiency,  $Nu(\text{exp})/Nu(\text{pred})$ , vs Time for Test M316. Test Specimen ZA3 After Sulfur Corrosion/NaCN Refurbishment**

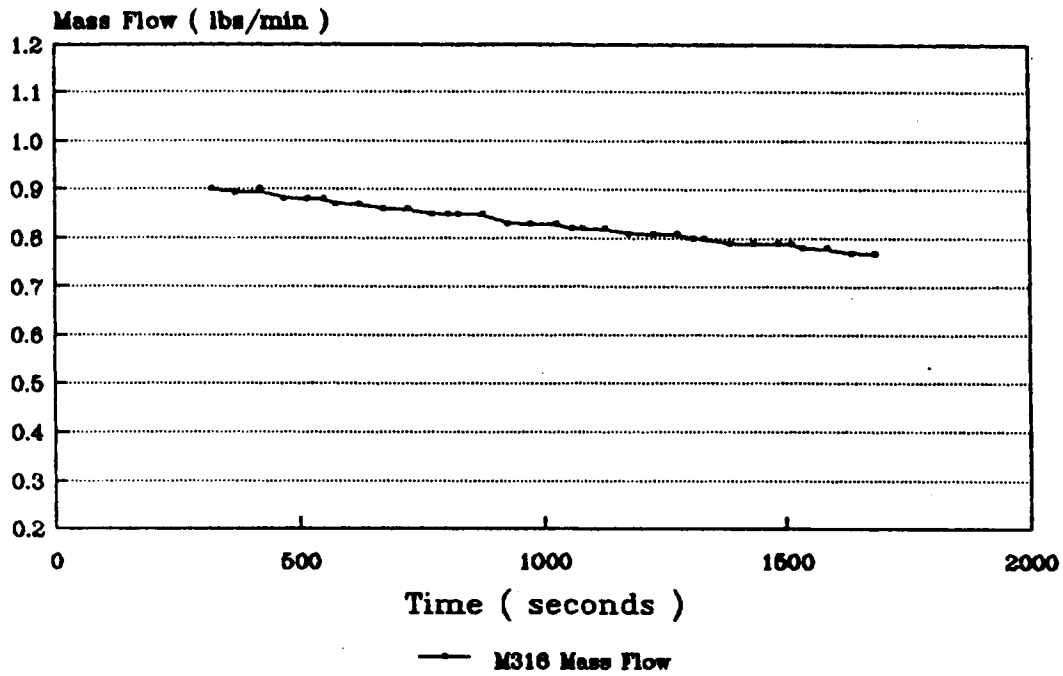
**Figure 48. Mass Flow vs Time for Test M316. Test Specimen ZA3 After Sulfur Corrosion/NaCN Refurbishment**

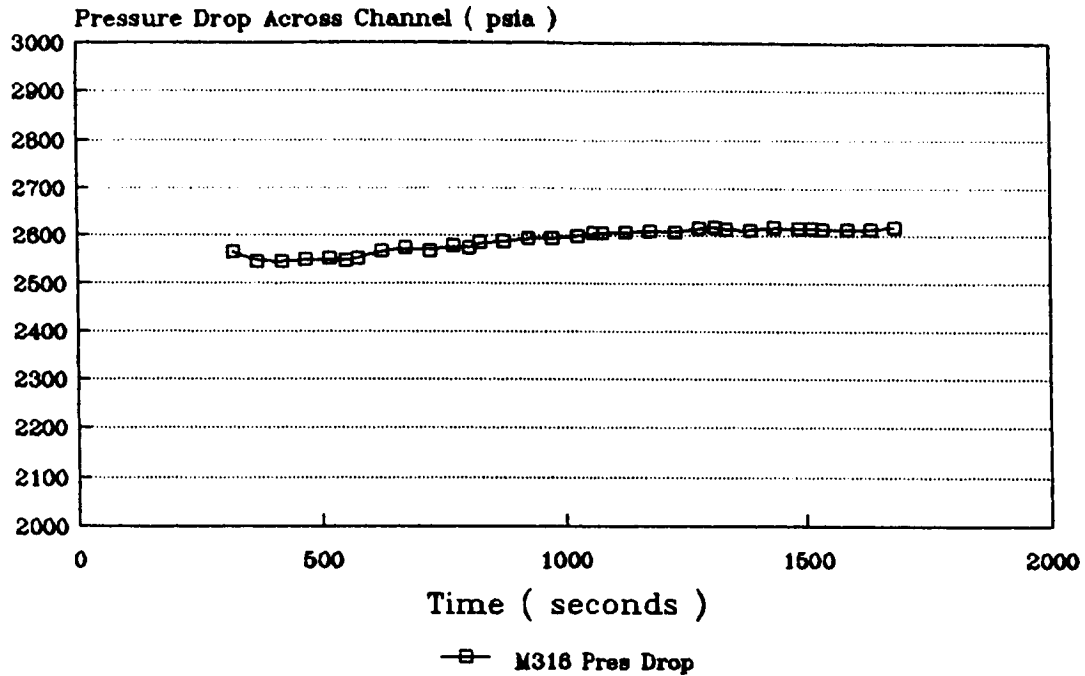
**Figure 49. Pressure Drop Across the Cooling Channel vs Time for Test M316. Test Specimen ZA3 After Sulfur Corrosion/NaCN Refurbishment**

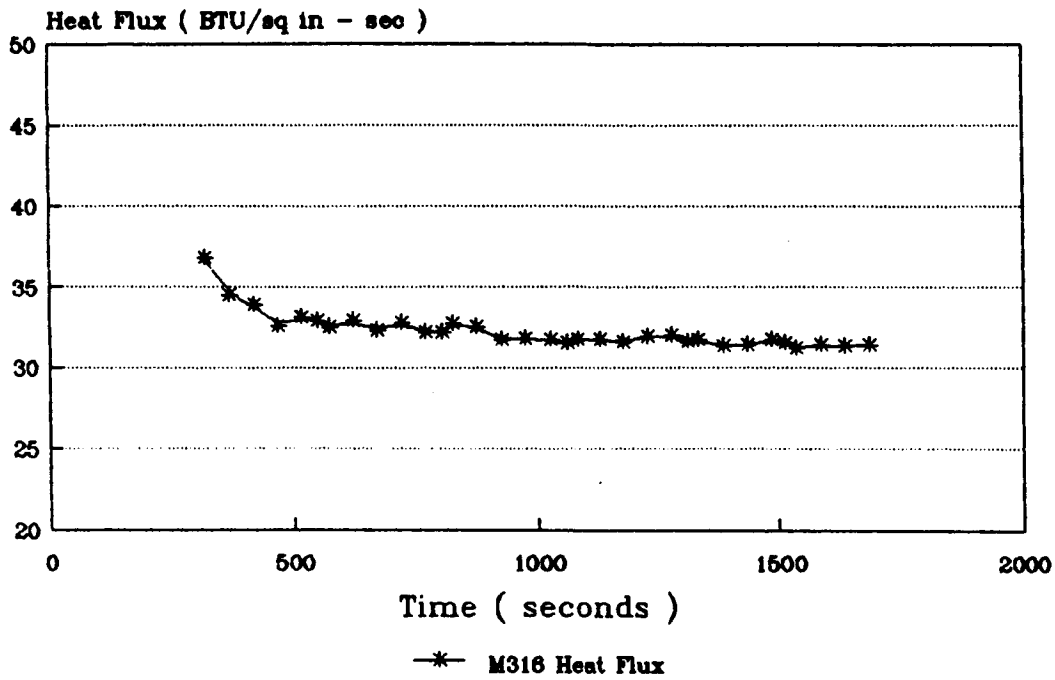
**Figure 50. Heat Flux vs Time for Test M316. Test Specimen ZA3 After Sulfur Corrosion/NaCN Refurbishment**

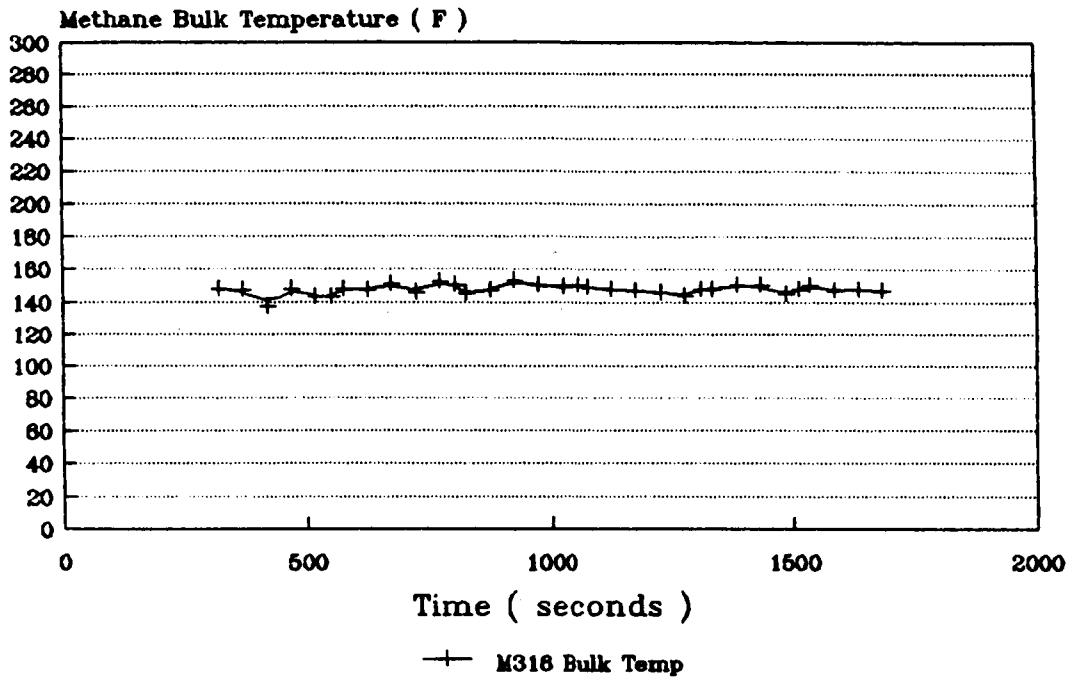
**Figure 51. Methane Bulk Temperature vs Time for Test M316. Test Specimen ZA3 After Sulfur Corrosion/NaCN Refurbishment**

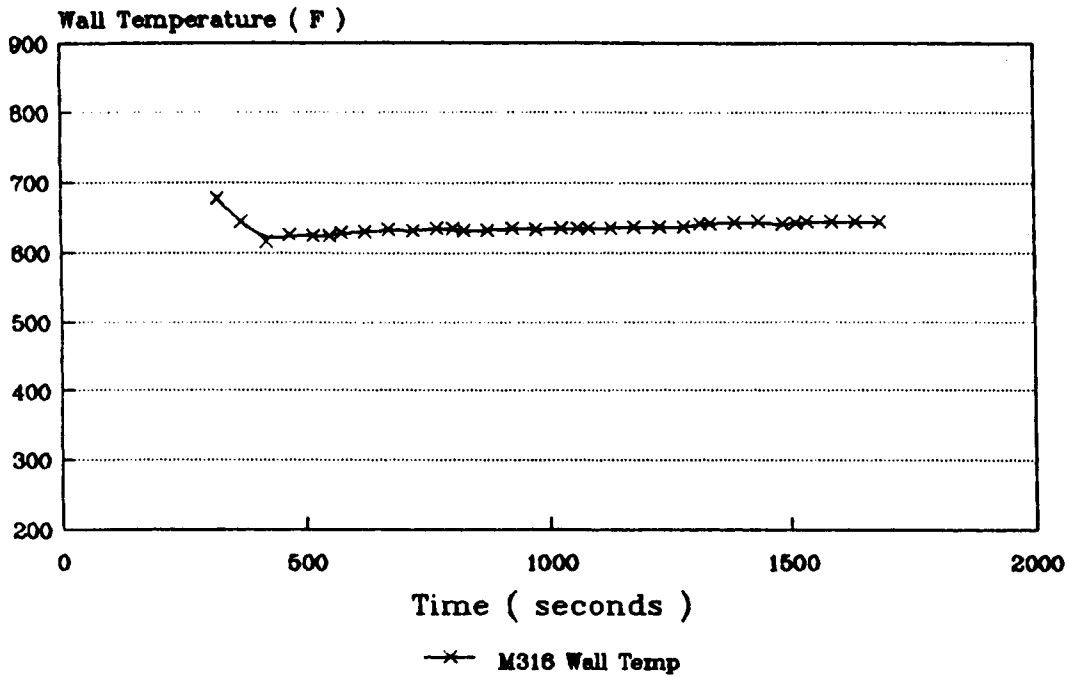
Figure 52. Cooling Channel Wall Temperature vs Time for Test M316. Test Specimen ZA3 After Sulfur Corrosion/NaCN Refurbishment

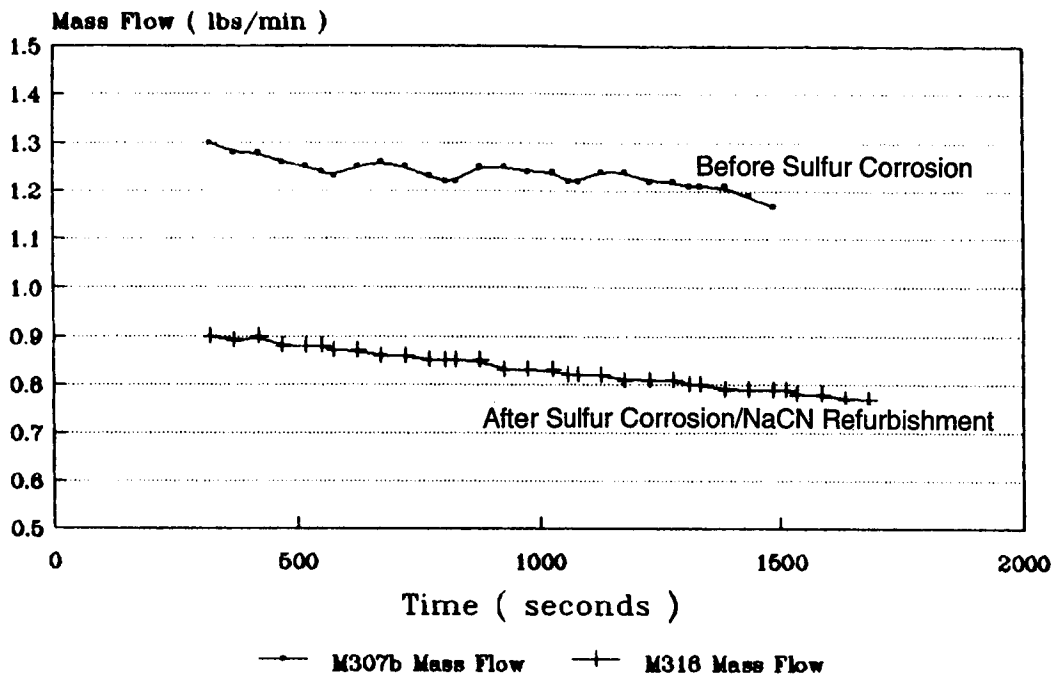
**Figure 53. Mass Flow Performance for Specimen ZA3 Before Sulfur Corrosion (M307b) and After Sulfur Corrosion/NaCN Refurbishment (M316).**

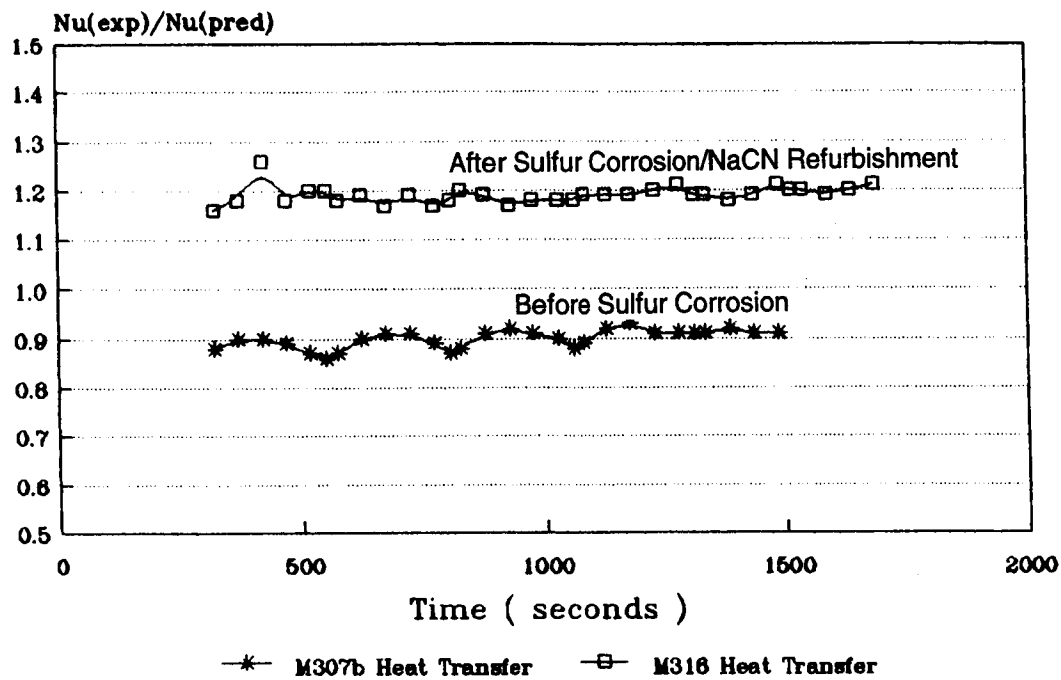
**Figure 54. Heat Transfer Performance of Specimen ZA3 Before Sulfur Corrosion (M307b) and After Sulfur Corrosion/NaCN Refurbishment (M316)**

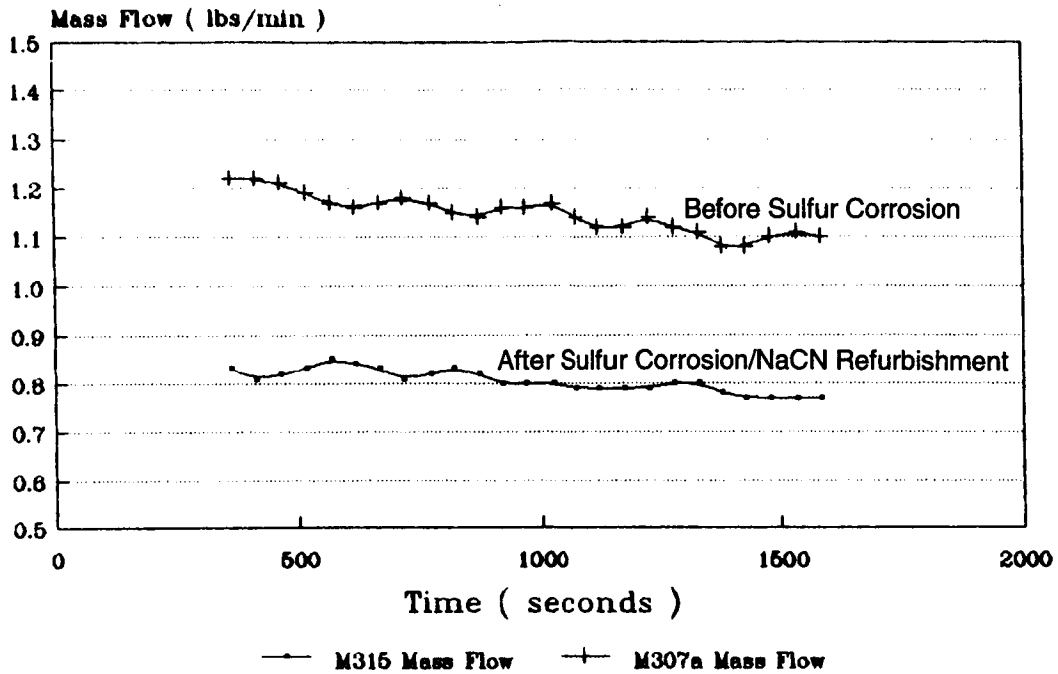
**Figure 55. Mass Flow Performance for Specimen ZA13 Before Sulfur Corrosion (M307a) and After Sulfur Corrosion/NaCN Refurbishment (M315)**

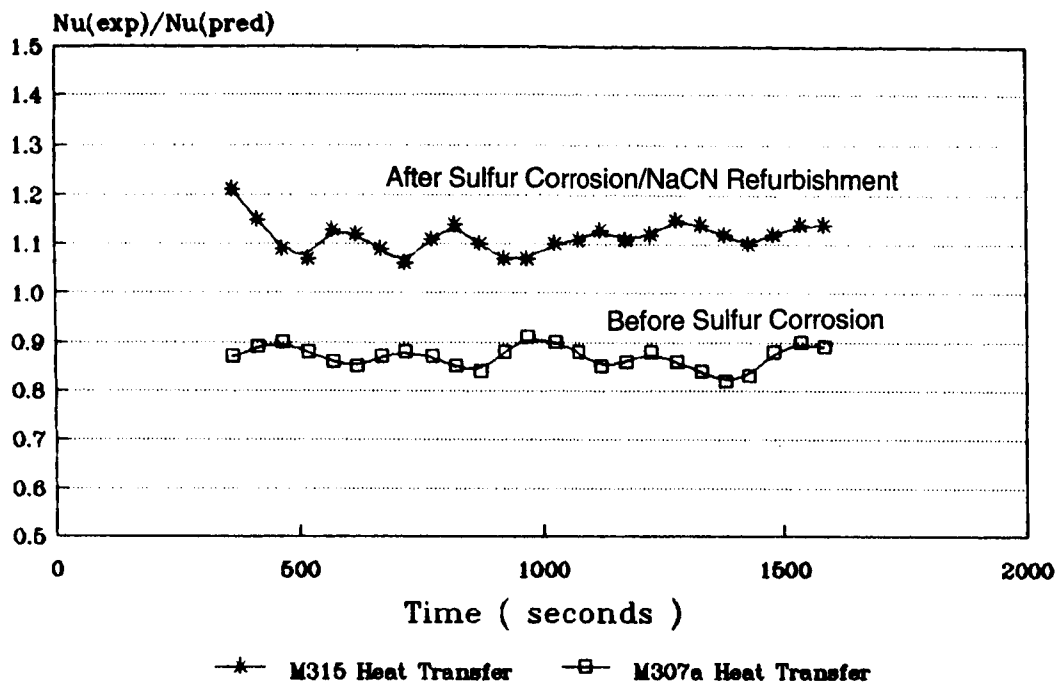
**Figure 56. Heat Transfer Performance for Specimen ZA13 Before Sulfur Corrosion (M307a) and After Sulfur Corrosion/NaCN Refurbishment (M315)**

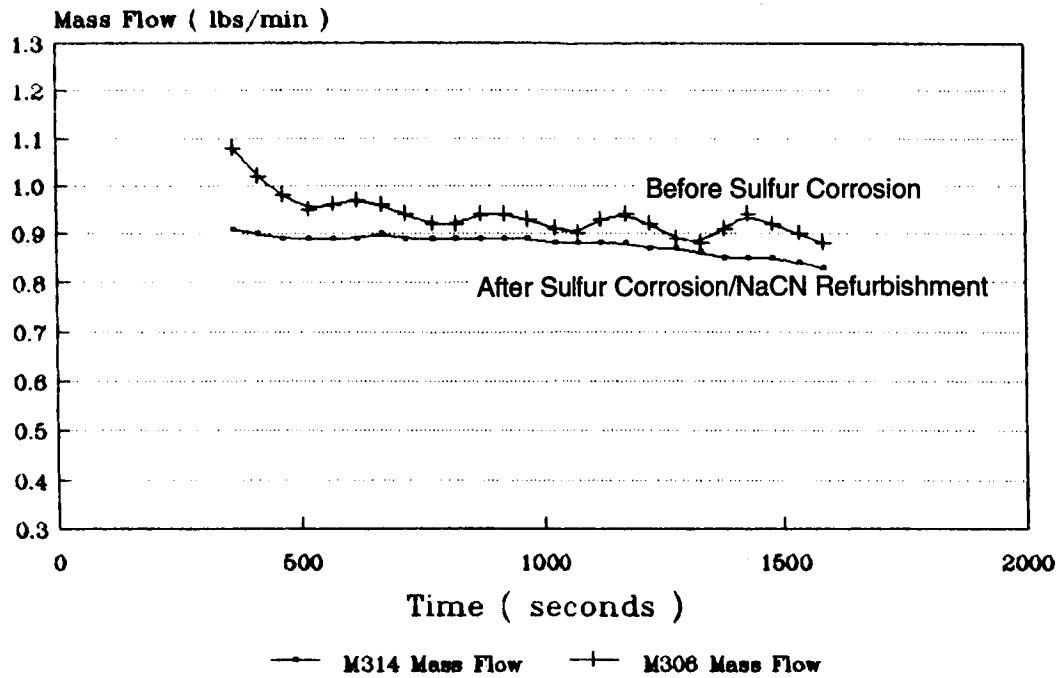
**Figure 57. Mass Flow Performance for Specimen ZA18 Before Sulfur Corrosion (M306) and After Sulfur Corrosion/NaCN Refurbishment (M314)**

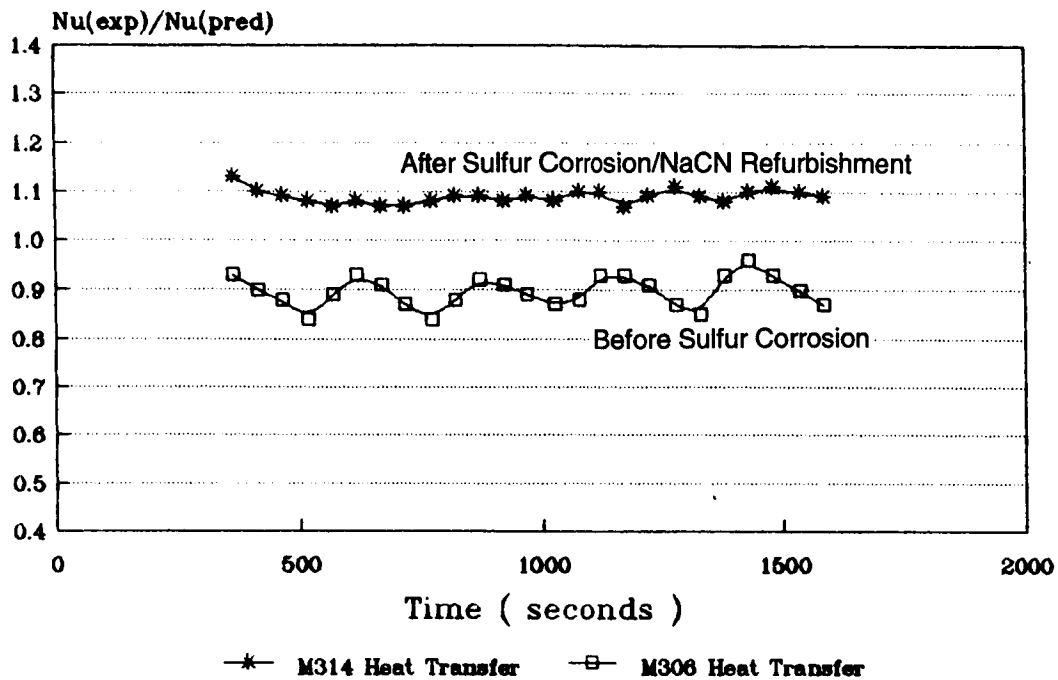
**Figure 58. Heat Transfer Performance for Specimen ZA18 Before Sulfur Corrosion (M306) and After Sulfur Corrosion/NaCN Refurbishment (M314)**

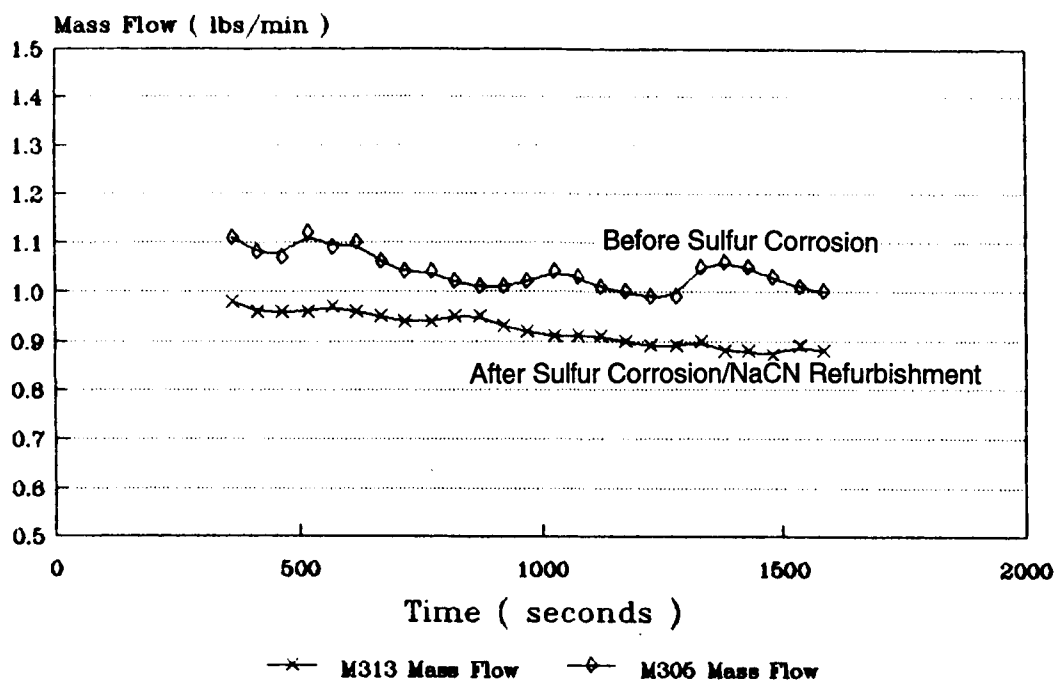
**Figure 59. Mass Flow Performance for Specimen ZA23 Before Sulfur Corrosion (M305) and After Sulfur Corrosion/NaCN Refurbishment (M313)**

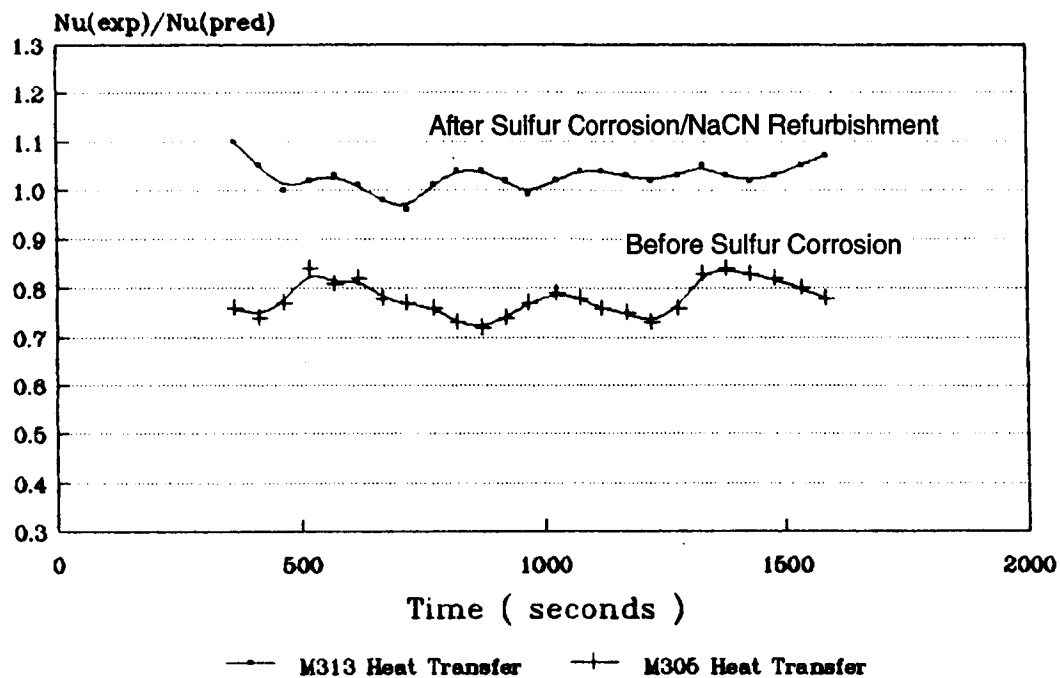
Figure 60. Heat Transfer Performance for Specimen ZA23 Before Sulfur Corrosion (M305) and After Sulfur Corrosion/NaCN Refurbishment (M313)

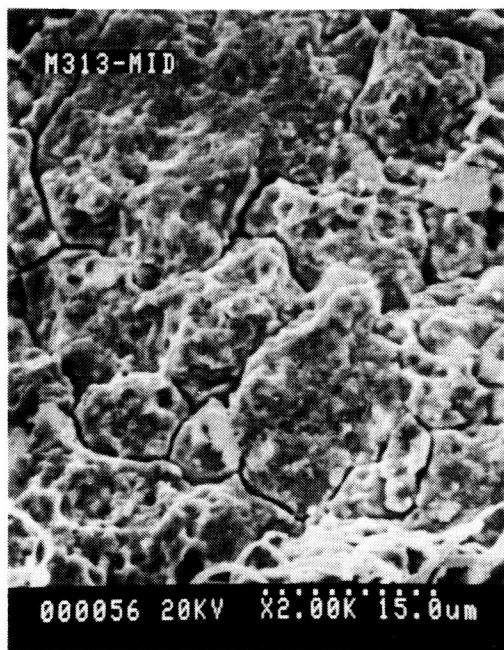
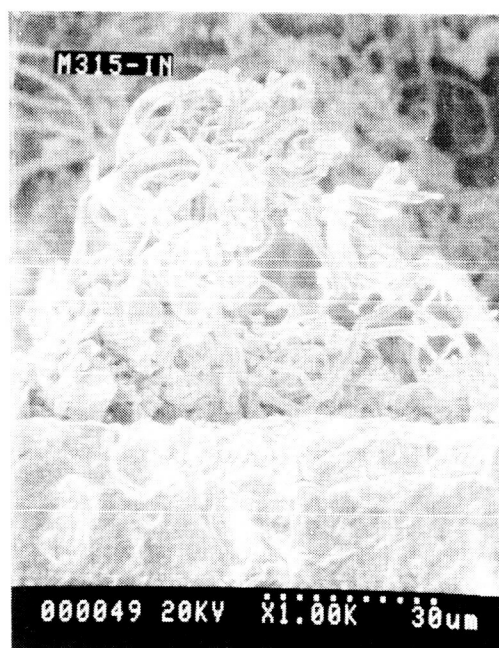
Figure 61 is a collection of SEM photomicrographs that show the common channel surface features. Pitting (Figure 61b) and "mud cracking", i.e., well defined grain boundaries (Figure 61a,c), were the most common features. Both of these features support the mechanism of preferential grain boundary attack by the sulfur corrosion as shown pictorially in Figure 46. The "copper wool" feature is shown in Figure 61c,d where it appears to be growing out of the side wall. This feature was far less common than the other features, but it was present in all four test specimen. Figure 62 is a collection of SEM photomicrographs of the "copper wool" that clearly shows the complex nature of its structure. Finally, Figure 63 is an EDS spectrum of the "copper wool" taken from the close-up in Figure 62d. Note, that only the elements present in NASA-Z are detected. Thus, this interesting feature is truly "copper wool." The origin of this highly unusual feature is unknown, however it should be noted that it bares a remarkable resemblance to the fibrous form of  $\text{Cu}_2\text{S}$  shown in Figure 35. Thus, one possible explanation is that the "copper wool" is derived from the fibrous form of  $\text{Cu}_2\text{S}$ . This could only be possible if the fibrous form of  $\text{Cu}_2\text{S}$  actually contains a copper alloy core because aqueous NaCN would completely remove the feature if it were pure  $\text{Cu}_2\text{S}$ . Fibrous  $\text{Cu}_2\text{S}$  with a copper alloy core might occur in the following manner. NASA-Z is not a completely homogeneous alloy, i.e., there are intermetallic stringers within the alloy itself. The stringers have a higher zirconium content than the surrounding matrix and may corrode at a different rate than the matrix. If this rate is slower than that of the surrounding matrix, the matrix can corrode preferentially leaving the stringers intact. This can lead to fibrous  $\text{Cu}_2\text{S}$  structures with a copper alloy core. As the matrix grains and grain boundaries are corroded, the fibrous  $\text{Cu}_2\text{S}$  will appear to emerge from the surface by being "pushed" by the volume increase as the copper reacts to form  $\text{Cu}_2\text{S}$ . When the  $\text{Cu}_2\text{S}$  is removed by the NaCN treatment, the "copper wool" remains behind. Whether this speculative mechanistic hypothesis is correct or not, it is certainly clear that this feature as well as the other surface features do represent a very significant increase in surface roughness that easily explains the observed increase in heat transfer performance and attendant loss in mass flow that results from the overall sulfur corrosion/NaCN refurbishment process.

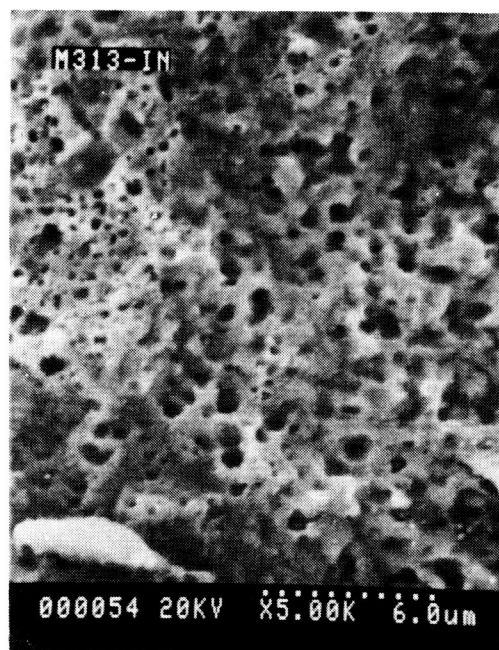
- (a) Well Defined Grain Boundaries and Pitting (Very Common)
- (b) Pitting (Very Common)
- (c) "Copper Wool" (Moderately Common)
- (d) Close-up of "Copper Wool". Note Similarity to Fibrous Form of  $\text{Cu}_2\text{S}$  Shown in Figure 35

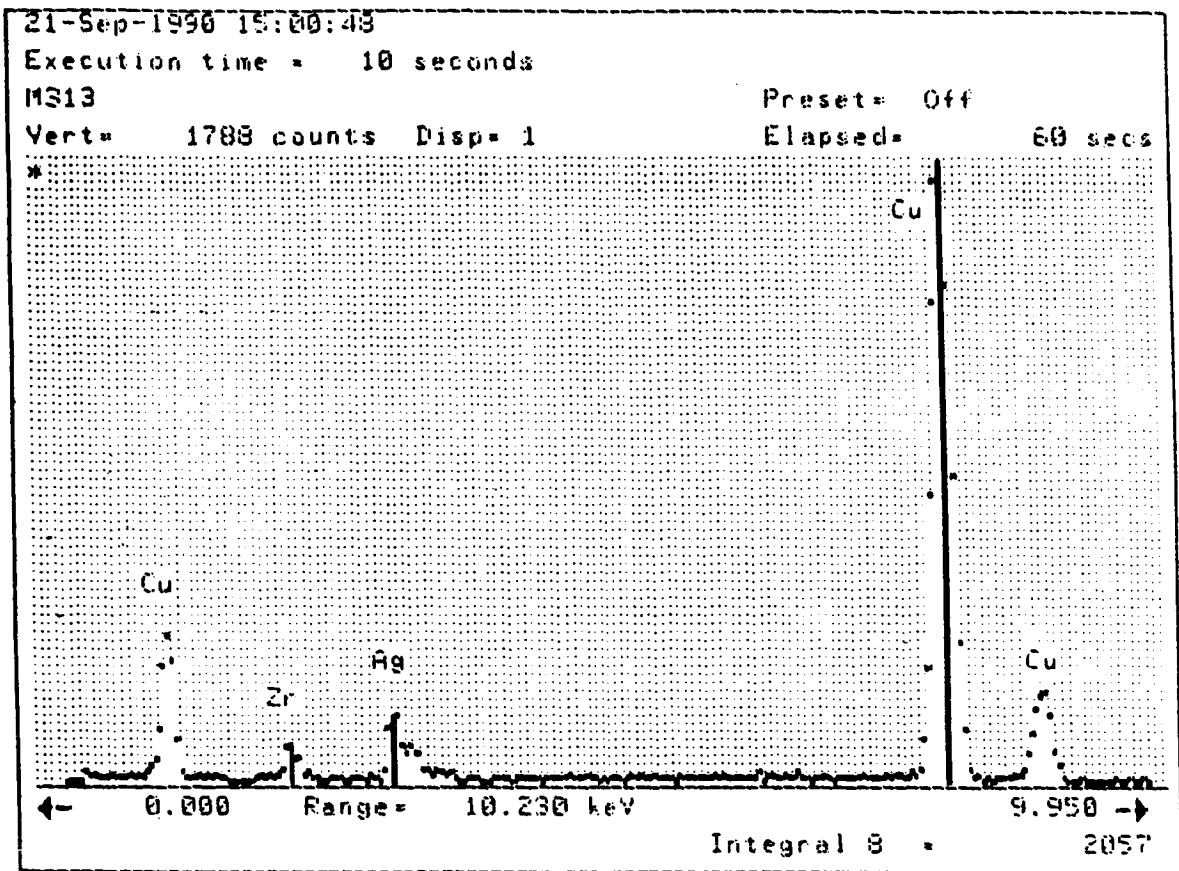
Figure 63. EDS Spectrum of "Copper Wool" From Close-Up in Figure 62d
