NASA Contractor Report 182075

**LABORATORY TEST AND ACOUSTIC ANALYSIS OF CABIN
TREATMENT FOR PROPFAN TEST ASSESSMENT AIRCRAFT**

H.L. Kuntz and R.J. Gatlineau

**LOCKHEED AERONAUTICAL SYSTEMS COMPANY
Burbank, California**

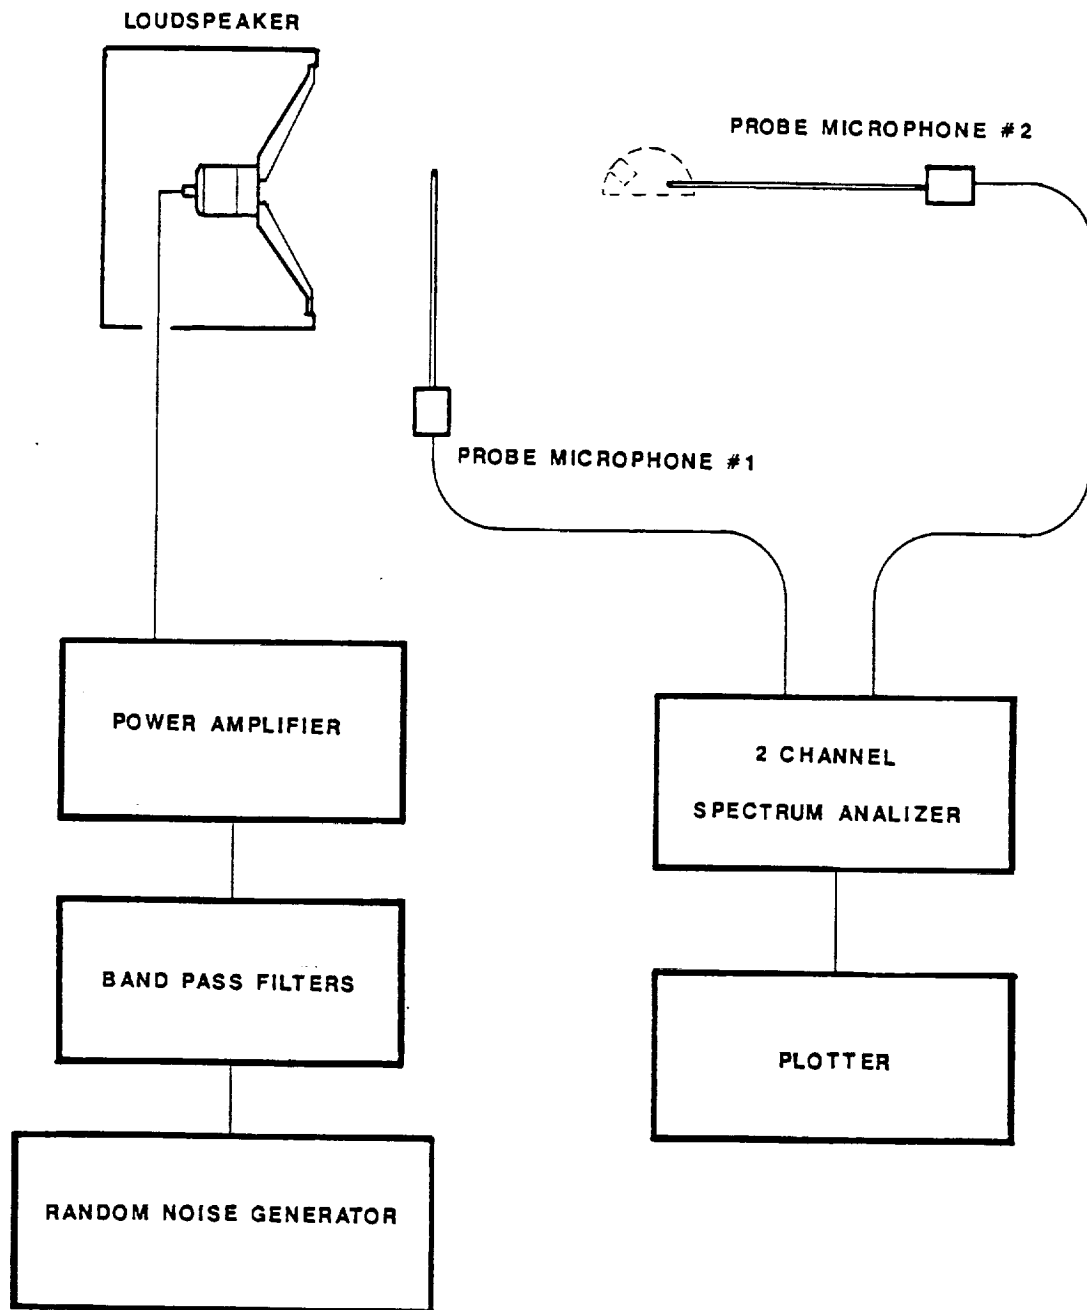
Figure A-2: Block diagram of the resonator test setup.
