NASA
Reference
Publication
1268

Development of the Burst and Transient Source Experiment (BATSE)

J. M. Horack

J. M. Horack
*George C. Marshall Space Flight Center
Marshall Space Flight Center, Alabama*

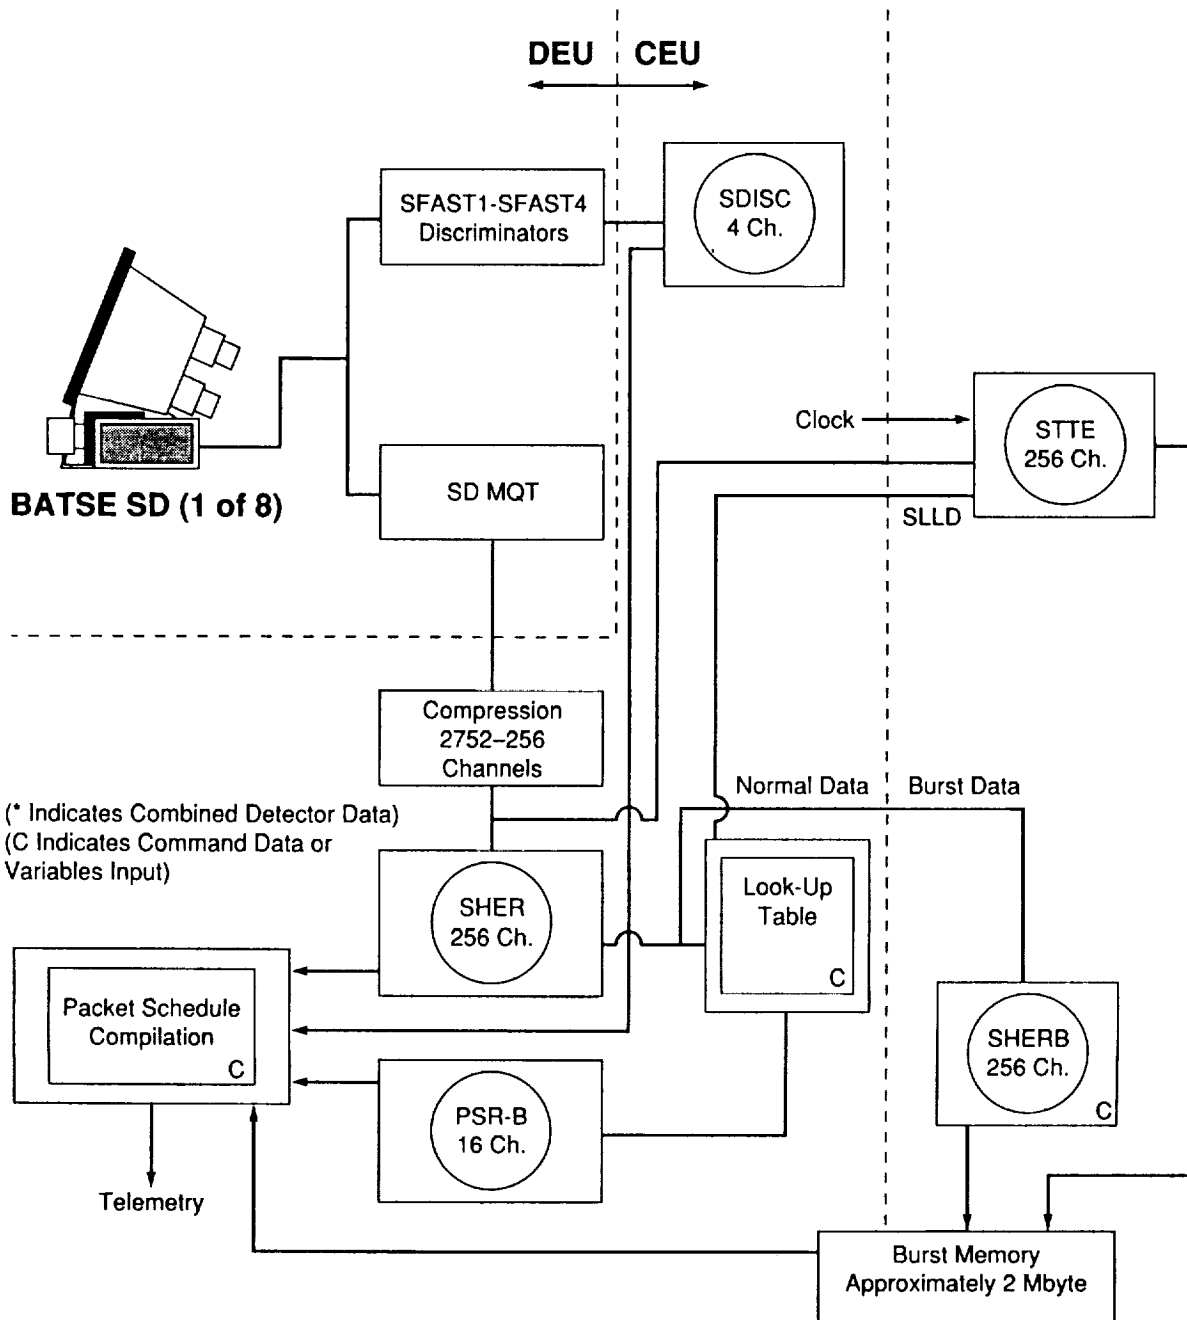
Figure 2.11. Spectroscopy Detector Data Flow Diagram.

The spectroscopy discriminator and high energy resolution (SDH) function provides the interface for the five data signals generated by the SD MQT board in the DEU of each DM. Like the DCH function, the eight SDH boards are independently connected to the DEUs such that a failure in one will not affect the operation of the other seven. The primary function of the SDH is to process the five science data signals into two separate data types, SDISC and SHER. SDISC data are produced by counting the number of SFAST1, SFAST2, SFAST3, and SFAST4 data pulses received over a fixed time period. This is identical to what was described for the DCH function. The pulses represent threshold levels of energy incident on the SD NaI detector. SHER data are produced by processing the SD MQT signal. This signal is equivalent to the

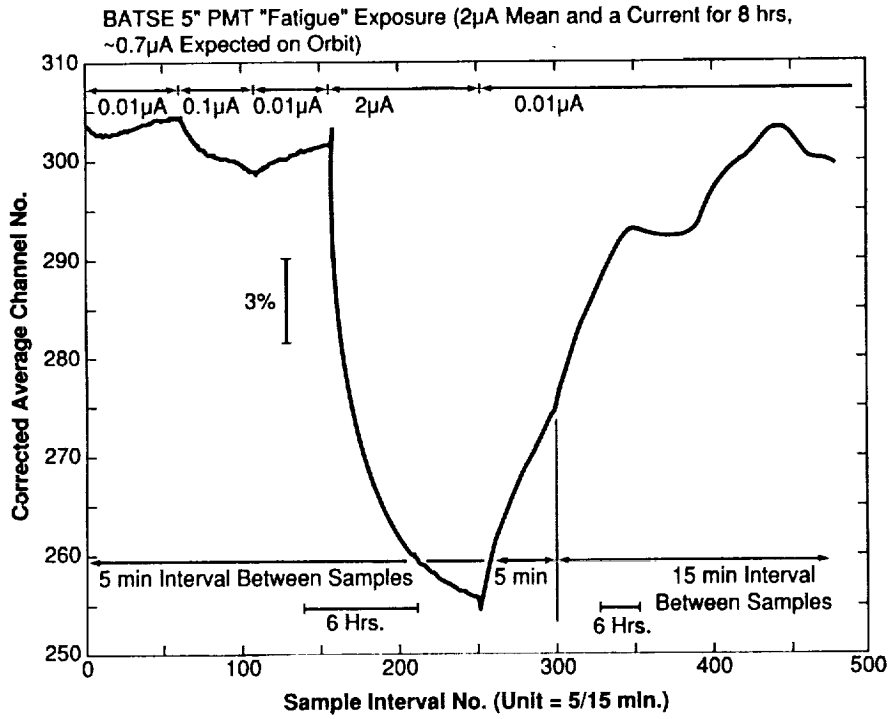
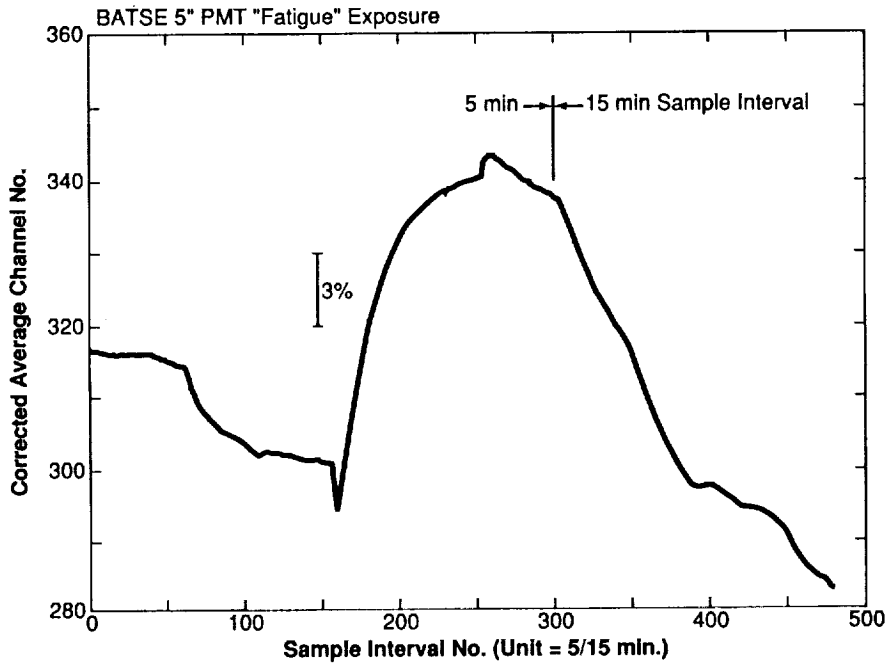
Figure 3.9. Gain Response to Fatigue Exposure (Two Types) Observed During MSFC PMT Screening Tests.

Gain response to this fatigue exposure identified two classes of tubes, with approximately one-third of the tubes being reduced in gain during the 2 μA exposure, and two-thirds showing an increase. Recovery times for both classes were comparable, typically 3-6 hours. An example of each type is shown in Figure 3.9. The gain variations for the flight PMTs is shown in Figure 3.10.

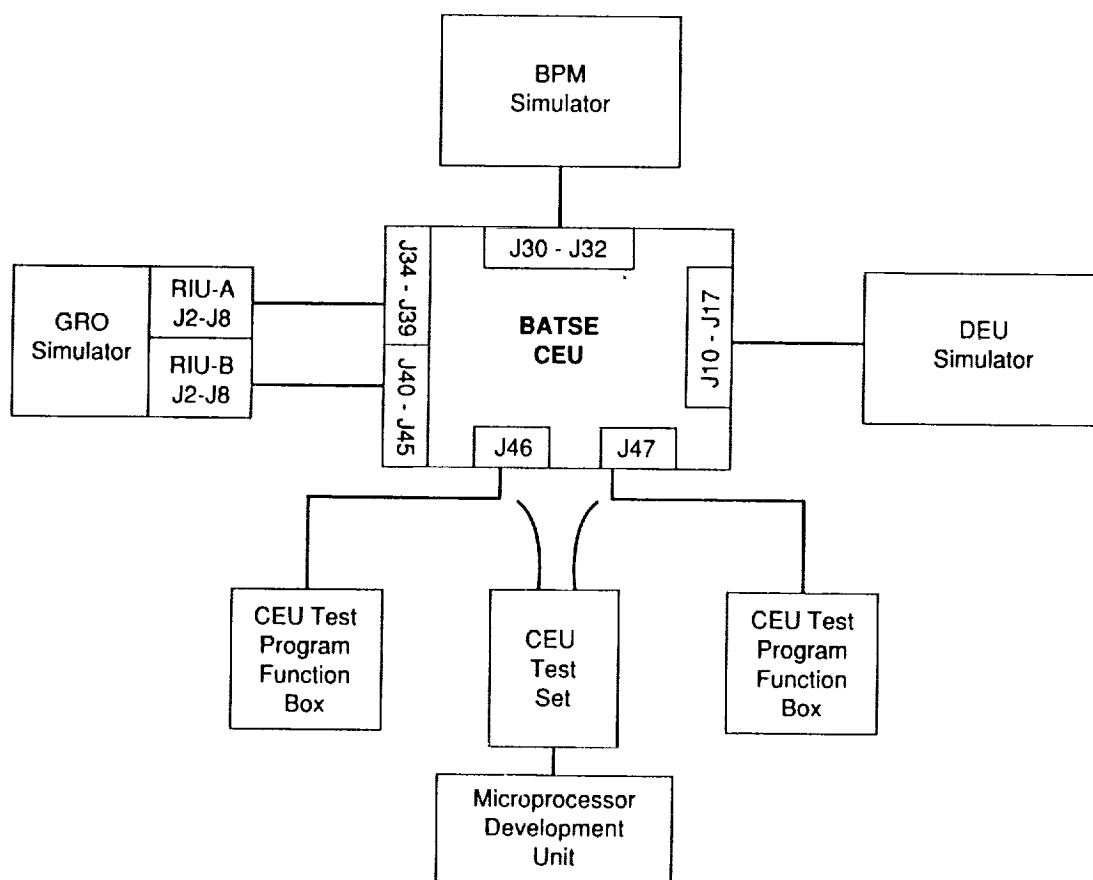
Figure 3.31. CEU Stand-Alone Testing Configuration.

Each test presented in this section was executed under the same configuration with minor changes for the individual tests as required. The CEU was placed on a table and connected to several pieces of ground support equipment. Two test-program function boxes were connected to J46 and J47. The microprocessor development unit and CEU test set were also connected in this area. Ports J30-J32 were connected to the BPM simulator. Detector modules were simulated by a piece of GSE designed to emulate the DEU in each module. This simulator was connected to ports J10-J17. The spacecraft interface, at J34-J39 and J40-J45, was made between the CEU and the GRO simulator. This simulator contained two remote interface units (RIU) and transmitted data and commands to the BATSE IGSE computer system. Figure 3.31 is a schematic of this test configuration.

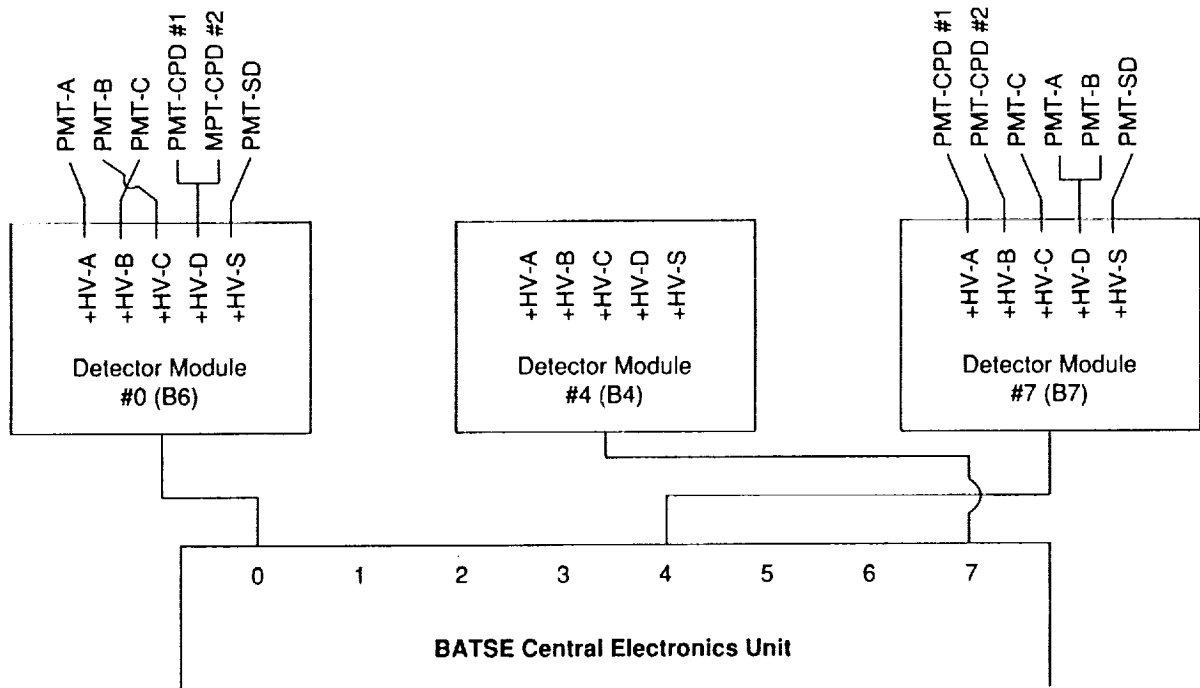
Figure 3.34. BATSE Thermal Vacuum Troubleshooting Test #1 Instrument Configuration.

The first BATSE system thermal vacuum test had produced several anomalies. The SFAST discriminator of detector module #7 was not operating properly. High voltage system failures occurred on PMT C of detector module #0 and on the CPD of detector module #7. Because of the isolation of the hardware inside the vacuum chamber, troubleshooting was limited to operations which could be done in the current instrument configuration. At the times of these anomalies, the BATSE team was unable to discern whether, for example, the failure of the SFAST discriminator was located inside the detector module or inside the CEU receiving circuitry. Likewise, a breakdown in the +HV system could be located inside the PMT, inside a cable, or at any of the +HV junctions and connectors. To facilitate the localization of these anomalies, the BATSE instrument was re-configured into the mode detailed in Figure 3.34.

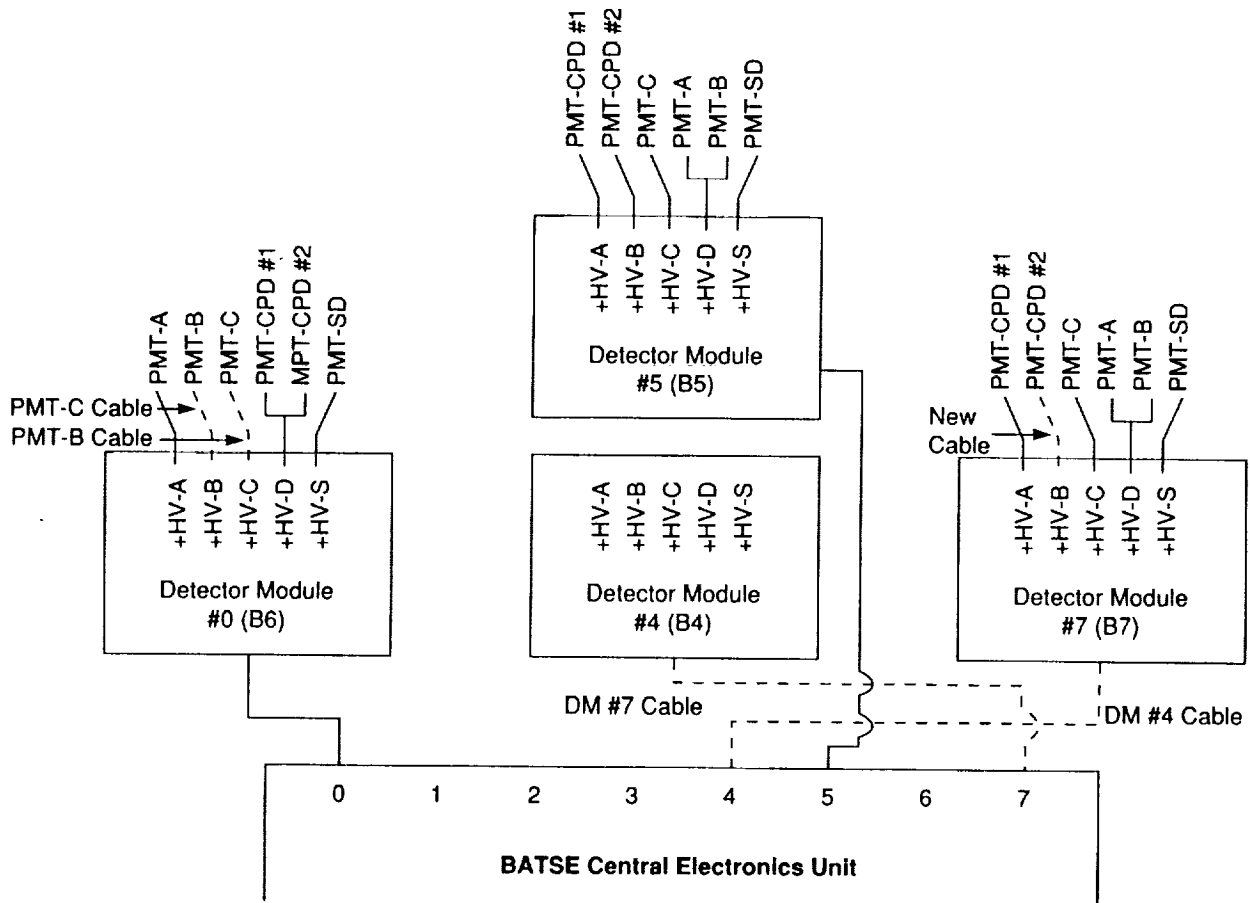
Figure 3.35. Second Thermal Vacuum Troubleshooting Test Instrument Configuration.

In an effort to further isolate both the problems which became apparent in the first test and the new problems, a second troubleshooting test was executed following repressurization of the chamber. In this test, significant changes were made to the configuration of BATSE. Detector Module #7 was reconnected to CEU port #7; however, module #4's cable was used. Module #4 received DM #7's cable. This was done to further isolate the SFAST3 problem. At that point, the possibility existed that the SFAST3 anomaly was due to a cable problem. Evidence of a problem on SFAST3 of detector module #7 would now positively indict the CEU as the source of the anomaly.
