NASA Conference Publication 3162
Part 2

LDEF Materials Workshop '91

Proceedings of a workshop held at
H. J. E. Reid Conference Center
NASA Langley Research Center
November 19-22, 1991

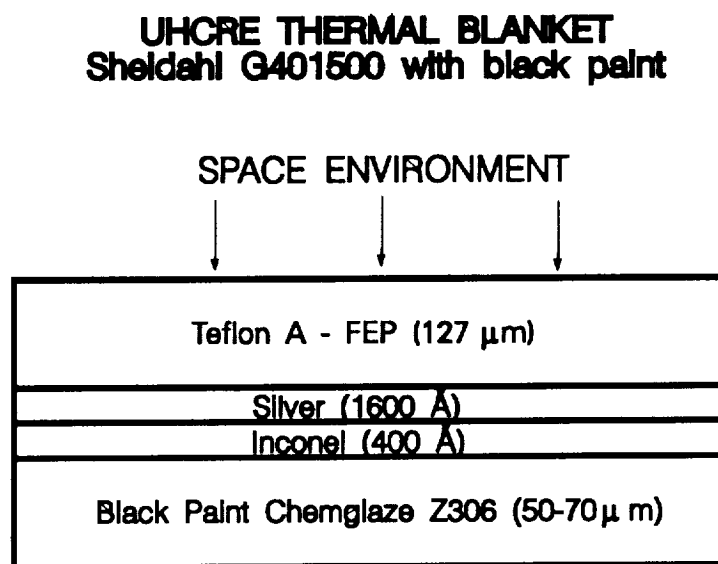
Figure 1. Layout of UHCRE thermal blanket

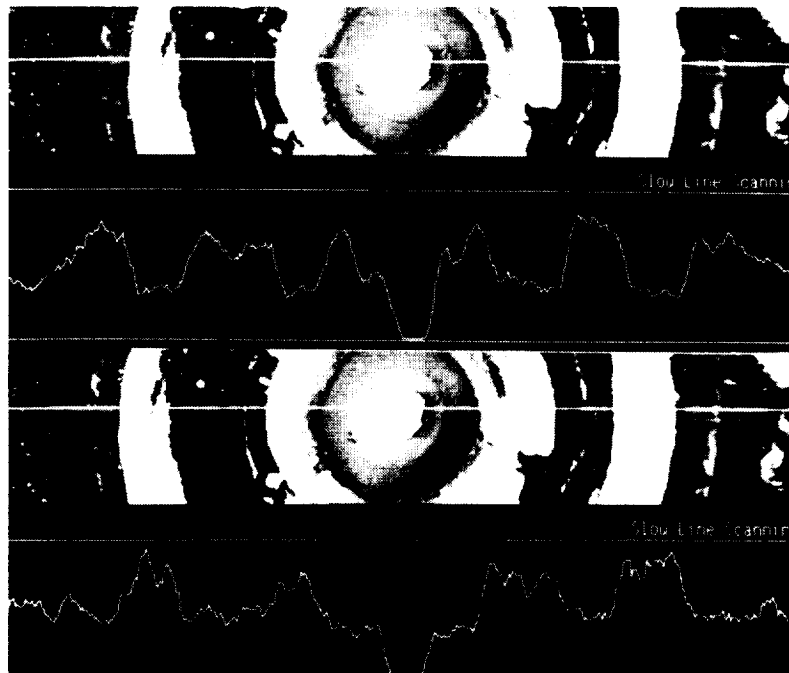
Figure 3. Oxygen linescan (top) and Fluor linescan across the rings.

Obviously these dark rings are oxidised silver. Oxidised silver frequently occurs when silver is exposed to atomic oxygen found in low earth orbit. X-ray analysis indeed confirms the presence of silver-oxide in these black regions. The X-ray spectrum of the light rings shows the presence of fluor, which was absent on the dark rings. Indeed, a linescan across the sample, on oxygen and fluor, reveals an alternating pattern of oxygen and fluor with oxygen in the dark areas and fluor in the light areas. Carbon is found everywhere on these rings. A linescan across one of the samples is found in figure 3.

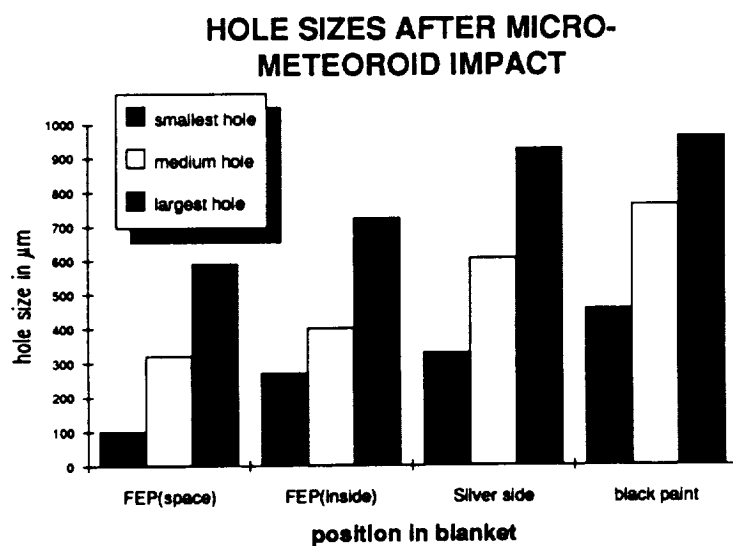
Figure 4a. Holes sizes measured in UHCRE Thermal blanket after micro-meteoroid impact

The sizes of the impact holes of the three examined samples are given in figure 4a. The first position is the space side of the FEP. The second position is the under side of the FEP that was in contact with the silver layer. The third position is the entrance hole in the silver layer, while the fourth position is the rear side of the blanket, i.e. the black paint Chemglaze Z306. A specific row of holes is illustrated in figs. 4b– e.

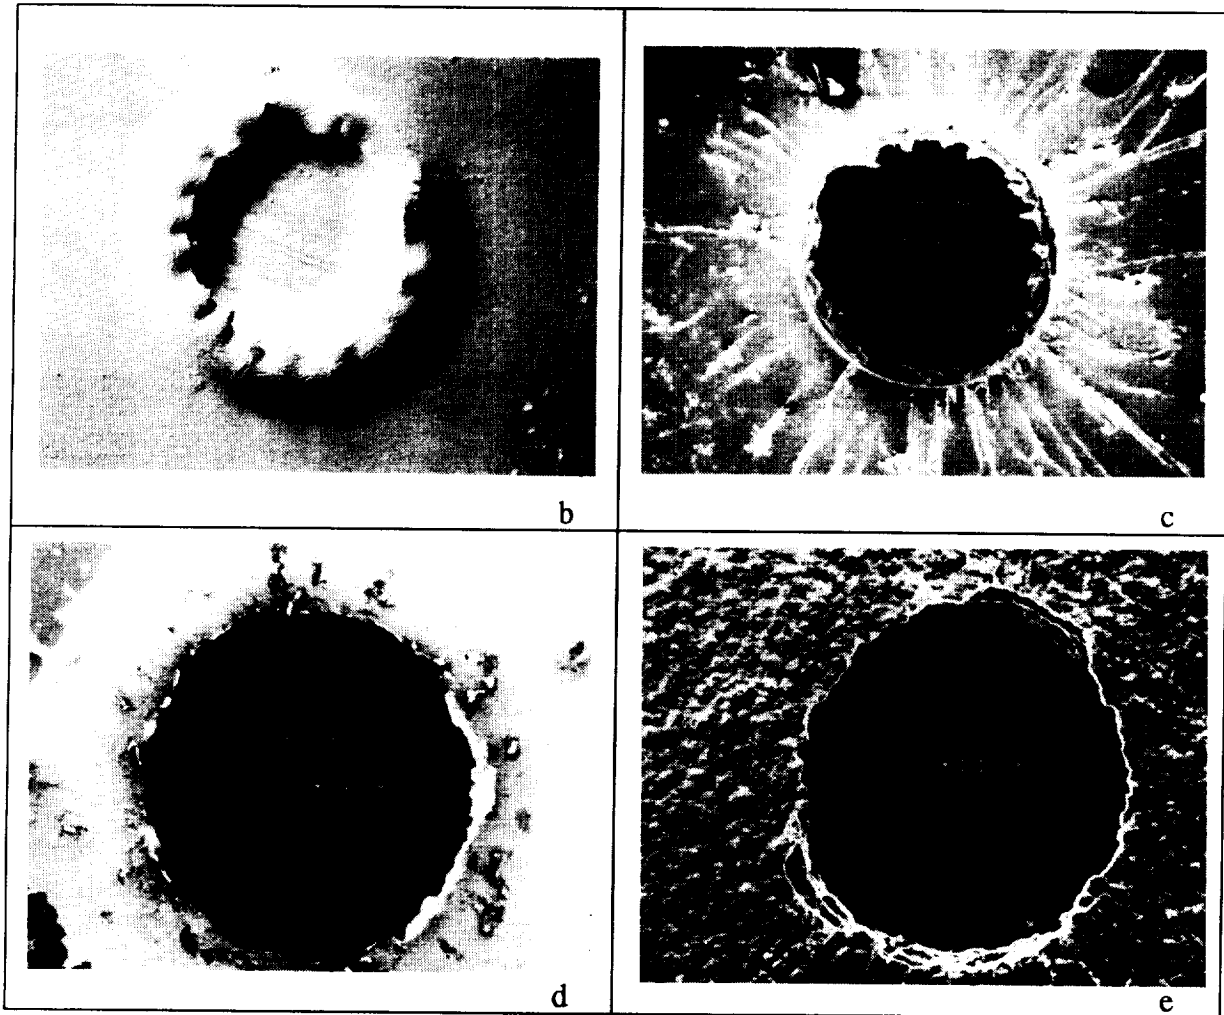
Figure 4b. SEM view on the space exposed side of the FEP layer showing the smallest hole with deformed edges and atomic oxygen erosion (size 590 μm).

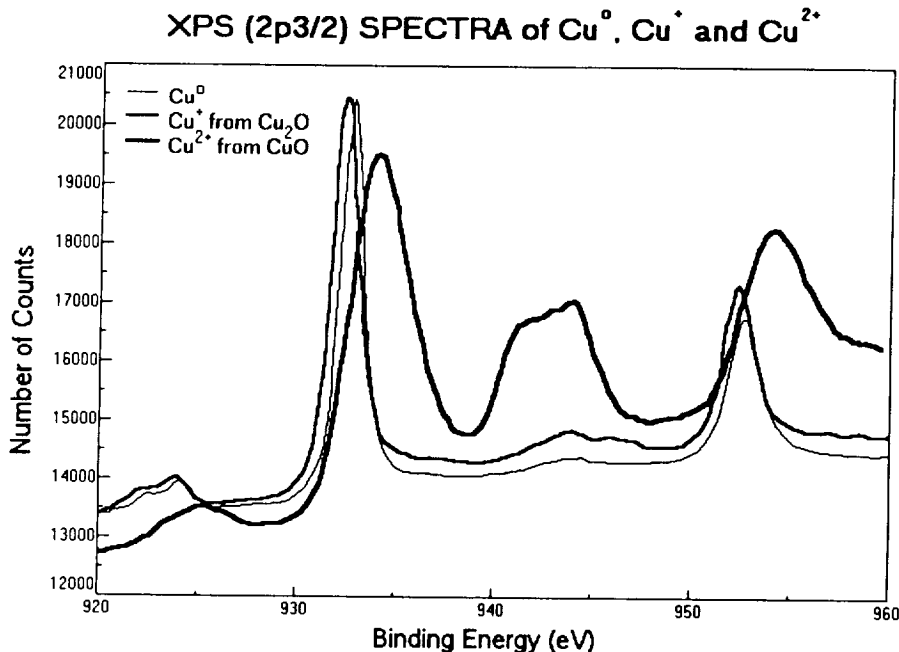
Figure 5. Copper 2p spectra of Cu⁰, Cu⁺ and Cu²⁺ showing the chemical shifts due to the oxidation state. The 2p spectrum of Cu²⁺ shows the two strong 'shake up' satellites.

The Auger-XPS spectra are measured at the surface of the sample E10 and after repeated etching with the Argon ion gun. At the surface the presence of a thin CuO layer is determined. After two sputtering events the CuO signal disappears and a Cu₂O signal is measured. As discussed, the measurement of a Cu₂O signal after a CuO signal does not necessarily mean that Cu₂O is really present. A part of the oxide layer of sample E10 was removed using a new scalpel blade while the specimen was positioned on the Auger specimen table. Immediately after the partial removal of the oxide layer the sample was returned into the airlock to avoid any re-oxidation. Auger-XPS spectrum of this area shows the presence of Cu₂O instead of CuO. This sequence of oxide layers is consistent with observations on copper oxidised in air at low temperature as depicted in figure 6.

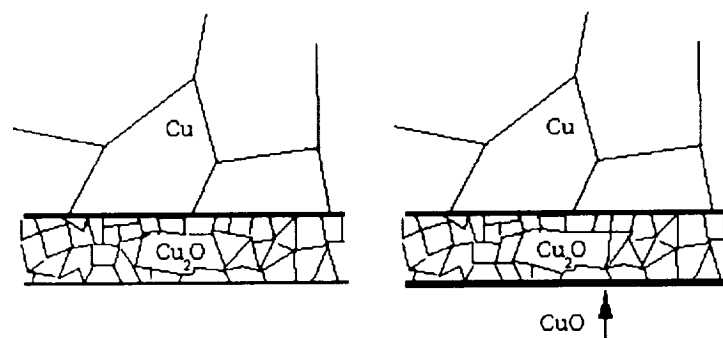
Figure 6. *Left: pure copper oxidised at low pressure or in air above 1025 °C. Right: pure copper oxidised in air below 1025 °C. (from ref. 5)*

At low oxygen pressures, the only oxide found on copper is Cu_2O as illustrated in figure 7. It is reasonable to assume that this is also true for copper exposed under low earth orbit conditions. The presence of a CuO layer on top of the Cu_2O layer as found on the LDEF samples should then be questioned. It can be argued that this CuO layer is formed on ground during the time of storage after retrieval of LDEF.

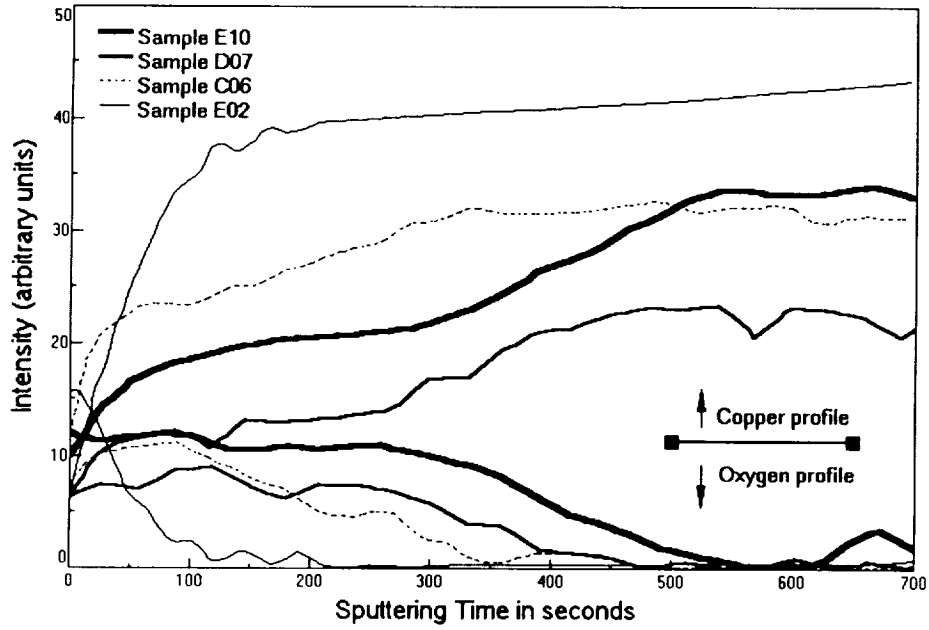
Figure 7. Depth profile of Copper and Oxygen from the Cu samples exposed on LDEF. The four upward curves are the Cu profiles and the four downward curves are the oxygen profiles.

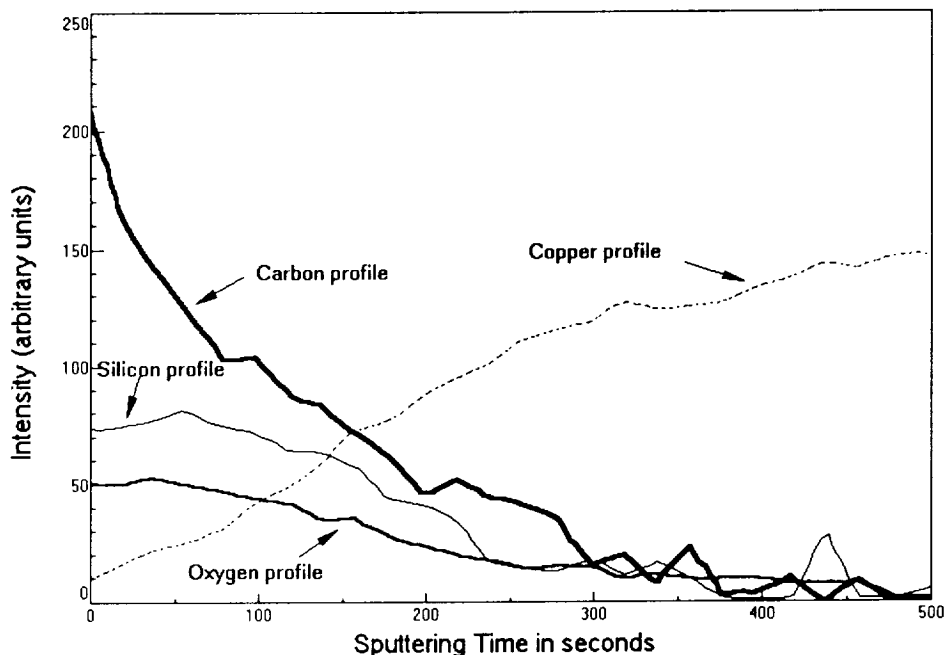
Figure 9. Depth profile of Carbon, Copper, Silicon and Oxygen from sample D01. The Carbon, the Silicon and the Oxygen decay in the same manner.

The copper signal starts off much lower than the oxygen signal as opposed to the signal seen in figure 8. The carbon, the silicon and the oxygen signals decay in the same manner reaching zero intensity at the same sputtering time. When the intensities of these three signals are negligibly small the copper signal approaches its maximum. This indicates the presence of a silicon oxide instead of a copper oxide. The silicon oxide contains significant amounts of carbon, so probably the silicon oxide originated from a silicone contaminant. This contamination occurred very early in the mission because no significant traces of a copper oxide layer are found.

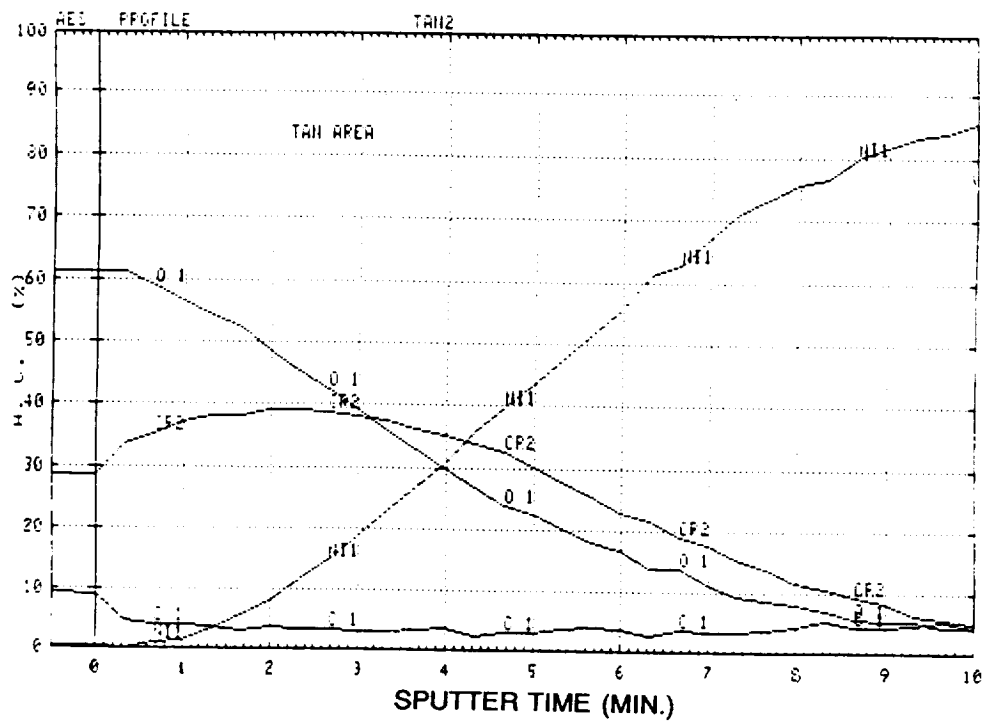
Figure 10. Auger Emission Spectroscopy Profile of Exposed & Discolored (Tan) Area.

These results are not conclusive. But based on the Auger results the following hypothesis is proposed. The discoloration was induced by a thermal effect, caused by the close proximity of the aluminum foil flap to the black chromium coating. The aluminum foil flap, with a low thermal mass and high absorptance to emittance ratio, became very hot, accelerating the atomic oxygen driven oxidation of the chromium. This hypothesis is currently in test using ESCA profiling to determine the chromium oxidation states as a function of depth (fig. 11).

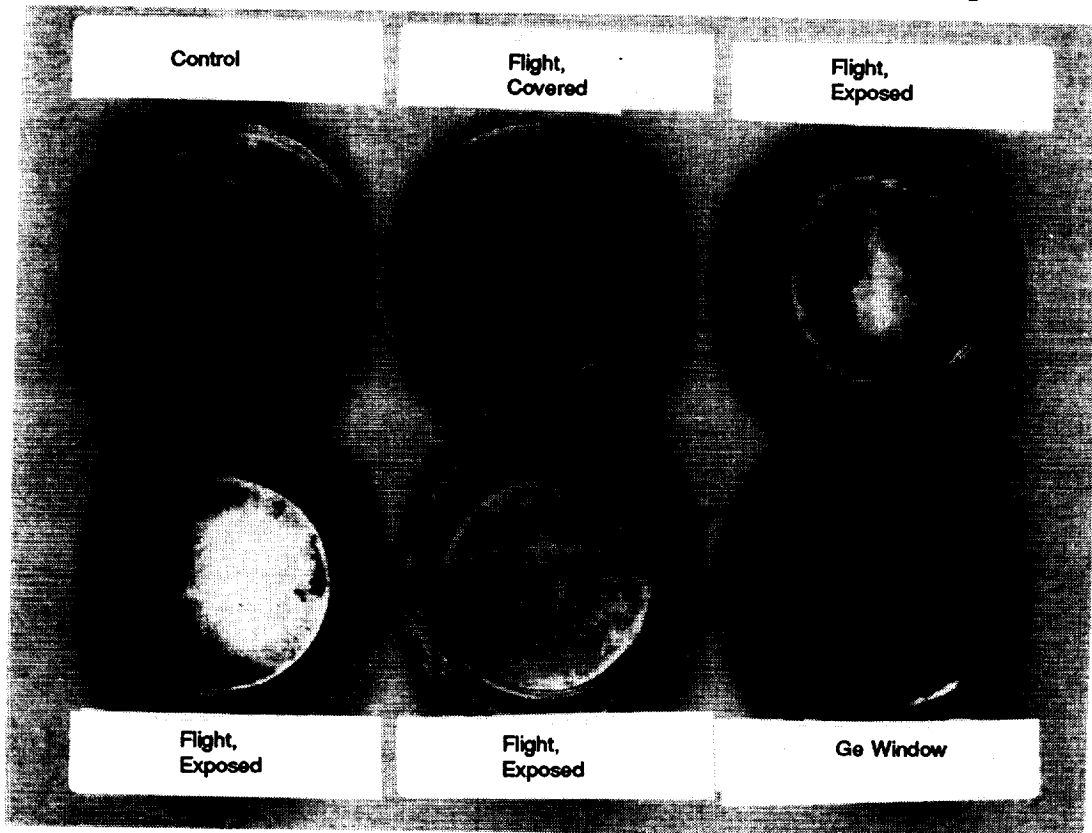
Figure 2

TlBrI Windows Showing Damage in Exposed Samples

Some of the detector housings had infrared-transmitting materials in their windows; some had no material in their windows. Three different window materials were used: germanium (Ge), thallium bromide iodide (TlBrI) and zinc sulfide (ZnS). There was no visible damage in the germanium or zinc sulfide windows. Also, there was no significant loss in signal strength of the flight detectors having these window materials as compared to control detectors of the same type.

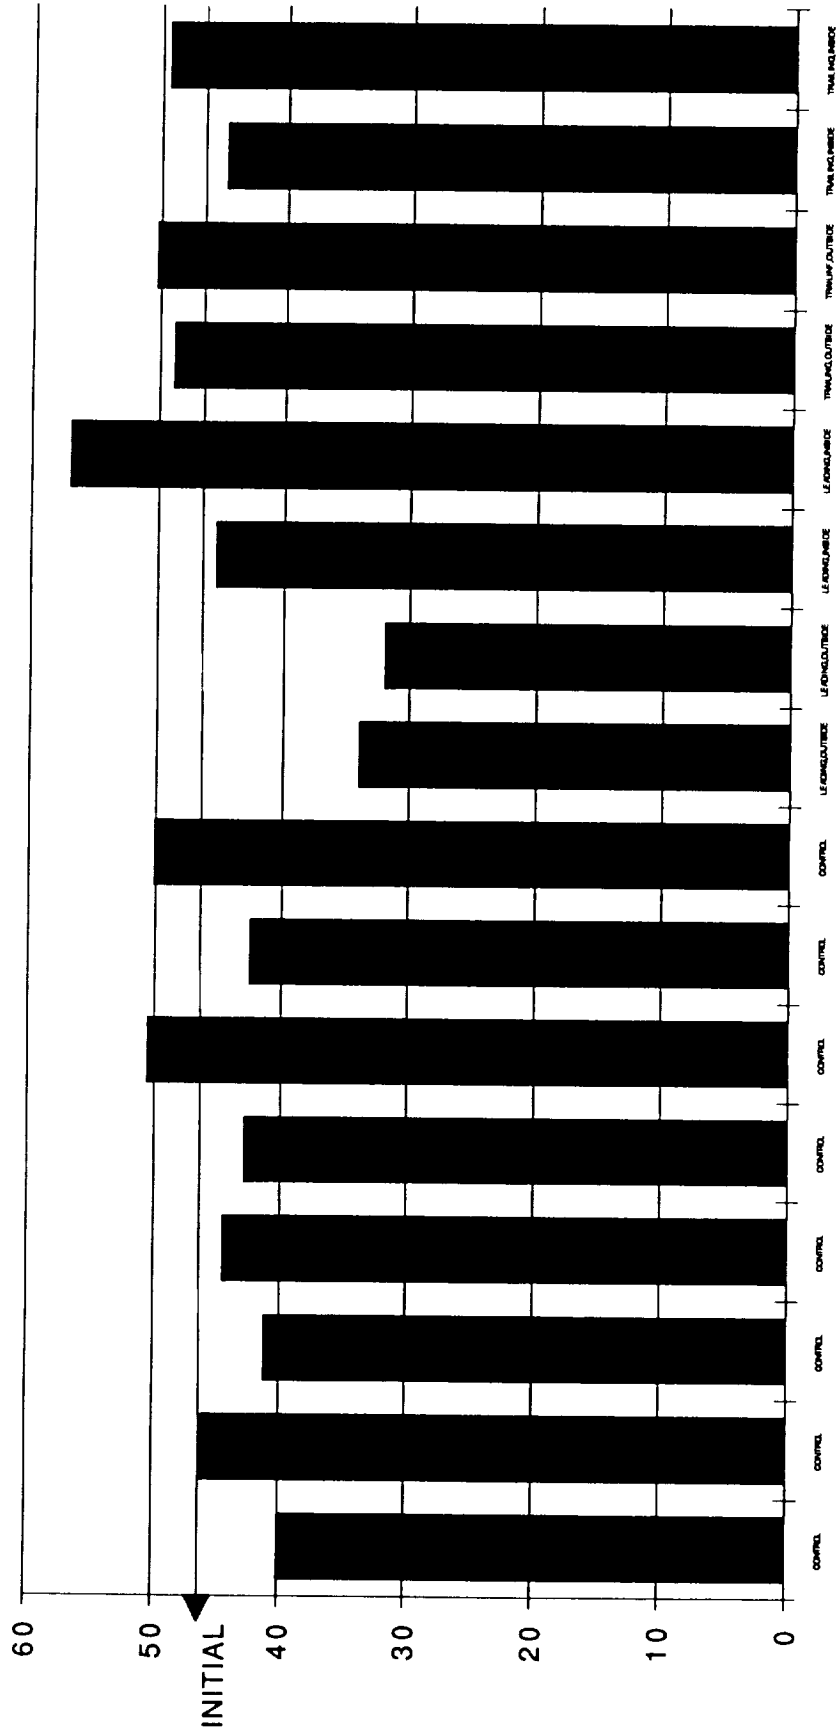
Figure 9. Bar Graph Showing Flexural Strength Data For All Samples for GDSSD P75S/934 Graphite/Epoxy Composite.

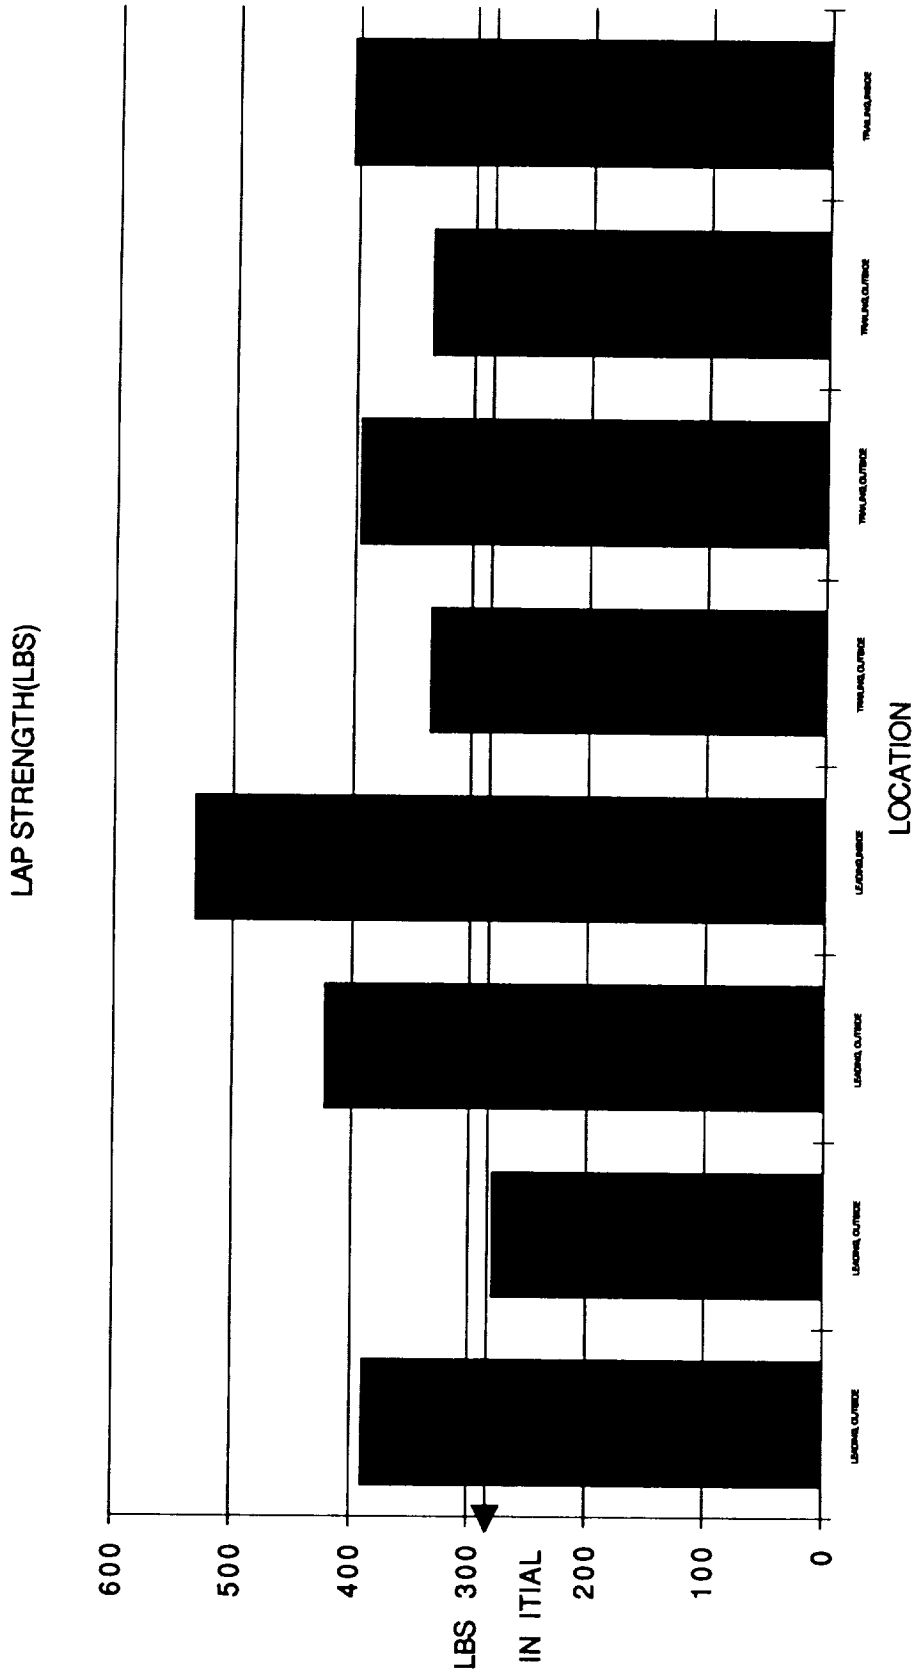
Figure 13. Bar Graph Showing Lap Shear Strength Data For All Samples for GDSSD Spot Welded W722/P-1700 Composites with a ZnO Coating.

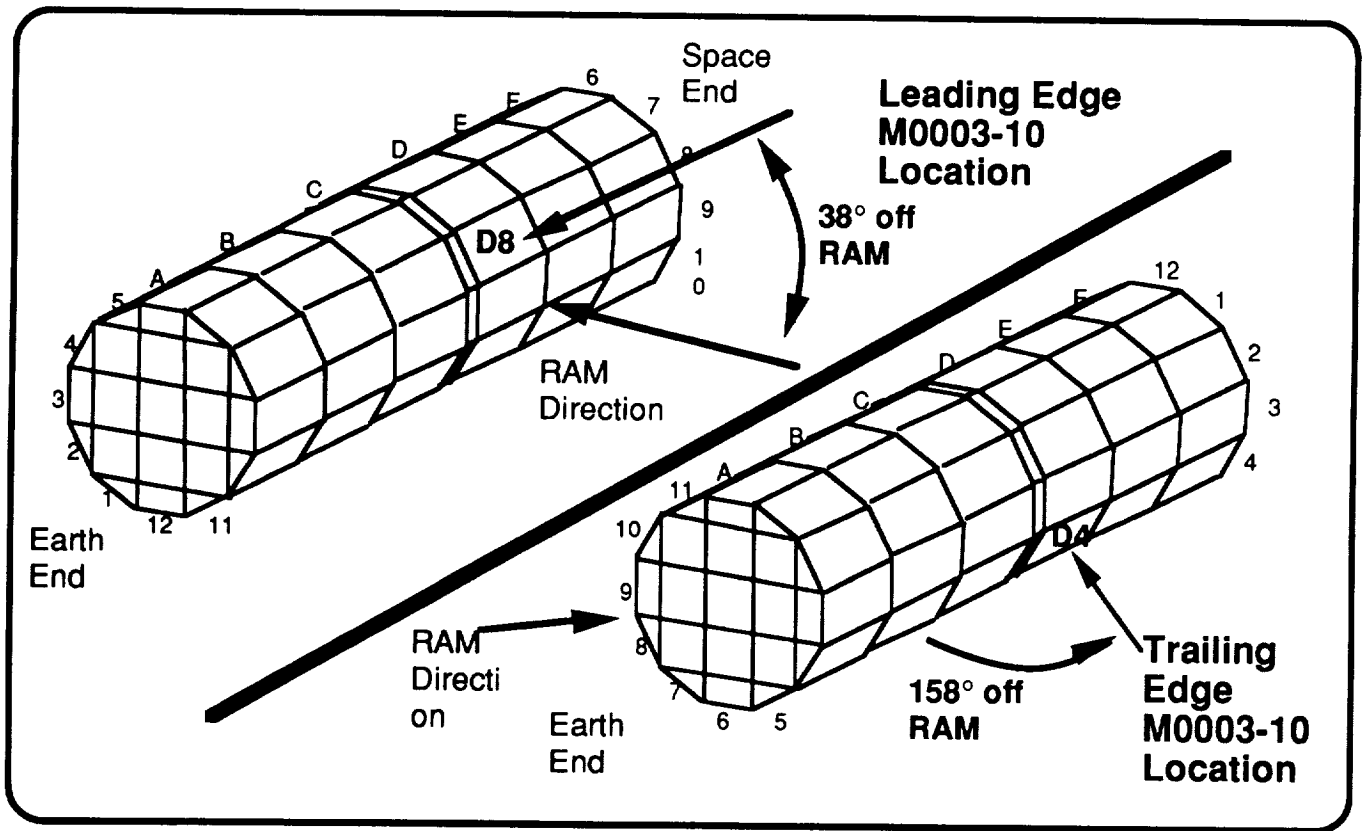
Figure 1. Location of M0003-8 experiment on LDEF

The specimens of experiment M0003-10 were intentionally positioned at both leading and trailing edges in order to provide varied exposure conditions. At the mission altitudes the atomic oxygen was swept by the LDEF leading edge surface. The trailing edge specimens received practically no atomic oxygen exposure.

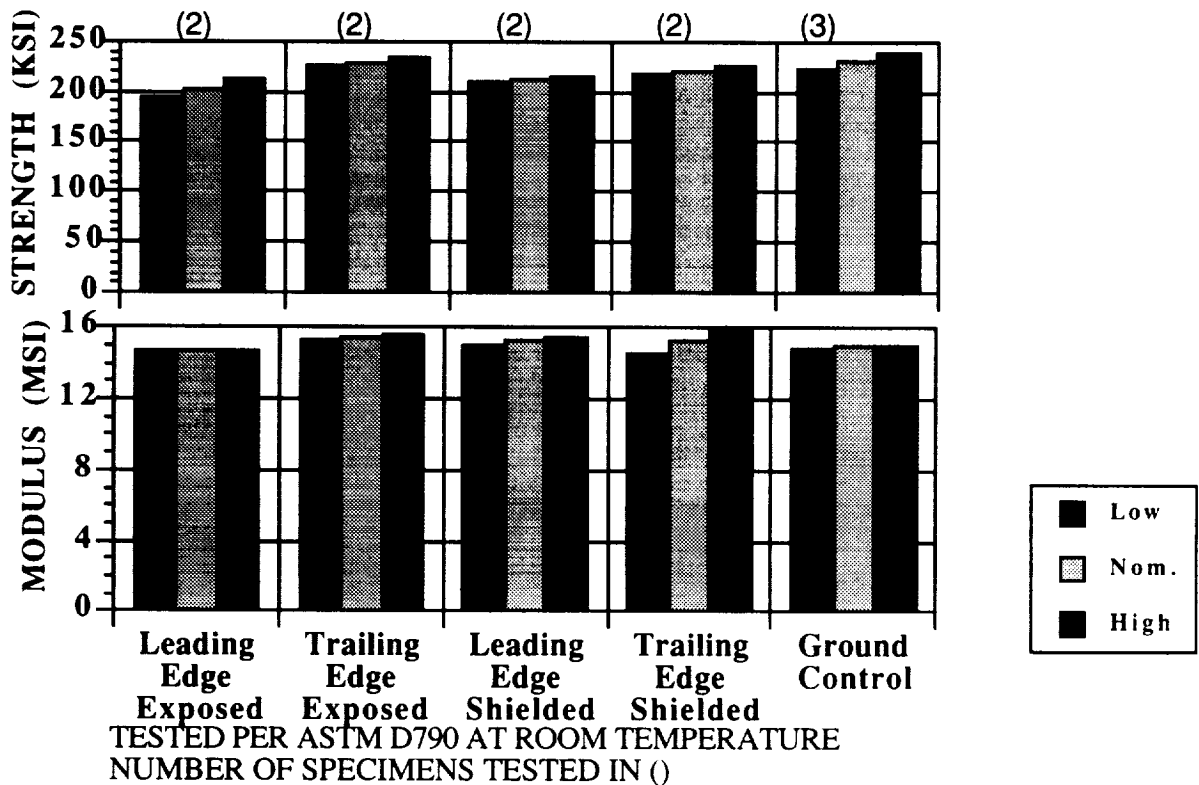
The 934 epoxy/T300 graphite specimens did not show any significant loss in flexure properties between the different positions on LDEF and the ground control. These results are based on the post flight cross-sectional areas. The loss of material for the leading edge exposed specimens results in a performance reduction for a given specimen. As these specimens were unidirectionally (0°) reinforced, the load that would have been carried by the eroded material on the leading edge exposed specimens was carried by the remaining 0° material. For these specimens the only mechanical performance loss was due to material loss on the leading edge exposed specimens. Ply orientation plays a significant role in flexure properties behavior when AO erosion is involved.

Figure 4. Flexure strength and modulus of 934/T300 specimens, (0°) 16 plies

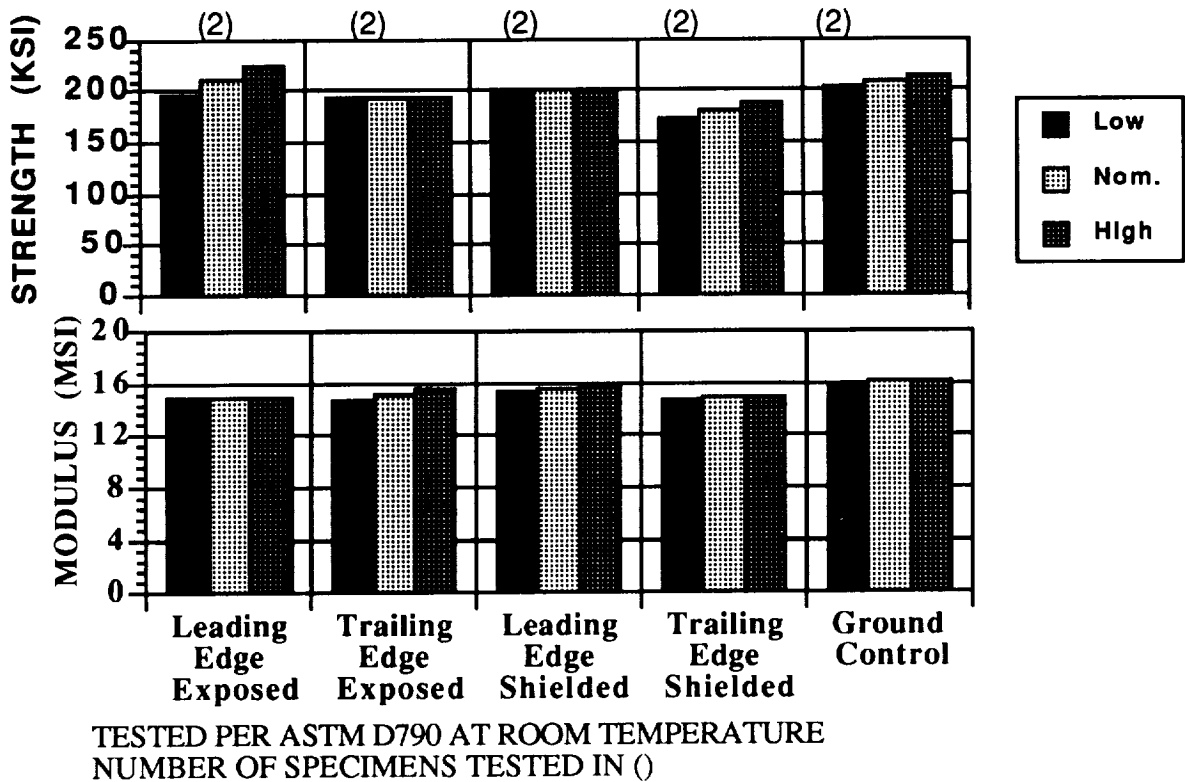
The 3501-6 epoxy/AS graphite flexure test results show very little change in modulus values among the different exposure conditions and the ground control. The strength values show some variation from position to position, most likely due to the inherent scatter with polymer matrix composite strength measurements and the small sample size. Once again the 0° orientation of the reinforcement allows the underlying plies to pick up the load from the eroded surface ply on the leading edge exposed specimens. This is a similar situation to the 934/T300 results where mechanical performance reductions are due to erosion of material on the leading edge specimens.

Figure 5. Strength and modulus of 3501-6/AS specimens, (0°) 16 plies

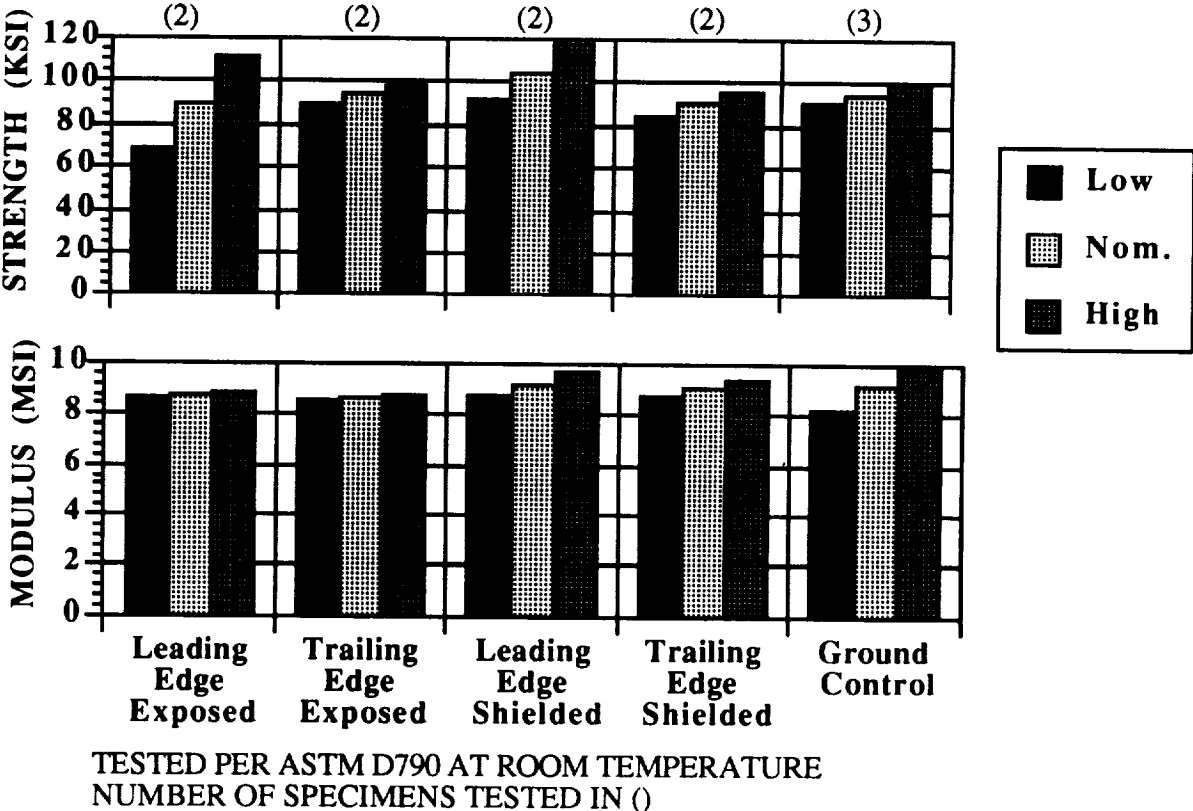
The P1700 polysulfone/T300 graphite specimens were reinforced with a 0°,90° woven fabric. Here also as with the unidirectionally reinforced specimens there is continuous reinforcement in the load direction in each ply. No significant changes in either flexure modulus or strength were found.

Figure 6. Flexure strength and modulus for P1700/T300 specimens, (0°,90°) fabric 8 plies.

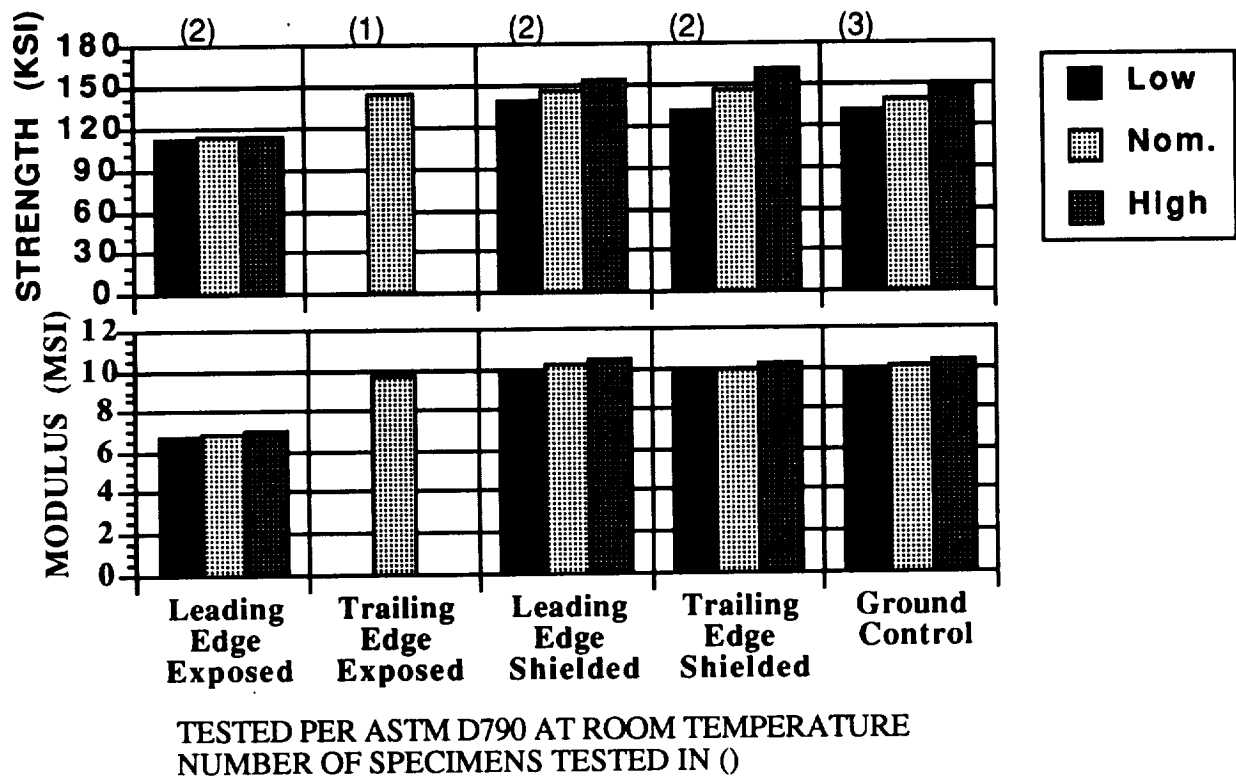
The non AO exposed specimen data show no significant change in flexure properties compared with the ground control data.

Figure 7. Flexure strength and modulus for PMR-15/C6000 specimens $(0^\circ, \pm 45^\circ, 0^\circ, \pm 45^\circ)_s$

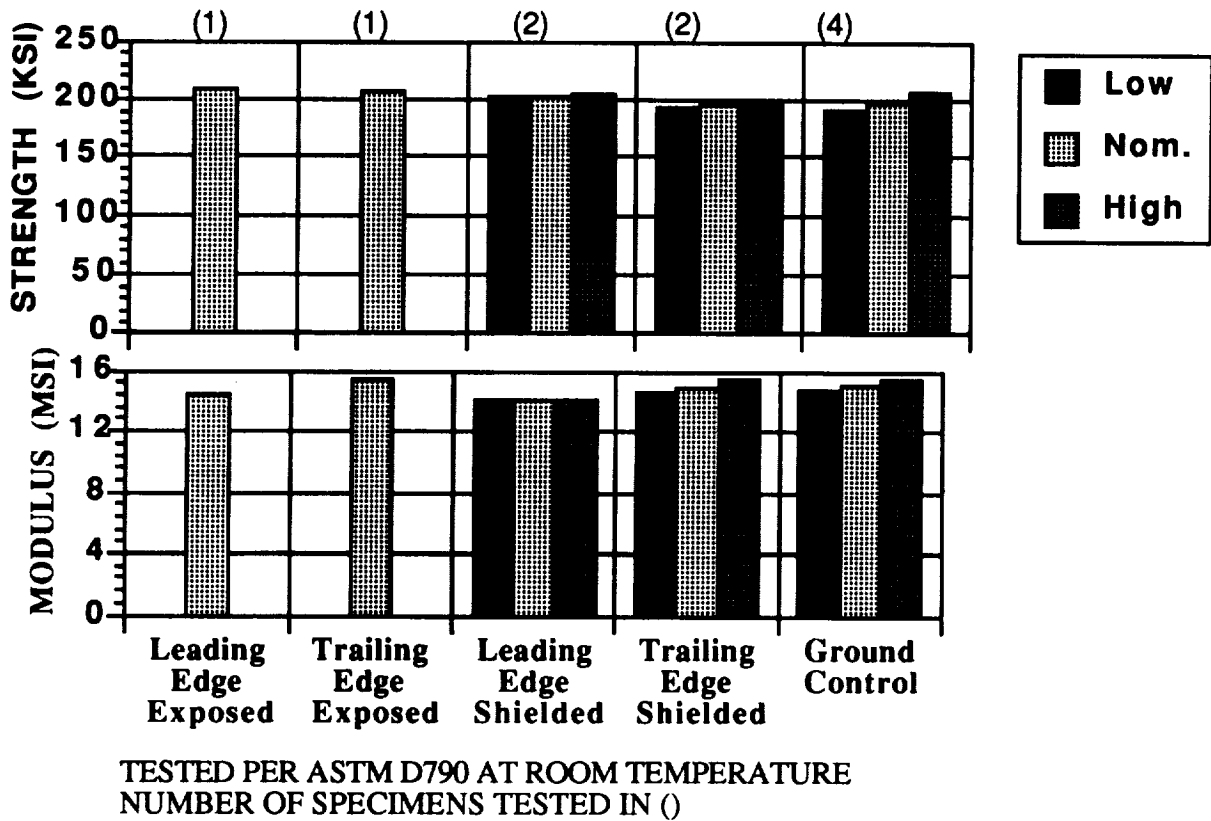
The LARC 160 polyimide/ graphite flexure test results show very little change in modulus values among the different exposure conditions and the ground control. The strength values show some variation from position to position, most likely due to the inherent scatter with PMC strength measurements and the small sample size. Once again the 0° orientation of the reinforcement allows the underlying plies to pick up the load from the eroded surface ply on the leading edge exposed specimens. This is a similar situation to the other unidirectionally reinforced material results where mechanical performance reductions are due to erosion of material on the leading edge specimens.

Figure 8. Flexure strength and modulus for LARC 160/graphite specimens, (0°)

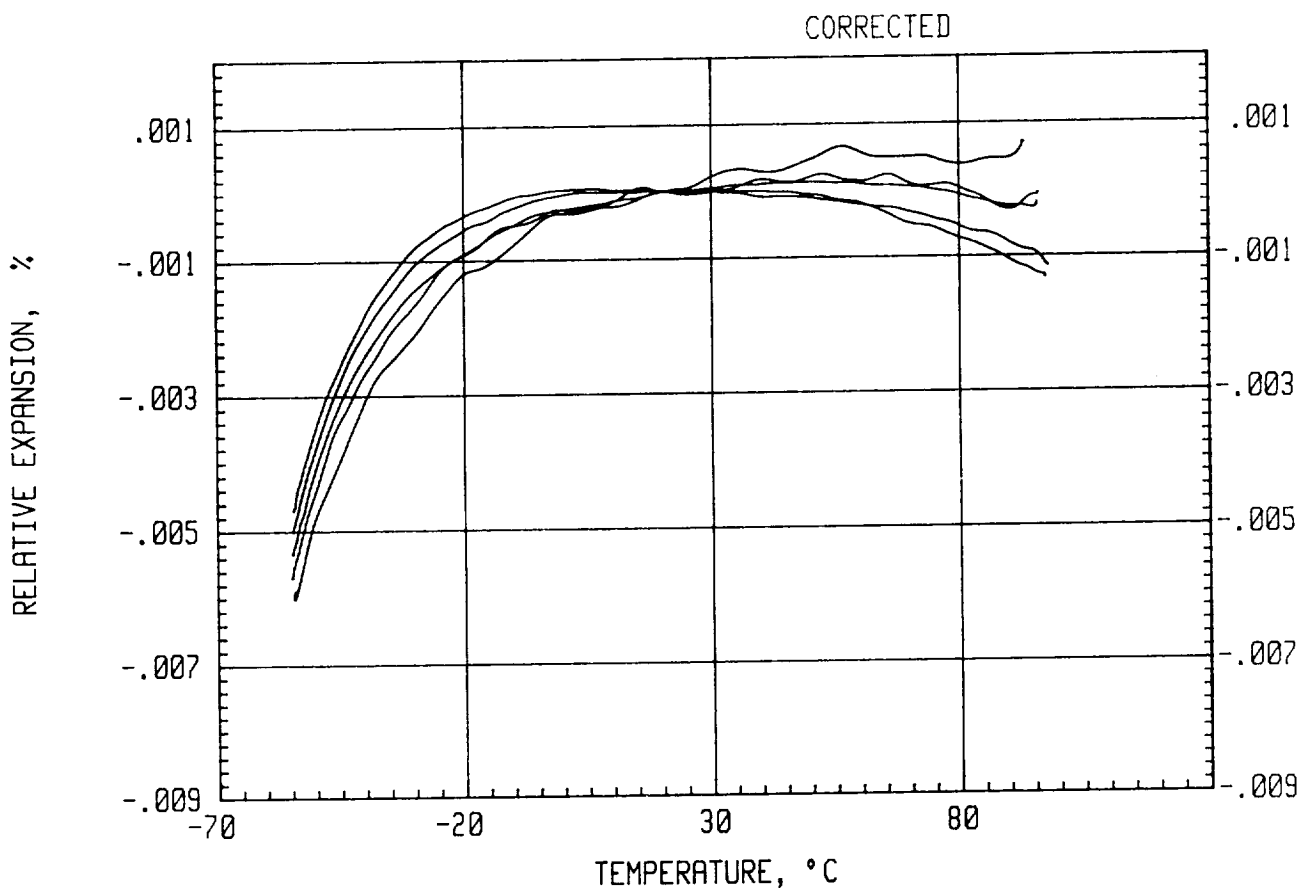
Thermal expansion coefficients were measured in the 0° direction for each material using a Netzsch model 402 dilatometer. The dimensional change vs. temperature plots for the PMR-15 polyimide/C6000 graphite specimens shown in Figure 9 are representative of all the composite specimens. This plot includes values for leading and trailing edge shielded and exposed specimens as well as the ground control. The accuracy of this measurement technique is approximately 0.001% relative expansion as plotted. Therefore these measurements indicate no significant change in thermal expansion properties. However, as will be discussed in the following section, significant variations in microcracking in the PMR-15 polyimide / C6000 graphite specimens were found. This technique for measuring thermal expansion properties is not sensitive enough to measure the impact of this microcracking.

Figure 9.- Thermal expansion properties of PMR 15 polyimide/C6000 graphite LDEF specimens

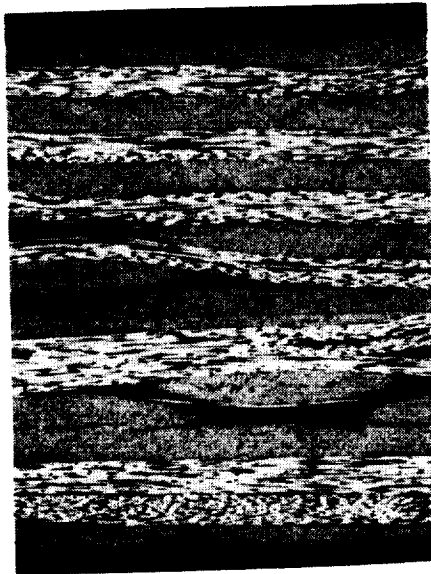
Figure 10 shows a magnified cross sectional view of the leading edge P-1700 polysulfone/T300 graphite and PMR 15 polyimide/C6000 graphite specimens. These photomicrographs were taken at 50X and 100X magnification respectively. Intralaminar cracking can be seen in the outer plies of both specimens.

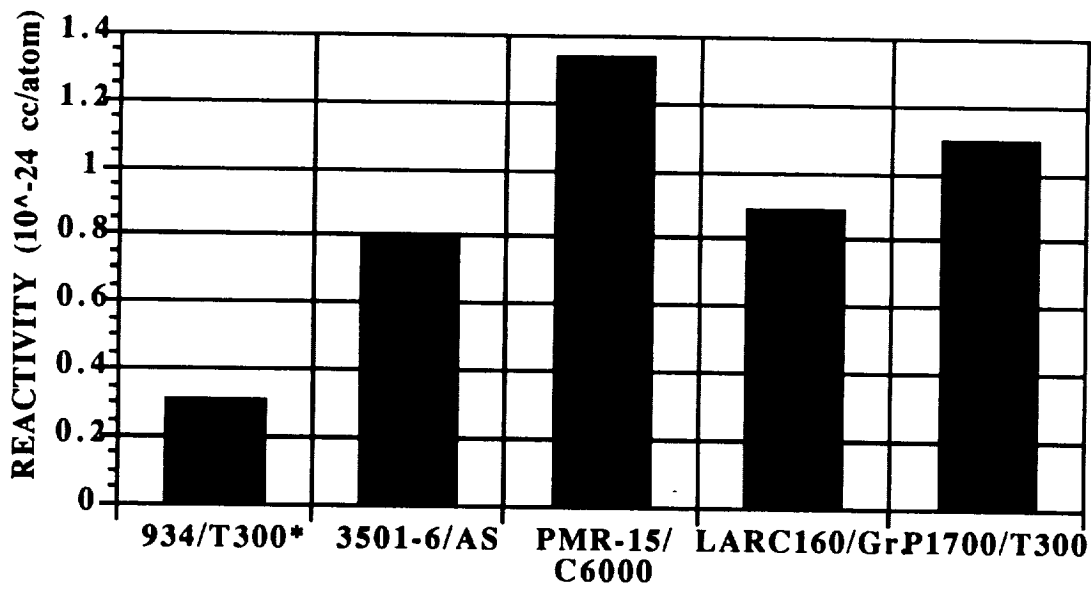
Atomic oxygen reactivity values shown in Figure 11 for the five composite systems flown were calculated based on mass loss data. These values do not correspond well to the relative levels of local material loss as observed using optical microscopy. This suggests that other factors are involved in the mass loss of the whole specimen. Local areas of surface contamination were observed using scanning electron microscopy on many of the specimens. These areas appear to have experienced reduced or no erosion due to shielding by the contaminants. Other areas were observed with reduced erosion and no surface contaminant suggesting that a contaminant may have provided temporary shielding from atomic oxygen attack. Reactivity values for composite systems and any other material may best be obtained through local thickness loss measurements near a shielded area by microscopy or profilometry.

Calculated from weight loss data measured at the Aerospace corporation

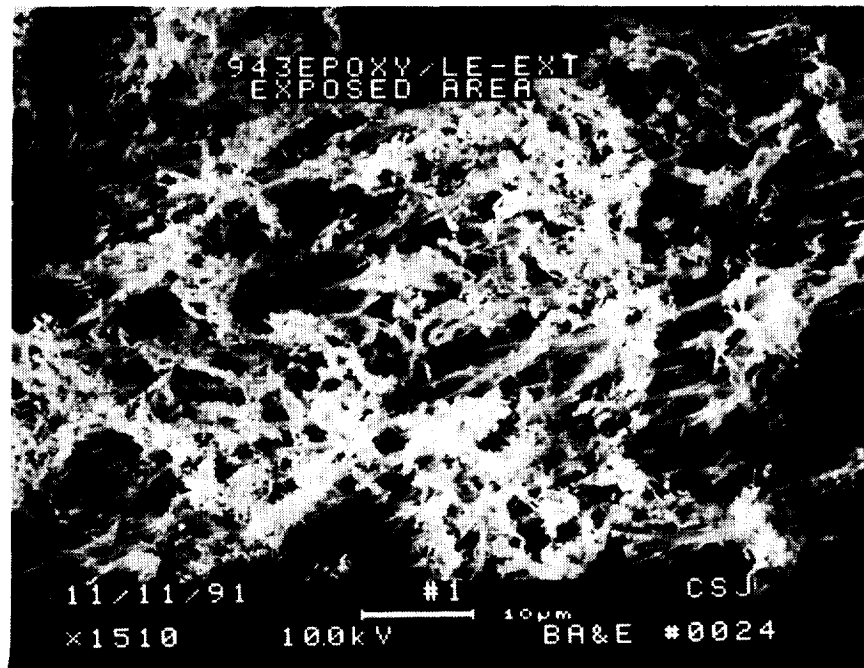
Figure 12 shows the surface of a 934 epoxy/T300 graphite specimen. A jagged peak like structure exists with a stringy, "ash" like material concentrated in clumps around the peaks. The jagged peaks and "ash" structures are ubiquitous among the graphite reinforced specimens. However the level and texture of these features differ from composite type to composite type.

Figure 12. Scanning electron photomicrograph of leading edge exposed 934 epoxy/T300 graphite surface

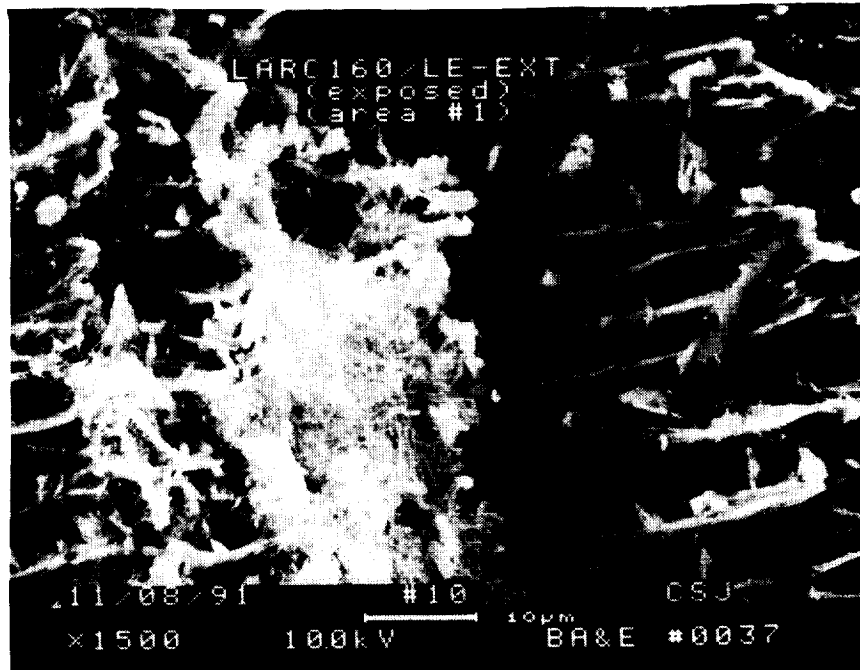
Figure 16. Scanning electron photomicrograph of leading edge exposed LARC 160 polyimide/graphite surface

Figure 16 shows the surface of a leading edge exposed LARC 160 polyimide/graphite specimen. The jagged peak size and spacing appear similar to the PMR-15 polyimide. The "ash" structure also appears similar with more "clumps" present. An area of contamination can be seen just to the left of the center. These areas were common on all leading edge exposed surfaces.

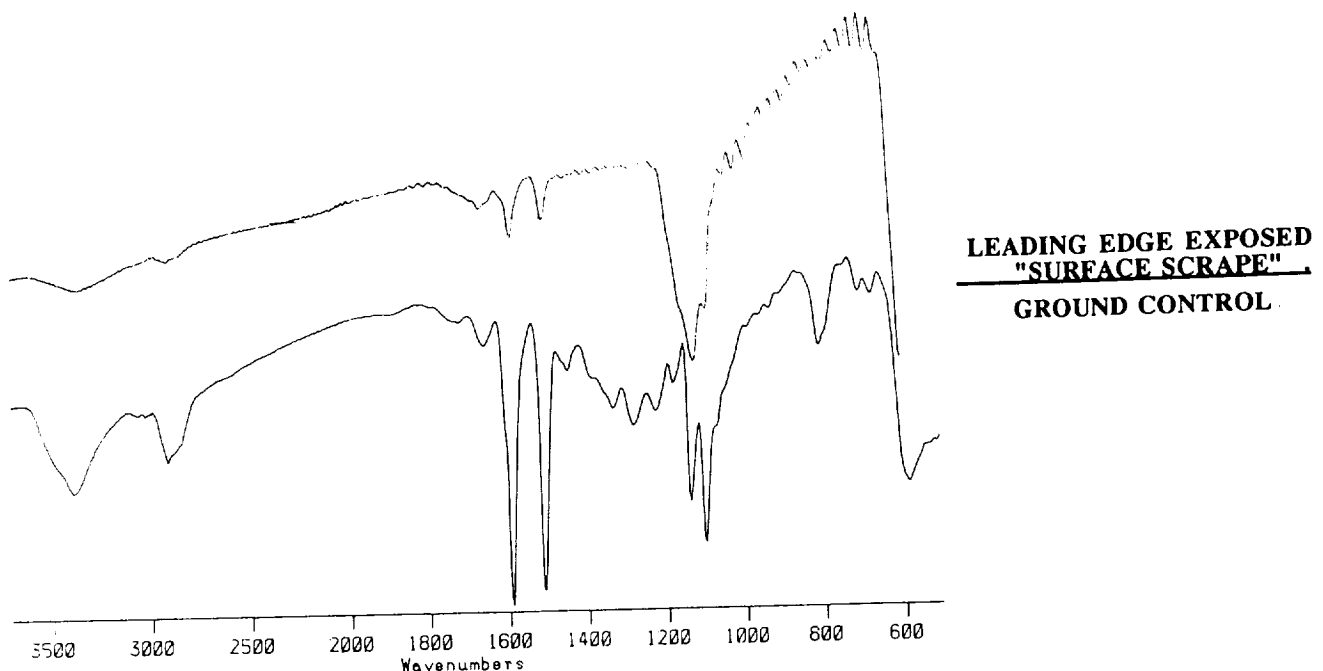
The presence of sodium sulfate on only certain polymer matrix composites suggests that contamination from other LDEF sources is improbable. One possible source of this compound is that residual sodium contamination from manufacture of graphite fiber tows is combining with sulfur from the composite matrix material curing agent to form AO resistant sodium sulfate. This may offer an explanation for the light and dark banded pattern reported for a 5208 epoxy/T300 graphite specimen flown on LDEF.⁵ The banding may be due to variations in the residual levels of sodium in or on the carbon fiber tows from the manufacturing process.

Figure 18. FTIR spectroscopy trace for 3501-6 epoxy/AS graphite specimens
