NASA Conference Publication 3162
Part 2

LDEF Materials Workshop '91

Proceedings of a workshop held at
H. J. E. Reid Conference Center
NASA Langley Research Center
November 19-22, 1991

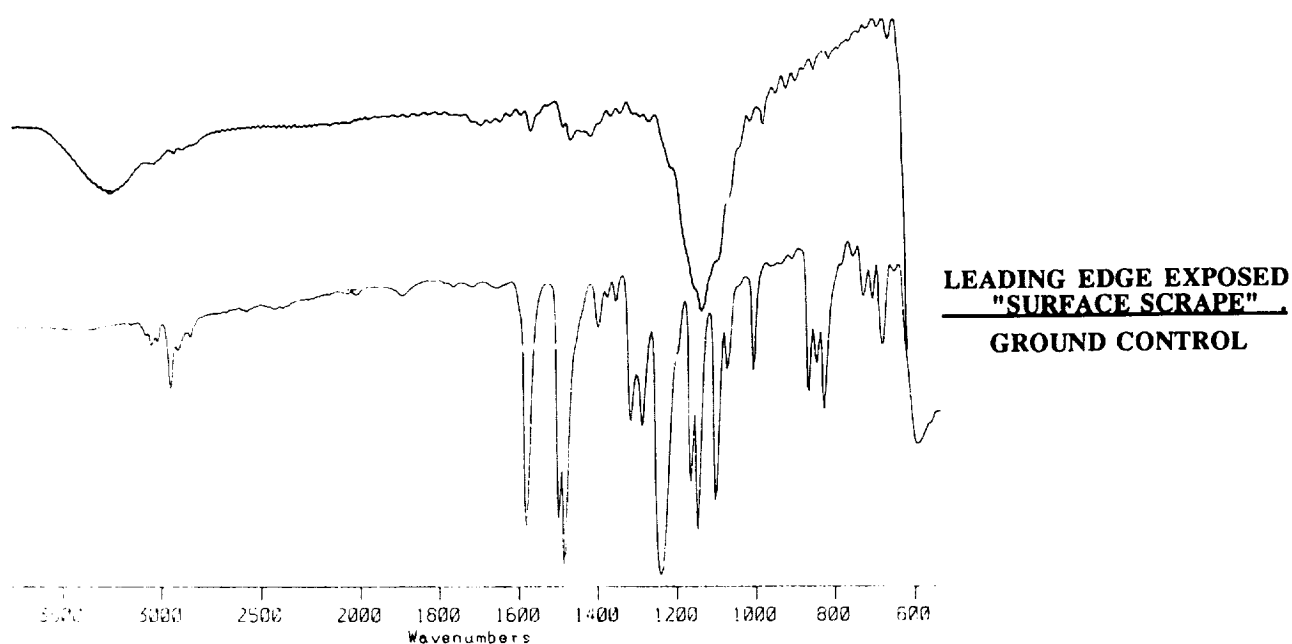
The IR trace for the leading edge exposed P1700 polysulfone/T300 graphite as shown in Figure 19 also shows the presence of a broad peak in the 1100 to 1200 wave number region. Comparison to the ground control indicates that most of the matrix resin has been eroded from the surface. As mentioned previously the presence of sodium sulfate has been found on the surface of the P1700 polysulfone/T300 graphite leading edge exposed specimens using X-ray diffraction. The source of sulfur in this case may be the sulfur incorporated into the backbone of this polymer system.

Figure 19. FTIR spectroscopy trace for P1700 polysulfone/T300 graphite specimens

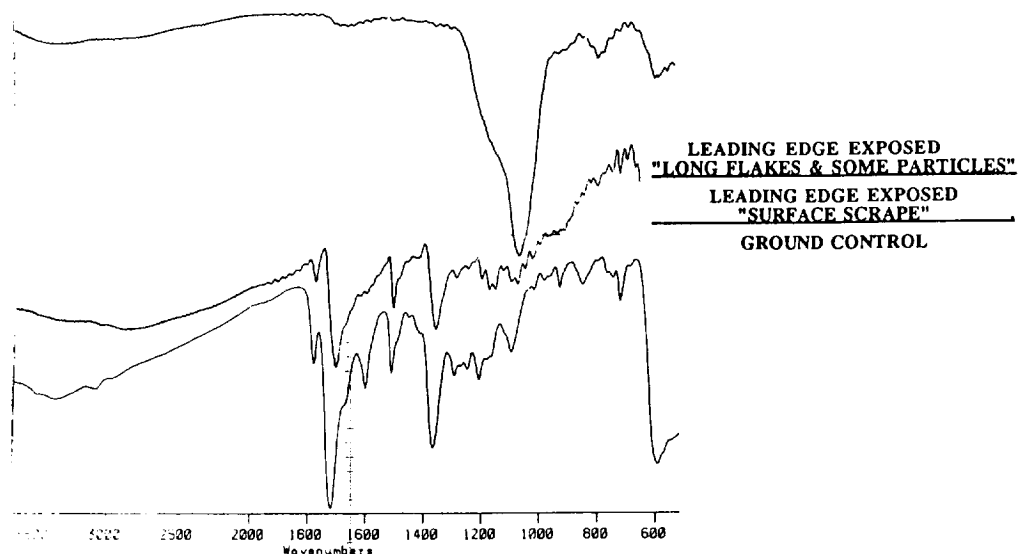
Figure 21. FTIR spectroscopy trace for LARC 160 polyimide/ graphite specimens

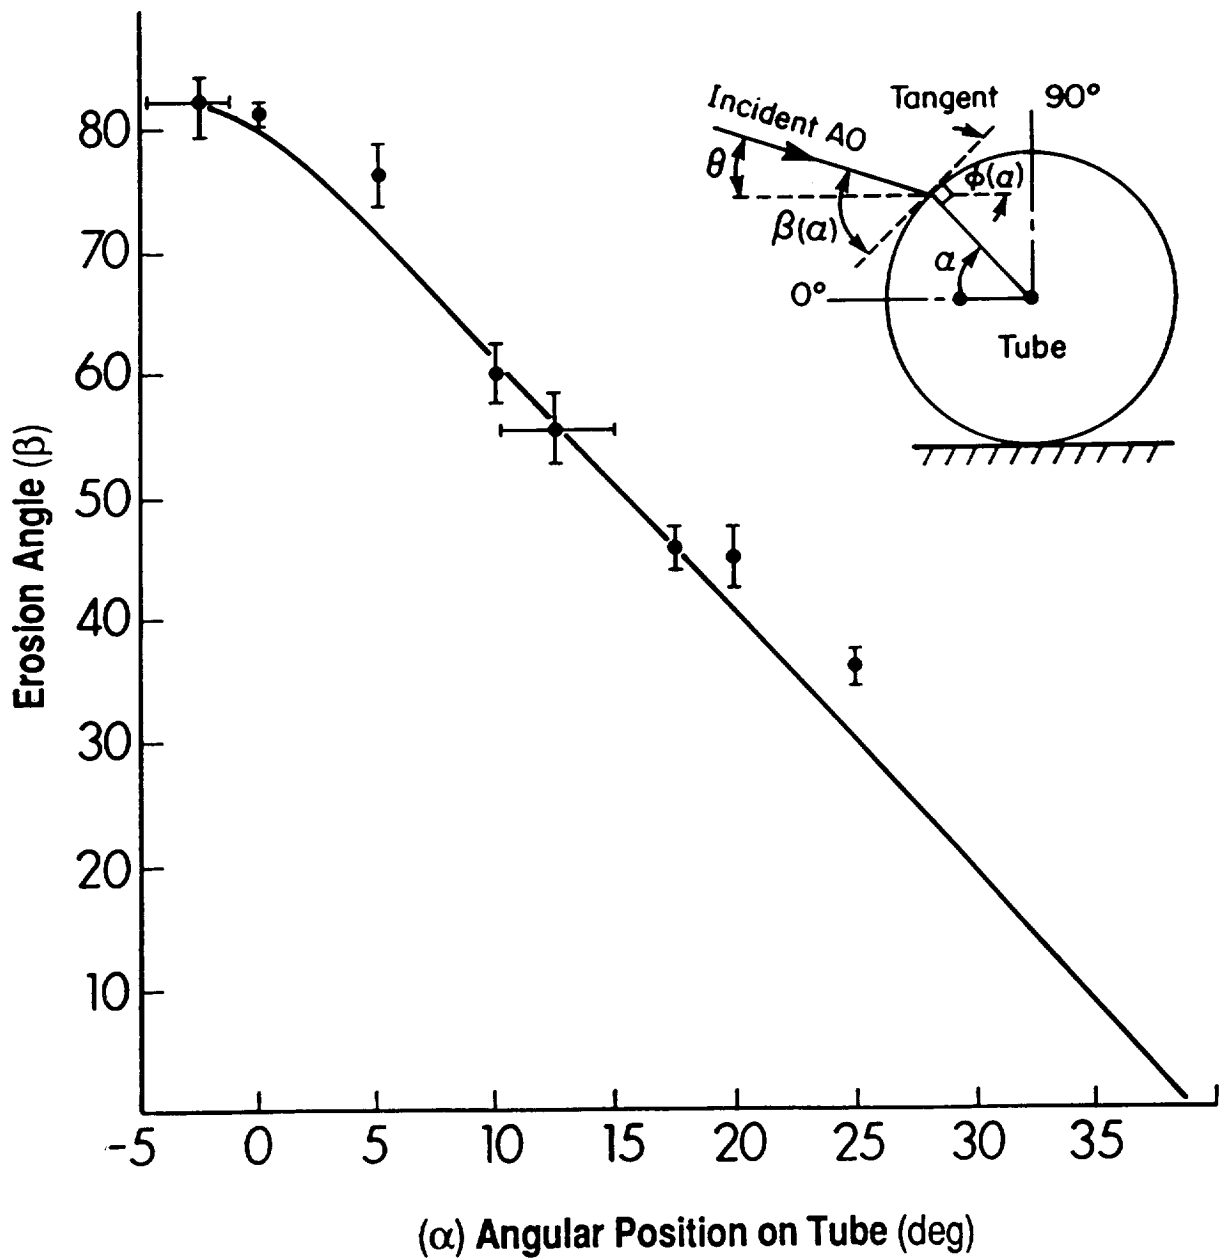
Fig. 4 Variation in Erosion Angle (β) with Angular Position (α) around Boron/Epoxy Tube [SP-290, ($\pm 45^\circ$)_{4S}]

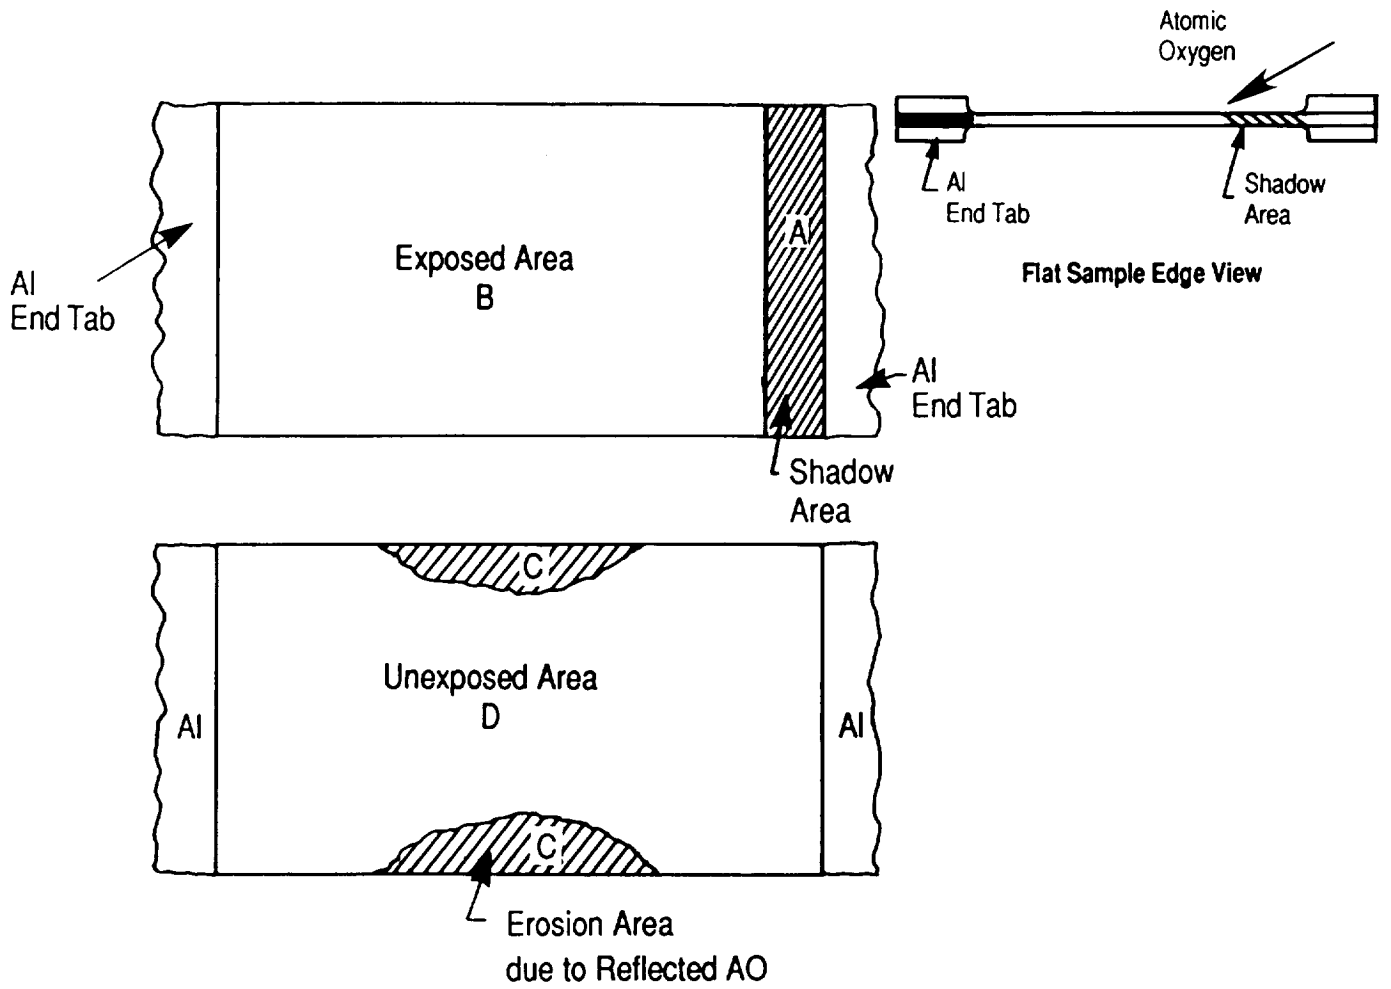
Fig. 6 Kevlar®/Epoxy (SP-328) Flat Plate Laminate

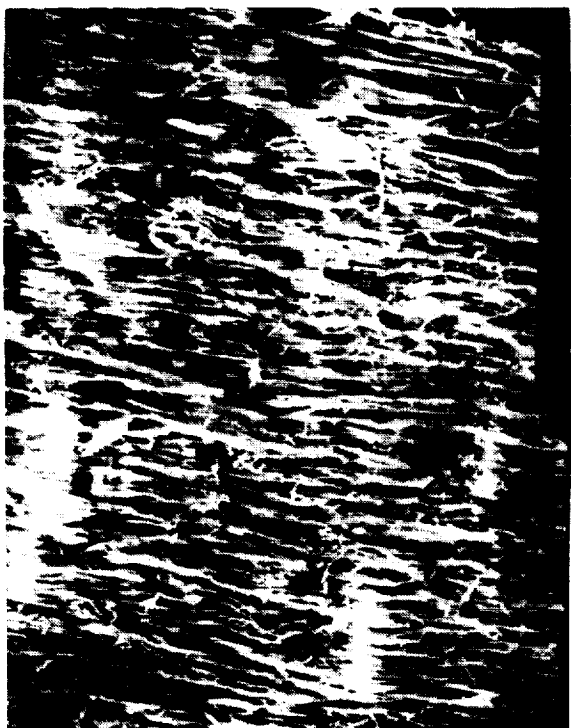
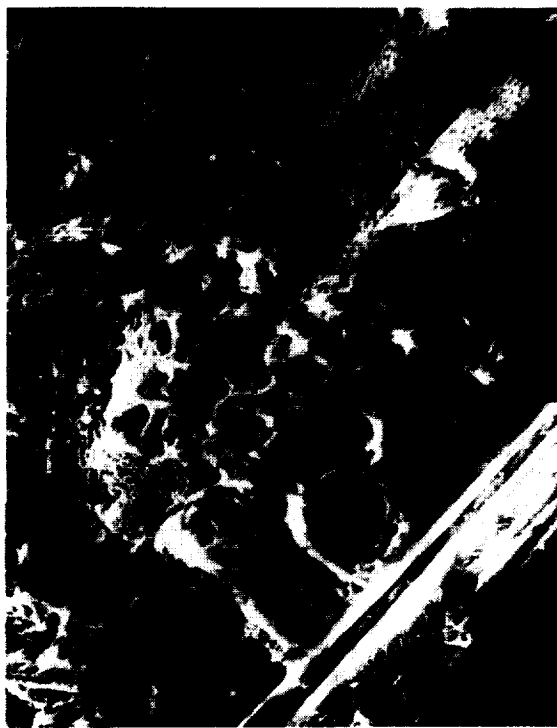
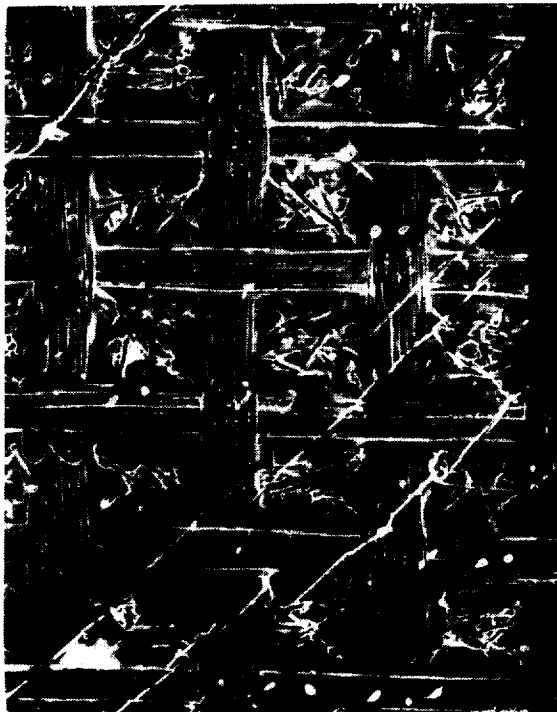
Fig. 7 SEM Photographs of Kevlar®/Epoxy Laminate [SP-328, ($\pm 43^\circ$)_{4S}]

Exposed Area B (x750)

Erosion Area C (x750)

Unexposed Area D (x50)

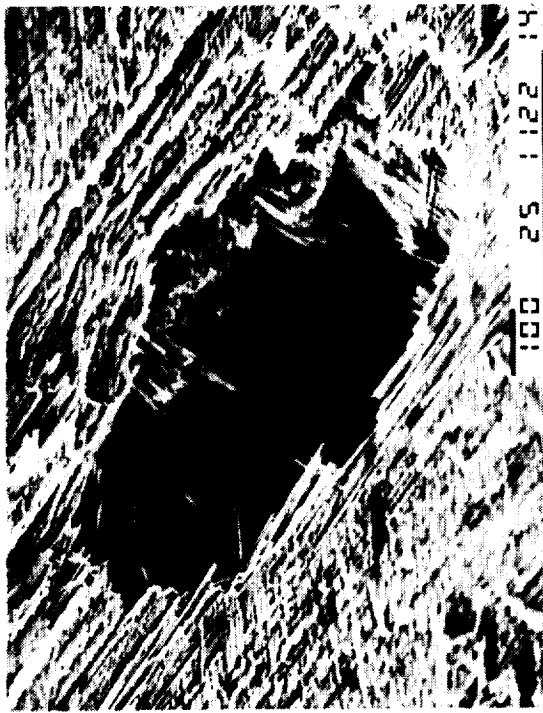
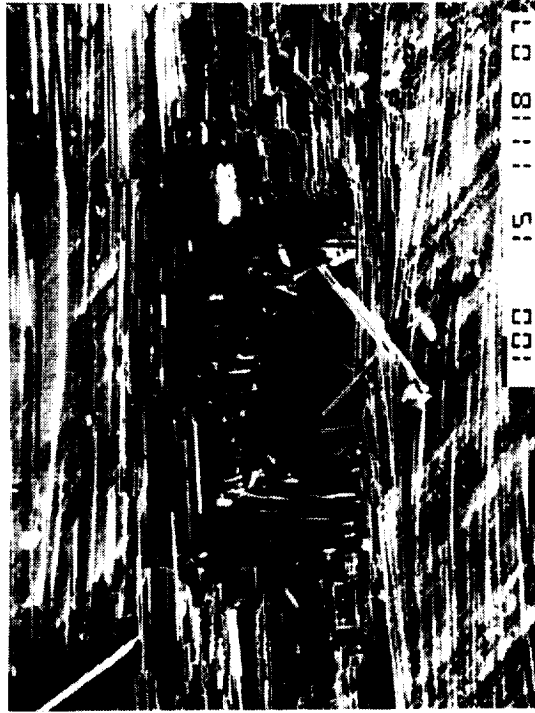
Fig. 17 SEM Photographs of Micrometeoroid/Debris Impact/Exit Holes and AO Erosion Morphology for Graphite/Epoxy Tube [SP-288/T300, ($\pm 43^\circ$)_{4S}]

Impact Hole - Exposed Surface
(x100)

Exit Hole on
Inside Tube Wall
(x75)

Micrometeoroid/debris impacts on polymer matrix composites do not produce the typical hemispherical craters found on metallic structures. Rather, because of the brittle nature of the resin matrix, one generally finds penetration holes with adjacent surface damage, some internal ply delamination and local fiber fractures. For brittle fibers such as graphite, the impact and exit holes exhibit brittle fiber fractures such as shown in Figure 17. On the other hand, tough non-brittle fibers such as aramid fail in a "brush or broom" mode surrounding the impact damage region. Figure 18 presents four impacts on a single Kevlar®/epoxy tube [SP-328, (± 45)_{4s}]. Enlargements of the damage areas are given in Figure 19 where it can be seen that three penetrations occurred with one grazing (or low energy) impact that produced only local surface damage. Note the fiber failure mode in photo 4. From the enlargements, it was possible to scan the images to calculate the surface damage area and impact hole size. Using an image enhancement backlighting technique that works well on translucent materials, one can also estimate the penetration depth of the impacting particle. Figure 20 presents the images and data obtained for these four impact sites. At this point in time, only 10 impact sites (out of 84) have been found on the composite samples, a summary of which is given in Table II with estimates of surface damage area, hole size and penetration. Such data will be useful for estimating total damage on composite structures that arises from micrometeoroids/debris.

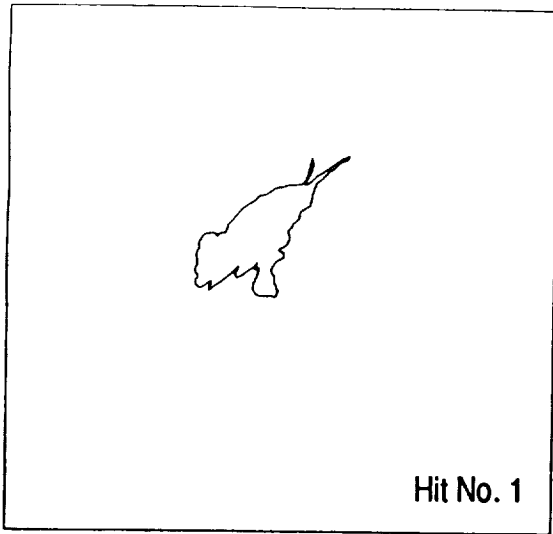
Hit No. 1

Fig. 19 Micrometeoroid/Debris Impact Damage (x100) on Kevlar®/Epoxy Tube [SP-328, $(\pm 45^\circ)_4S$]

Surface Damage Area = 0.223 mm^2
Extent of Penetration = 1 - 2 plies

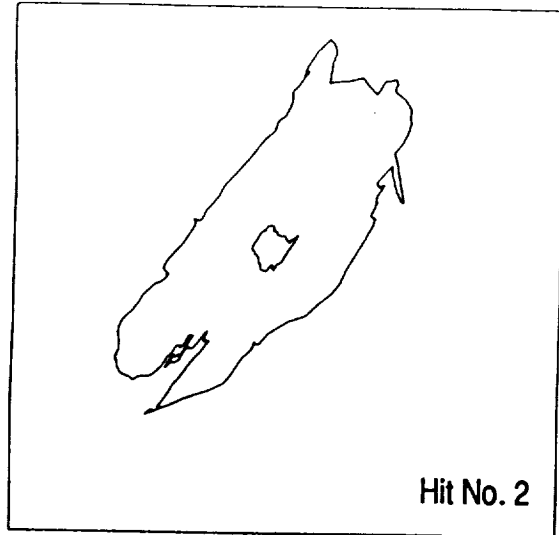
Hit No. 2

Surface Damage Area = 1.445 mm^2
Crater Area = 0.033 mm^2
Crater Diameter = 0.204 mm
Extent of Penetration = 2 - 3 plies

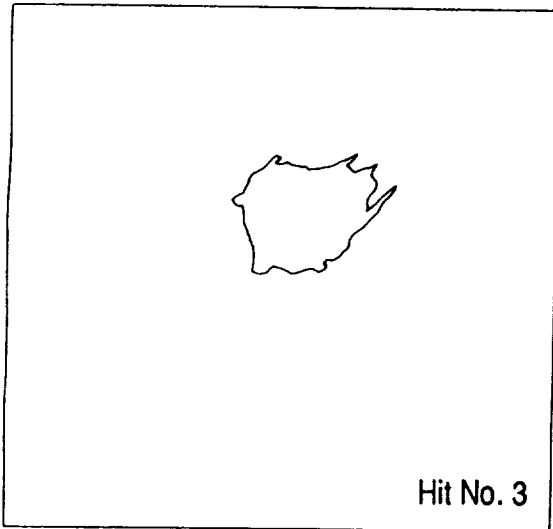
Hit No. 3

Surface Damage Area = 0.370 mm^2
Extent of Penetration = 0 - 1 plies

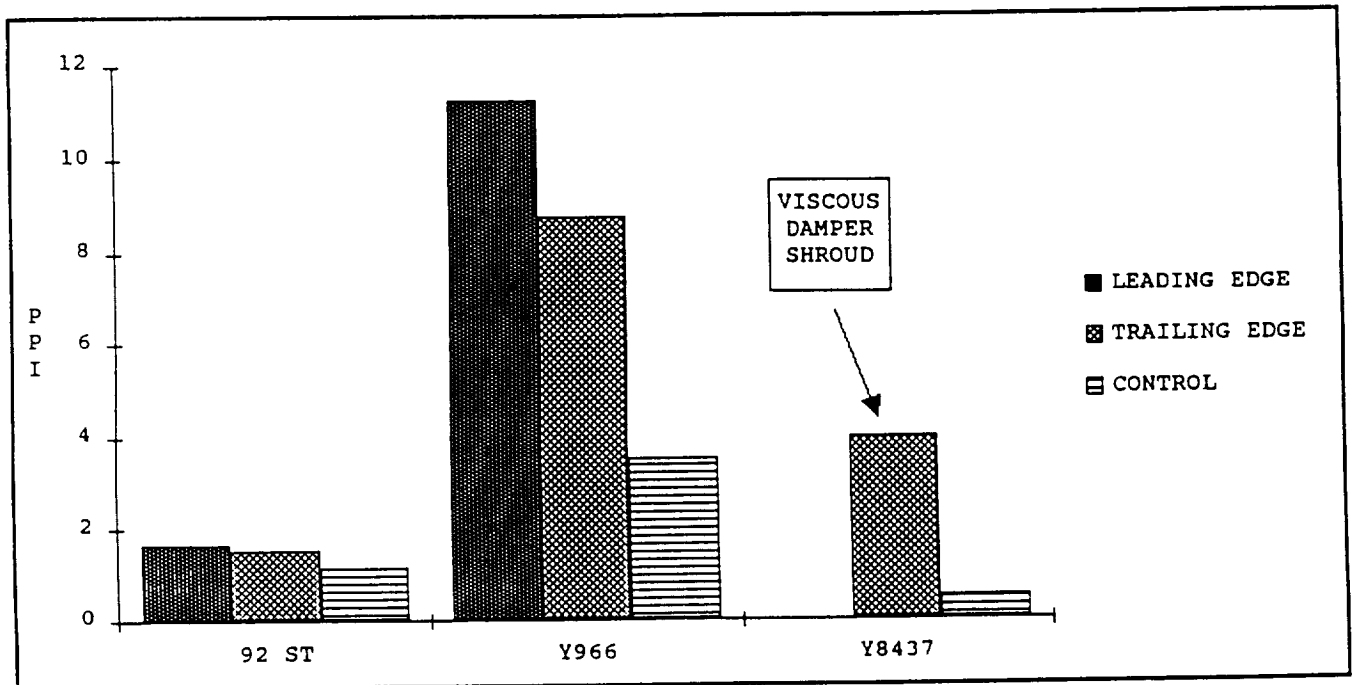
Peel Strength of 3M Tapes

3M tape 92 ST, a Kapton tape with a silicone adhesive was tested on experiment A0054, Space Plasma High Voltage Drainage. Peel strength of tape 0.787 inch wide bonded to aluminum was 1.3 pounds on a leading edge tray, 1.2 pounds on a trailing edge tray, and 0.9 pounds for a fresh, unflown tape.

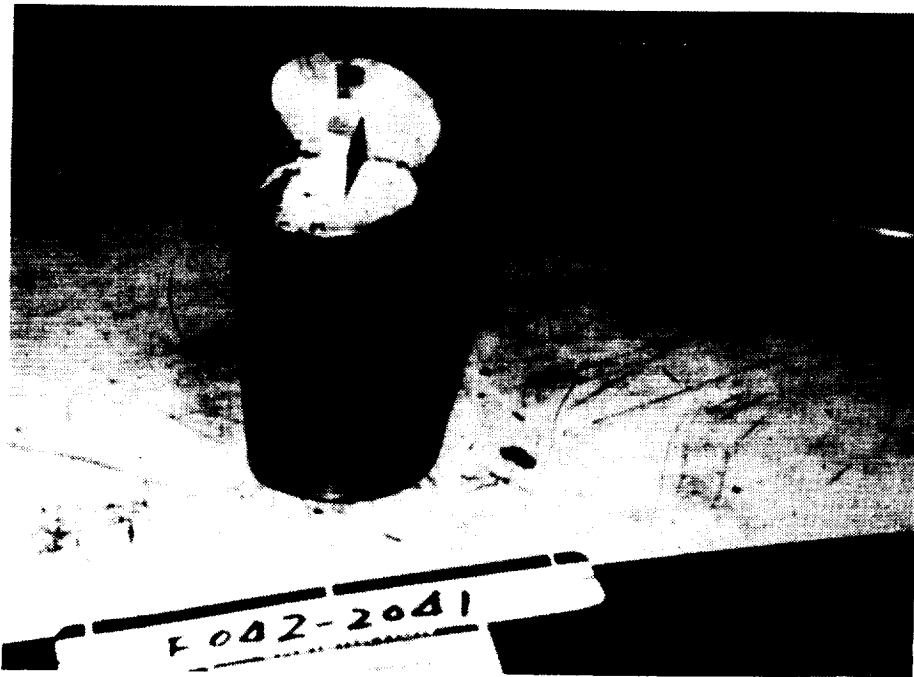
LISO₂ Cell Opened

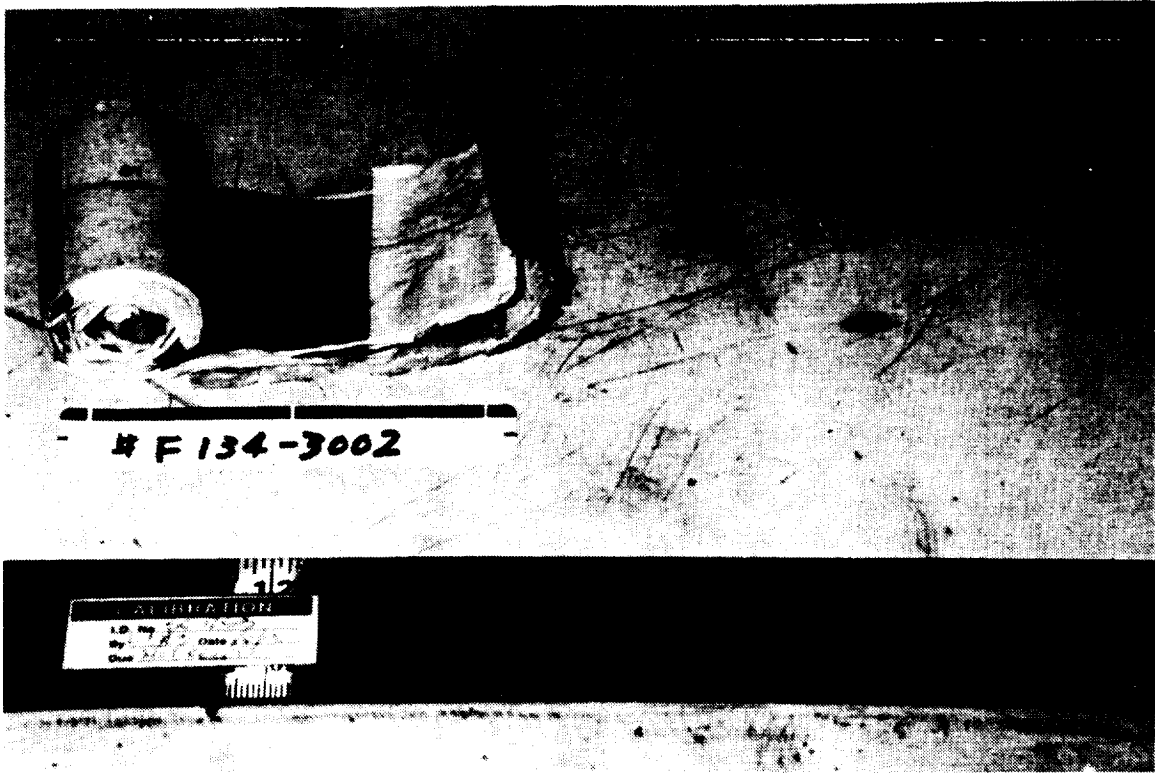
LiSO_2 Cell Electrode Materials

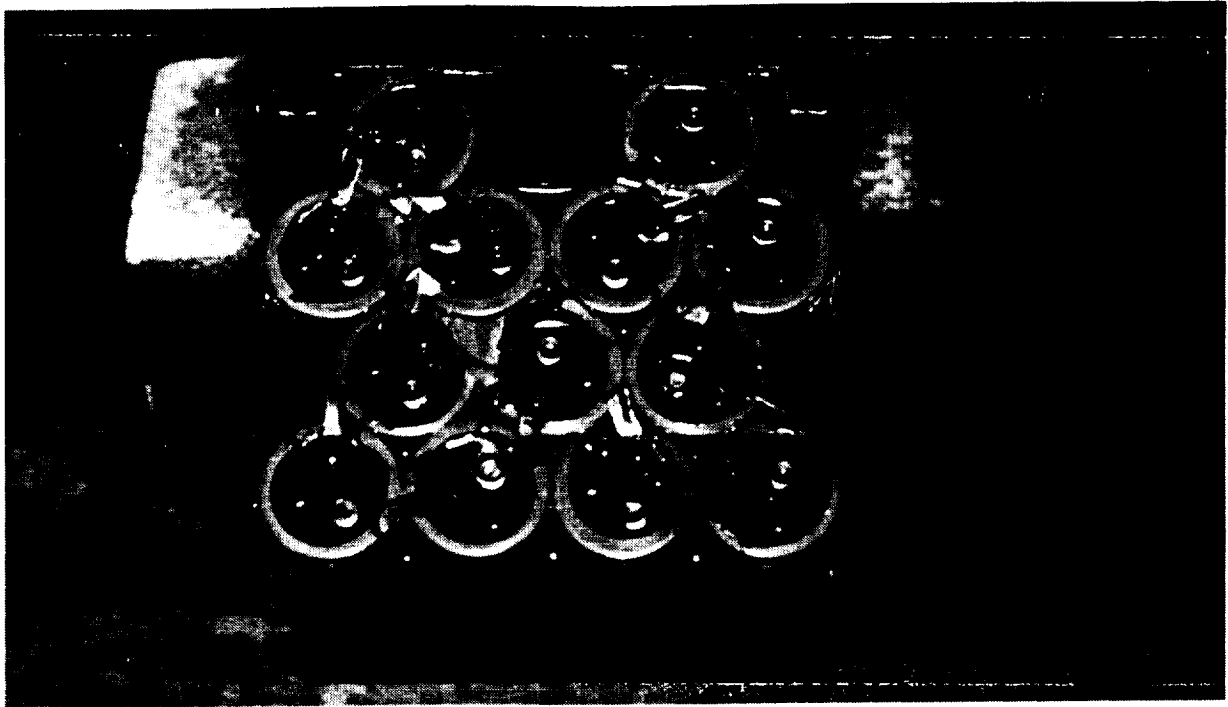
LiCF Cells Removed From Battery Case

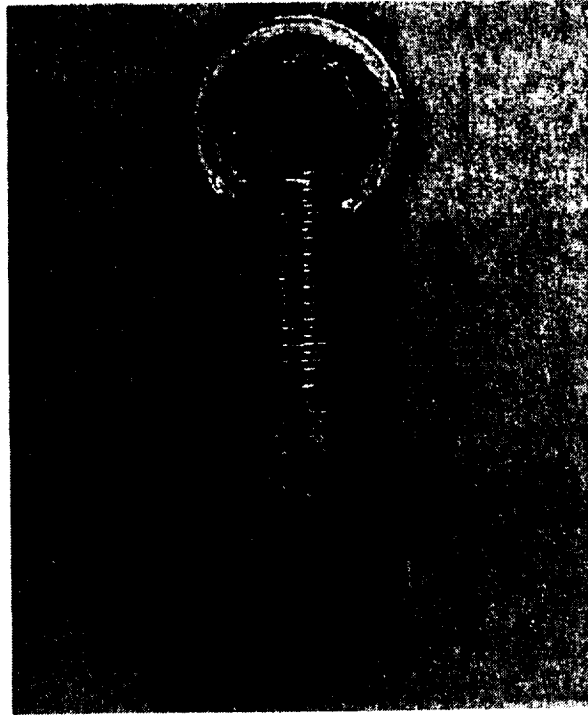
G4-6B

These two photos (fig. 8) show a typical "B1" tray clamp bolt. Both the unseating and prevailing torques were close to the average values. The condition of the bolt threads is nominal.

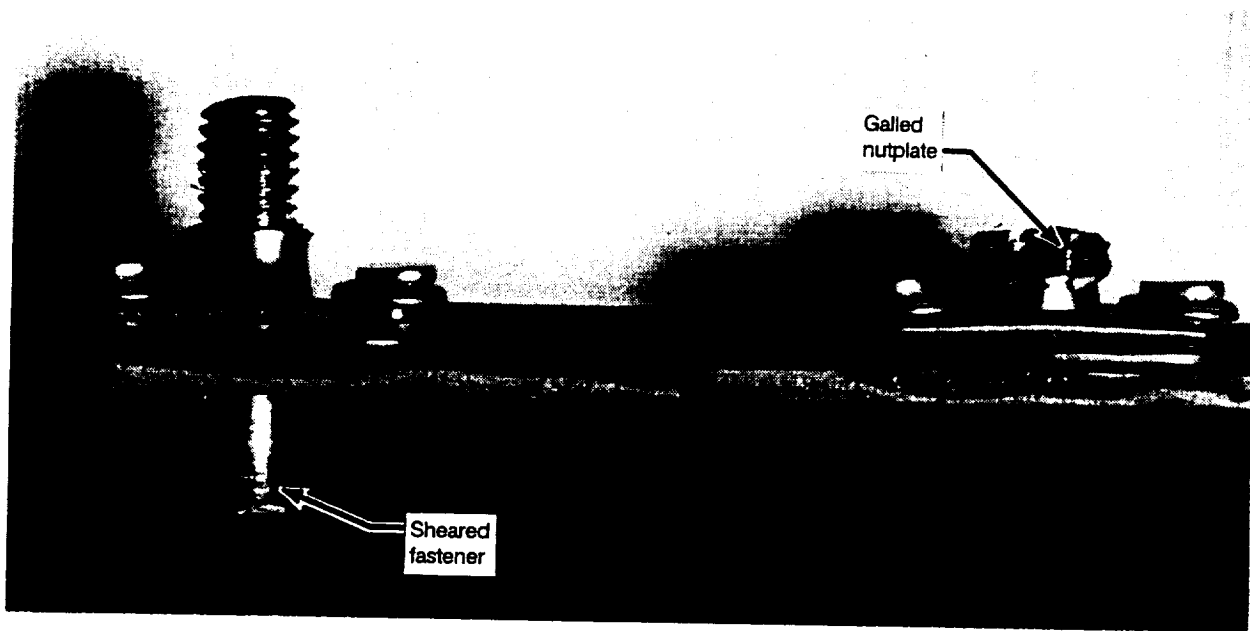
A0175 Sheared Fastener and Galled Nutplate

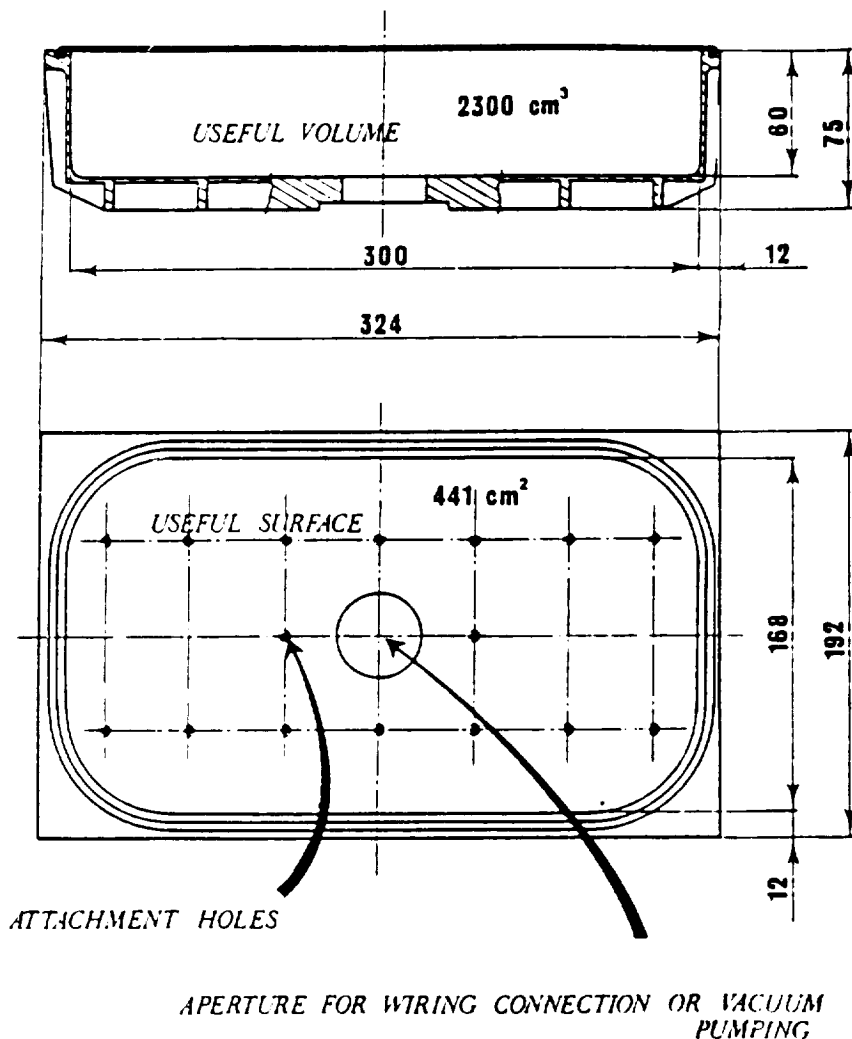
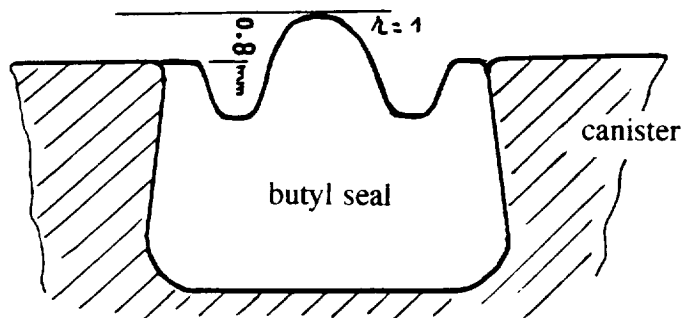
Figure 1. Canister dimensions and Butyl seal cutting out

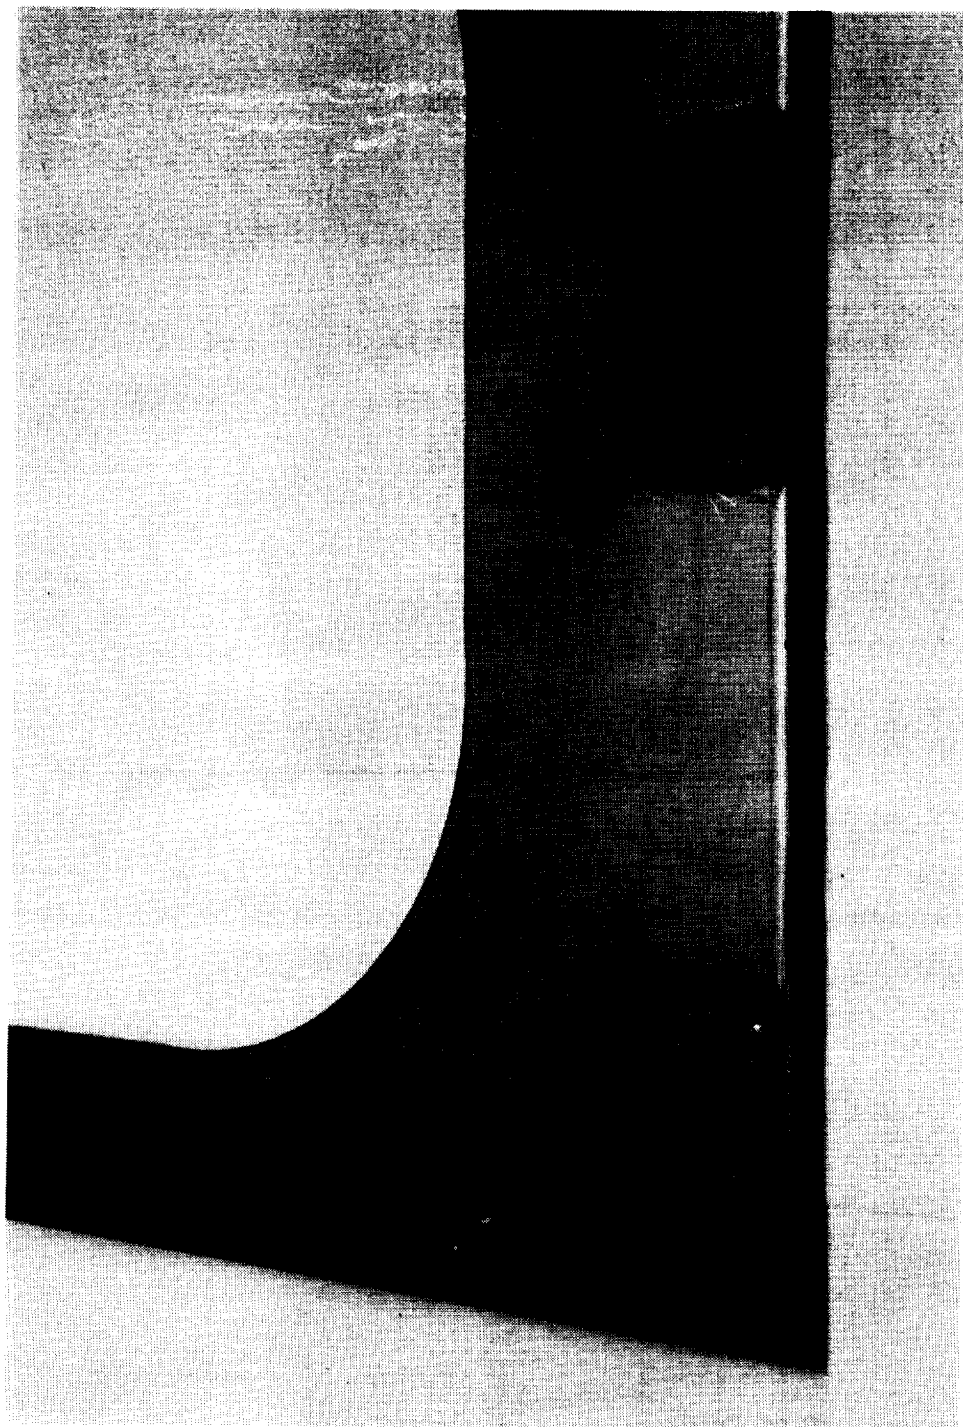
Figure 2. Velcro color change and glue trace
on rigid shield

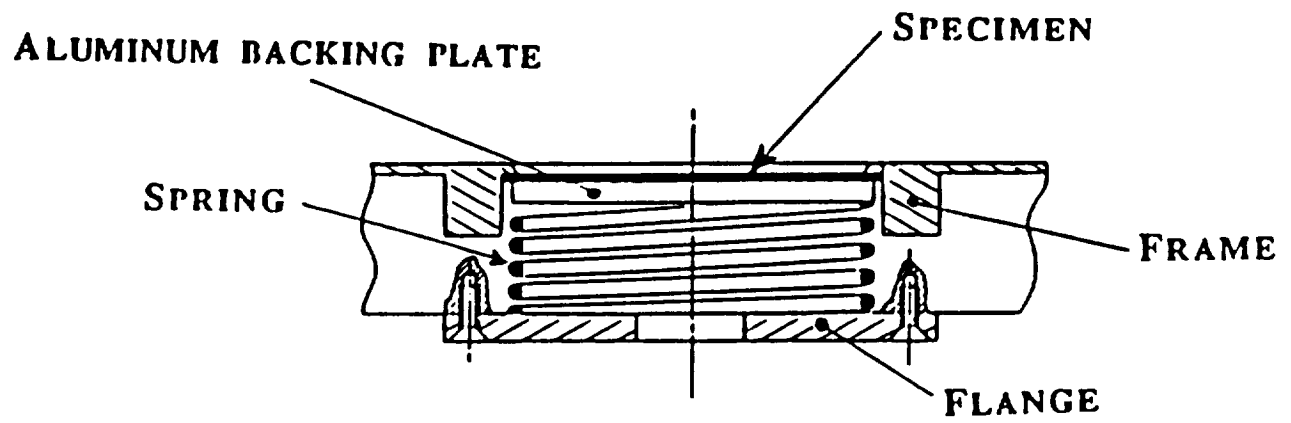
Figure 7. Steel spring and aluminum plate configurations
