# Results from the Testing and Analysis of LDEF Batteries

**Steve Spear  
Harry Dursch  
Chris Johnson**

**Boeing Aerospace**

## Results from Testing and Analysis of LDEF Batteries

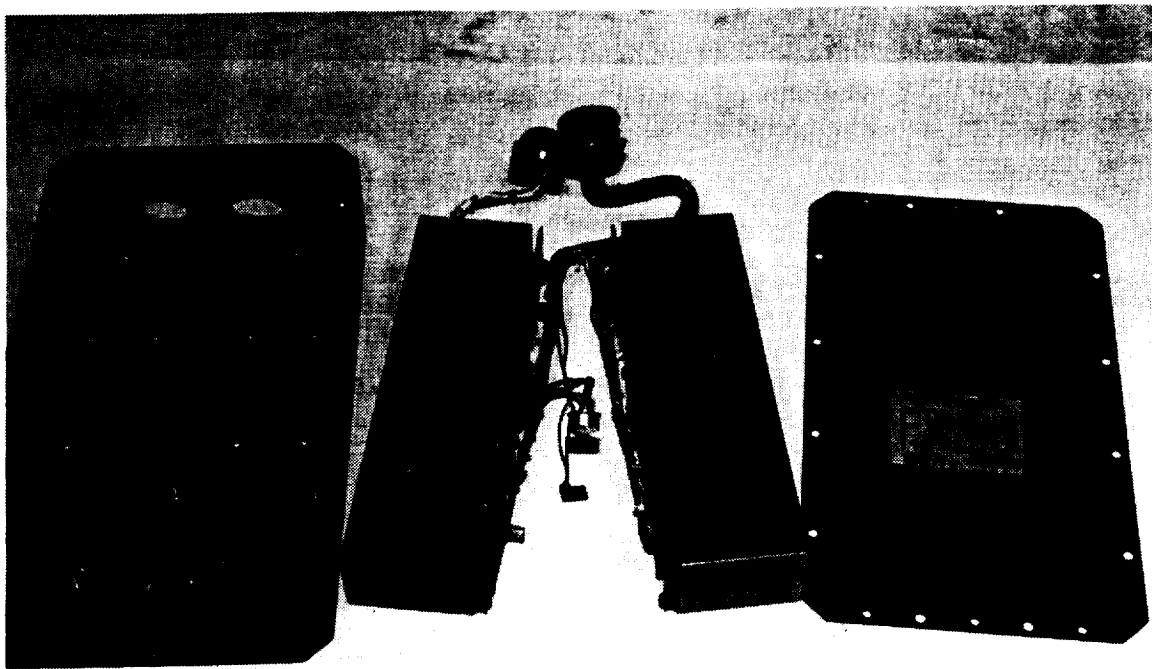
The following four figures show representative photographs of the LiSO<sub>2</sub> battery disassemblies performed at SAFT. This figure shows both a LiSO<sub>2</sub> battery case disassembled and a close up of a LiSO<sub>2</sub> cell block.

*LiSO<sub>2</sub> Battery Case Disassembled*

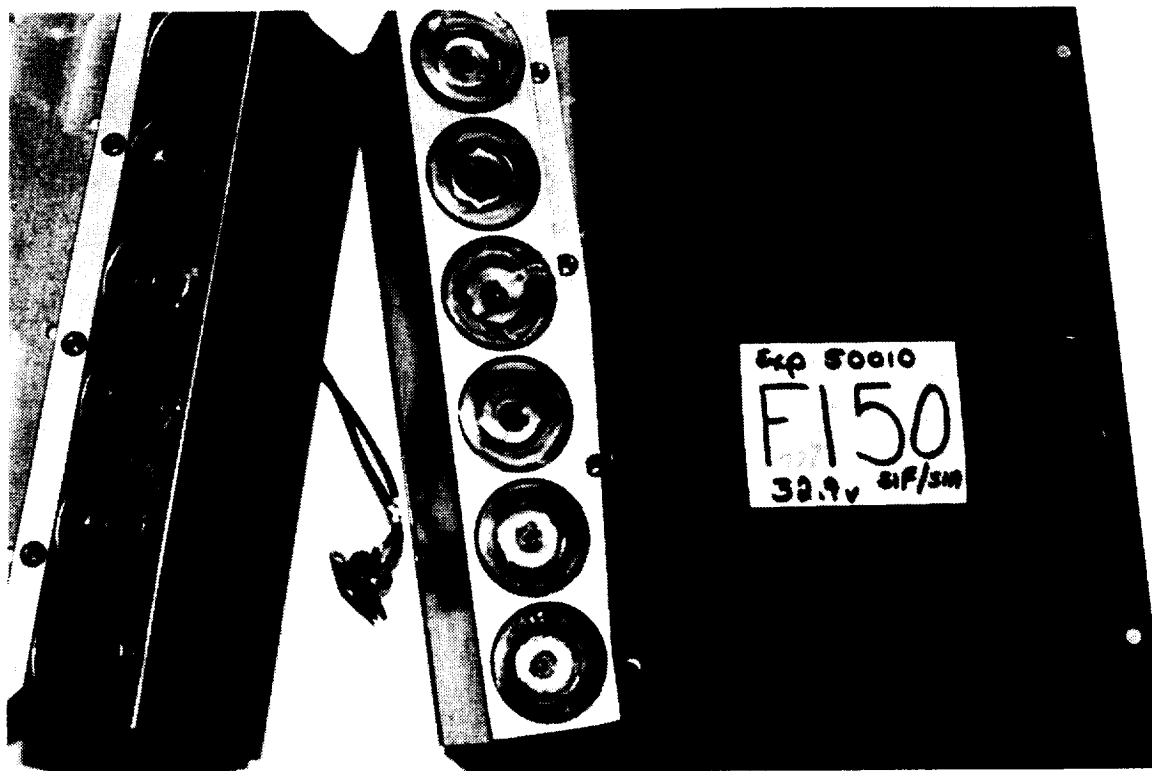
*Closeup of LiSO<sub>2</sub> Cell Block*

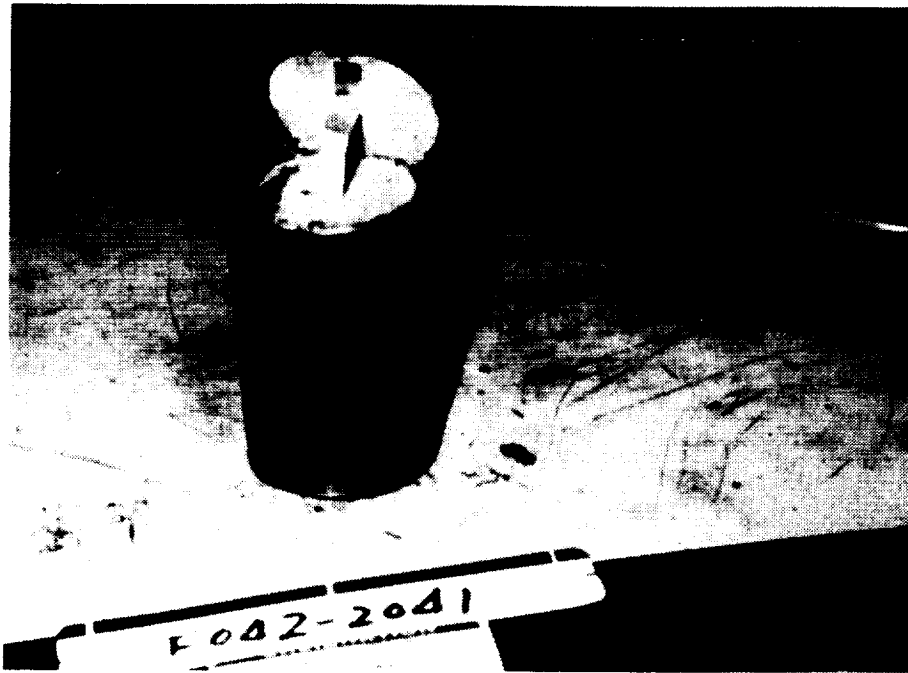
This figure shows a LiSO<sub>2</sub> cell opened and a close up of the corrosion around the glass to metal seal. The corrosion around the seal was expected and was also found on the control batteries.

*LiSO<sub>2</sub> Cell Opened*

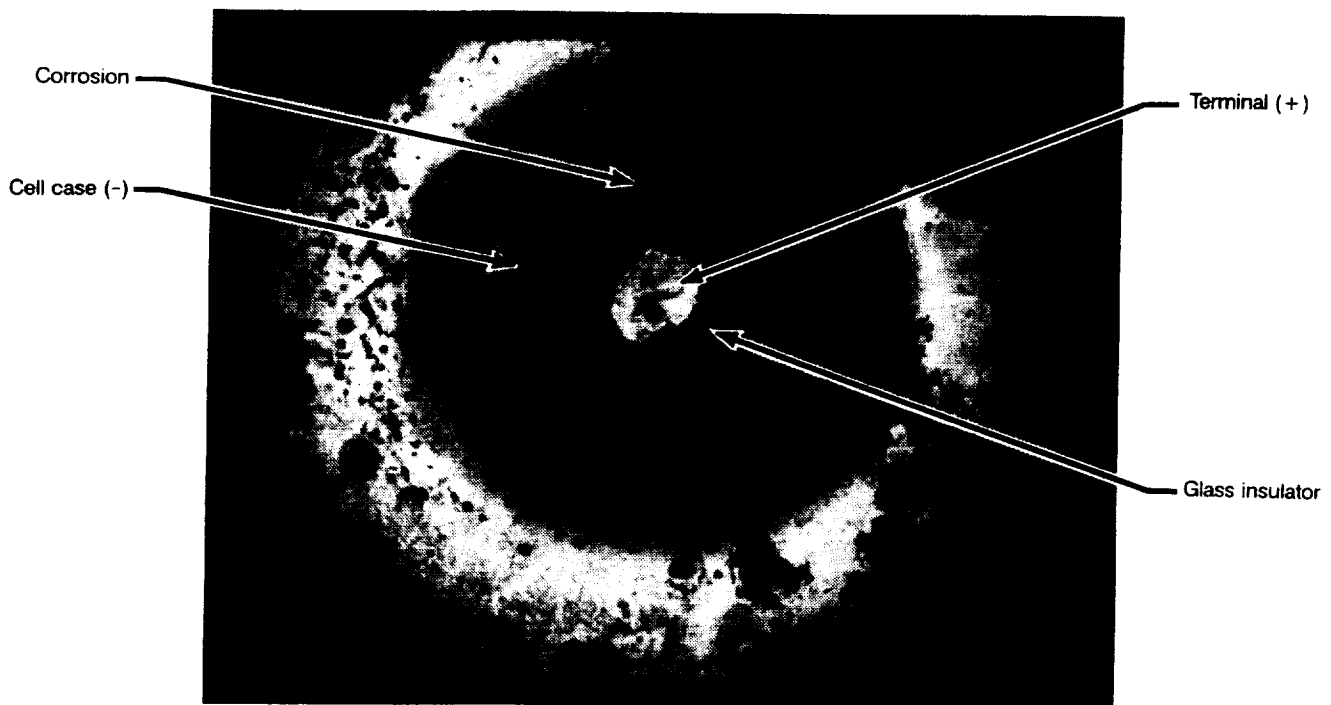
*Closeup of Glass to Metal Seal*

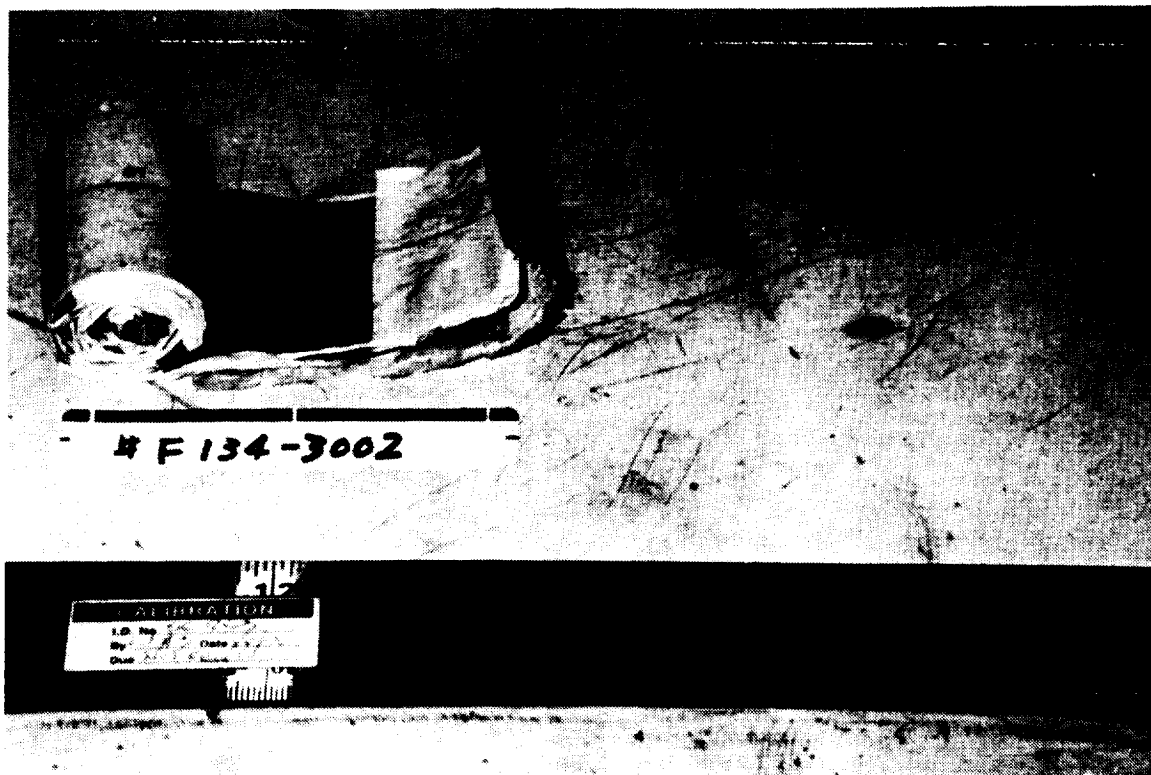
Shown is the condition of the lithium anode and the carbon cathode from a control battery. Note the good condition of the lithium strip.

*LiSO<sub>2</sub> Cell Electrode Materials*

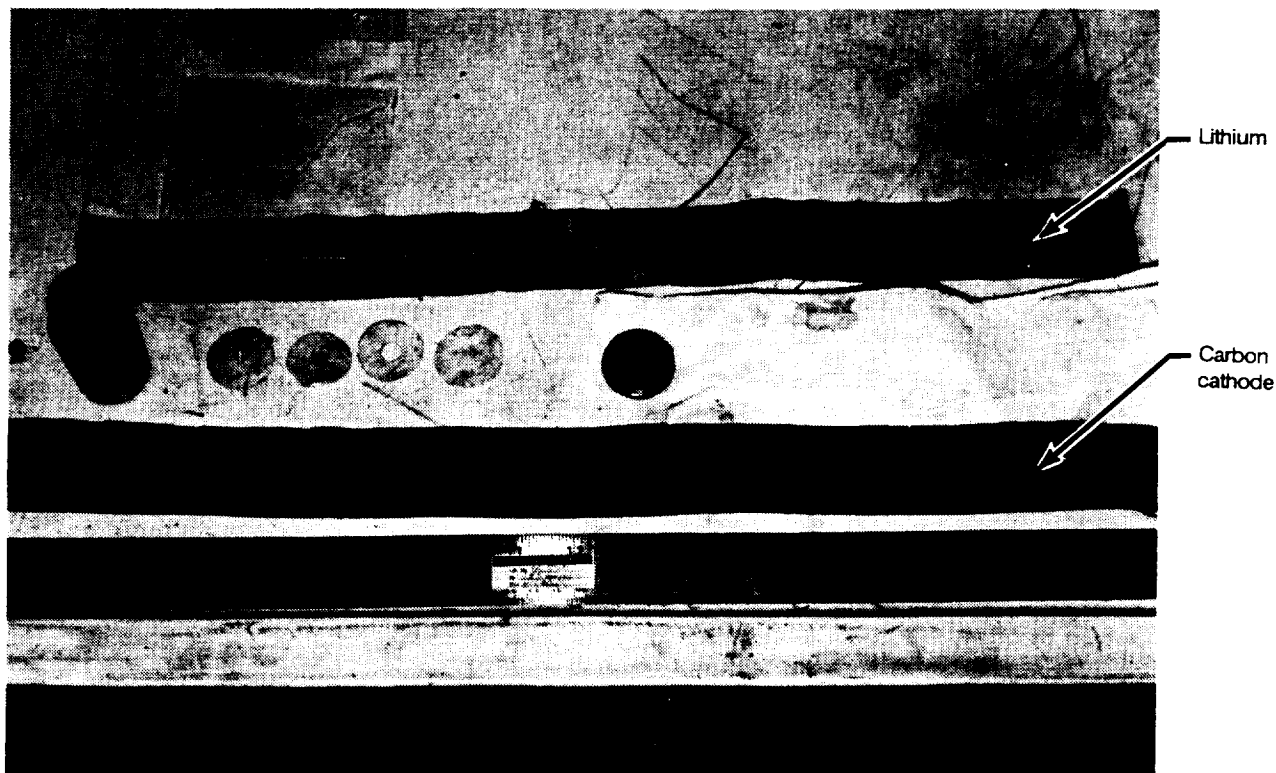
*LiSO<sub>2</sub> Cell Components - Control Cell*

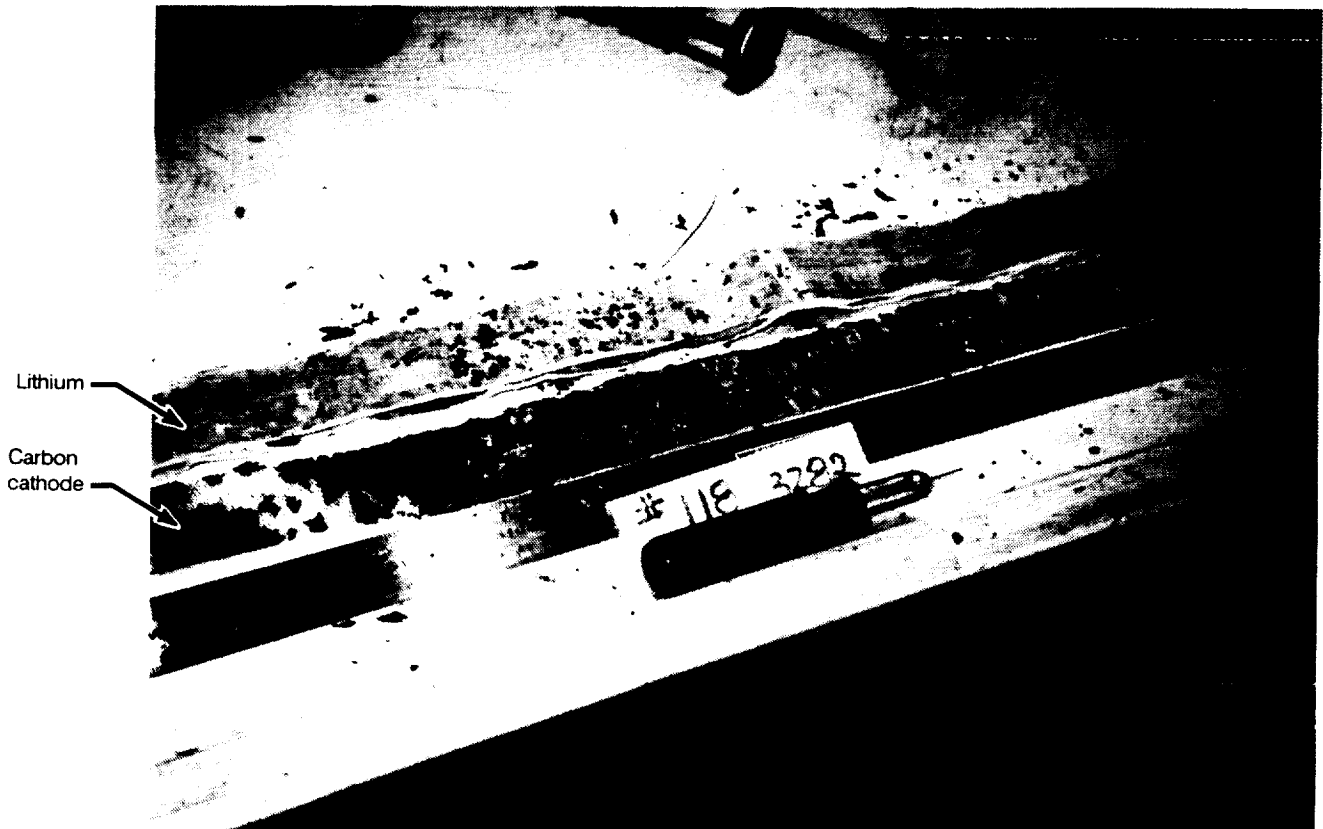
This photo shows the lithium and carbon from a flight battery that was at a 35% state of charge. Note the absence of lithium.

*$\text{LiSO}_2$  Cell Components – Flight Battery With a 35% State of Charge*

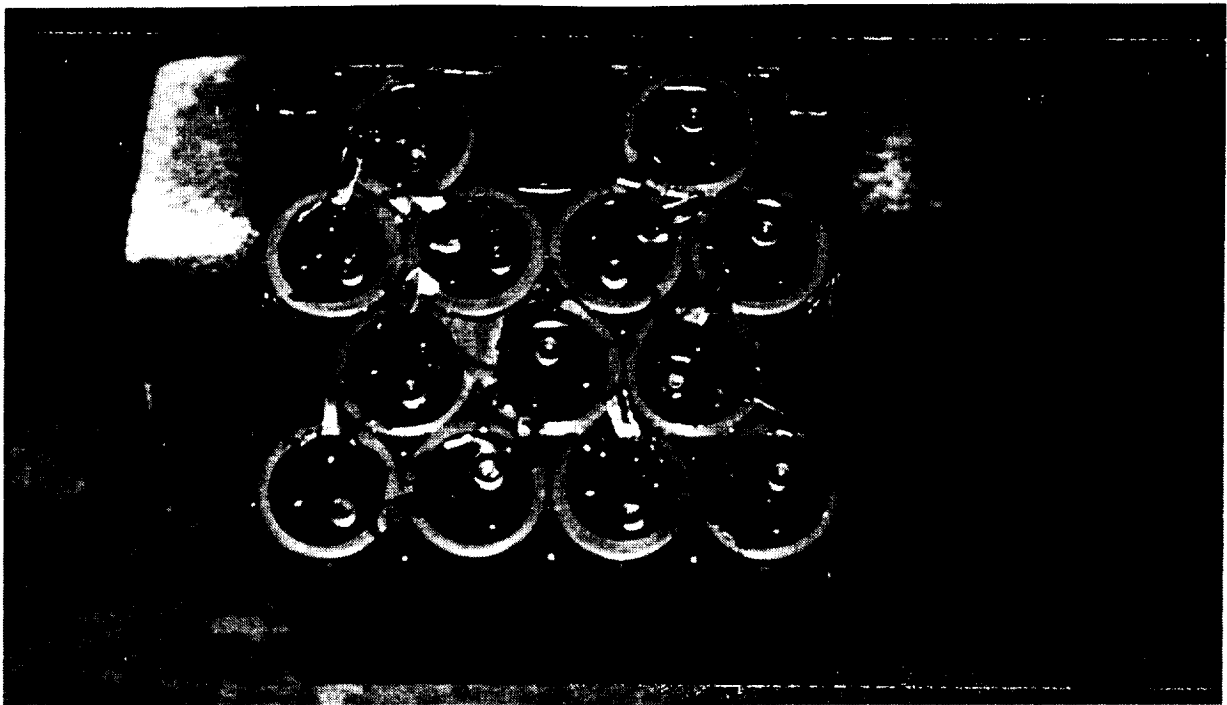
All ten LiCF batteries possessed a strong odor, first noticed during the deintegration of S0069 and S1005 at MSFC. The electrolyte used in the Eagle-Picher Industries LiCF batteries is dimethyl sulfite, which contains small amounts of other sulfur compounds that can be quite odorous. AZ Technology investigated the cause and effect of the leaked electrolyte vapors from the ethylene propylene battery containment case. The presence of the odor was determined to be the normal byproduct of the discharge process. The LiCF cell is designed with an expansion diaphragm on the top of the cell with a sharp, rigid protrusion adjacent to the diaphragm. This photo shows a LiCF battery (made up of 13 individual cells) removed from the battery case. The diaphragm expanded during the slow discharge process when internal cell pressure increased. Eventually the diaphragm was punctured, releasing the electrolyte vapors. The cells were sealed in battery boxes. The O-ring seal experienced softening and deformation due to the extended exposure to the electrolyte vapors which allowed the vapors to leak from the battery box. However, this created no performance problem for the battery or associated experiment hardware. It is important to note that the ground-stored LiCF batteries experienced the same phenomena.

*LiCF Cells Removed From Battery Case*

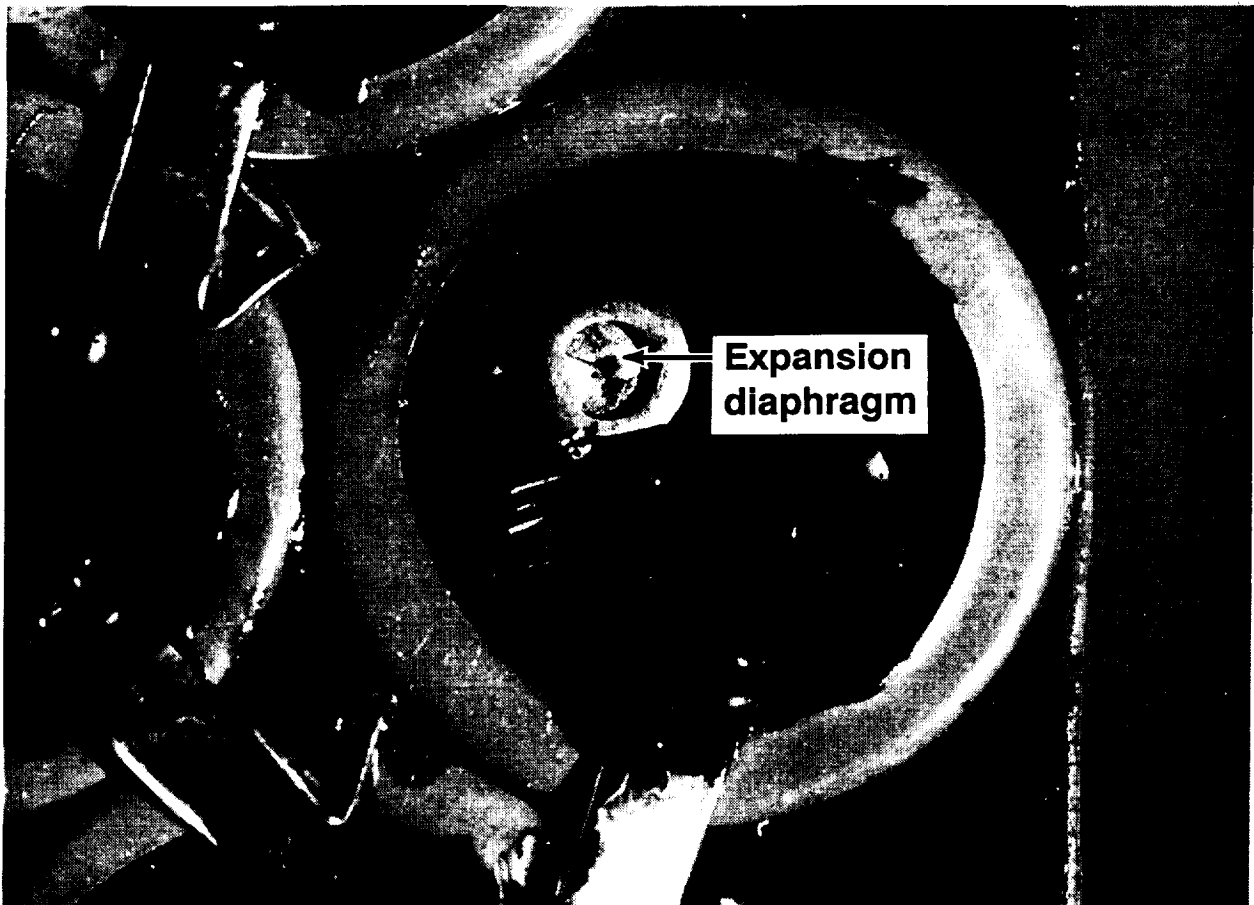
The cells were roughly double D size having vented construction with a rated capacity of 25 Ah and a nominal voltage of 3 volts. The cells were potted in a plastic block and hermetically sealed with a "can opener" vent for relief of cell over-pressure.

*LiCF Cell*

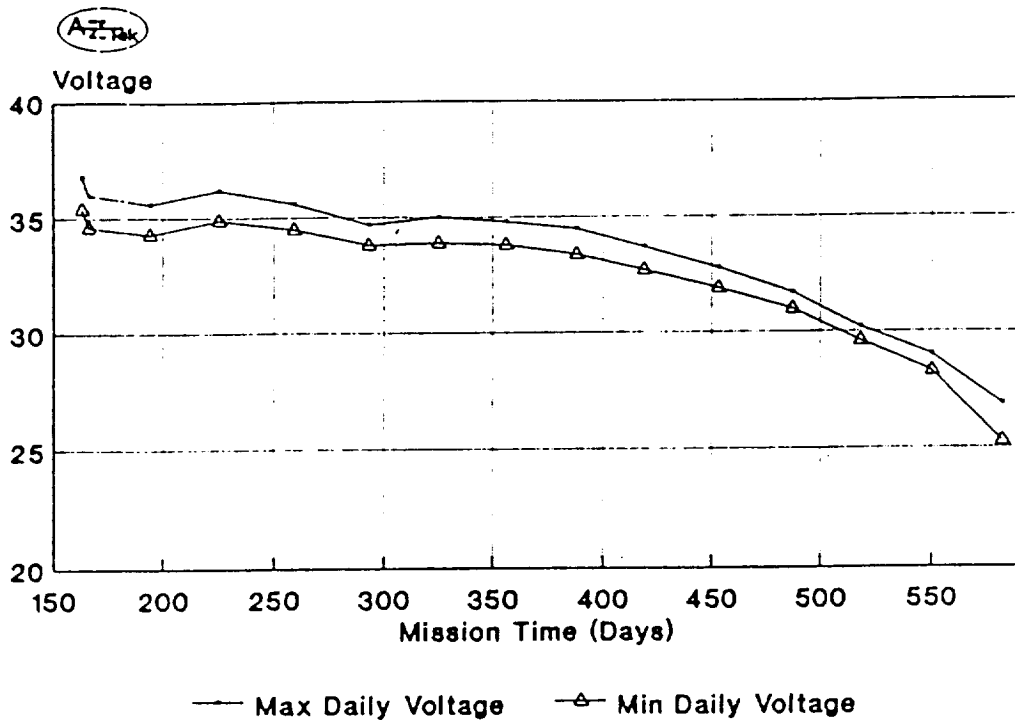
**LICF Voltage Versus Time On-orbit**

This figure, provided by AZ Technology, shows the gradual degradation of battery voltage versus time for one of the four batteries used on S0069.

**Gradual Degradation of Voltage with Flight Duration**

12 Month Mission - Achieved

12 to 18 Month Expected Life - Achieved

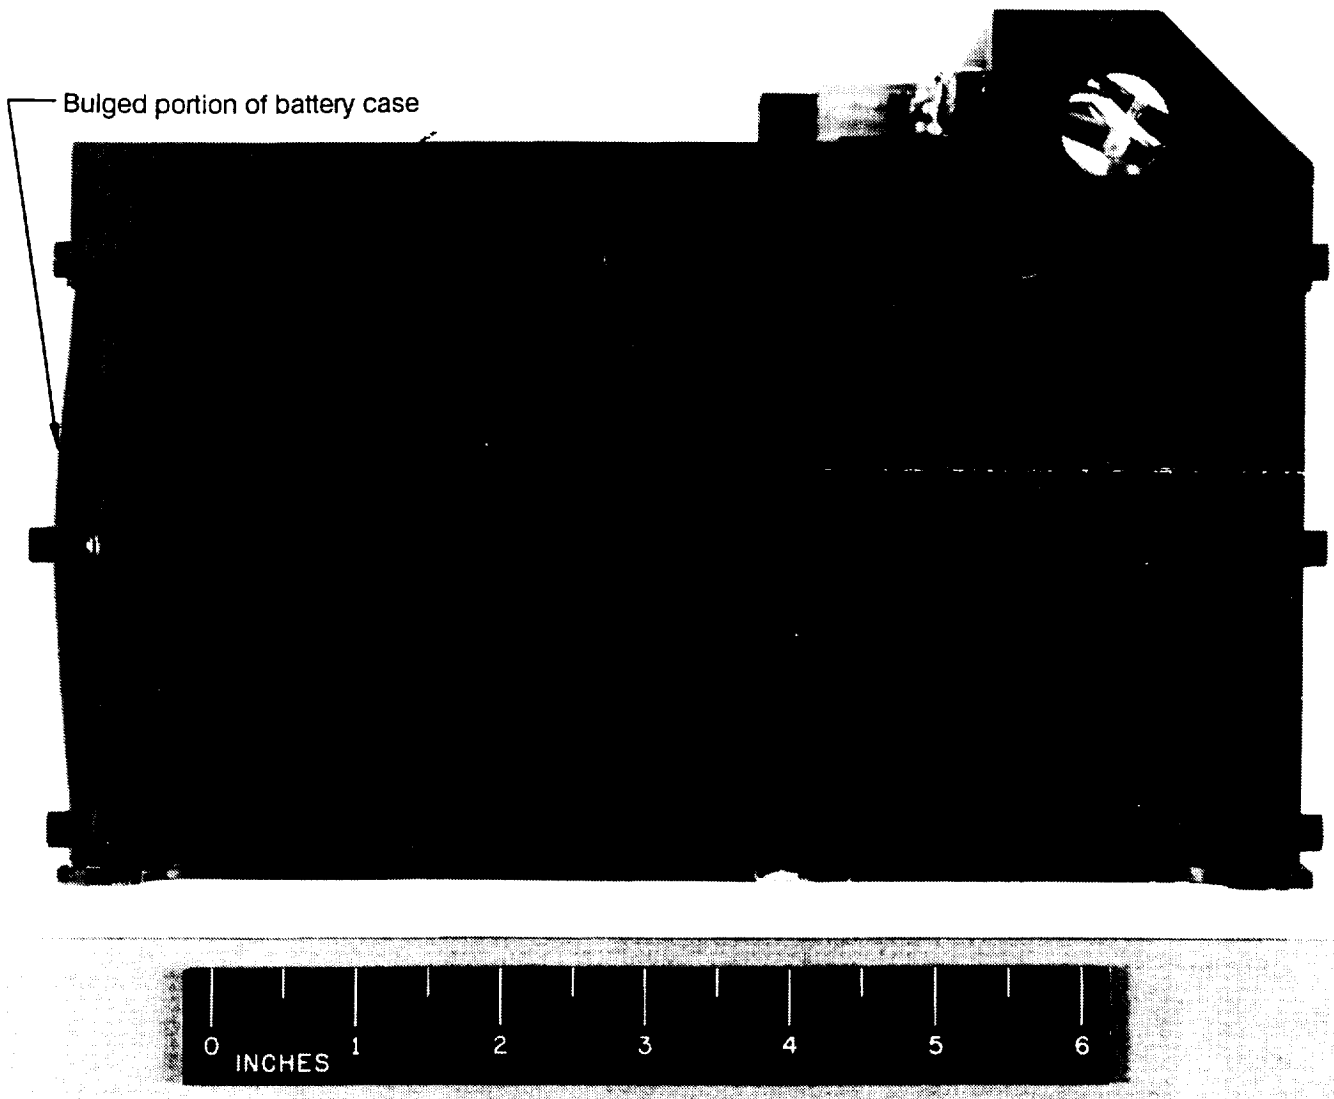
One NiCd battery manufactured by General Electric was flown on the Low Temperature Heat Pipe Experiment (Experiment S1001). This battery was continuously charged by a four arrays of solar cells which were located on the space end of LDEF. Analysis and testing of the battery was performed by S. Tiller and D. Sullivan of NASA GSFC. The battery consisted of 18 cells, which were mounted on an aluminum baseplate. Pre-flight power analysis for the 12 Ah NiCd battery indicated a need for 2 to 3 amp discharge. However, reduction in the experiment current requirements during flight resulted in much lower power demand. This led to an overcharging situation that caused the development of internal pressure, resulting in the bulging of the cell case. This bulging is especially noticeable on one end of the cell pack, as shown in this figure.

LDEF/HEPP  
POWER SYSTEM BATTERY  
(12-AH NiCd)

Bulged portion of battery case

*Bulging of NiCd Battery Case*

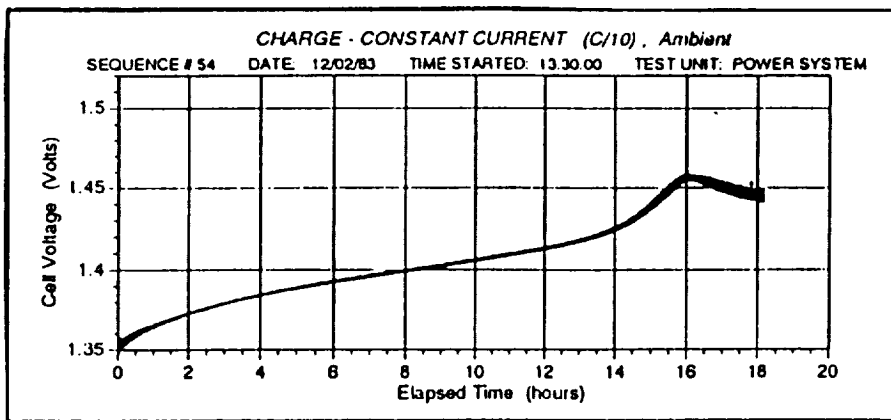
The loss of overcharge protection is obvious from the difference in voltage performance shown for the pre-flight and post-flight measurements of cells on constant current, as shown in this figure. Pre-flight charge profile showed all cells were matched and reached full state of charge in 18 hours, while maintaining voltage below 1.46 volts. Post-flight data showed considerable differences between cells with cell #10 (this cell bulged the most during the mission) reaching a high voltage of 1.52 volts which tripped the charge for the battery off at 14 hours of charge. Discharge testing produced similar results.

### Constant Current Charge Indicates Loss of Overcharge Protection

Pre-flight Capacity Charge

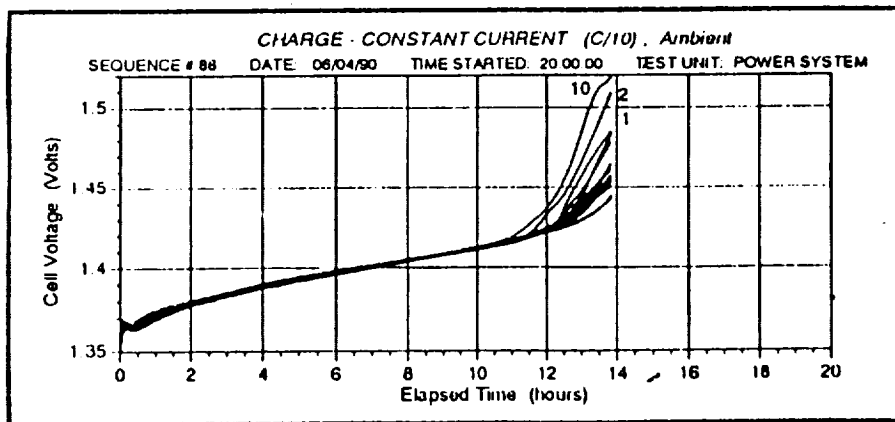
Despite the obvious bulging of some cells, loss of overcharge protection, and failure of cell #10 during the open circuit recovery test, the battery still had the capability to provide output current in excess of the cell manufacturer's rated capacity of 12 Ah.

Post-flight Capacity Charge showing loss of overcharge protection
