NASA Conference Publication 3162  
Part 1

# LDEF Materials Workshop '91

Proceedings of a workshop held at  
H. J. E. Reid Conference Center  
NASA Langley Research Center  
November 19-22, 1991

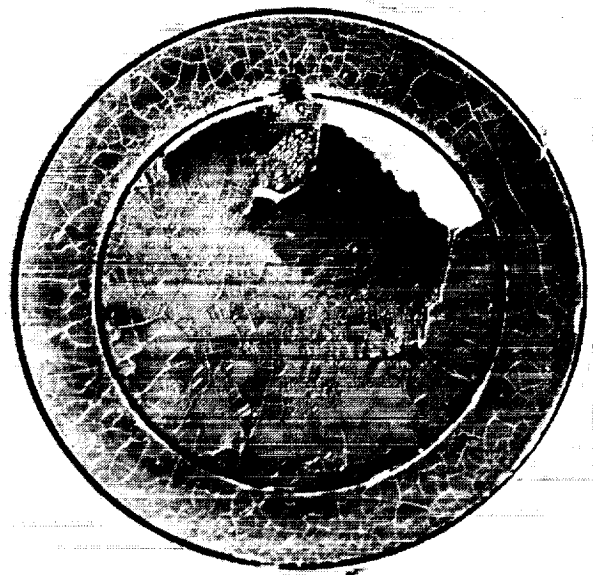
A276/RTV670

A276/OI650

Figure 9. Photographs of Overcoated A276 Samples.

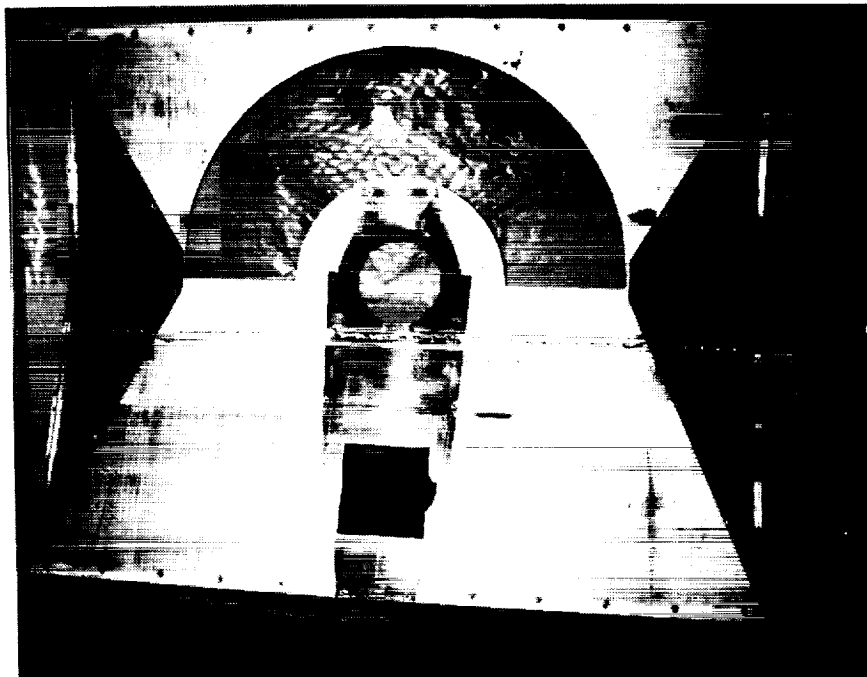
Figure 18. TCSE Front Cover.

The front cover of the TCSE was covered with 2 mil silver Teflon and suffered significant degradation. This photograph shows the front cover. This cover is aluminum with the pre-adhesive silver Teflon film applied to it. The specular undamaged areas on the left and right sides and in the middle were protected by secondary covers. The streaky discoloration was caused by a cracking of the silver/inconel backing on the Teflon and the subsequent migration of components of the Y966 adhesive through the cracks into the silver and Teflon interface. This contaminant was then degraded to a dark brown by solar UV exposure. This cracking was caused by the application of the pre-adhesived silver Teflon including the removal of the paper backing and the working of the surface to remove air bubbles.

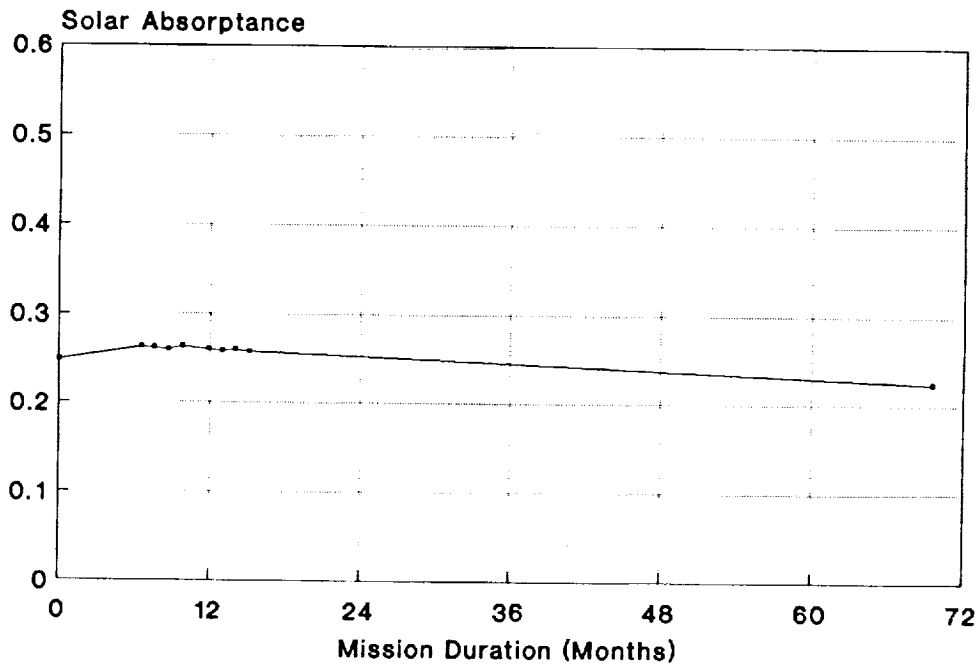
White Tedlar is another material that was expected to degrade over the 5.8 year LDEF mission due to solar UV exposure. Instead, the reflectance properties of this material improved slightly, as shown in Figures 25 and 26. The surface remained diffuse and white, similar to pre-flight observations. As with A276, Tedlar has been shown to be susceptible to AO erosion. The erosion effect of AO is the apparent reason for the lack of optical degradation of these flight samples.

Figure 25. Reflectance Data for White Tedlar.

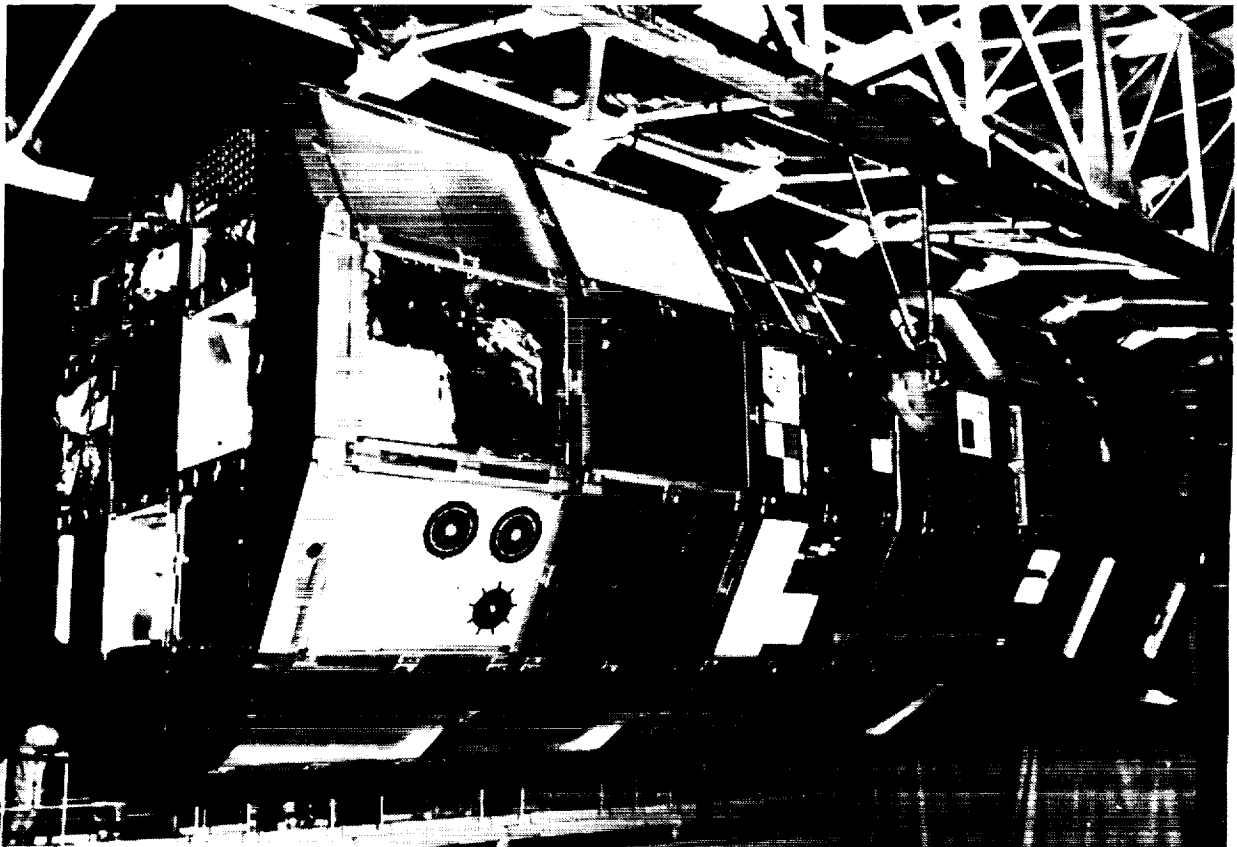
Figure 1. LDEF in Orbital Processing Facility

The photograph in figure 1 shows the extensive damage done to some of the experiments on the leading edge side and the space end of the vehicle. The M0003 experiment is located near the center of the vehicle at the scuff plate.

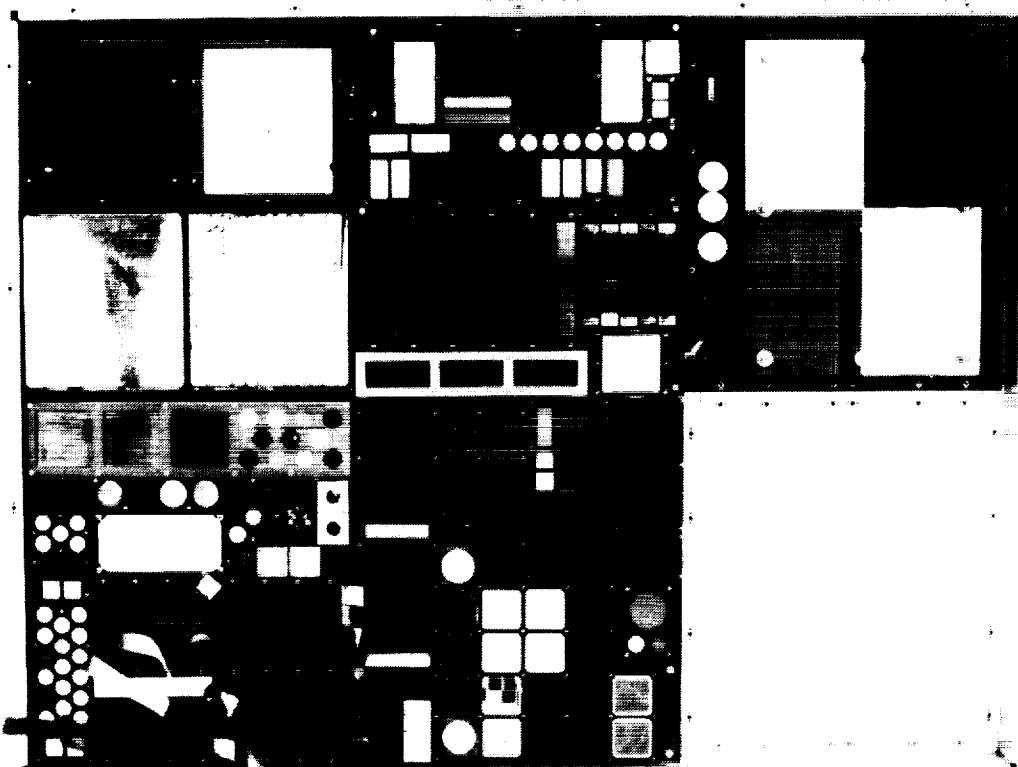
Figure 4. M0003 Post Flight Leading Edge Tray

A photograph of the recovered M0003 leading edge tray originally located in the D9 position is shown in figure 4. Among the various areas of visible damage, note the condition of the polymeric films portion of the M0003-5 experiment located in the lower left quadrant of the tray. The thermal control material discs and squares are located in the far lower left quadrant. Atomic oxygen contributed some physical damage to the materials, especially the front surface. Silver mirrors and radiation contributed some color changes .

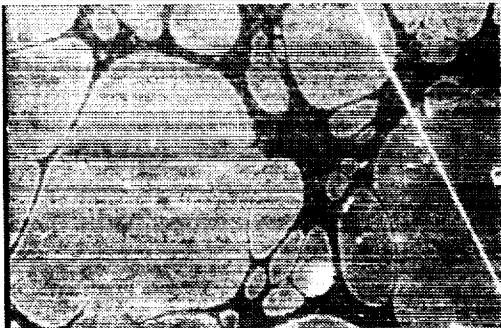
10 months of exposure

Unexposed
