## LDEF YAW AND PITCH ANGLE ESTIMATES

Bruce A. Banks  
NASA Lewis Research Center  
Cleveland, Ohio

## INTRODUCTION

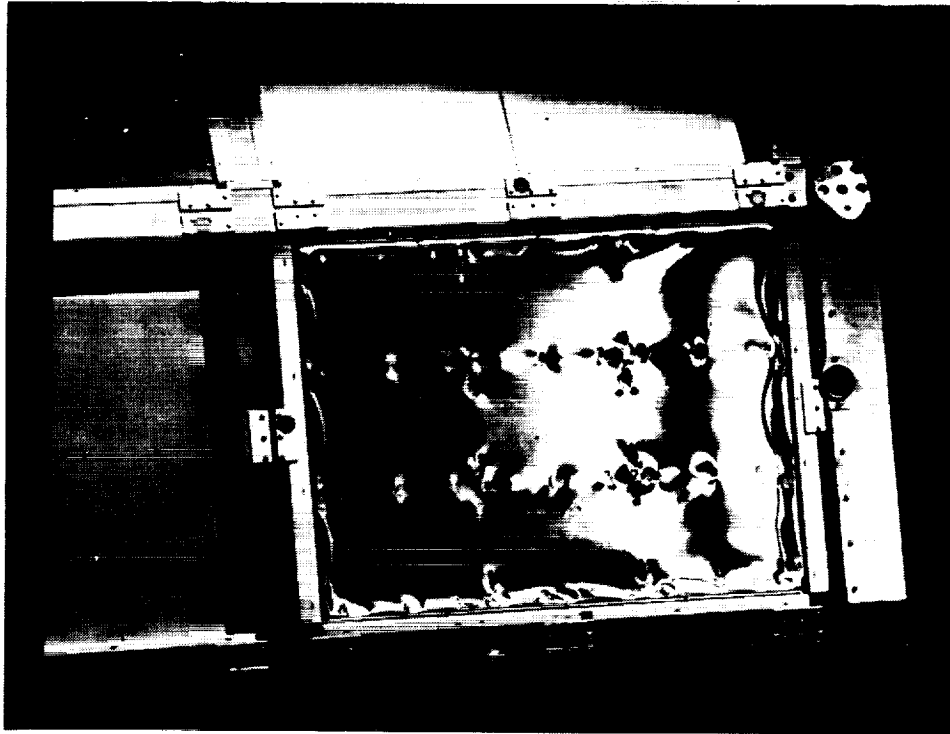
Viewgraph #6:

This photo shows the openings in the tray corners, as well as the nut plates on the tray flanges, which were used pre- and post-flight to attach protective covers over the experiments.

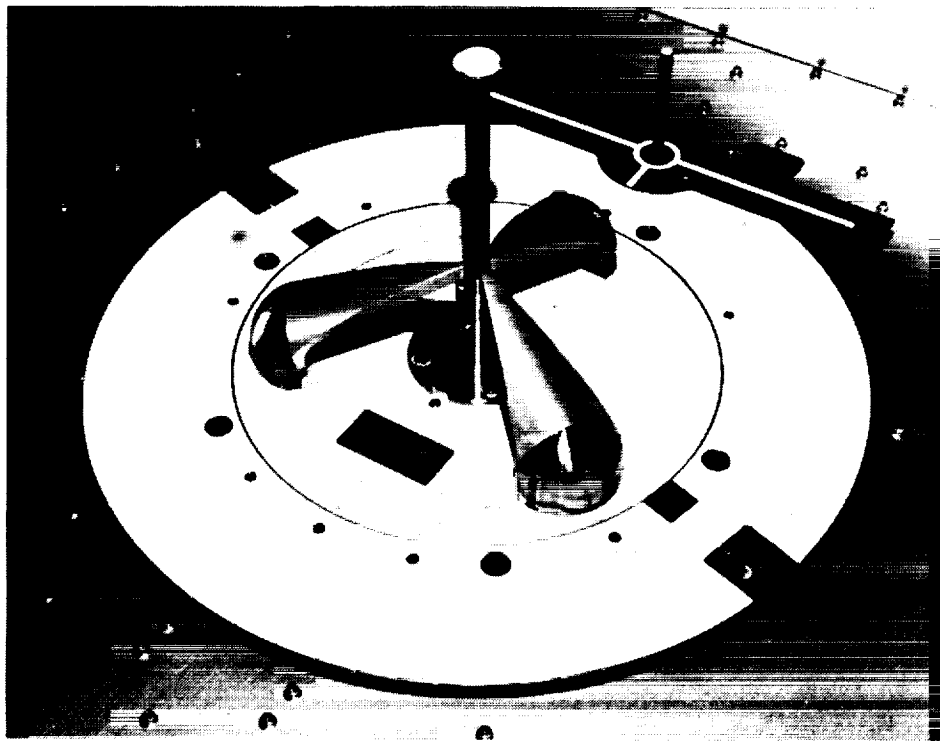
Viewgraph #18:

This is a photo of the grapple fixture which did not reveal atomic oxygen shadows from the grapple alignment pin.
