CHARACTERIZATION OF SELECTED LDEF - EXPOSED POLYMER FILMS AND RESINS

Philip R. Young and Wayne S. Slemp
NASA Langley Research Center
Hampton, VA 23665-5225

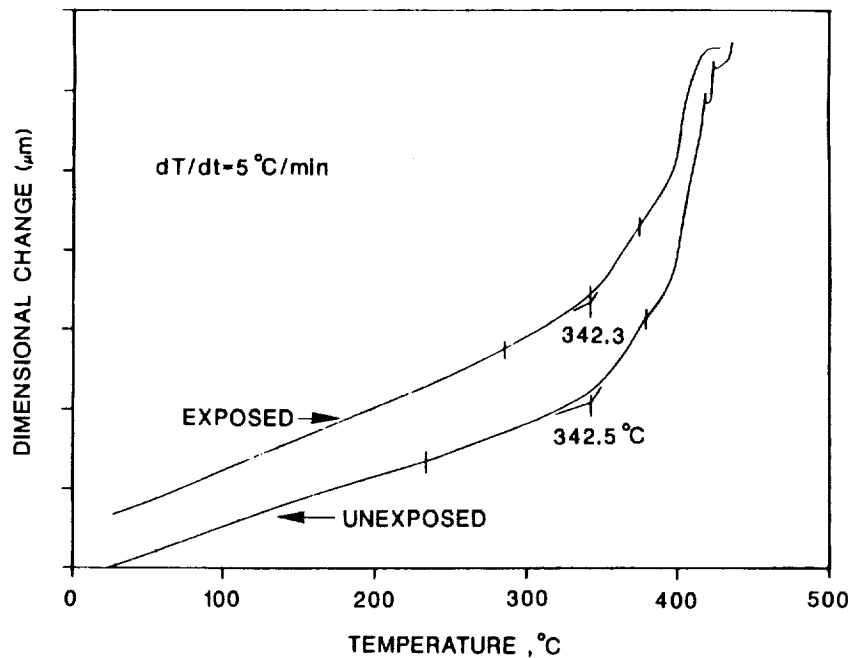
TMA OF PMR - 15/C6000 LDEF COMPOSITES

The PMR - 15/C6000 composite specimen from Row 7 was also examined by Thermal Mechanical Analysis (TMA) in the expansion mode. For the analysis, a probe is placed in contact with the composite surface. The temperature of the specimen is then increased, and any displacement in the probe is carefully noted. The inflection at 342°C in the curves for unexposed and exposed samples is indicative of the glass transition temperature (T_g) of the matrix resin. Since 342°C is an acceptable T_g for properly cured PMR - 15 (13), we conclude that the T_g of this material was not affected by 5.8 years of exposure. However, AO induced resin loss was noted with this specimen.

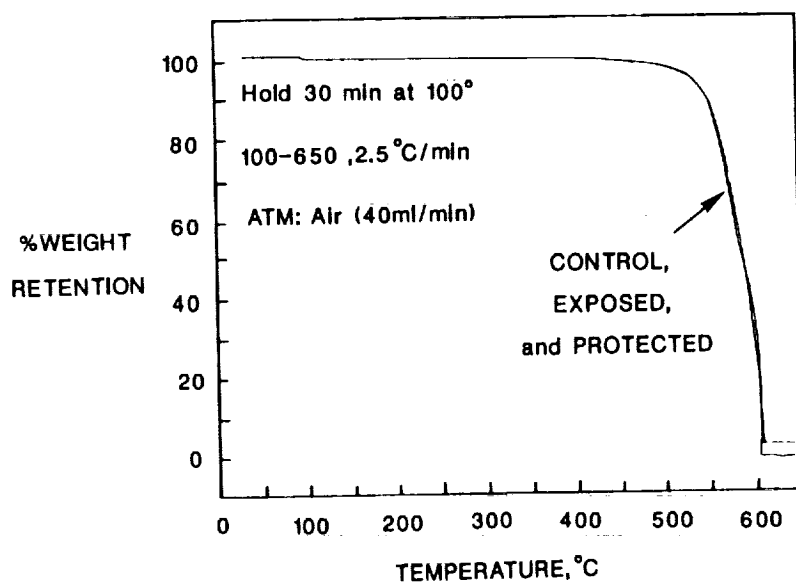
TGA OF LDEF - EXPOSED KAPTON FILM

Thermal gravimetric analysis (TGA) failed to differentiate between control, flight protected, and flight Kapton films exposed on the space end of LDEF. Weight loss curves for the three specimens were virtually superimposable. Perhaps isothermal TGA weight loss measurements, currently being performed, will detect a difference between the films.

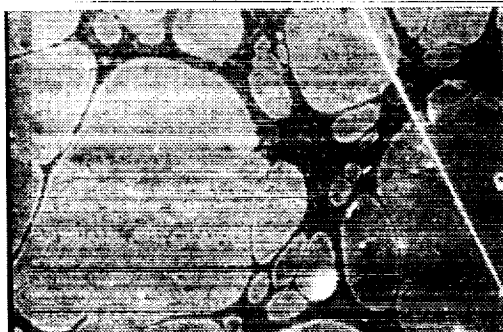
SEM OF POLYIMIDE - POLYSILIXANE COPOLYMER

The evidence emerging from the investigation of most polymeric materials which flew on LDEF suggests that there are no gross changes in chemistry as a result of exposure. This conclusion is based on various infrared, thermal, XPS, and solution property measurements. The subtle differences which are observed are primarily surface effects. However, substantial changes are often noted in physical and mechanical properties.

At least one material, an experimental polyimide-polysiloxane copolymer, which flew on a B9 experiment, did exhibit a significant change in chemistry after only 10 months of exposure. The figure shows SEM photomicrographs of unexposed and exposed film. A two-phase morphology is apparent. Regions that were light in appearance before exposure became dark after exposure, and dark areas became light. These two phases may have contained different amounts of the two copolymer segments which responded differently to AO exposure.

Unexposed

Exposed

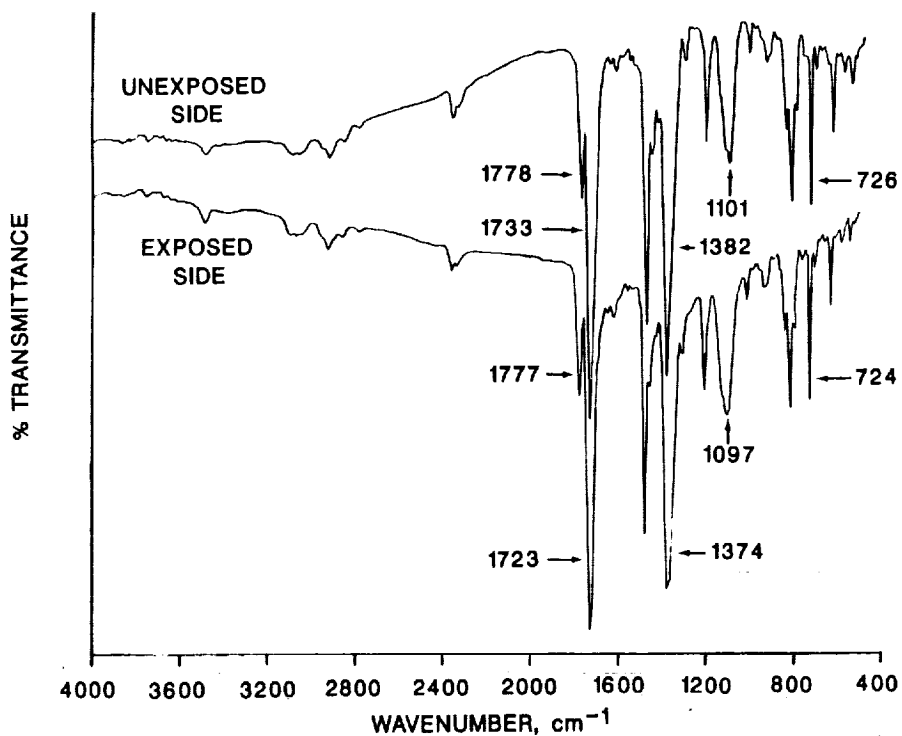
DR-FTIR SPECTRA OF STS-8 PMDA-DAF FILMS

While the physical appearance and mechanical properties of the two films had clearly deteriorated, chemical analyses to date have shown little difference between exposed and control specimens. The figure gives DR-FTIR spectra for the PMDA-DAF film. The spectra of both sides are essentially the same except for slight shifts in the absorption of five imide-related bands noted in the figure. These frequency shifts have not been interpreted but similar shifts in imide-related bands have been observed in this laboratory for polyimides that were not exposed to space.

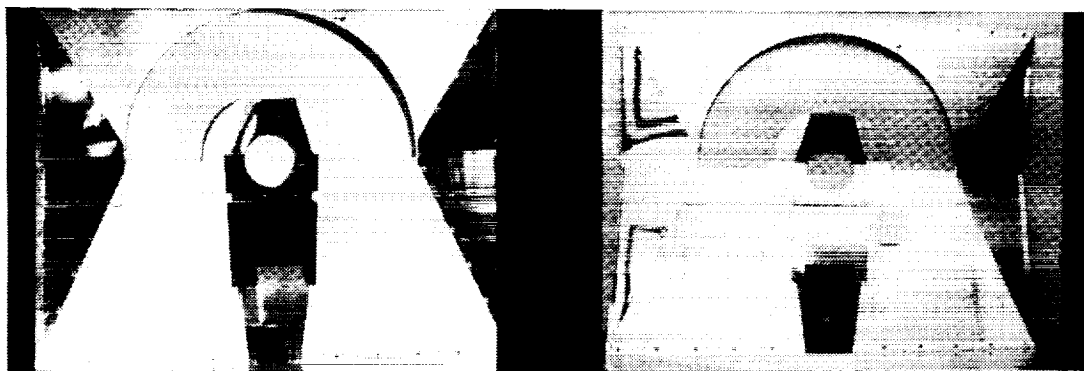
POST EXPOSURE EFFECTS FRONT COVER-LDEF THERMAL CONTROL SURFACES EXPERIMENT

J. M. Zwiener of the Marshall Space Flight Center provided two photographs taken one year apart of the front cover of the Row 9 Thermal Control Surfaces Experiment (S0069). The photographs were taken under similar lighting, angle, and distance considerations. The silvered FEP Teflon covered panel had changed in visual appearance during the year in which it was stored under prudent laboratory conditions. The diffraction patterns visible in the upper left-hand corner of the 1990 photo are real. They are not present in the 1991 photo. Brownish streaks in the coating had also intensified with age.
