**NASA/ASEE SUMMER FACULTY FELLOWSHIP PROGRAM**

**MARSHALL SPACE FLIGHT CENTER  
THE UNIVERSITY OF ALABAMA**

**POST-IMPACT BEHAVIOR OF  
COMPOSITE SOLID ROCKET MOTOR CASES**

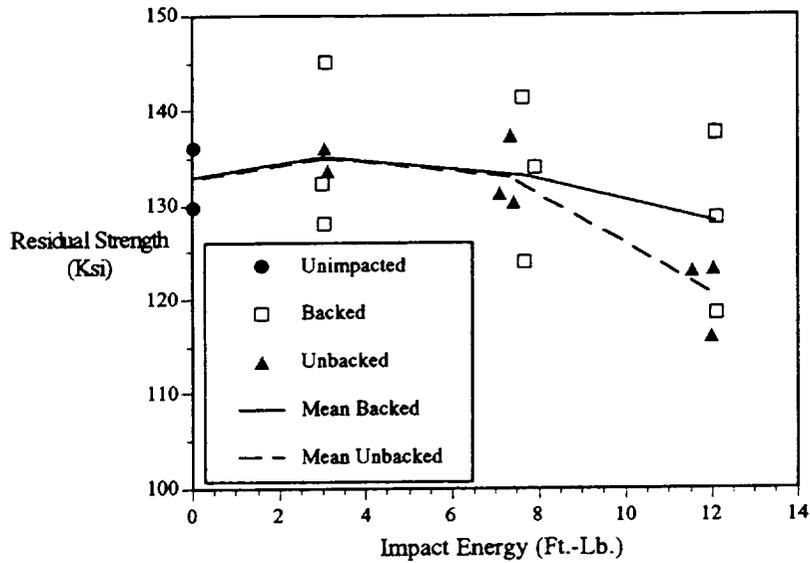
Figure 1 shows residual strength versus impact energy for both backed and unbacked materials. All of the individual test results are presented in the figure. In order to obtain reference strength data, two specimens were tested for tensile strength without being subjected to any impact loading. The tensile strengths for these specimens correspond to the two solid circles plotted at zero impact energy. There is significant scatter in the tensile strength data. Some of this scatter can be attributed to the inherent variability of the composites, and some of this scatter has been attributed to the influence of the grips on failure. While all of the specimens represented in Fig. 1 exhibited significant damage development and growth within the test section during the tensile test, in many of the specimens, the final fracture occurred within the gripped regions. The use of longer test specimens with a streamlined (dogboned) test section would help reduce this data scatter.

The average residual strength data for each of the impact levels, indicated by the lines in Fig. 1, reveal some interesting trends. Neither the backed nor the unbacked specimens exhibit appreciable changes in residual strength resulting from the low and intermediate energy impacts. The backed specimens might show a slight reduction in residual strength after the high energy impact. On the other hand, the unbacked specimens exhibit a 10 percent reduction in tensile strength after the high energy impact. As expected, the unbacked specimens are more susceptible to tensile strength reduction after impact than the backed specimens.

Figure 1. Plot of residual tensile strength versus impact energy for backed and unbacked specimens.

The inert propellant does provide sufficient reinforcement to limit the deflection of the composite, and hence reduce the effect of the impact.
