# Integrity Testing of Brush Seal in Shroud Ring of T-700 Engine

Prepared for the  
Seals Workshop  
sponsored by the NASA Lewis Research Center  
Cleveland, Ohio, August 5-6, 1992

1. AGENCY USE ONLY (Leave blank)		2. REPORT DATE August 1992		3. REPORT TYPE AND DATES COVERED Technical Memorandum
4. TITLE AND SUBTITLE  Integrity Testing of Brush Seal in Shroud Ring of T-700 Engine			5. FUNDING NUMBERS  WU-590-21-11

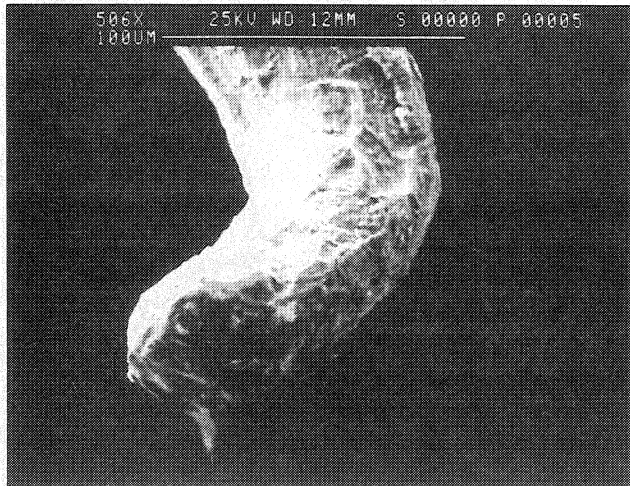
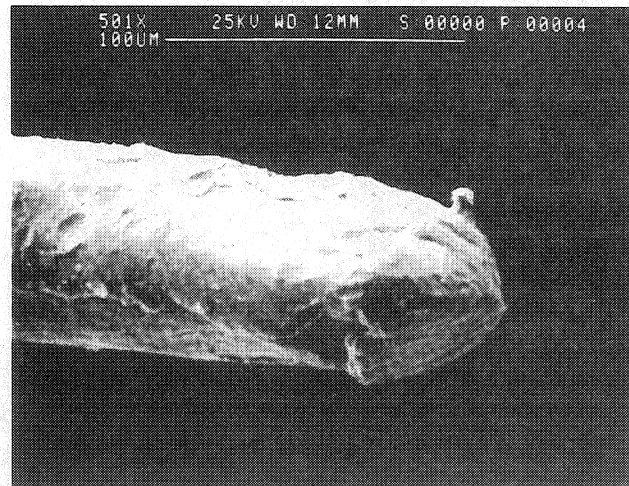
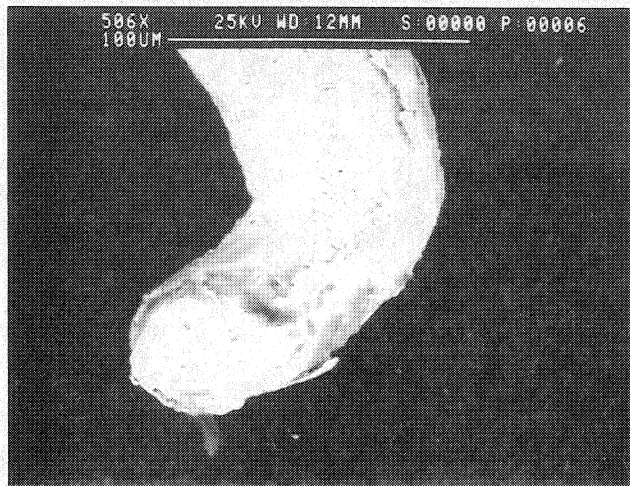
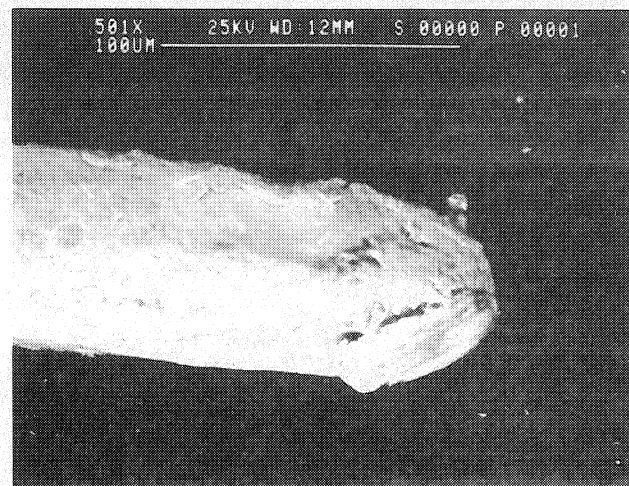
Figure 9.—Typical brush seal debris found in engine exhaust duct.

(a) Typical bristle tips.

(b) Surface features.

Upon initial engine startup, an orange burst was noted and was assumed to be expelled brush bristles (i.e., those that were inadequately attached, were pulled out by rotor irregularities, or were embedded within the blade row gaps during the blind installation and "snapped" or "yanked" or "bent" aside during engine break-in). Residual bristles from the exhaust were photographed (fig. 9). Although they appeared to be highly oxidized and stressed, they were curly and still wirey. The number of residual bristles decreased with operation until none were noted. It is assumed that at this time the bristles and the rotor were in nearly line-to-line contact (i.e., rubbed in). Precooling the bristles during the initial rub-in may mitigate bristle loss and the orange burst.

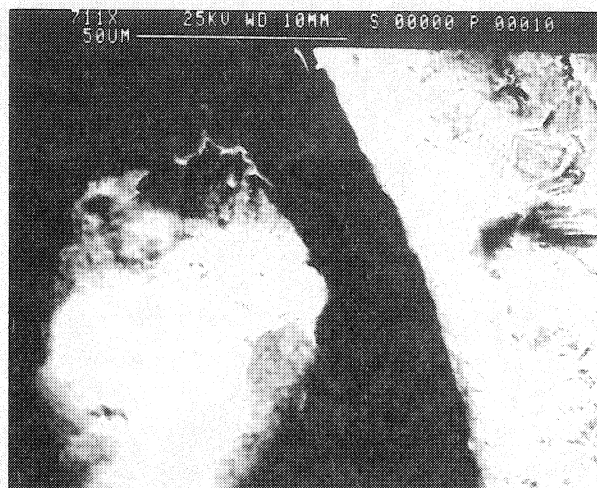
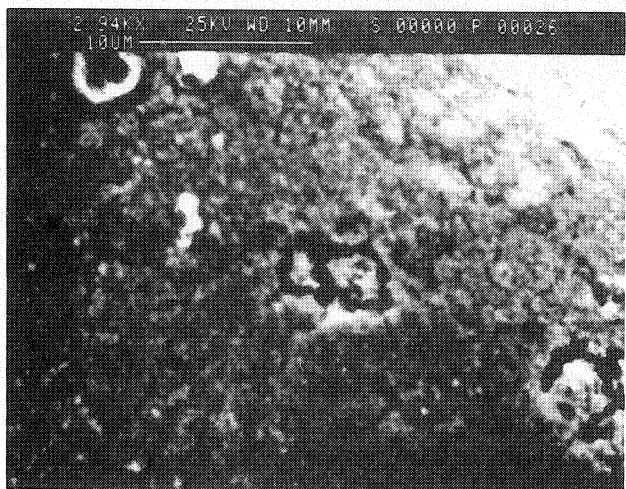
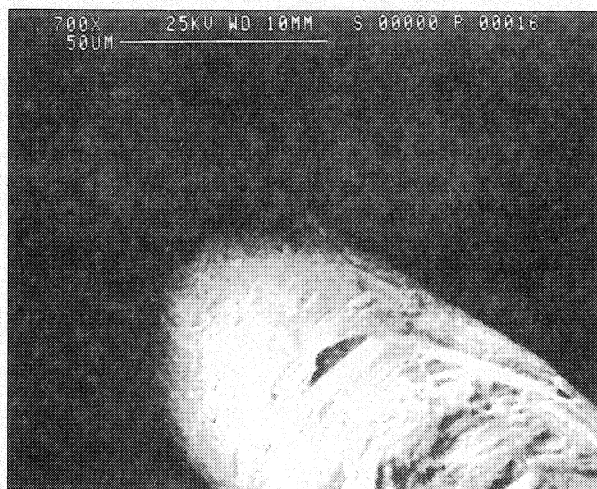
Figure 9.—Continued.

(b) Continued.
