Mechanisms for Capacity Fading in the  $\text{NiH}_2$  Cell  
and its Effects on Cycle Life

Albert H. Zimmerman  
Electronics Technology Center  
The Aerospace Corporation  
El Segundo, California 90245

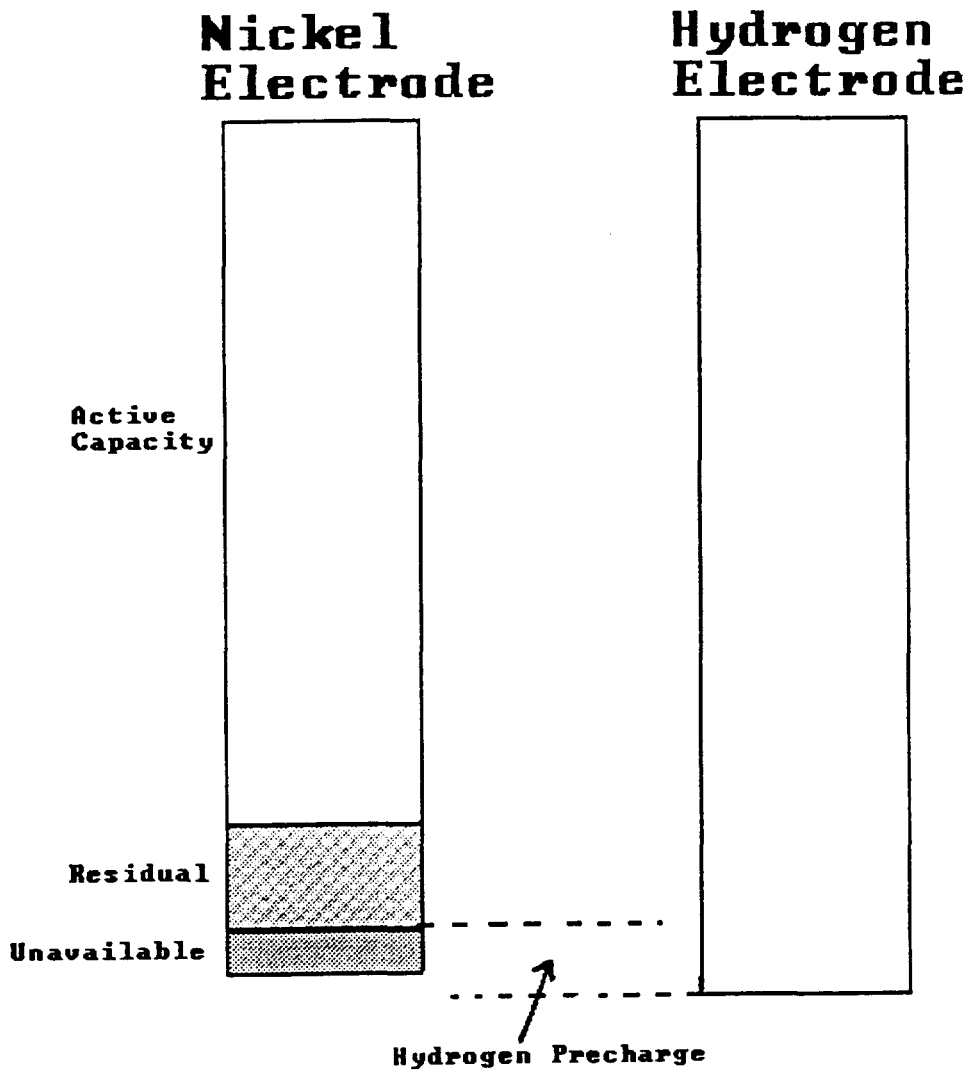
FIGURE 1.

# Normal Hydrogen Precharged Nickel Hydrogen Cell

The balance between the capacity in the nickel electrode and that in the hydrogen electrode in a hydrogen precharged nickel hydrogen cell is graphically illustrated in Fig. 1. The cell

is built with sufficient hydrogen gas to leave some hydrogen remaining in the fully discharged cell. In this case the cell capacity is always limited by the active capacity of the nickel electrode, assuming that no significant leaks exist in the cell pressure vessel. Typically the nickel electrode delivers approximately 70-80% of its total capacity at useful discharge rates. The remaining capacity is divided into residual capacity, i.e. capacity that can be discharged at reduced rates and voltages, and unavailable capacity, which simply cannot be electrochemically discharged. The relative proportions of residual and unavailable capacity can vary depending on the construction details of the nickel electrode and how it is charged and discharged. However, the residual capacity is often about 20% of the cell capacity and the unavailable capacity is about 5% of the total.

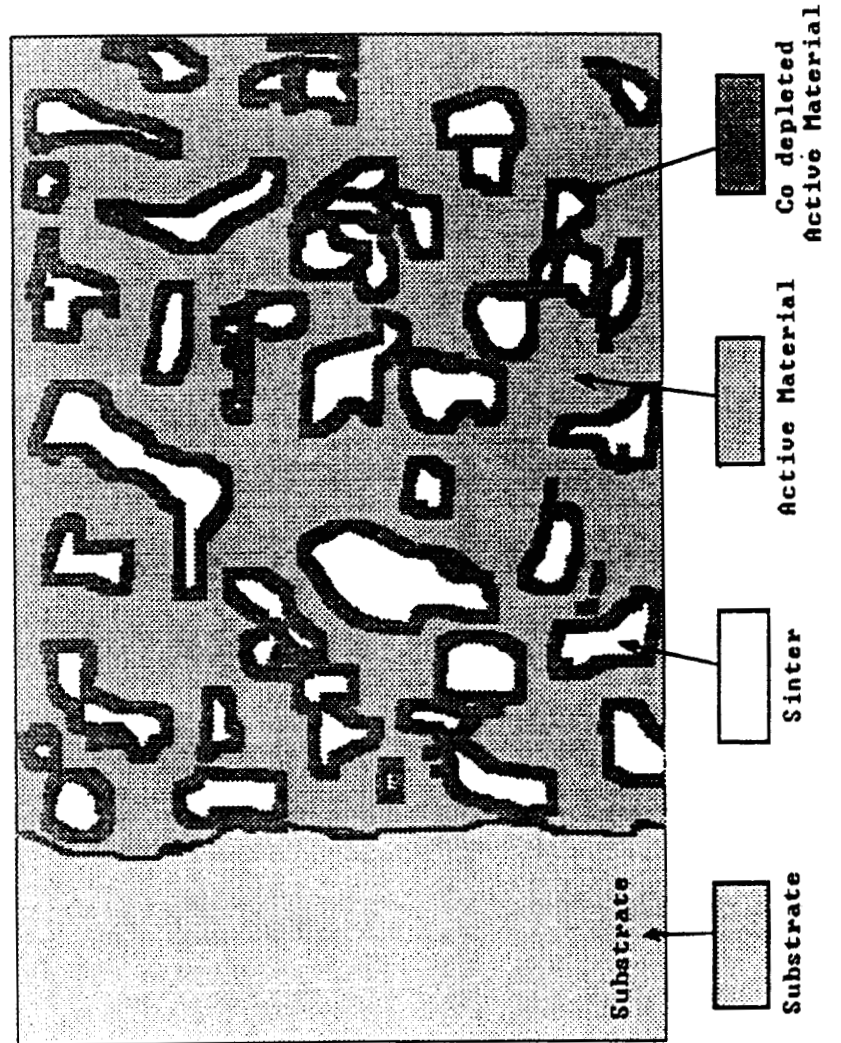
**FIGURE 2.**  
**Movement of Cobalt**  
**in Active Material**  
**of Nickel Electrode**

The reducing environment at the nickel metal surfaces during storage initiates reduction of the nickel and cobalt hydroxides (cobalt hydroxides are generally added to the nickel electrode active material at levels of 5-10% to improve performance and life) if the cell potential is below 0.1 volts, which is guaranteed by the presence of excess hydrogen. These reduction reactions produce finely divided nickel and cobalt metal in the layers that are in electrical contact with the nickel current collecting surfaces within the sinter of the electrode. This solid state reduction process propagates slowly into the active material deposit during lengthy storage periods. Subsequent recharge of the cell will oxidize these metallic particles to the respective nickel and cobalt hydroxides. As described in Ref. 1, cobalt hydroxide thus formed is soluble to some extent in alkaline electrolyte, forming the dicobaltite ion,  $\text{HCoO}_2^-$ . Movement of this ion results in migration of cobalt away from the nickel surfaces. The cobalt is redeposited in any of a number of inactive cobalt containing phases, including  $\text{CoOOH}$ ,  $\text{CoHO}_2$ , and  $\text{Co}_3\text{O}_4$  during subsequent cell operation. Capacity fading can result from layers of these poorly conducting materials preventing discharge of some active material, or probably more likely, preferential discharge of the cobalt-depleted layer surrounding all the current collecting surfaces. Such preferential discharge will occur because cobalt depleted nickel hydroxide has an elevated discharge voltage. The depleted layer thus formed during discharge can isolate charged material that is not close to the current collector, since the discharged material has relatively poor electronic conductivity. Fig. 2 illustrates this condition.

The net consequence of the degradation illustrated in Fig. 2 is a non-uniform discharge of the nickel electrode, leaving behind an appreciable amount of isolated charged active material. Such a non-uniform discharge can also result from non-uniform loading, sinter that contains large voids, or anomalous phase distributions in the active material. We have developed an empirical test that allows the degree of discharge uniformity to be quantified using a simple procedure. This test is indicated in Fig. 3, where a flooded (31.29% KOH) nickel electrode is discharged at 10 ma/cm<sup>2</sup> following a 32 hr charge at 2 ma/cm<sup>2</sup> (prior to this cycle a standard conditioning cycle is used to stabilize the electrode). A uniformity parameter F is defined as

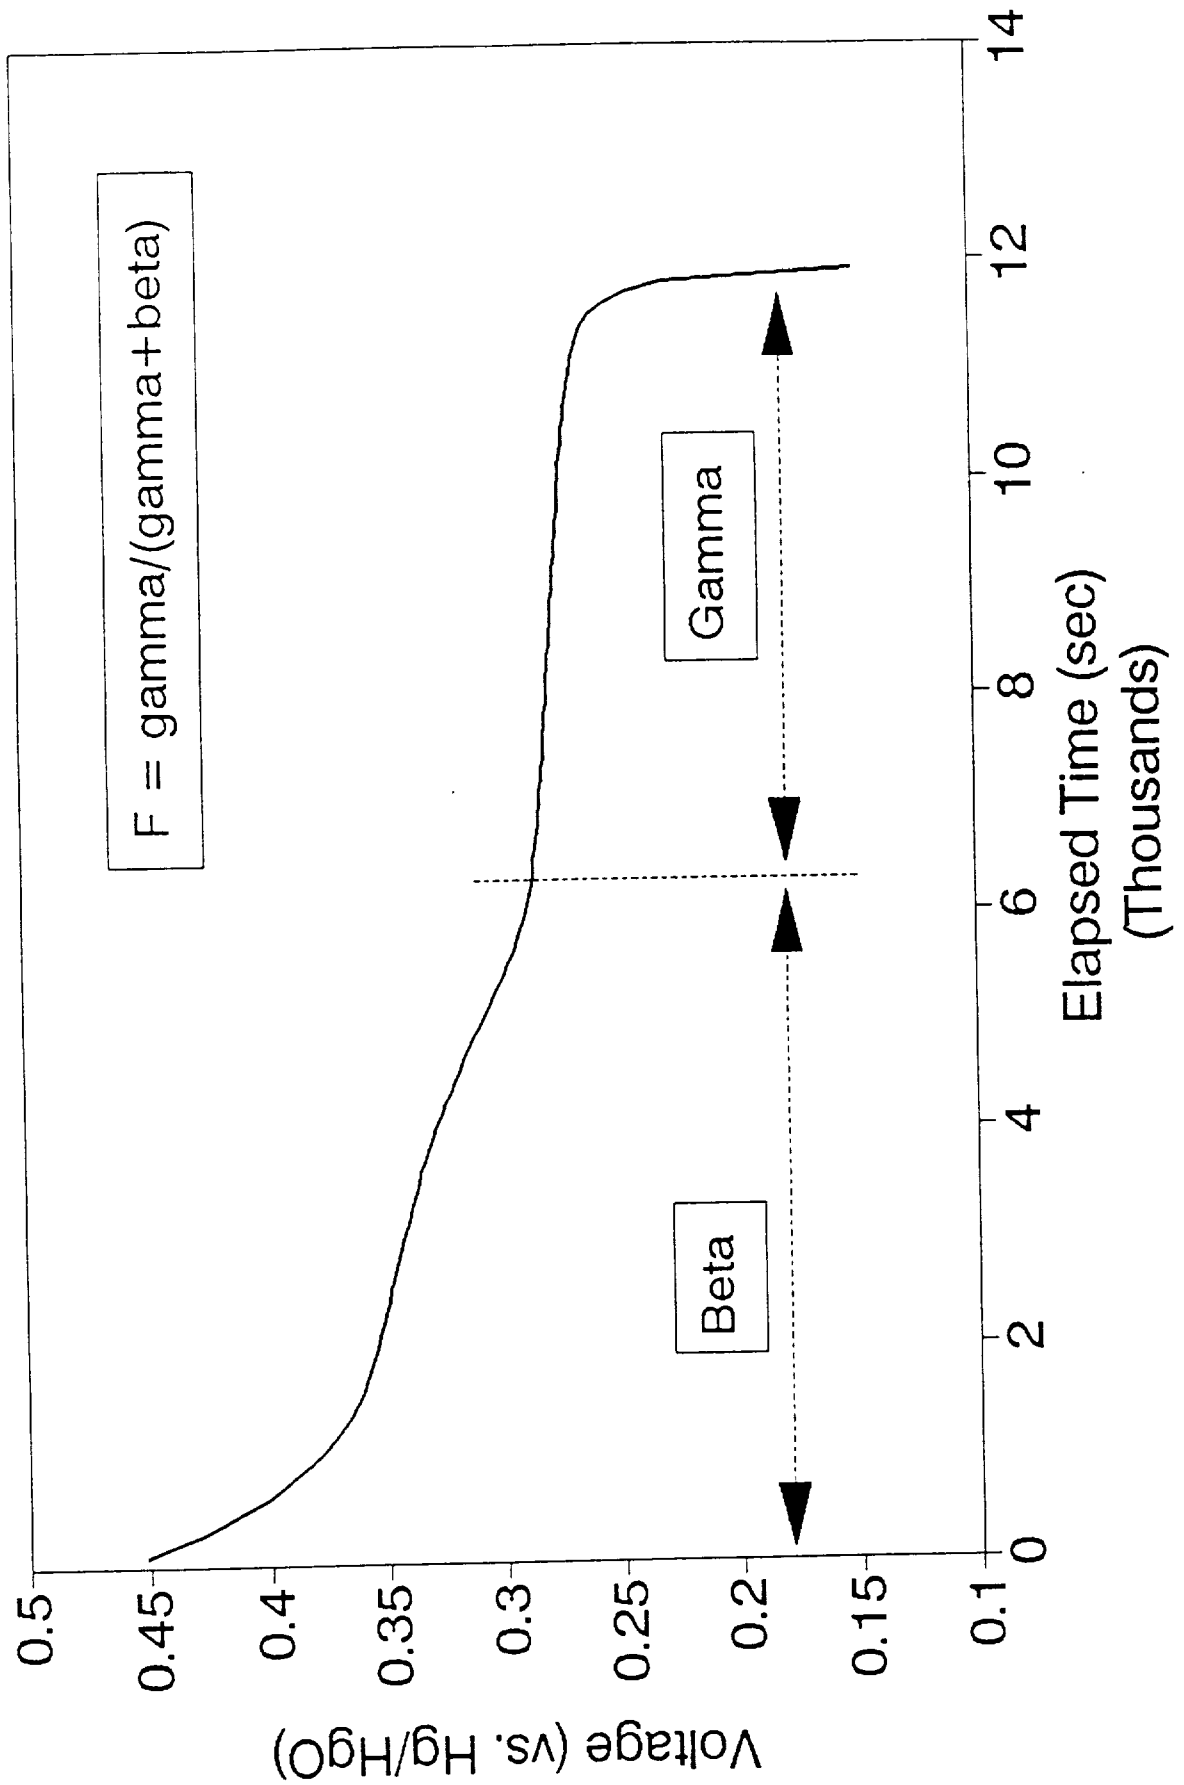
FIGURE 3.  
 Definition of Uniformity Parameter, F  
 31% KOH, 10 ma/cm<sup>2</sup> disch after 32 hr ch

$$F = \text{Gamma}/(\text{Gamma} + \text{Beta})$$

where gamma and beta are the relative quantities of the  $\gamma$ -NiOOH and  $\beta$ -NiOOH discharged at the 10 ma/cm<sup>2</sup> rate. It has been empirically found that non-uniform discharge results in isolation of the lower potential gamma phase, as well as a reduced tendency to readily form this phase during the standard recharge employed in this test.

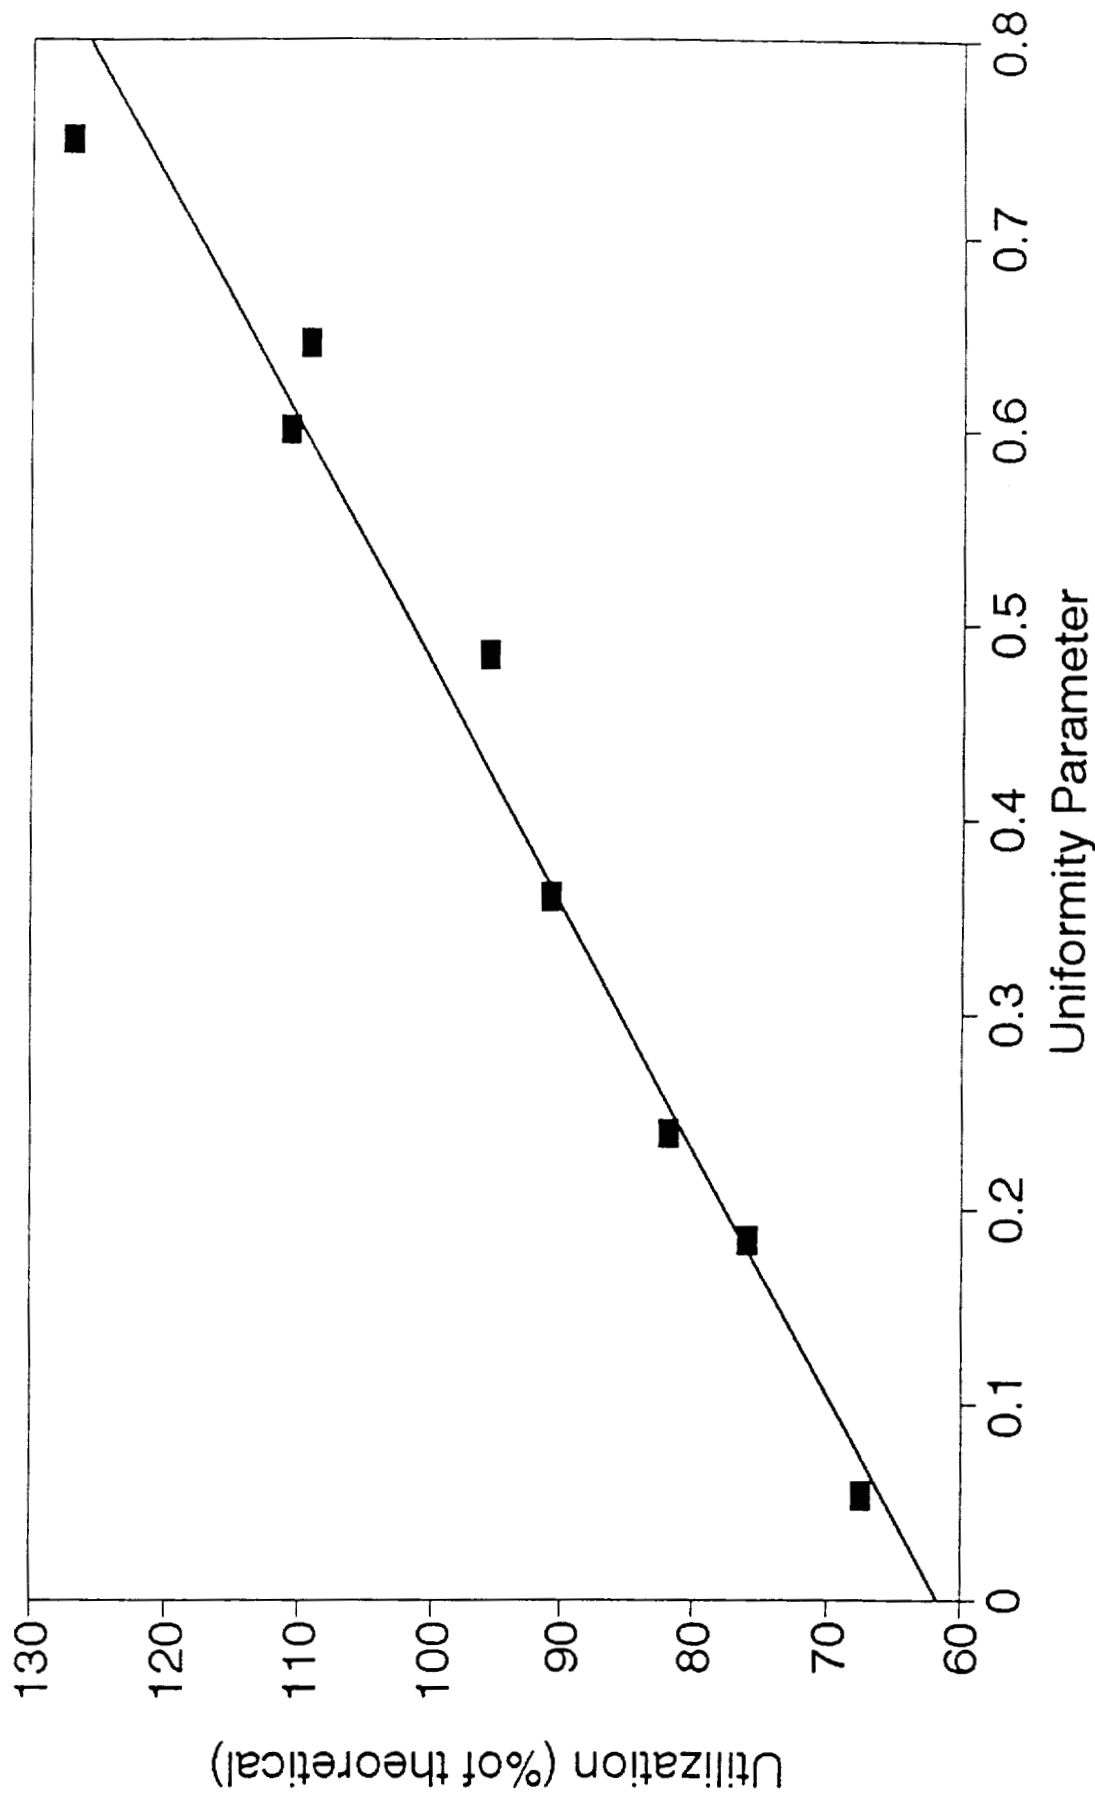
FIGURE 4.  
**Nickel Electrodes in 31% KOH**  
 Utilization vs. Uniformity Parameter

Figure 4 indicates the correlation typically found between active material utilization at the 10 ma/cm<sup>2</sup> discharge rate and the uniformity parameter F. Normal nickel electrodes typically fall between 90 and 110% utilization, with variables such as cobalt level, sinter porosity and uniformity, loading level, and local loading uniformity giving a significant range of utilization across different electrode lots and types. Very uniformly and lightly loaded electrodes with high cobalt levels can easily give utilizations as high as 130% or more, as indicated in Fig. 4. However, nickel electrodes from cells that have experienced fading exhibit a significant reduction in both utilization and the uniformity parameter F. The three points in Fig. 4 having lowest utilization are all from cells that exhibited differing, but significant degrees of capacity fading. Thus, an empirical test such as that indicated in Figs. 3 and 4 can provide a good indication of the origin of degradation in any given nickel electrode. Particularly when the measurements are combined with chemical analyses for CoHO<sub>2</sub>, the level of which also has been found to correlate with capacity fading (Ref. 2), an excellent diagnostic capability for the root cause of capacity fading emerges.

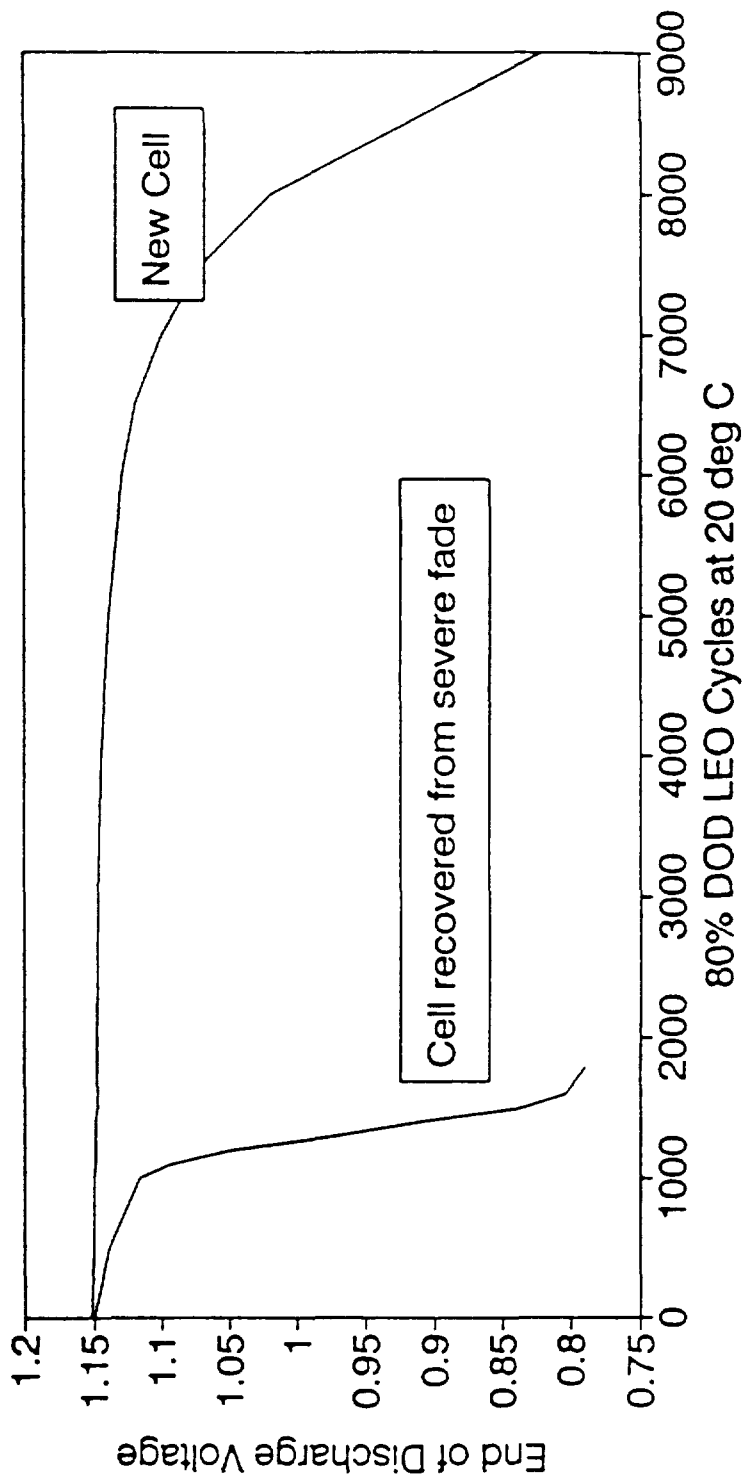
**FIGURE 5.**  
**PERFORMANCE OF FADED CELL AFTER CAPACITY RECOVERY**  
**BY EXTENSIVE CYCLING**

- **RAN LIFE TEST: 80% DOD, LEO CYCLE, 20 DEG C, 1.05 RETURN RATIO**
- **CONCLUSION: FADING DEGRADES CYCLE LIFE SIGNIFICANTLY, EVEN WITH APPARENT CAPACITY RECOVERY**

To evaluate this concern a hydrogen precharged nickel hydrogen cell that had experienced approximately a 30% capacity fade during several years of storage, followed by capacity recovery by means of about 250 80% depth-of-discharge LEO cycles, was placed on an accelerated cycle life test. The results of this life test are indicated in Fig. 5 along with the cycle life behavior of a new cell (no fading) of the same design in the identical life test cycling regime. The conclusion drawn from the test in Fig. 5 is that in spite of the recovery seen in cell capacity, the chemical changes that had taken place in the nickel electrode during storage resulted in loss of about 85% of the cycle life capability of this cell for these test conditions. In view of these results, it clearly is very desirable to avoid the chemical changes responsible for capacity fading.

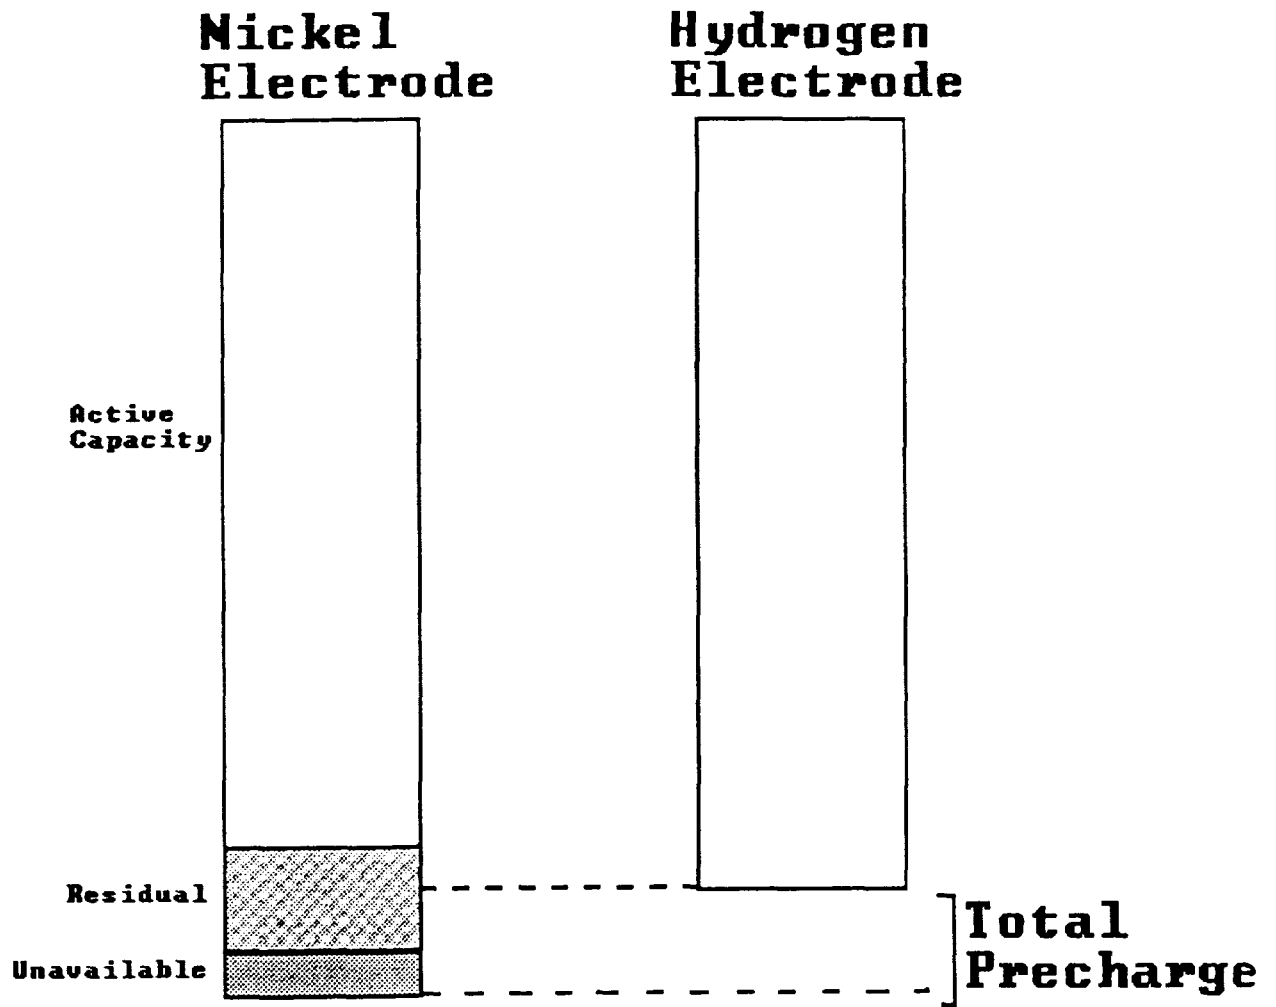
FIGURE 6.

# Normal Nickel Precharged Cell

The positioning of the relative nickel and hydrogen electrode capacities indicated in Fig. 6 has some potential problems. First, if the nickel electrode has an extremely high utilization, the band of residual charge will be quite narrow, resulting in a very narrow window of acceptable precharge. In this situation it is probably more desirable to increase the nickel precharge into the active capacity region, instead of risking cell degradation if the nickel precharge is insufficient. It should be noted here that any oxidation of sinter or other materials in the cell during operation will tend to increase the amount of hydrogen in the cell. Thus, some excess nickel precharge is highly desirable to get the cell through early life cycling and storage without developing a hydrogen precharge.

The second point to note in Fig. 6 is that any significant shifts in the amounts of either residual capacity or unavailable capacity during cell operation can convert a nickel precharged cell into a cell that is effectively hydrogen precharged. There are several

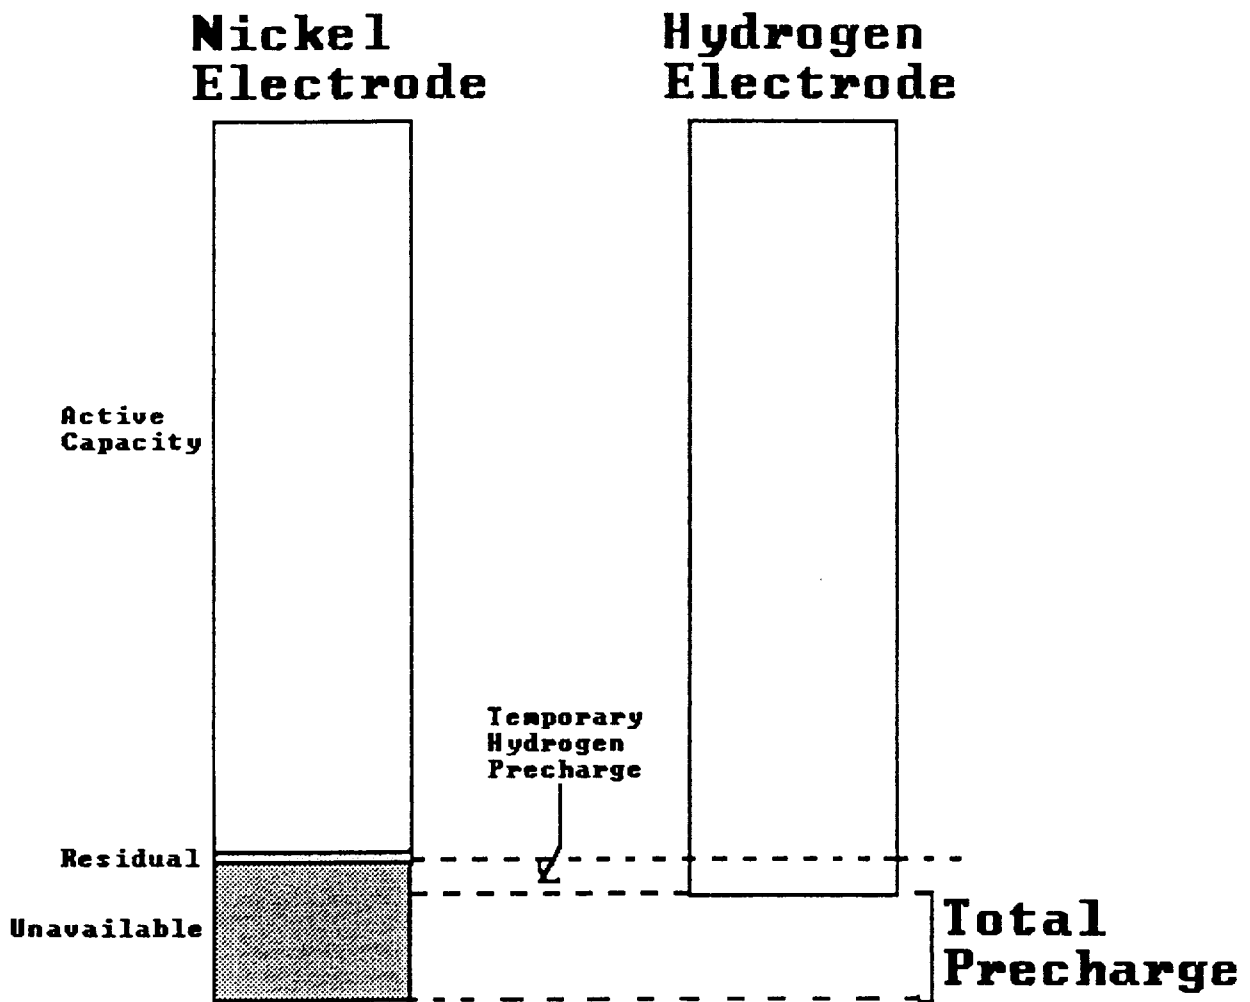
FIGURE 7.

# Nickel Precharged Cell After Stand in Partly Charged or Open-Circuit Charged State

operational conditions commonly encountered during cell testing that can shift the amounts of residual and unavailable capacity significantly, and thus are to be avoided just prior to storage periods except under carefully controlled test conditions. The first of these conditions is indicated in Fig. 7, and involves allowing the charged cell to stand open circuit prior to discharge. Such open circuit stand, which is commonly used for charge retention tests, causes most of the residual capacity to become unavailable through charge redistribution processes described in Ref. 3. This can easily convert a nickel precharged cell into a cell that contains undischageable hydrogen, although this hydrogen may eventually be depleted by self-discharge processes. Storage of this cell at a low voltage, however, will clearly initiate the processes responsible for capacity fading in the hydrogen precharged nickel hydrogen cell. Thus, a common test to which nickel hydrogen cells are exposed is capable of temporarily generating conditions known to degrade cell performance.

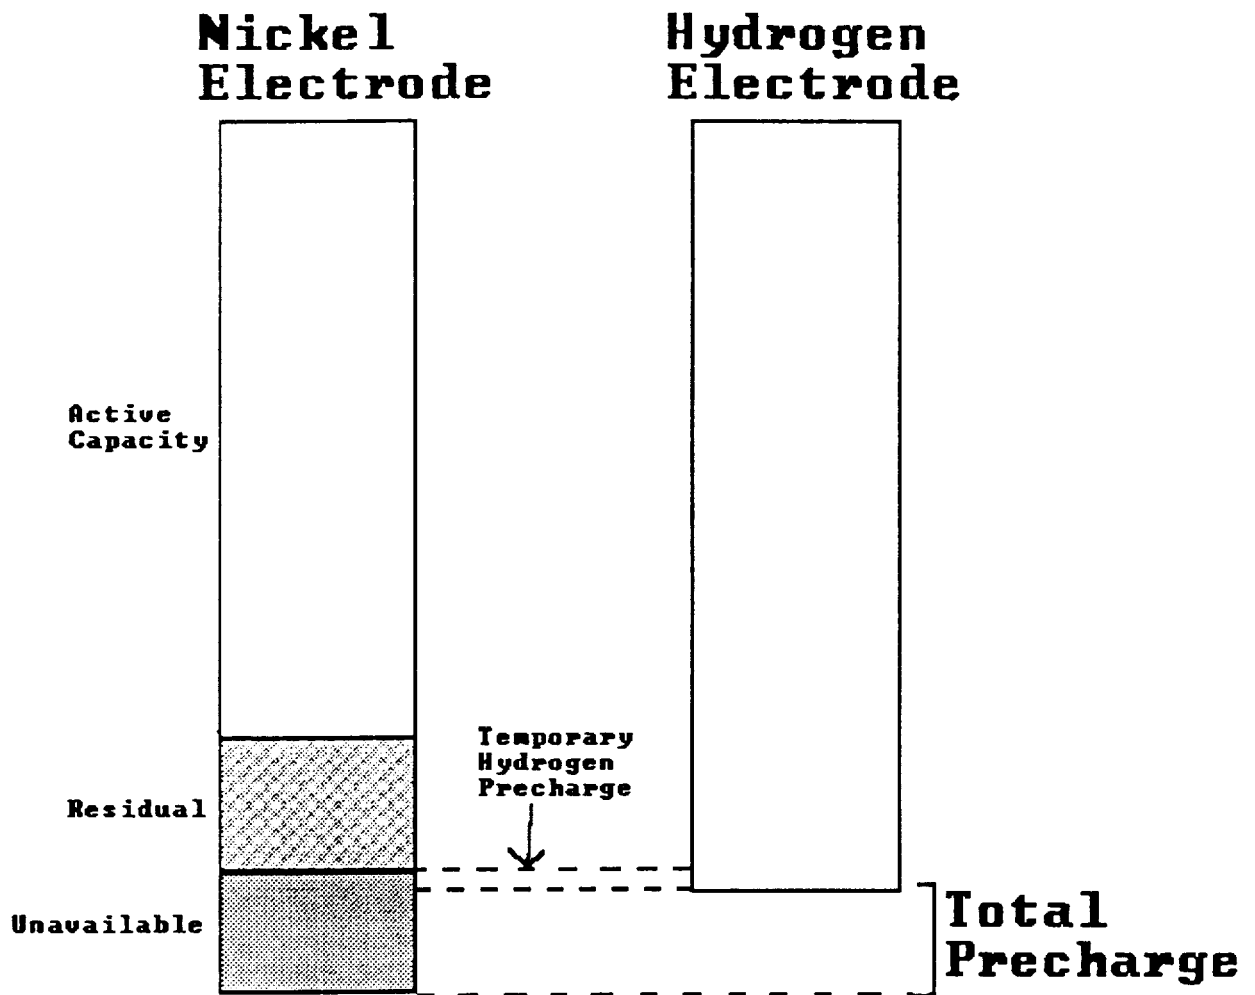
FIGURE 8.

# Nickel Hydrogen Cell After a Low-Temperature Discharge

Another relatively common test condition that can have a similar effect is indicated in Fig. 8. Here the cell is simply discharged at low temperature, which significantly increases the amounts of both residual and unavailable capacities. This is primarily due to the reduced conductivity of the active material at lower temperatures. Here again, the unavailable capacity in the discharged cell can rise to exceed the level of hydrogen in the cell, thus leaving a temporary hydrogen precharge condition. The scenarios presented in Figs. 7 and 8 clearly show that a nickel precharged cell should be carefully prepared for a storage period, employing a standard preparation cycle which is guaranteed to leave the desired state of precharge.

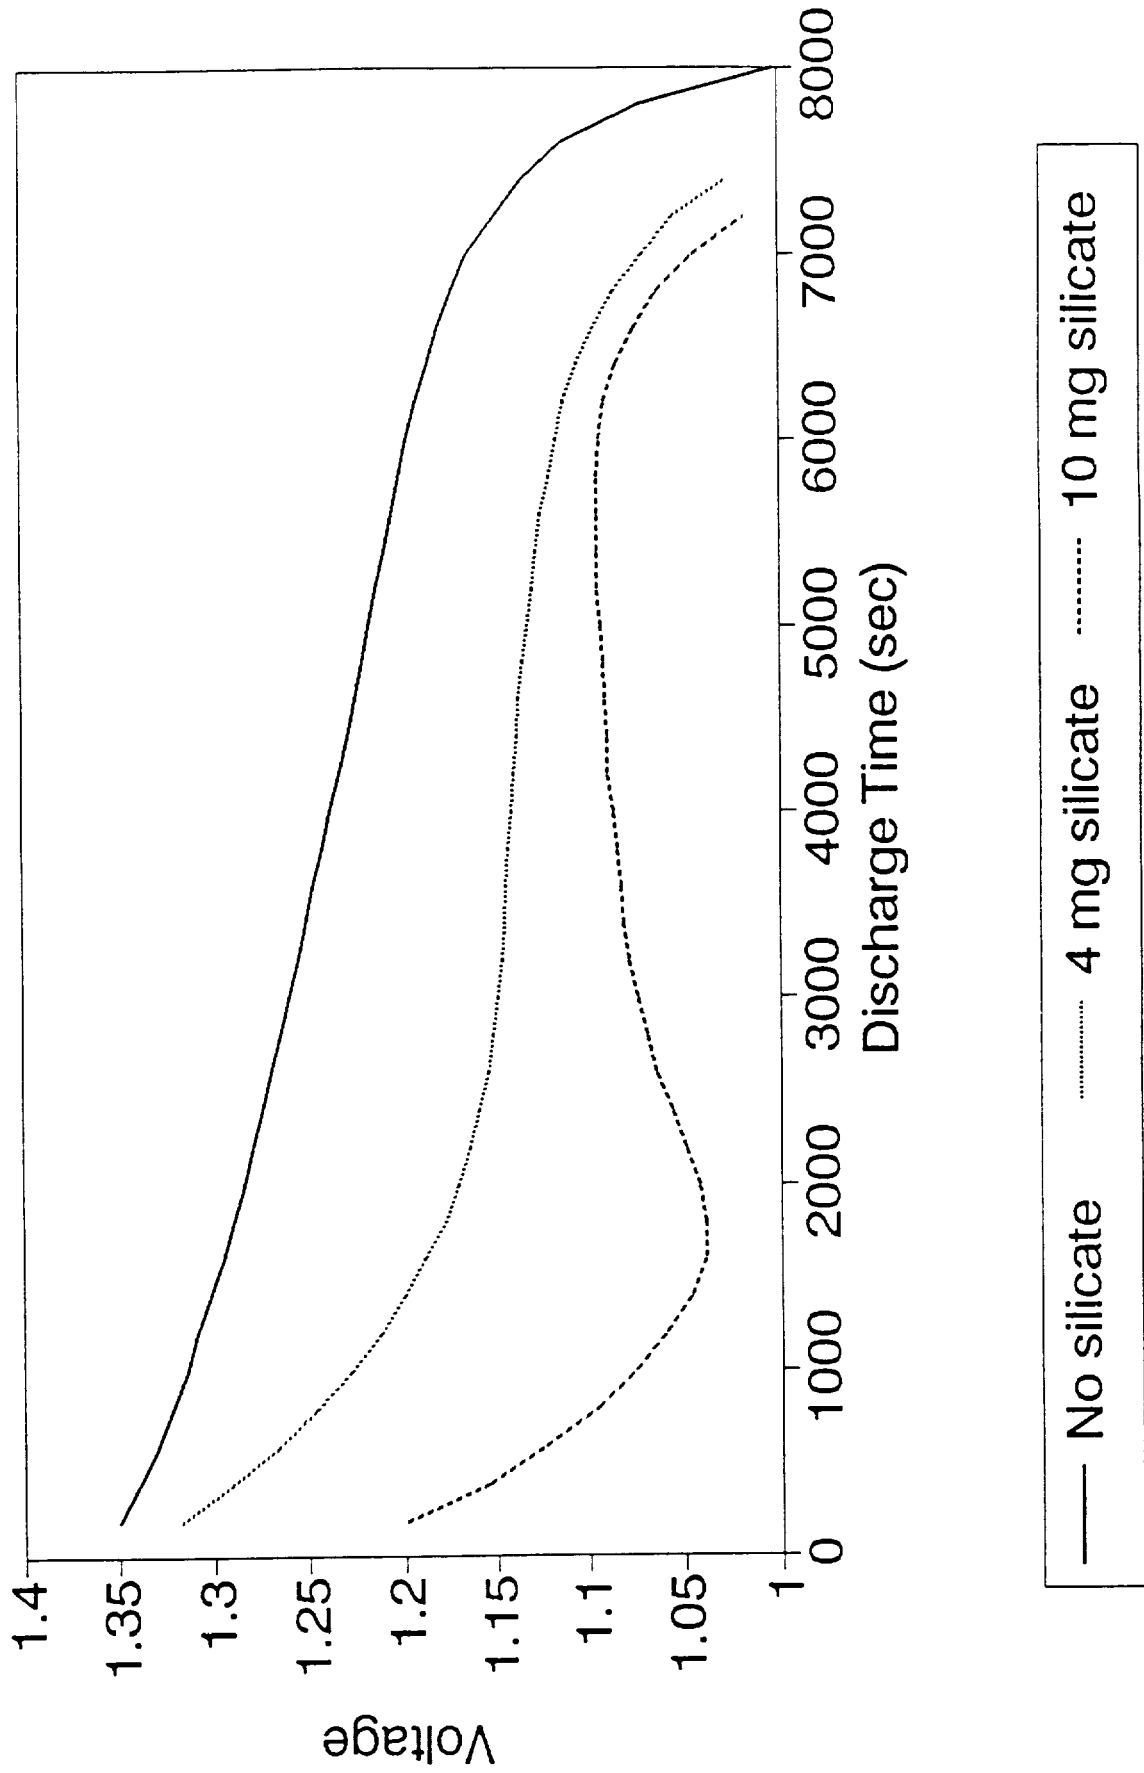
FIGURE 9.  
**Discharge of NiH<sub>2</sub> Cell with Silicates**  
 15 ma/cm<sup>2</sup>, 0 deg C

be a significantly depressed discharge plateau voltage as indicated in Fig. 9, which in extreme cases can exhibit a pronounced minimum part way through the discharge. The results of Fig. 9 are for small laboratory cells operated at 600 psia of hydrogen, and with calcium silicate added to the interface between the nickel electrode and the zircar separator. The behavior of Fig. 9 developed gradually over approximately 40 100% depth-of-discharge cycles at 25 deg C, performed over a period of 44 days.

Clearly, silicate contaminants can decrease cycle life, although the extreme case represented in Fig. 9 may not be representative of the silicate levels from spot contamination. However, cells containing silicate based separators such as asbestos have exhibited anomalous discharge voltage profiles much like those of Fig. 9, ranging in severity from causing failure within the first 100 cycles, to causing failure after 12,000 LEO cycles at 40% depth-of-discharge.

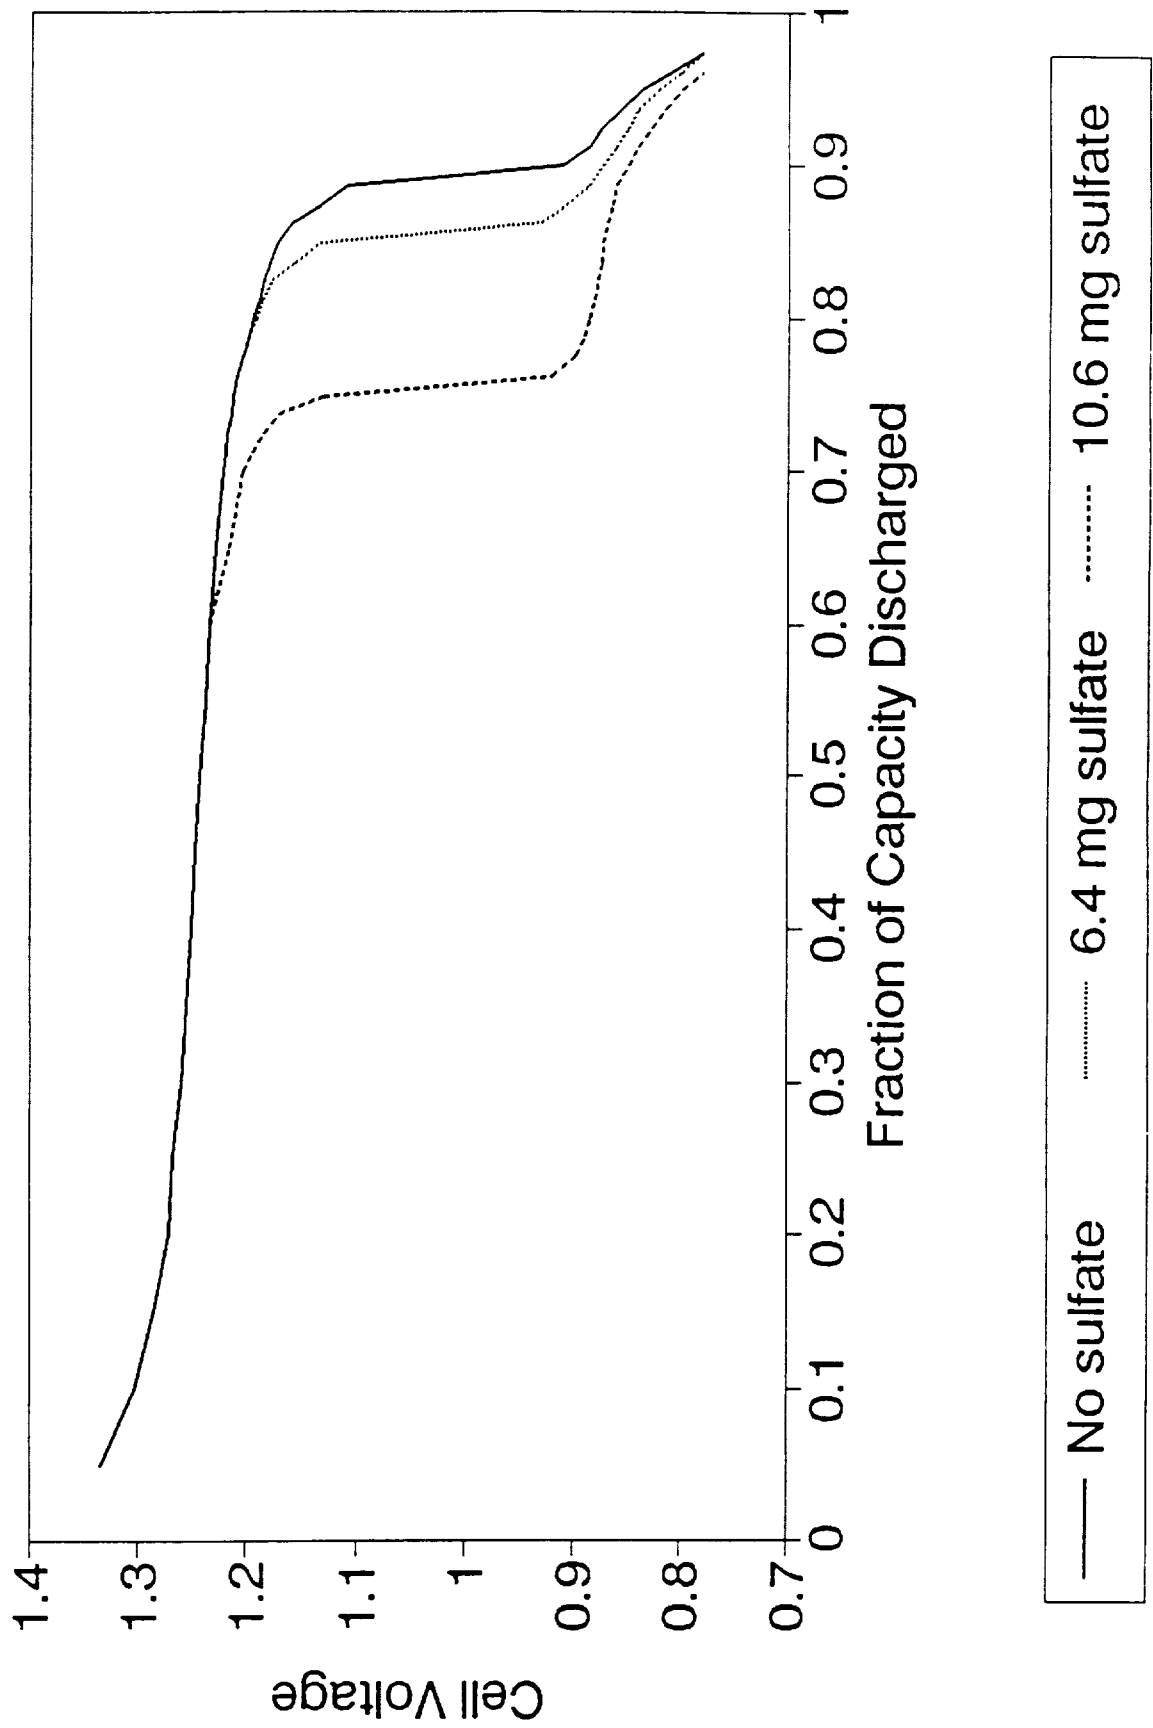
Figure 10.  
**Discharge of NiH<sub>2</sub> Cell with Sulfate**  
 15 ma/cm<sup>2</sup>, 20 deg C

Another contaminating material that has been found to change the relative amounts of residual and unavailable capacity is sulfate ions in the electrolyte (Ref. 4). More than 300-500 ppm of sulfate in the electrolyte can result in significant increases in the amount of capacity discharged on the second plateau, particularly when combined with low temperature operation and charged open circuit stand. This behavior is indicated in Fig. 10, again for small nickel hydrogen cells operated at about 600 psia with calcium sulfate added between the zircar separator and the nickel electrode. In actual nickel hydrogen cells, the sources for such sulfate materials have been found to be spot contamination by mineral particles (gypsum,  $\text{CaSO}_4$ , most commonly), and separators. Sulfates have been found in both zircar and asbestos separator materials.

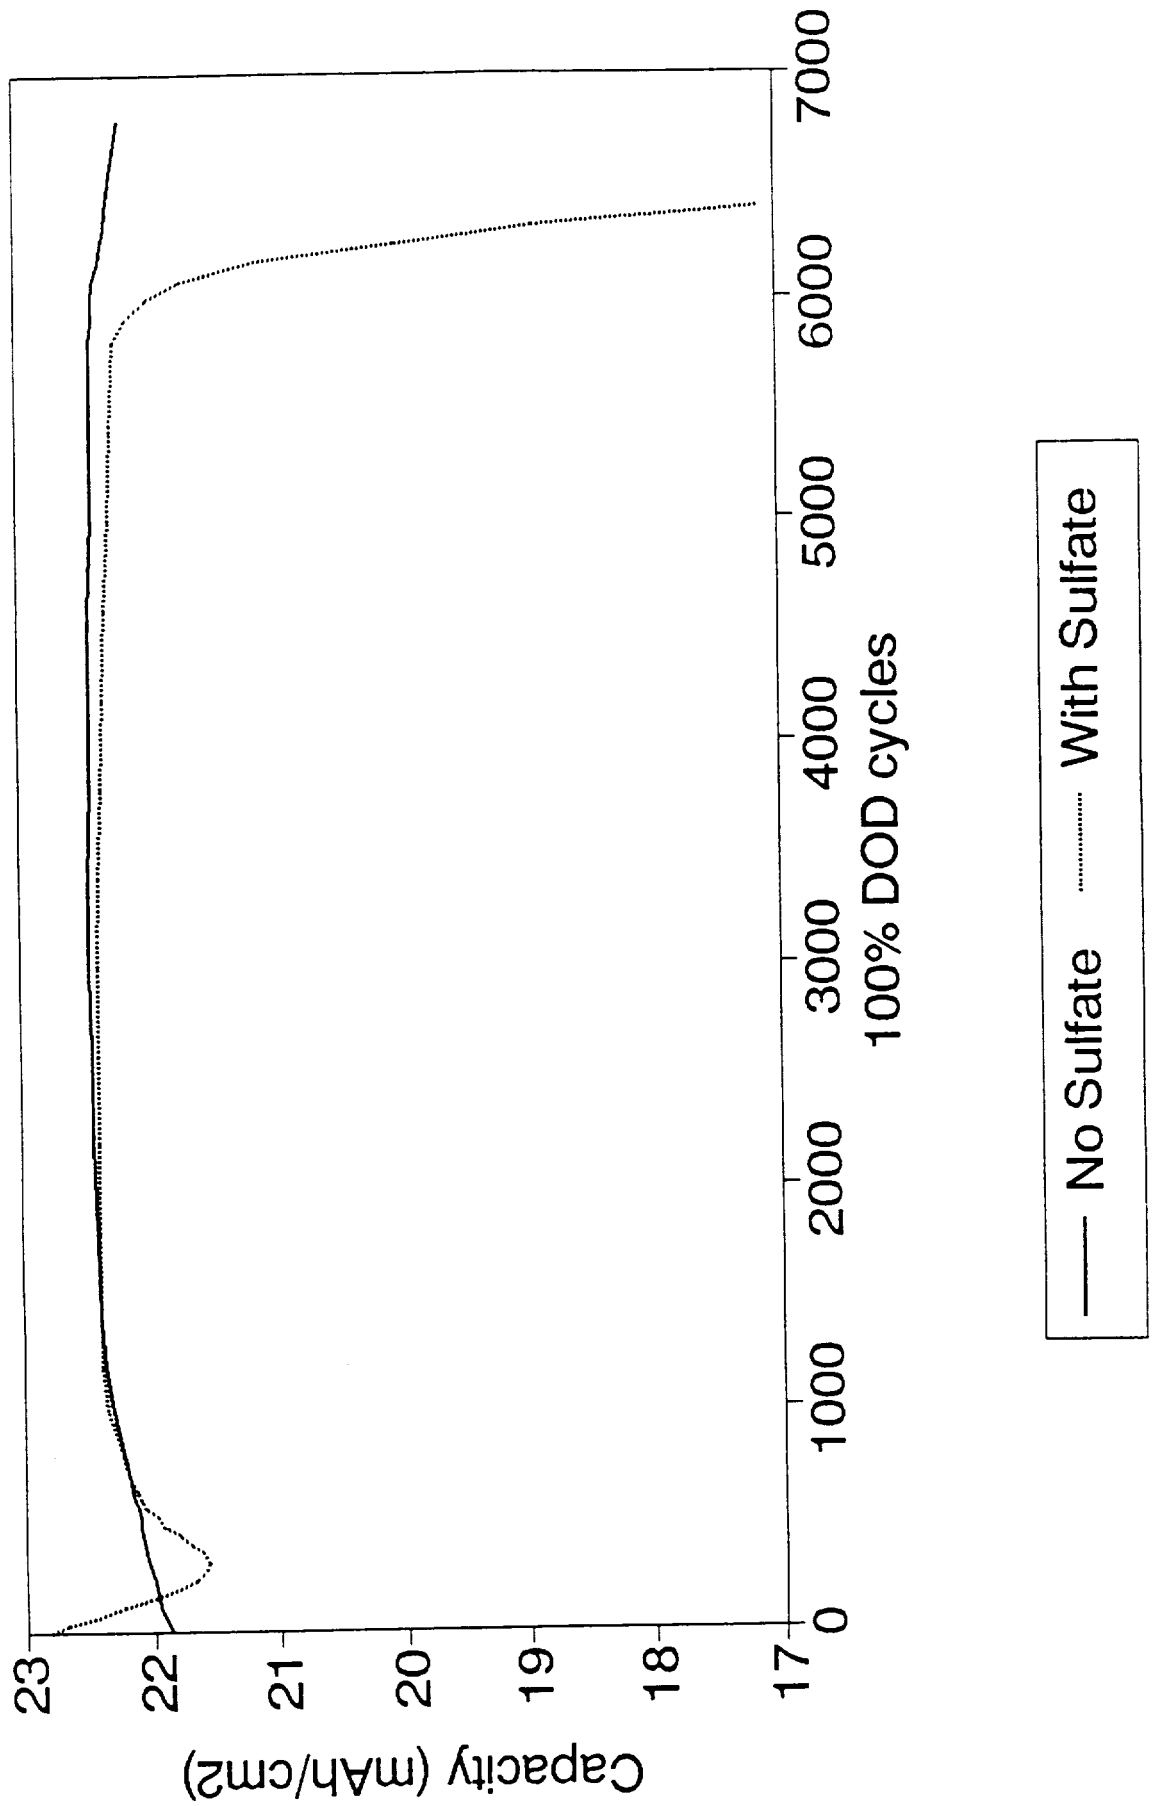
FIGURE 11.  
**Cycling of Ni Electrode with Sulfate**  
 100 ma/cm<sup>2</sup>, 23 deg C

Figure 11 indicates capacity performance over 6500-7000 accelerated cycles for flooded nickel electrodes in 31% KOH with 0.5 g/100 cc of calcium sulfate added. This test was to 100% depth-of-discharge, with 100% depth defined as 0.0 volts vs. Hg/HgO at 100 ma/cm<sup>2</sup>. Charge return was 100% of the beginning of life capacity of each electrode as measured at the 10 ma/cm<sup>2</sup> discharge rate. After 6500 cycles, the electrode cycled with added sulfate

exhibited a discharge voltage plateau depressed to near the 0.0 volt level, thus its capacity appeared to suddenly drop. Actually the discharge voltage of this electrode had degraded continuously during the cycling after about cycle 1000. The electrode cycled with no sulfate had experienced only about a 20 mv drop in the discharge plateau after nearly 7000 cycles, and essentially no capacity loss. After almost 7000 cycles this test was stopped based on the observation that the electrode cycled with sulfate had failed while the electrode cycled with no sulfate remained far from failure.

In Fig. 11 the electrode cycled with no sulfate exhibited a normal capacity profile over cycle life. A capacity rise during the initial 2000-3000 cycles was followed by a level then a gradually dropping capacity. With sulfate present, however, a very different behavior was seen. The initial rapid drop, then rise in capacity over the first 800 cycles appears to be associated with the slow incorporation of sulfate species into the cobalt sites within the active material. Thereafter, while capacity appears to be relatively stable, the cobalt in the active material is slowly undergoing solubilization causing the active material to lose cobalt, as well as experiencing accelerated corrosion. About 10% of the sinter had corroded after 6500 cycles. It is likely that the combination of these changes played a significant role in the earlier failure of the electrode exposed to sulfate.
