Mechanisms for Capacity Fading in the  $\text{NiH}_2$  Cell  
and its Effects on Cycle Life

Albert H. Zimmerman  
Electronics Technology Center  
The Aerospace Corporation  
El Segundo, California 90245

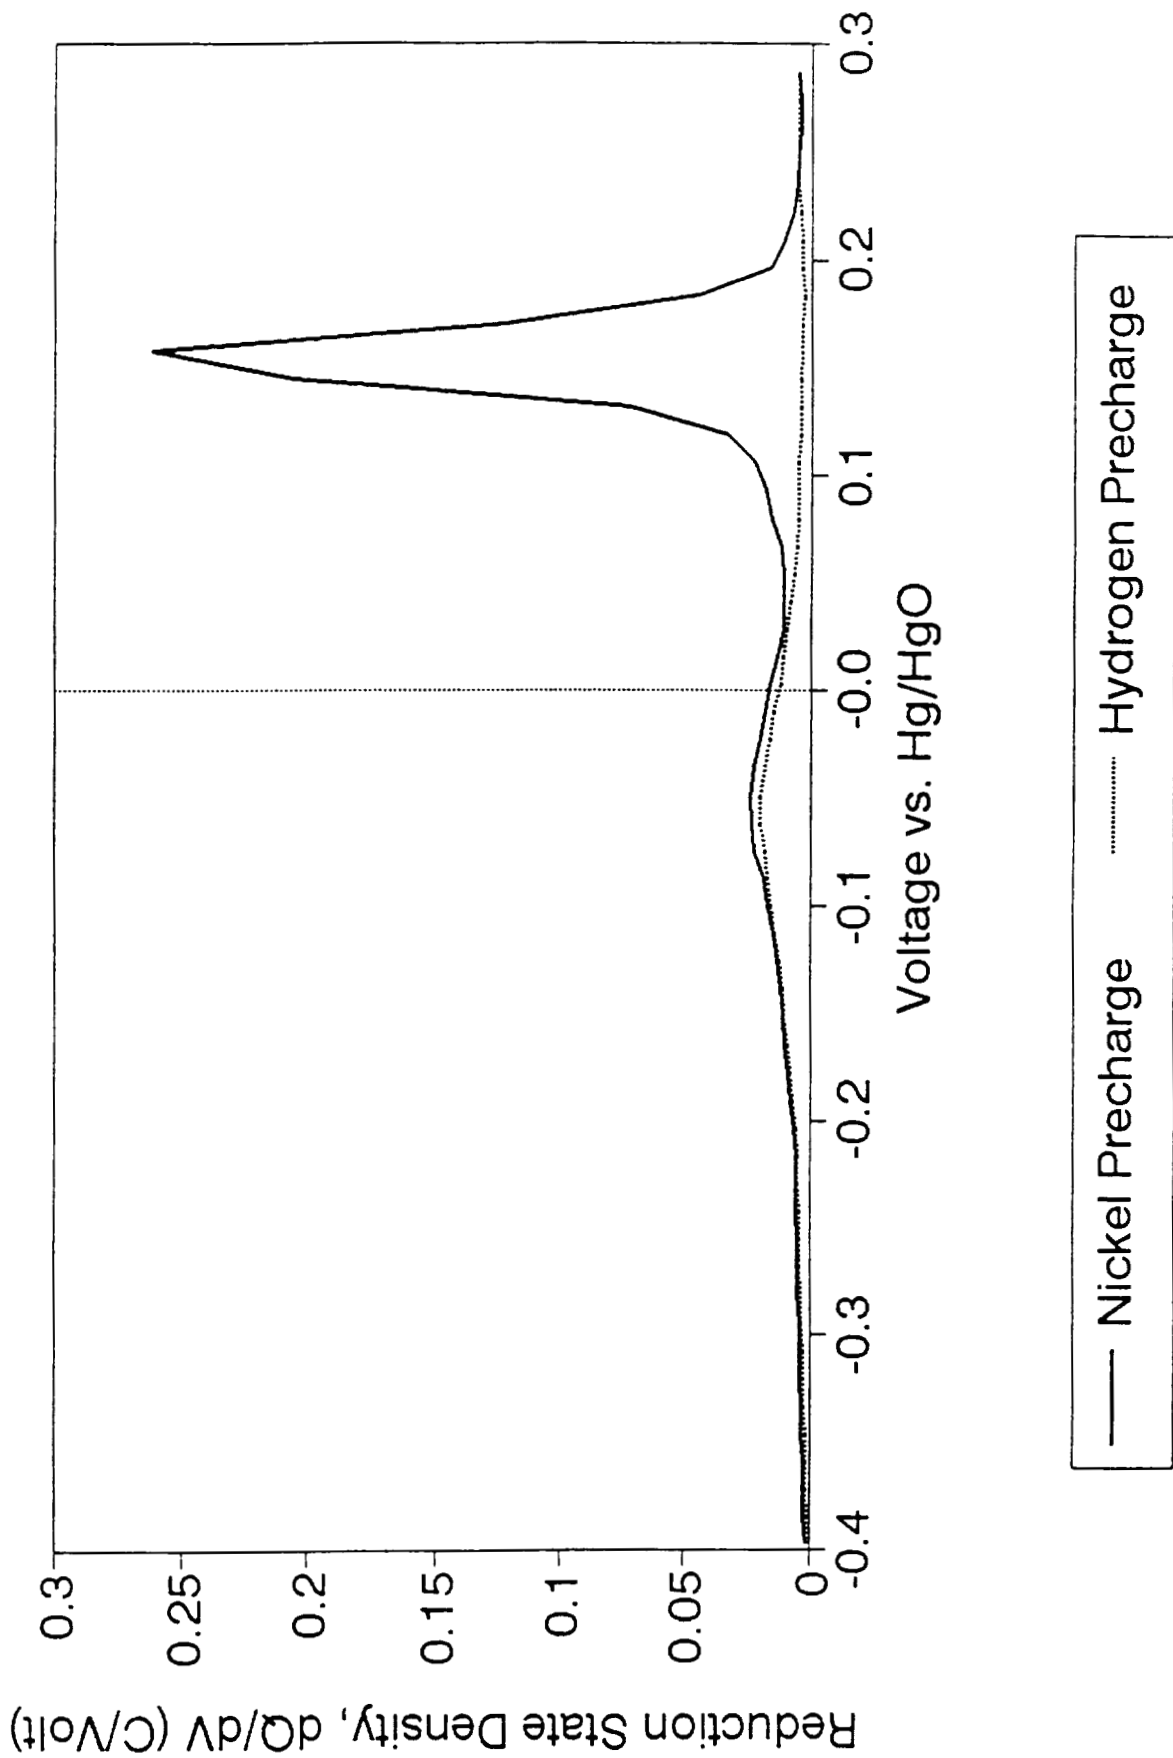
FIGURE 12.

# Reduction State Density vs. Potential Nickel Electrodes from Stored Cells

The  $\text{NiCo}$  oxyhydroxide compound formed in a nickel precharged cell provides an unambiguous signature indicating whether the precharge has indeed remained intact over the life of the cell. Figure 12 shows the voltage signature for this compound. While not having a high electrochemical activity, in a slow scan voltammetric measurement (Fig. 12 uses less than a  $2 \mu\text{V}/\text{sec}$  sweep rate) reduction of a well defined phase is seen at about 0.15 volts vs.  $\text{Hg}/\text{HgO}$ . This is a potential region where a normal nickel electrode has a

clean minimum in its electrochemically active constituents. Complete reduction of this compound causes it to dissociate within a 24 hr period. Subsequent oxidation of the nickel electrode shows no trace of being able to regenerate this structure, unless done very quickly, whereupon very limited reversibility is seen. Thus, the observation of the 0.15 volt peak of Fig. 12 in a nickel electrode from a stored cell is good evidence that the cell has not experienced temporary conversion to a hydrogen precharged condition at any time in its past history. Conversely, the complete absence of this structure in nickel electrodes from a stored cell with nickel precharge suggests that at some time the precharge has been compromised. We have in fact used this method in several instances to detect conditions that can temporarily compromise the nickel precharge in a cell.

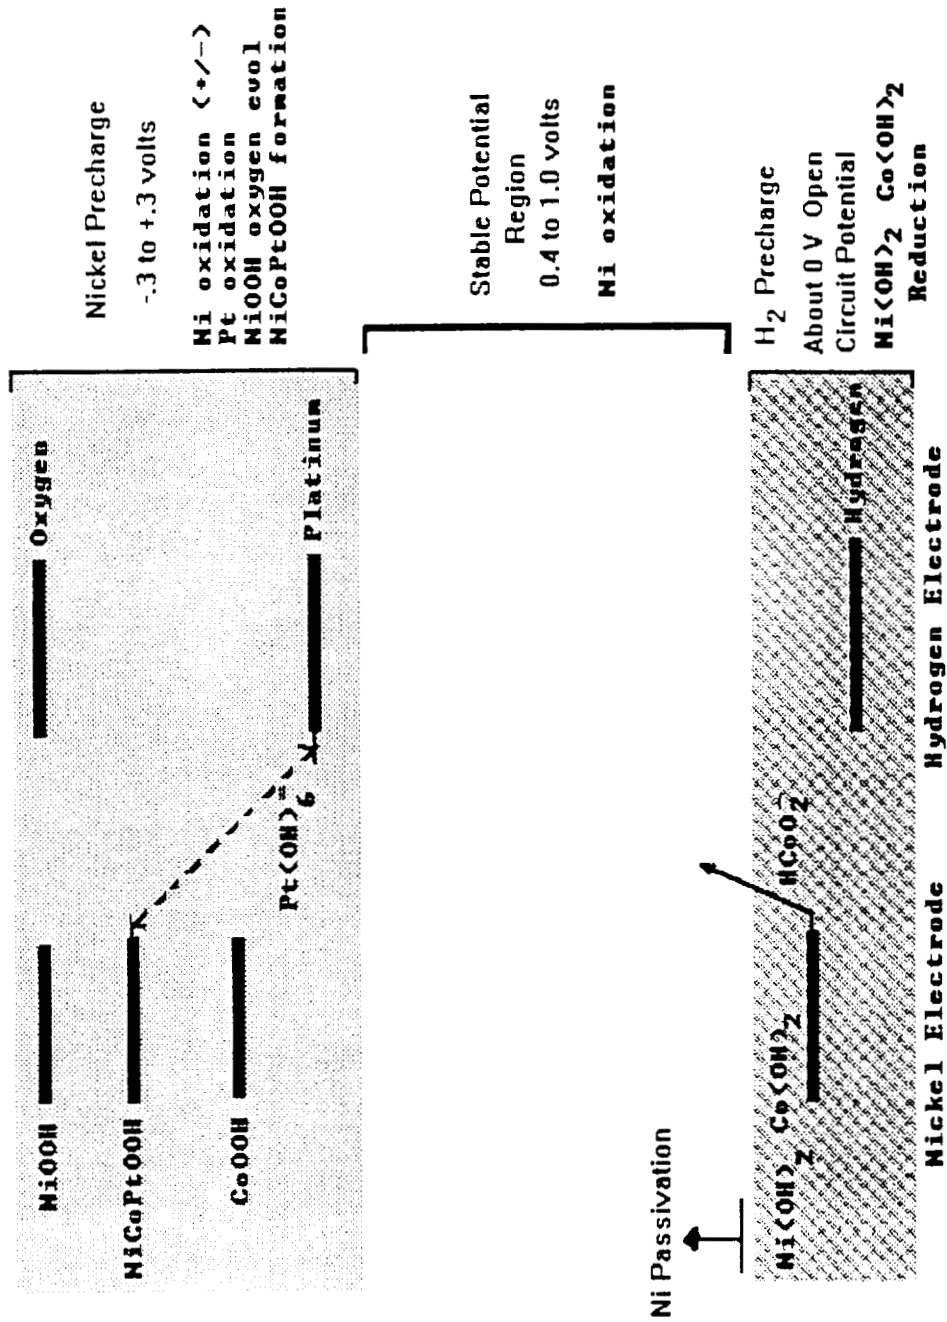
FIGURE 13.  
**Nickel Hydrogen Cell  
 Reactions and Regions  
 of Stability**

Figure 13 attempts to summarize the principal processes that can occur in stored nickel hydrogen cells. At the bottom of Fig. 13, the situation in a hydrogen precharged cell is shaded in. The depleted nickel electrode is reduced to a potential near that of the hydrogen electrode, giving an open circuit cell potential near zero. At these potentials the nickel and cobalt hydroxides in the active material can undergo reduction, and if the potential is subsequently increased, the dicobaltite ion can form from cobalt hydroxide. Above about 0.3 volts vs. hydrogen the nickel sinter begins to oxidize and develops a passivation layer, becoming fully passivated above about 0.5 volts.

The shaded region at the top of Fig. 13 indicates the reactions that can take place during storage of a nickel precharged cell. The platinum electrode is driven above the potential at which it can oxidize to the potential dictated by the oxygen in the cell, again giving a cell voltage of 0 to +0.3, depending on the exact oxygen pressure in the cell. Formation of platinate ions and their reaction with the nickel electrode can eventually reduce the potential of the nickel electrode, thus driving the open circuit cell potential negative. When the CoOOH couple is also included, it is possible to have the open circuit potential of the stored cell go negative by up to -0.3 volts. Thus the open circuit potential of a stored nickel precharged cell can drift between about 0.3 and -0.3 volts, depending on the oxygen pressure and the chemical state of the nickel precharge.

The most interesting aspect of Fig. 13 is that there is a region in the middle where none of the reactions considered here are possible except nickel corrosion. However, at cell potentials above 0.5 volts and below 1.0 volt, nickel metal is passivated, and actually more

stable than in ambient atmosphere, assuming that no anionic species are present that can accelerate corrosion by breaking down the passivation layer. Whether a cell has a hydrogen precharge or a nickel precharge, it can be maintained in this window of stability simply by maintaining a cell potential of 0.5 to 1.0 volts. This appears to be an ideal storage condition for a nickel hydrogen cell, one which eliminates concern over the precise details of precharge, its level, and its stability.
