NASA Technical Memorandum 106140

NDE of PWA 1480 Single Crystal Turbine Blade Material

Stanley J. Klima, Thomas W. Orange, and Robert L. Dreshfield
Lewis Research Center
Cleveland, Ohio

April 1993

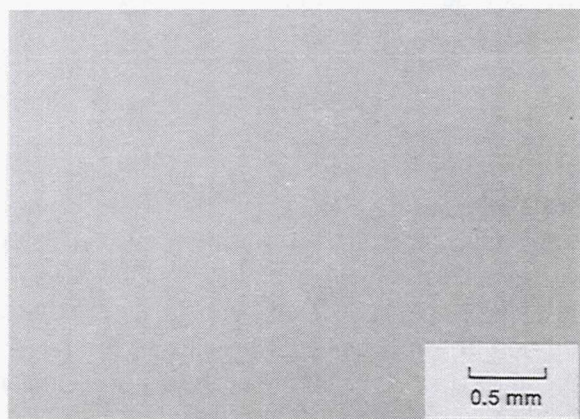
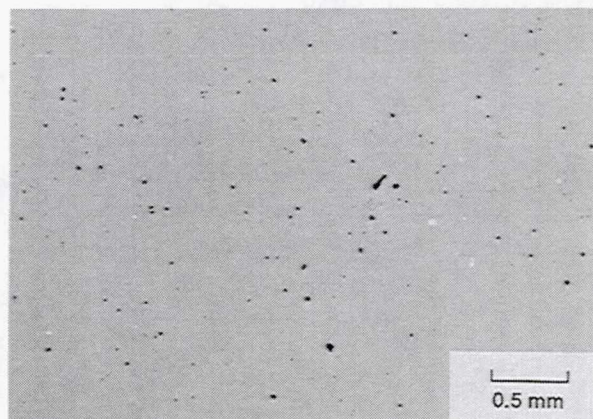
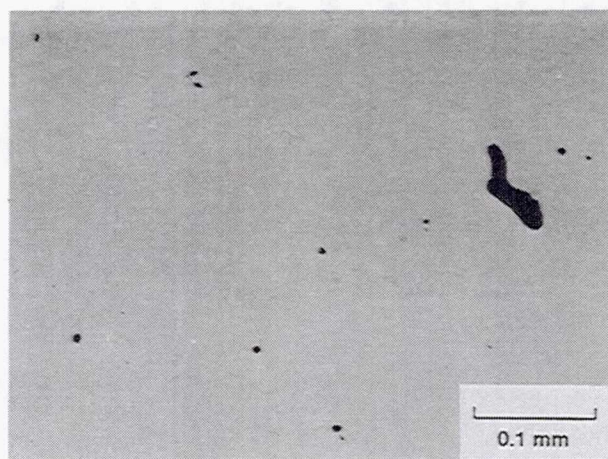
Figure 1.—Typical pore distribution in HIPed and unHIPed PWA 1480 single crystal material. No pores were observed in HIPed material at these magnifications. Unetched crosssections normal to the <100> direction.

randomly chosen HIPed fatigue specimens from this program revealed little evidence of internal voids at magnifications up to 200X. An example of a typical unetched crosssection of a HIPed sample in figure 1 shows no voids. It should be noted that HIPing cannot close pores open to the surface so the possibility still remains for many voids to exist in parts of blades with little or no surface material removed.

ground specimens also exhibit no systematic differences between HIPed and unHIPed material. Comparisons with metallographic evidence in figure 1 suggest that there are fewer indications than might be expected in the unHIPed samples, probably because the liquid cannot penetrate into voids unless they are significantly larger than 10 μm . On the other hand, the HIPed sample results show more

indications than would be expected from the metallographic evidence (fig. 1). More evidence is required to determine whether the latter are true or false indications. Liquid penetrant results on polished specimens did not differ substantially from the ground specimen results and therefore examples are not shown here.

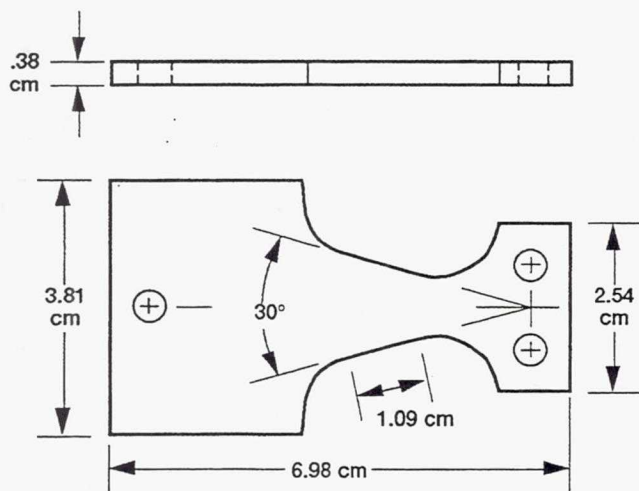
Figure 2.—Cantilever bending fatigue test specimen.

SPECIMENS AND TESTING - Cantilever plane-bending fatigue specimens were machined from both as-cast and HIPed slabs to specifications shown in figure 2. The design provides for a constant stress test section over an area of 1.25 cm². To study the effect of surface condition on fatigue life and the ability of NDE to detect the voids that contribute to crack initiation, specimens with three surface conditions were prepared. These included HIPed and unHIPed specimens with an unfinished surface (essentially as-cast except for subsequent thermo-mechanical treatments), machined specimens finished to nominally 0.2 µm RMS by grinding, and polished specimens prepared by grinding to a similar finish and lapping with alumina polishing compound to remove some of the cold

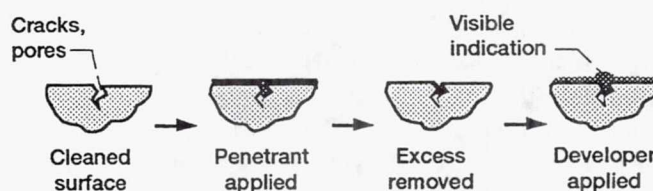
Figure 3.—Fluorescent liquid penetrant method. Penetrant enters surface-connected discontinuities where it is retained after removal of excess from outer surfaces. Powder developer wicks penetrant from the discontinuity so it can be highlighted by ultraviolet light.

surface of a solid object with a continuous film that is drawn into surface discontinuities such as cracks and pores by capillary action. Figure 3 schematically illustrates the process. The object must be cleaned to optimize wettability and to eliminate absorbent foreign matter that would create false indications. Vapor solvent degreasing is very effective for metallic objects. The part is then immersed in the penetrating liquid, and after a suitable dwell time the excess is washed from the surfaces, leaving residual penetrant only inside the discontinuities. A developer, consisting of a fine absorbent powder, is then applied to wick the liquid from the discontinuity to the surface in the immediate vicinity of the defect. The most sensitive penetrants contain particles that fluoresce in the presence of ultraviolet light, which highlights the flaw in darkened surroundings. A wide variety of penetrating liquids, dyes, fluorescent materials, and developers are available, and it is important to choose the optimum combination for a given application.

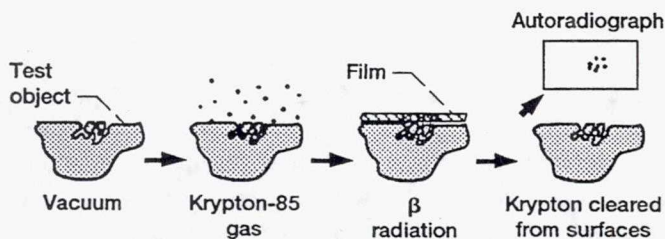
Figure 4.—Radioactive gas penetrant method. Krypton-85 gas is adsorbed onto the object but quickly escapes from the outer surfaces. Film or emulsion applied to object surfaces is exposed locally to β radiation from gas entrapped by the flaws, generating an autoradiograph.

RADIOACTIVE GAS PENETRANT - The penetrating liquid and radioactive gas techniques are similar in principle, but the procedures differ because of the greater mobility and radioactivity of krypton gas. The radioactive gas penetrant technique is illustrated in figure 4. The test object is cleaned and placed in a controlled environment chamber, and a vacuum pumped to remove adsorbed air molecules from all surfaces, particularly in the defect. The chamber is backfilled with dilute (less than 5 percent) krypton-85 gas which is adsorbed onto the object and defect surfaces. The krypton is then pumped from the chamber and the test object removed. The adsorbed gas on the object is quickly released into the atmosphere of the

chamber when it is pumped down, normally to a pressure of 0.1 mm Hg. Krypton gas remains entrapped in tight defects long enough to apply beta radiation sensitive film or emulsion to the surface and produce an autoradiograph showing the exact location and, to lesser degree, the relative volume of the defect. Shallow flaws with smooth sides can be missed if the surface opening is so great that the krypton molecules escape before film is applied. This limitation, coupled with the small diameter of the krypton molecule (0.3 nm) makes the method best suited to detection of relatively tight flaws. Thus, it may be most effectively used to complement rather than replace liquid penetrants. Gas penetrant evaluation of the fatigue specimens in this investigation was performed by Qual-X, Incorporated, the sole provider of this service in the United States.

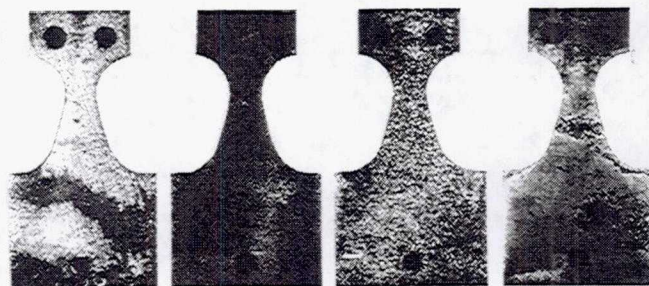
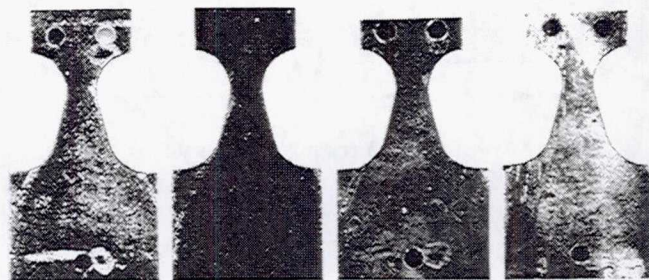
Figure 5.—Fluorescent penetrant indications on specimens with cast surfaces. High level of fluorescence is caused by a large pore population and rough surface texture.

LIQUID PENETRANT INSPECTION - Results of fluorescent liquid penetrant inspection of specimens with cast and machined surfaces are shown in figures 5 and 6 respectively. A high level of fluorescence is present in most cast specimens, typical of rough surfaces and a large surface pore population. The sample-to-sample variation indicates that subtle processing variations took place during casting or subsequent handling. Each specimen has a character of its own and no systematic differences appear to exist between the HIPed and unHIPed material. The machined specimens in figure 6 have a much lower background noise level and exhibit a relatively small number of discrete indications in clear contrast to the cast surfaces. The

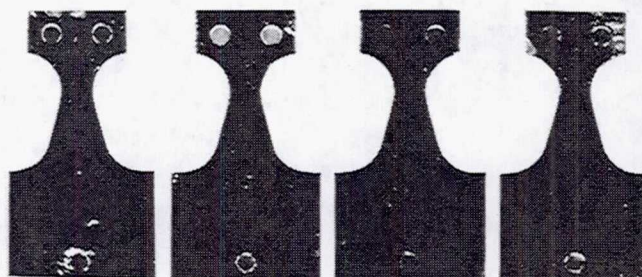
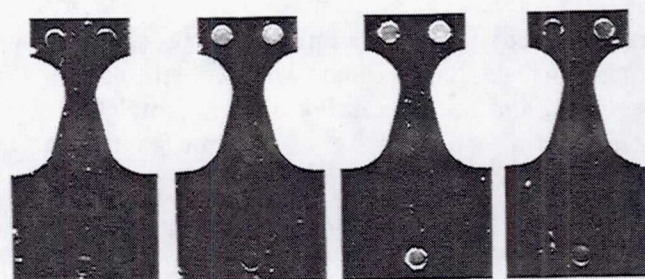
Figure 6.—Fluorescent liquid penetrant indications on specimens with machined (ground) surfaces. There is no significant difference in the number of indications on the HIPed and unHIPed samples.

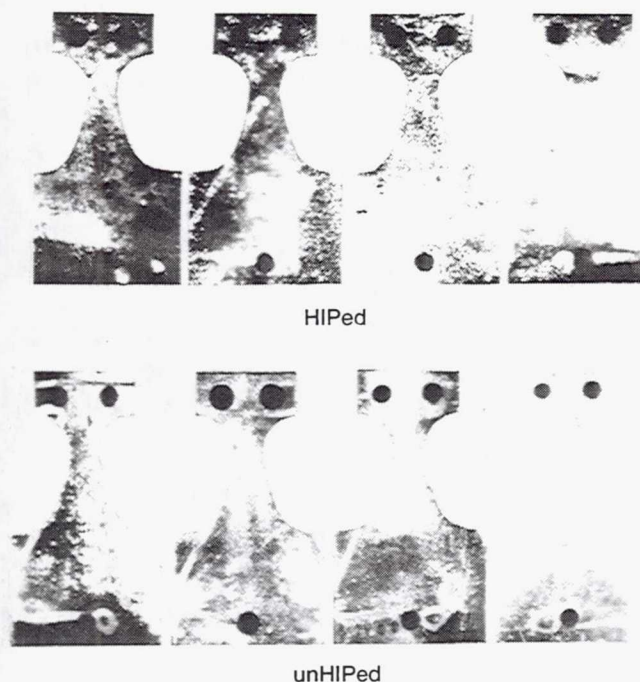
Figure 7.—Radioactive gas penetrant autoradiographs of specimens with cast surfaces. High level of gas retention by surface porosity and rough texture causes general exposure of film, making detection of discrete defects difficult.

GAS PENETRANT INSPECTION - Autoradiographs of specimens with cast, ground, and polished surfaces are presented in figures 7 to 9 respectively. The bright spots and areas are where the krypton gas was retained, resulting in darkening of the film placed in contact with the specimen surface. The prints in the figures show the inverse contrast to the original film. Figures 7 and 8 show results for the same specimens evaluated by liquid penetrant in figures 5 and 6. It is obvious that the cast specimens have far greater affinity for krypton gas than either the machined or polished surfaces. It is impossible to identify discrete indications on the cast surfaces. Five of the specimens (fig. 7) have white stripes running in random directions across the large end, which coincide with identification marks made by an indelible marking pen. Even though evidence of the marks was removed before NDE, the regions seem to have an affinity for krypton molecules. The cast surfaces in general retained krypton gas for a longer period of time than machined or polished surfaces, and had to be heated to drive off the adsorbed gas and get the level of radiation down to near background levels.

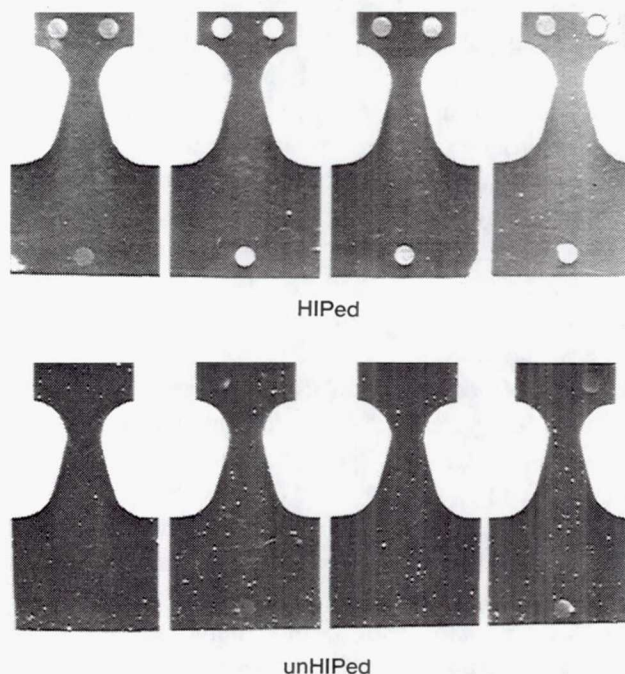
Figure 8.—Radioactive gas penetrant autoradiographs of specimens with machined (ground) surfaces. HIPed specimens exhibit very few indications, implying that internal porosity is virtually eliminated by hot isostatic pressing.

The autoradiographs of machined samples in figure 8 are very different from those of cast samples in that the

indications are discrete and relatively few in number. This is undoubtedly because a layer of relatively porous surface material was removed by grinding. Because of their small size some of the indications may not have reproduced well for publication, therefore, the observations will be described in text. There is a striking difference in the

number of indications in the unHIPed material compared to the HIPed material. The two HIPed samples on the right have two indications in the test section and a dozen or more in the large end, while the other two have no indications in the test section and very few in other parts of the specimen. The unHIPed specimens have countless indications throughout, which agrees generally with the metallographic observations described in an earlier section, insofar as the relative population of voids in the two materials is concerned. It should be noted that, although the specimens were identical, virtually none of the indications produced by the gas and liquid penetrants are in the same location on the surface. At this point there is insufficient analysis to determine whether the methods complement each other or if one or both are producing false indications.

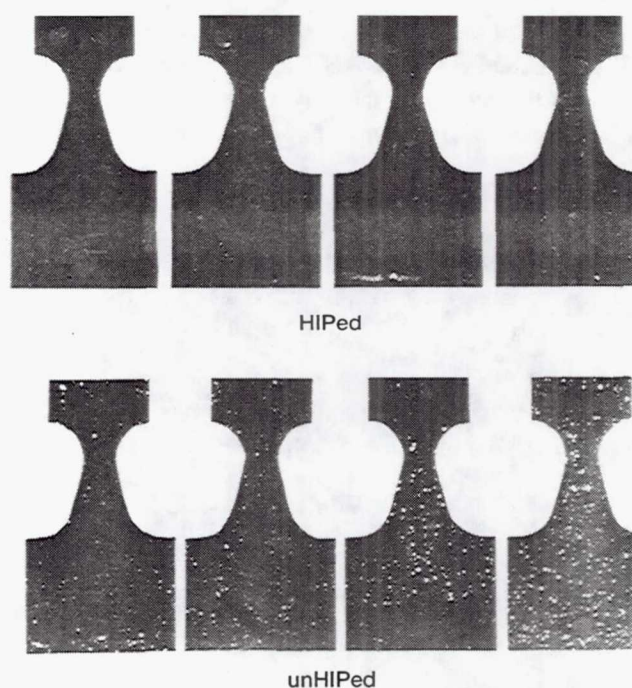
Figure 9.—Radioactive gas penetrant autoradiographs of specimens with polished surfaces. Comparison of un-HIPed samples with those in figure 8 suggests that polishing enhances detection of smallest pores by removing cold worked surface.

Figure 9 shows autoradiographs of HIPed and unHIPed specimens that were polished to remove the thin layer of disturbed (smeared) material usually caused by grinding. The results for HIPed material are similar to the ground surface results in figure 8, again confirming metallographic evidence that little porosity exists. However, the data for unHIPed material show somewhat more indications on polished samples than on as-ground samples. Because the specimens are different, it is possible that the polished set simply contains more voids, but there certainly is an implication that polishing enhances void detection by the gas penetrant. A similar effect was not evident on the same specimens with liquid penetrants, which produced few indications on both polished and ground surfaces. Thus, in general, the radioactive penetrant technique appears to provide more accurate information regarding the existence and distribution of very small pores.

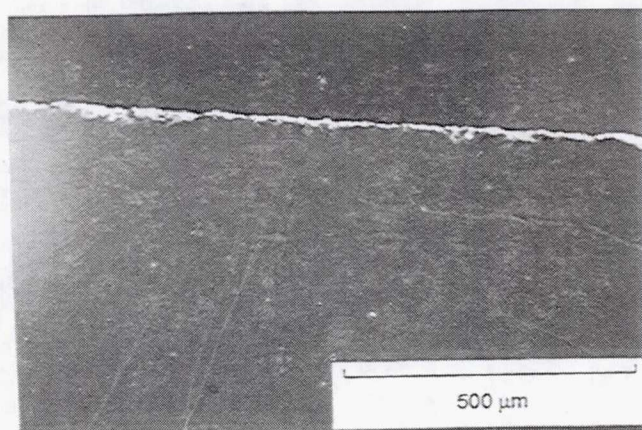
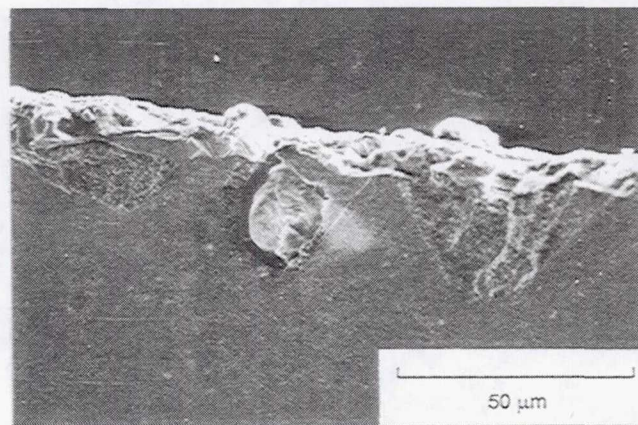
Figure 10.—Fracture surface of a HIPed specimen showing that cracking was initiated by a concentration of defects. Most cracks near cast surfaces started in γ -free reaction zones

METALLOGRAPHY AND FRACTOGRAPHY - An example of the type of crack origin observed in specimens with cast surfaces is shown in figure 10. Because of a

preponderance of defects at the cast surfaces, cracking always initiated at a point where a concentration of defects occurred. Figure 10 shows that the fatigue crack leading to fracture started in the vicinity of three defects, one of which may be an inclusion while other two have a different character. Instead of voids, they resemble pockets of extremely fine porosity. Metallurgical crosssections were taken from the ends of ten specimens for further study. Typical results are presented in figure 11 which shows closely spaced reaction zones along the cast surface that at low magnifications appear to be incipient melting, which is always of concern when solution treating or HIPing. At higher magnifications, however, pockets containing a fine granular structure beneath a skin-like layer are revealed. The structure has the appearance of γ' with the γ phase leached out. Energy dispersion scans (EDS) showed that the particles indeed are the γ' phase. The size and number of these pockets was similar for HIPed and unHIPed samples. Similar features were not observed internally or at a machined surface.

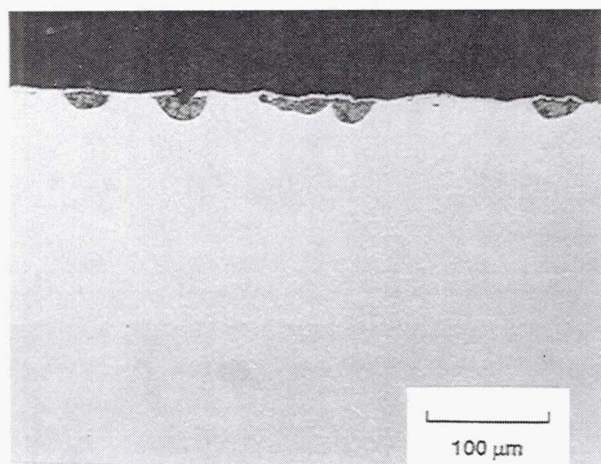
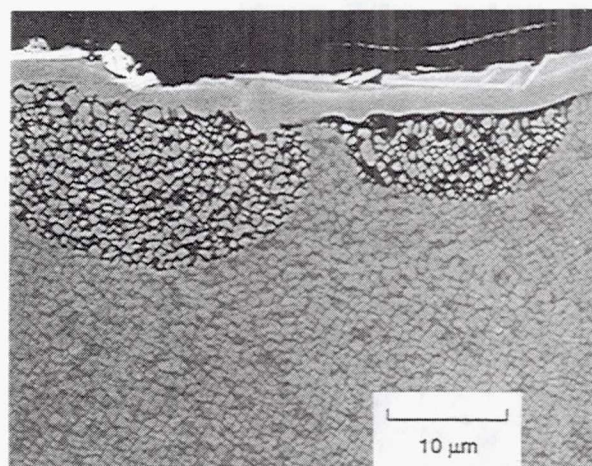
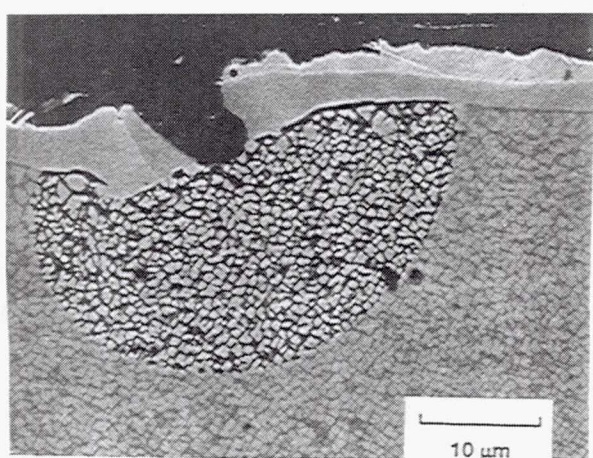
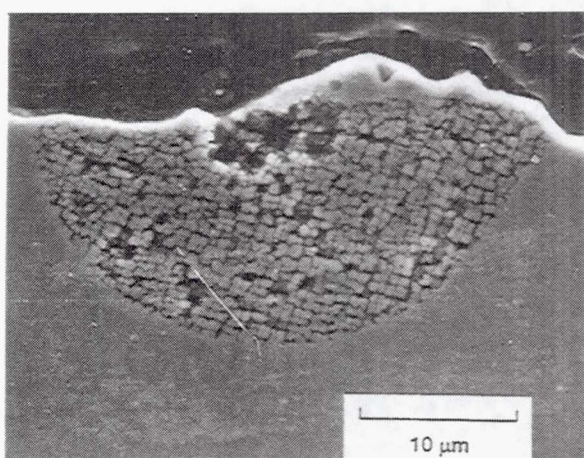
Figure 11.—Reaction zones near cast surfaces containing precipitate particles of γ' phase. γ matrix appears to have been leached out by a grain boundary etchant. Occurrence of reaction zones is similar in HIPed and unHIPed material.

Figure 11 also shows a subtle difference in the thickness of the skin on the HIPed and unHIPed materials. The HIPed samples had a dual layer skin that was a total of about 5 μm thick. EDS shows that the composition of the inner layer is identical to the γ' particles. The outer skin layer is similar to the γ phase except that it is higher in tantalum and, unlike γ , has a plate-like structure. EDS showed alternating plates to be essentially Ni_3Ta . The unHIPed samples had a much thinner skin, 1 μm or less, but a reliable analysis was not obtained. An example in figure 11 illustrates that these pockets may all be exposed to the surface through breaks in the skin. It was surmised that phosphoric acid grain etchant used to confirm that the casting is a single crystal, seeped under the skin and formed the reaction zones by leaching out the matrix because it could not be washed out.

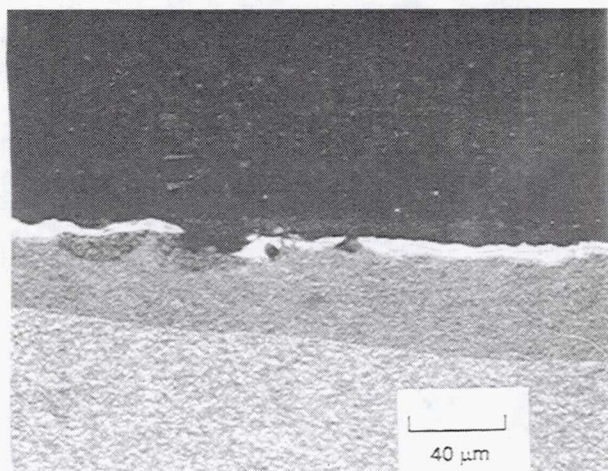
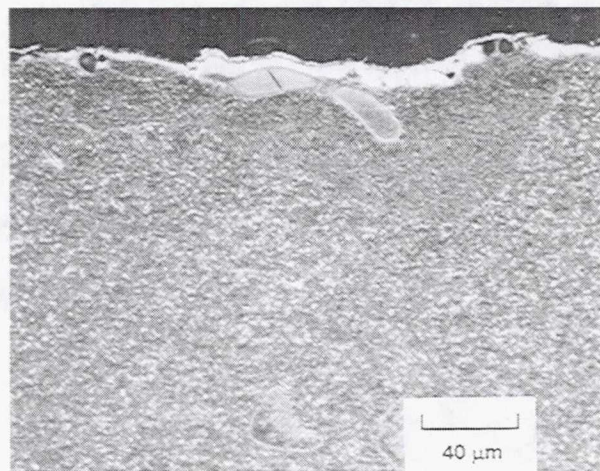
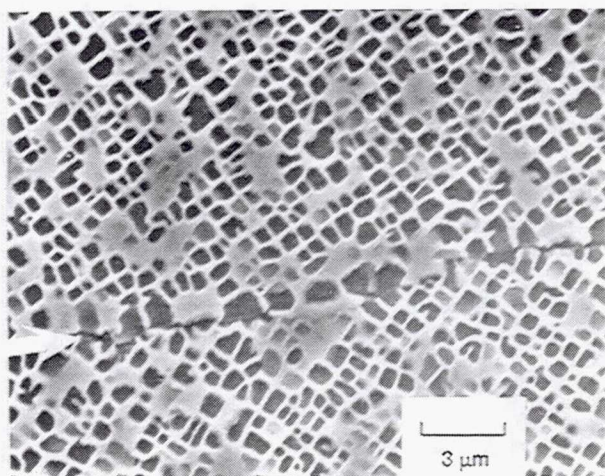
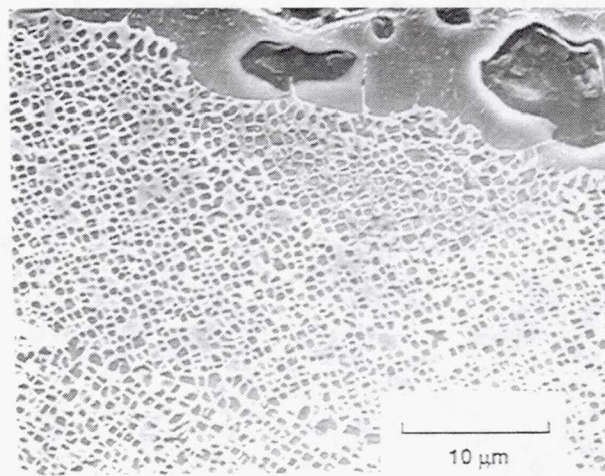
Figure 12.—Crosssections of HIPed specimens showing recrystallization near the cast surface. Recrystallization was discontinuous and observed only in HIPed material. Depth ranged up to 75 μm .

Figure 12 shows etched crosssectional views at the cast surfaces of HIPed fatigue specimens. The primary features are areas of recrystallized material along the cast edge, which are discontinuous and vary in depth up to 75 μm . The high magnification photographs confirm that the interface between the light and dark regions are grain boundaries. Since the alloy does not contain grain boundary strengtheners, it is expected that material containing these unwanted features would be relatively weak, especially where the grain boundary is oriented normal to loading direction. Recrystallization was not observed in the unHIPed specimens examined.

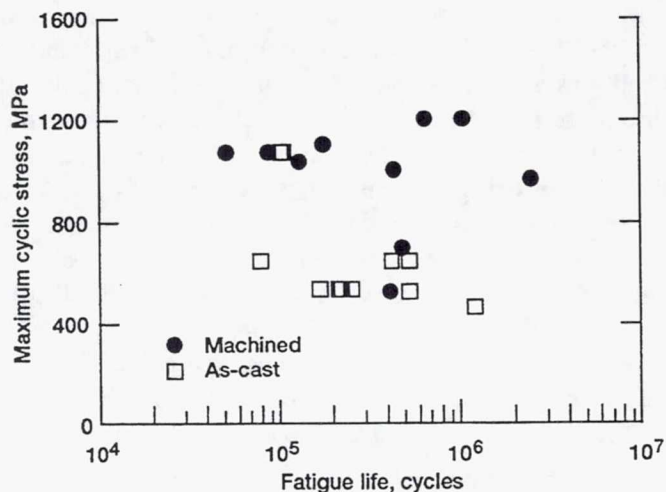
Figure 13.—Cantilever bending fatigue results on specimens with either machined or cast surfaces. Fatigue strength is improved by removing the cast surfaces.

FATIGUE TESTS - A comparison of the fatigue life of PWA 1480 specimens with cast and machined surfaces is presented in figure 13. Both HIPed and unHIPed materials are included without distinction. It is clear that the machined samples have a higher fatigue strength than specimen with cast surfaces. This is probably due to the removal of the large population of γ matrix-free reaction zones that exist near as-cast surfaces as described previously. Although the dimensions of individual zones

are small, collectively they probably constitute a significant stress concentration that leads to early cracking.

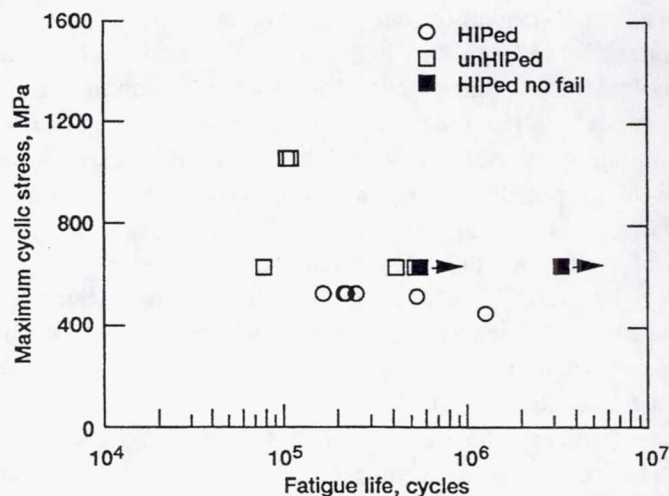
Figure 14.—Cantilever bending fatigue results on HIPed and unHIPed specimens with cast surfaces. HIPed specimens have slightly lower fatigue strength.

Figure 14 compares the fatigue strength of specimens in the HIPed and unHIPed conditions, with cast surfaces only. Taken as a whole, the two sets of data suggest a subtle difference in fatigue strength for the two material conditions and imply that HIPing has a weakening effect. Since both HIPed and unHIPed specimens contain γ free reaction zones, their existence alone cannot explain a difference in strength. As noted in the previous section the HIPed material was recrystallized along the cast surface. It is very likely that the combined negative effect of the reaction zones and the recrystallized areas results in slightly lower average fatigue strength for the HIPed specimens. The limited observations of this investigation suggest that a minimum of 75 μm must be carefully removed from cast surfaces to remove the reaction zones due to etching, and the recrystallized areas formed during HIPing, in order to achieve mechanical properties representative of the bulk material.
