CONTAMINATION ON LDEF:  
SOURCES, DISTRIBUTION, AND HISTORY

Gary Pippin and Russ Crutcher  
Boeing Defense & Space Group  
Seattle, WA 98124-2499  
Phone: 206/773-2846, Fax: 206/773-4946

In this paper we present an introduction to contamination effects observed on the Long Duration Exposure Facility (ref 1). The activities reported here are part of Boeing's obligation to the LDEF Materials Special Investigation Group (ref 2).

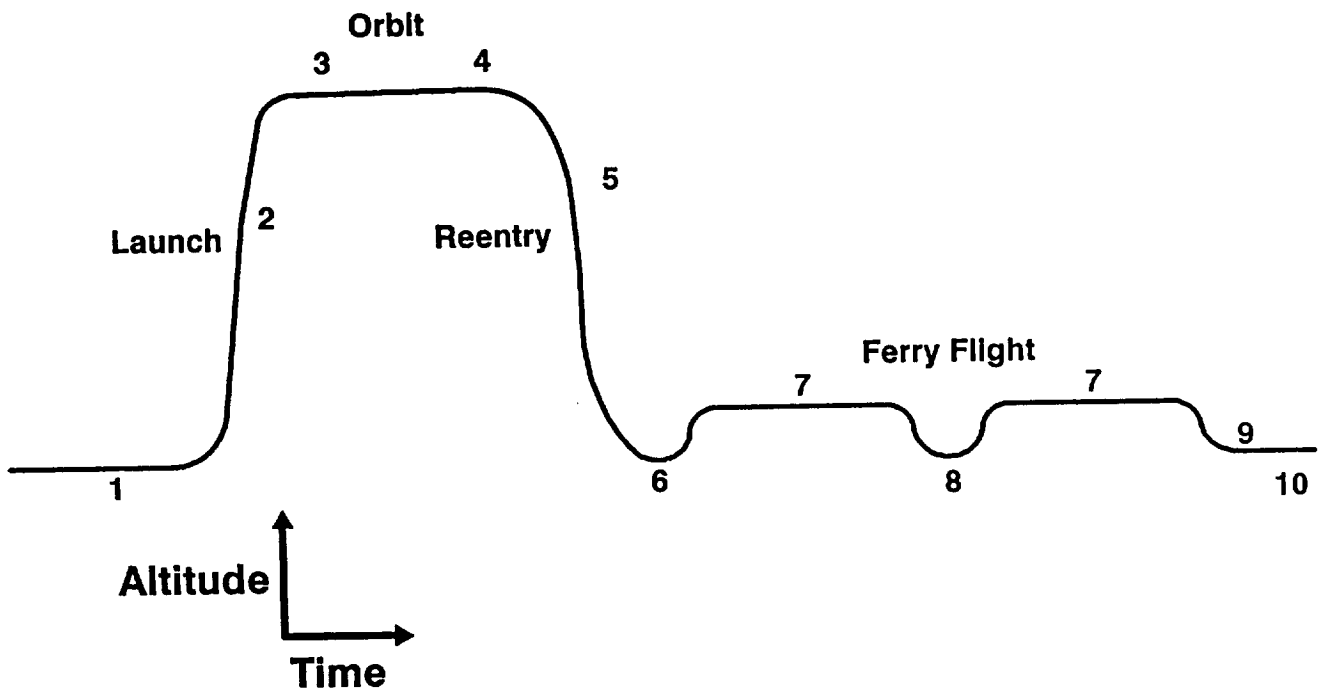
Figure 1. LDEF Contamination Exposure History

Figure 1 is a schematic mission time line to define the types of exposure. Time periods 1,6,8, and 10 are ground environments, and 3 and 4 are deployment from, and retrieval by, the shuttle. The mission may be usefully divided into three categories of contamination exposure periods. First, the preflight exposures include all the ground based processing, which created particles and films which were subsequently carried into orbit. Second, the on-orbit exposure, venting, outgassing and deposition, and subsequent degradation produced new particles and films whose composition varied with time. Third, the post flight environments included additional particulate deposition, moisture absorption, and molecular

film formation. Events during the first two periods must be evaluated for their effects on spacecraft performance. The third time period, post flight exposure, is not typical for payloads because most spacecraft are not retrieved. Therefore contamination from this time period must be viewed simply as an artifact to be factored out of analysis of material performance in flight.

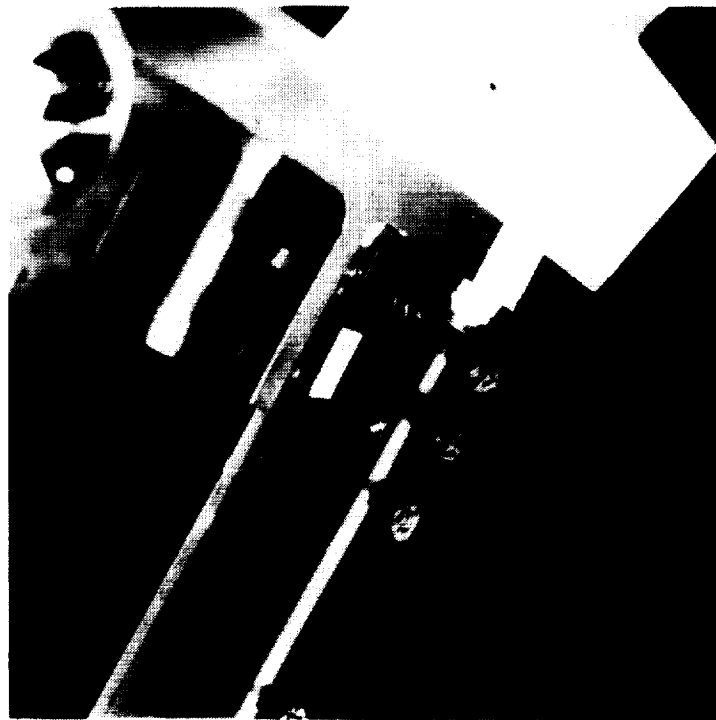
Figure 4. Shadowing from External Environmental Factors at LDEF Interior Locations

Figure 4 shows shadow patterns forming the silhouettes of nuts and bolts from an interior location on LDEF. This shadowing is due to external environmental factors effecting molecular fixing, and not localized outgassing. The edges of the “shadow” patterns are quite distinct and well aligned with one another.

The areas not protected by the bolts appear to have lightened rather uniformly, probably due to intermittent UV exposure through a small opening on the opposite side of the spacecraft. Figure 5 shows a NASA photo taken in SAEF 2 during deintegration. This is the corner of trays A9 and A10, the longeron and tray clamps between and part of the black coated cover plate for the earth end of the LDEF. The black covered plates are slightly raised relative to the structure. Dark brown deposits can be seen on the aluminum structure next to the black plate. This was a vent path from the interior of LDEF and shows that volatile species from the interior can be directed parallel to the exterior surfaces. This plot shows deposition only near the vents because their surfaces are essentially oriented into the ram direction and have been “cleaned” by atomic oxygen. Figure 6 shows an on-orbit photo with large scale deposition of molecular contaminants clearly visible in tray E12. Darkened areas are visible around each electrical feed through and in particular corrosion of the tray.
