SELECTED RESULTS FOR LDEF THERMAL CONTROL COATINGS

Johnny L. Golden
Boeing Defense & Space Group
PO Box 3999 M/S 82-32
Seattle, WA 98214-2499
Phone: (206) 773-2055, FAX: (206) 773-4946

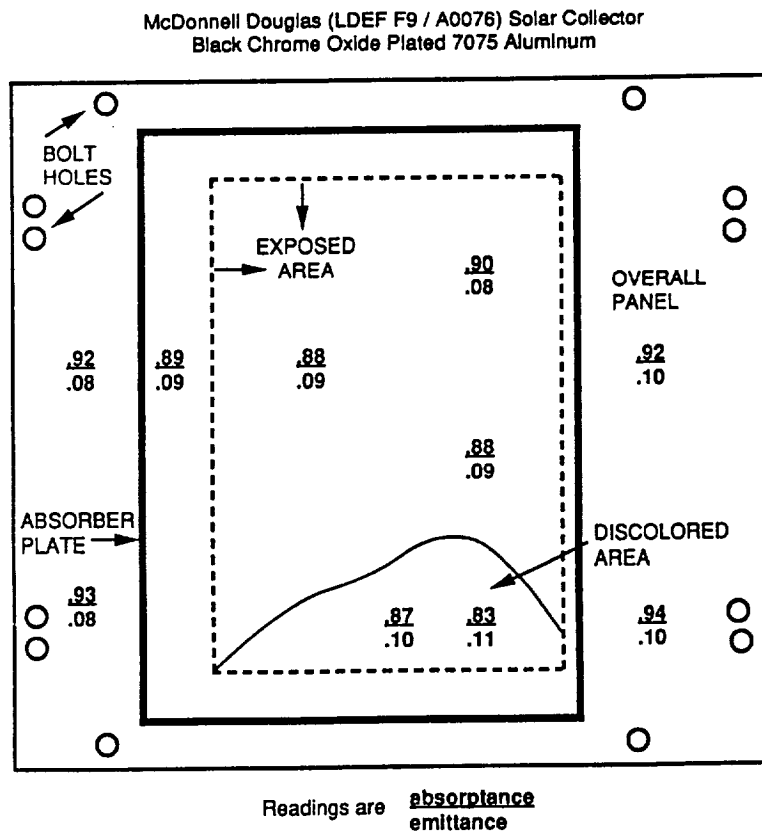
Figure 2. Optical properties of the black chromium plated solar absorber panel.

The optical properties of the various areas on the absorber panel were measured as depicted in figure 2. Emittance was not affected by any of the environmental exposures to the panel. The solar absorptance was reduced slightly on the exposed blue area and was significantly reduced in the tan area.

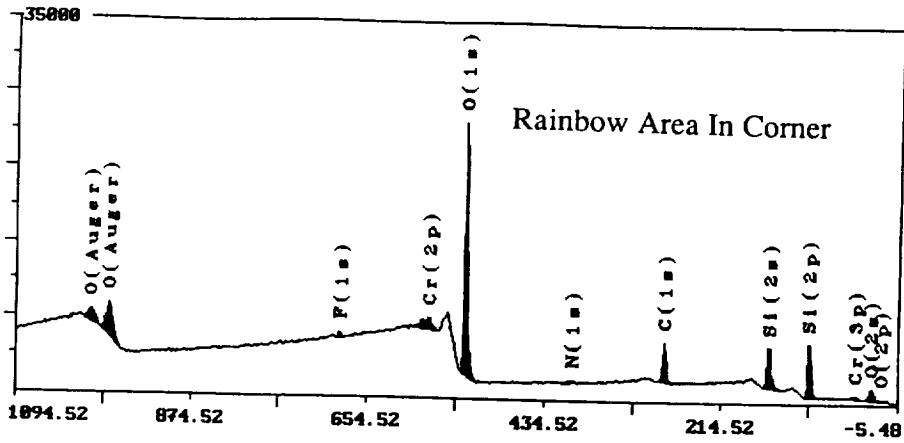
Element	Binding Energy	atom %
F (1s)	688.78	0.72 %
Cr (2p)	578.06	1.75 %
O (1s)	532.87	51.70 %
N (1s)	401.12	1.32 %
C (1s)	285.00	20.59 %
Si (2s)	153.69	23.93 %
Total Percent		100.00 %

Figure 3. ESCA survey of a rainbow colored area on the black chromium plated solar absorber panel

With the heating effect hypothesis discredited, surface analysis was again tried in order to illuminate the differences between the blue and tan areas on the absorber panel. Figure 3 is an ESCA surface survey of the iridescent or 'rainbow' area in one corner of the exposed area. Most notable in this survey are the high levels of oxygen, silicon, and carbon, indicative of silicone contamination. Figure 4 is an ESCA survey of the exposed blue area, where the silicon levels are significant but much less than that observed the corners of the exposed area. Figure 5 is a survey of the tan area, which appears to have lower silicon levels than the exposed blue area.

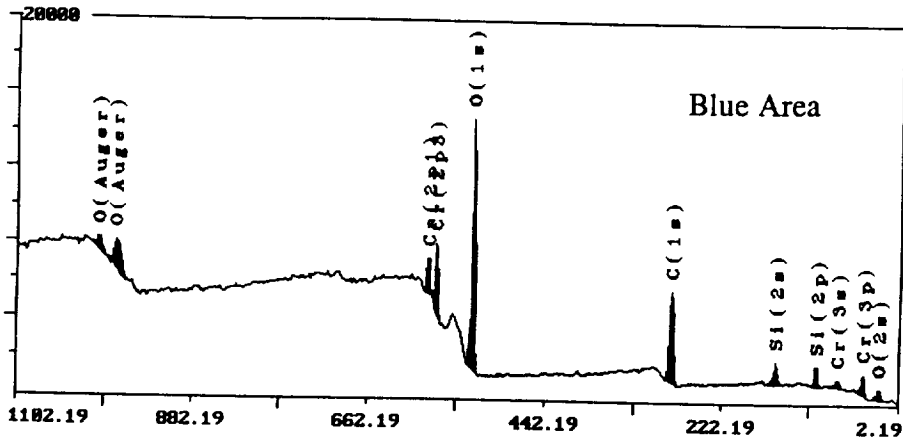
Element	Binding Energy	atom %
Cr (2p3)	578.50	4.16 %
O (1s)	532.68	44.02 %
C (1s)	285.00	43.05 %
Si (2s)	154.37	8.78 %
Total Percent		100.00 %

Figure 4. ESCA survey of a blue colored area on the black chromium plated solar absorber panel

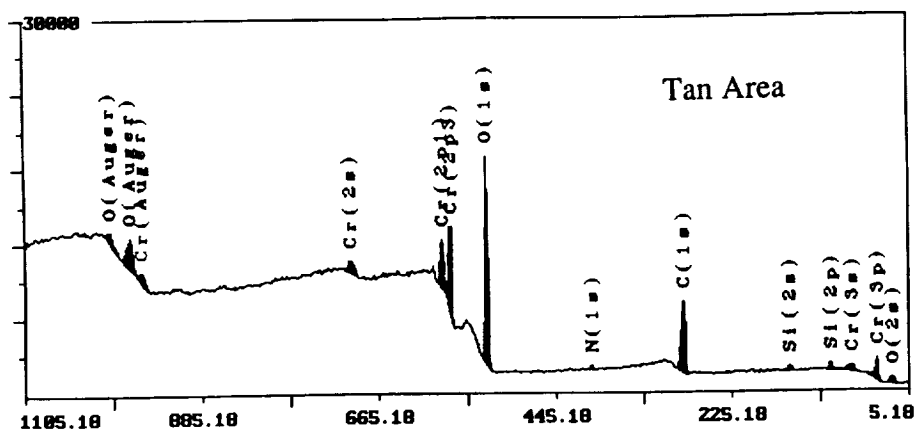
Element	Binding Energy	atom %
Cr (2p3)	577.16	6.29 %
O (1s)	531.82	43.19 %
N (1s)	400.04	0.80 %
C (1s)	285.00	45.14 %
Si (2p)	101.58	4.58 %
Total Percent		100.00 %

Figure 5. ESCA survey of a tan colored area on the black chromium plated solar absorber panel

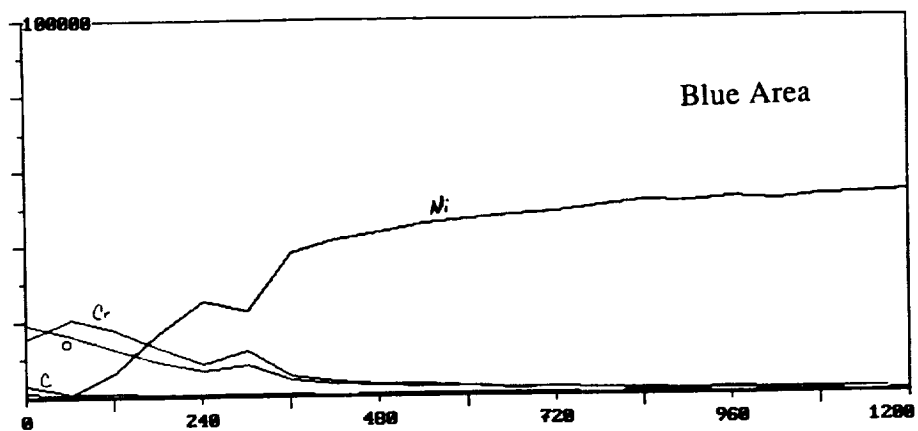
Figure 6. Auger profile of blue area on the black chromium plated solar absorber panel.

Elemental Auger profiles for the blue and tan areas are shown in figures 6 and 7. The blue area in figure 6 indicates initially chromium and oxygen, changing to mostly chromium metal with sputtering just as the nickel underplate begins to become apparent. The data from figure 6 is consistent with what is expected for both this system and for the unexposed original black surface. The tan area profile in figure 7 was unexpected. Note the scale on the y-axis is 10% of that in figure 6. It appears that the tan area is much thicker and more completely oxidized than the blue area. A consistent picture for this particular coating and the changes it exhibits has not been achieved; the analysis is continuing.

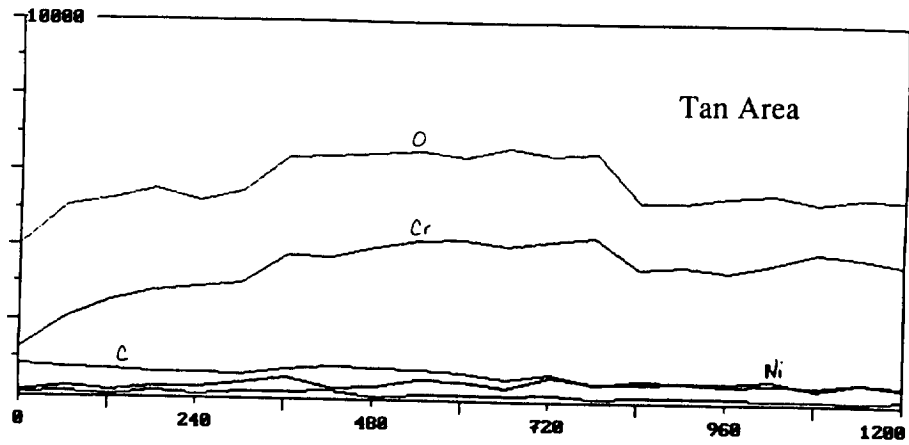
Figure 7. Auger profile of tan area on the black chromium plated solar absorber panel.

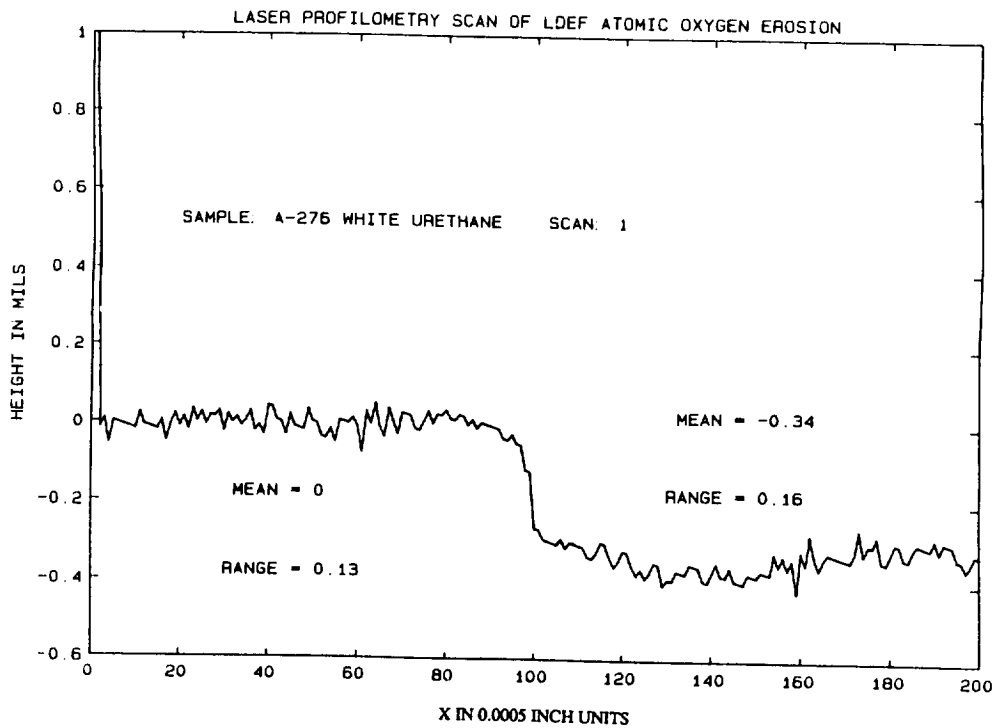
Figure 8. Laser profilometry of A276 white paint on tray D9 at a protected/unprotected interface towards row 10.

Specimens from the composite panel were taken from around the protected attachment areas, and the loose pigment on those specimens was removed by rag wiping. The specimens were then measured using laser profilometry. Height profiles from two different areas along the protected-to-unprotected interface are shown in figures 8 and 9. The figure 8 profile was taken perpendicular to the LDEF axis along the surface toward row 10. The LDEF yaw offset gave the incident atomic oxygen direct access to the paint at the washer interface, yielding a steep erosion profile. Figure 9 was also taken perpendicular to the LDEF axis, but along the surface toward row 8 (180° from figure 8). Here the yaw offset allowed the washer to shield the paint from atomic oxygen erosion at the interface, yielding a tapered erosion profile. The total erosion depth measured using these two profiles, plus four additional measurements, indicated atomic oxygen attack

into the A276 paint surface to a depth of about 10 μ m (0.0004 inch). Correlation has not been established between the depth of attack and the pigment layer porous structure (0.2 μ m TiO₂ particles, 1-2 μ m talc particles, 40.6 volume percent solids). It is not certain that this measured erosion depth is the limit for which atomic oxygen can penetrate into the A276 pigment layer. However, it seems likely that this must be the penetration limit based on the tortuous path atomic oxygen would have to follow in order to continue reacting with the paint resin layer.

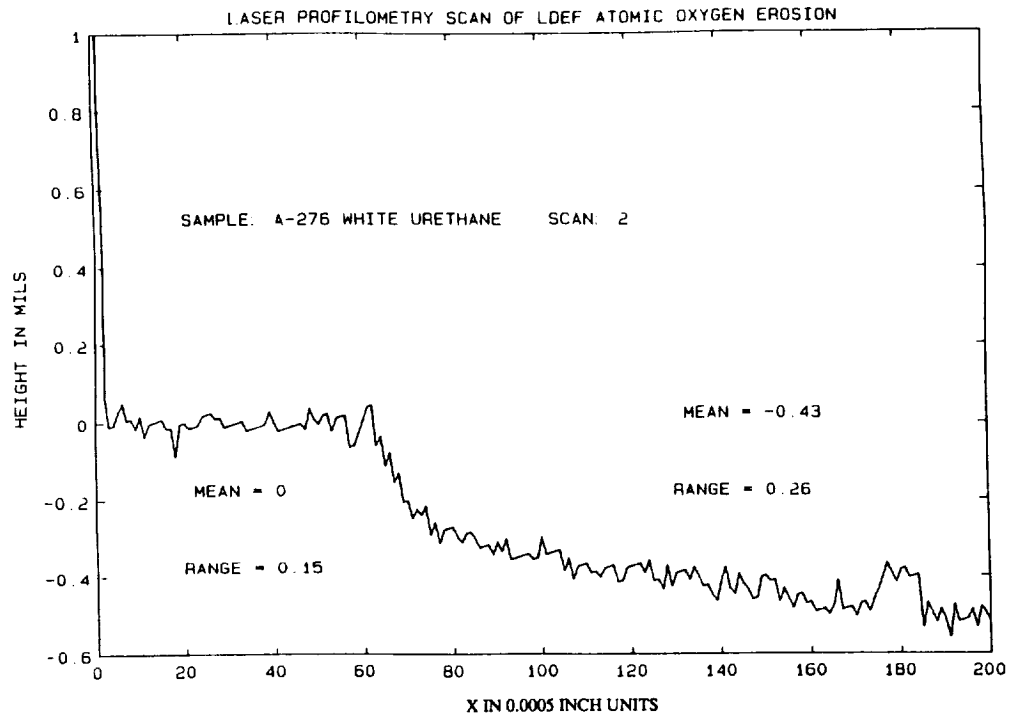
Figure 9. Laser profilometry of A276 white paint on tray D9 at a protected/unprotected interface towards row 8.

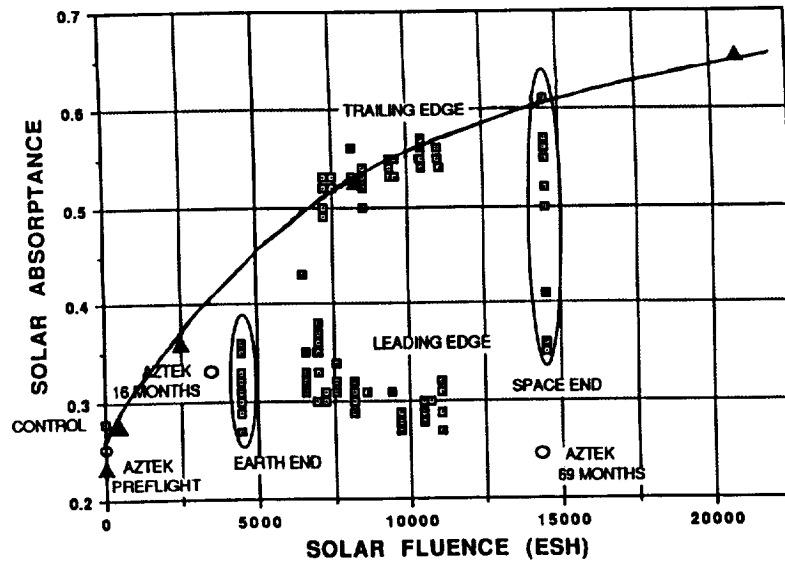
Fluence (per cm ²)	Scaled ESH	Absorbance
0	0	0.23
1 x 10 ¹⁴	420	0.27
6 x 10 ¹⁴	2500	0.36
2 x 10 ¹⁵	8300	0.52
5 x 10 ¹⁵	20800	0.66

Figure 10. Comparison of LDEF results with ground-based radiation test result from Boeing CRETC for A276 white paint.

The UV degradation of A276 paint on LDEF has been discussed previously (ref. 6). A276 on surfaces not exposed to atomic oxygen has exhibited a sharp increase in solar absorptance with UV exposure. Attempts made to locate ground-based test data for comparison with the LDEF results were essentially unsuccessful. Literature data for numerous white coatings (including A276) have been found, but these reports are typically limited to less than 1000 ESH total UV exposure, due to the moderate UV source intensities that must be used. Another limitation is that ground-based test results are from in-situ reflectance measurements, because of the recognized recovery effect that occurs when short-term UV exposure test specimens come in contact with air. The precise extent of reflectance recovery that may have occurred with the LDEF A276 paint specimens is unknown. The present levels of discoloration in the A276 coating have been determined to be due to degradation of the polyurethane resin portion of the coating, a degradation which cannot "recover".

For engineering purposes, it is essential to establish accelerated test criteria which can be used to predict performance life in a cost effective and timely manner. It was for this reason that comparison of the LDEF A276 results to ground-based UV exposure results was attempted. Failing this, a more controversial approach was made in applying the concept of radiation equivalence. Recent measurements have been made at Boeing Combined Radiation Effects Test Center (CRETC) on the A276 paint, concerning the effects of proton/electron radiation on solar absorptance.¹ A276 was irradiated with 40 keV protons and electrons, simultaneously and in roughly equal fluences to prevent sample charging. Significant degradation in solar absorptance was observed in-situ as a function of radiation fluence. For the purposes of trend comparison, the radiation fluence which produced a solar absorptance reading of 0.52 was arbitrarily equated with a LDEF UV exposure of 8300 ESH. All other particulate radiation fluence levels were scaled from this point. The scaled data set was then compared to the results for A276 white paint data from the LDEF tray clamps, as is shown in figure 10. The trends in the data are significantly similar. The comparison of these two sets of measurements is made here partly as a curiosity. But this comparison is made principally to stimulate thought on the concept of radiation equivalence for materials testing, recognizing the significant impact such an approach could have on long-term performance life prediction.
