1N-39
171949
P31
NASA TECHNICAL MEMORANDUM 107755

THE GROWTH OF SMALL CORROSION FATIGUE CRACKS IN ALLOY 2024

Robert S. Piascik¹ and Scott A. Willard²

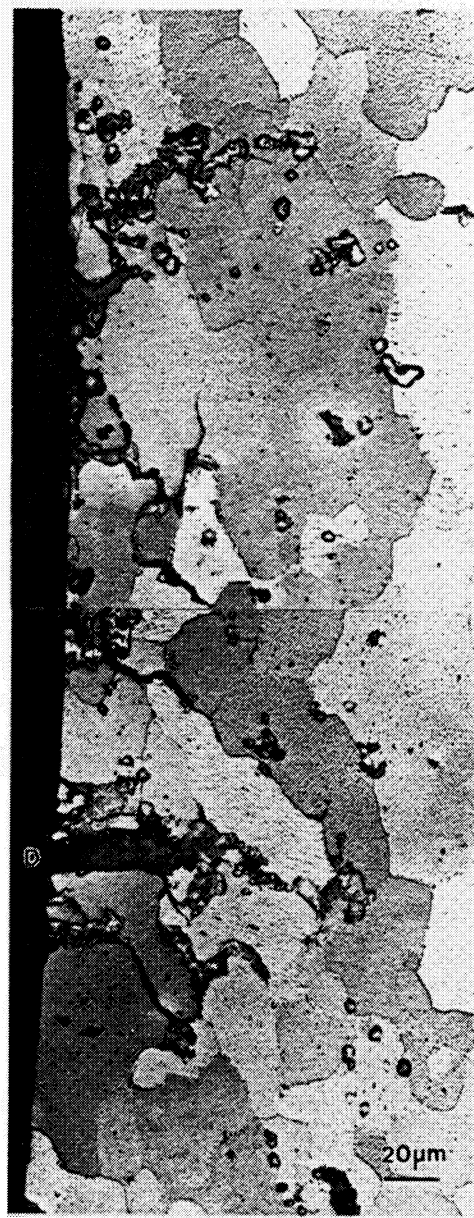
Figure 11. Region D in Figure 10 is shown at high magnification illustrating the extent of intergranular corrosion along the high stress region of the blunt notch surface.

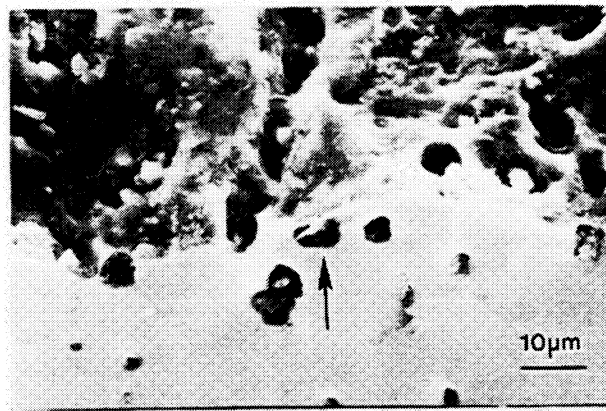
Figure 12. Fractographs showing (a) semicircular shape, crack arrest region (dashed line) and crystallographic morphology of small corrosion fatigue crack, (b) crack initiation region showing constituent particle pitting, (c) crack arrest region (shown in Figure 12a) increased corrosion due to crack arrest.

2. Crack Propagation: Figure 12 is a series of SEM micrograph at different magnification showing the region of crack initiation and the typical fracture morphology of a semicircular shaped corrosion fatigue surface crack ($a=315\ \mu\text{m}$) that was exposed to deaerated NaCl ($-700\ \text{mV}_{\text{SCE}}$). The fatigue crack initiated at the constituent particle pit shown in Figure 12b and marked by large arrows in Figures 12a and 12c. The crack is located mid-thickness in the high stress region of the notch root surface. Following initiation and IG microcracking, the crack grew primarily along a crystallographic (transgranular) crack path. During growth, the crack front maintained a nearly semicircular shape as shown by the intermediate crack arrest mark noted by the dashed line in Figure 12a. The dark region, marked by the dashed line in Figure 12a and shown in greater detail in Figure 12c, exhibits severe corrosion that occurred during crack arrest. The fracture surface region adjacent to the heavily pitted dark region contains secondary cracks marked by small arrows in Figure 12c. This is evidence of stress assisted intergranular cracking that occurred during crack arrest. Further cyclic loading reestablished transgranular fatigue crack growth. Examination of other corrosion fatigue cracks reveal no evidence of crack arrest suggesting that in many instances microstructural barriers did not restrain crack propagation.
