LDEF SPACE PLASMA-HIGH VOLTAGE DRAINAGE EXPERIMENT  
POST-FLIGHT RESULTS

J.Y. Yaung, B.K. Blakkolb, W.C. Wong, L.E. Ryan,  
H.J. Schurig and W.W.L. Taylor

TRW, Space & Technology Group  
One Space Park  
Redondo Beach, CA 90278

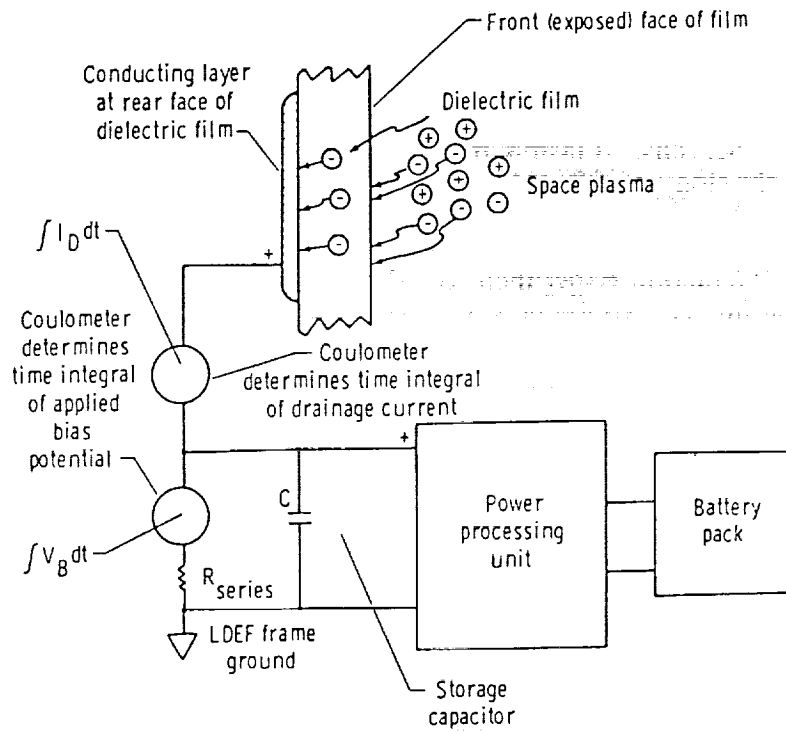
Figure 1. Schematic of SP-HVDE

A schematic of the SP-HVDE is shown in Figure 1. Separate coulombmeters were employed to obtain time integrals for the leakage current and bias voltages for each set of samples. These devices can record currents flowing in either direction by either deplating or plating the electrodes. The Plessey coulombmeters used in the experiment had been plated to 10,000 mA-seconds by the manufacturer. The duty cycle of the storage capacitor was 0.5%, with the power processing unit, consisting of DC-DC power converters controlled by a switching circuit, satisfying the duty cycle requirement.

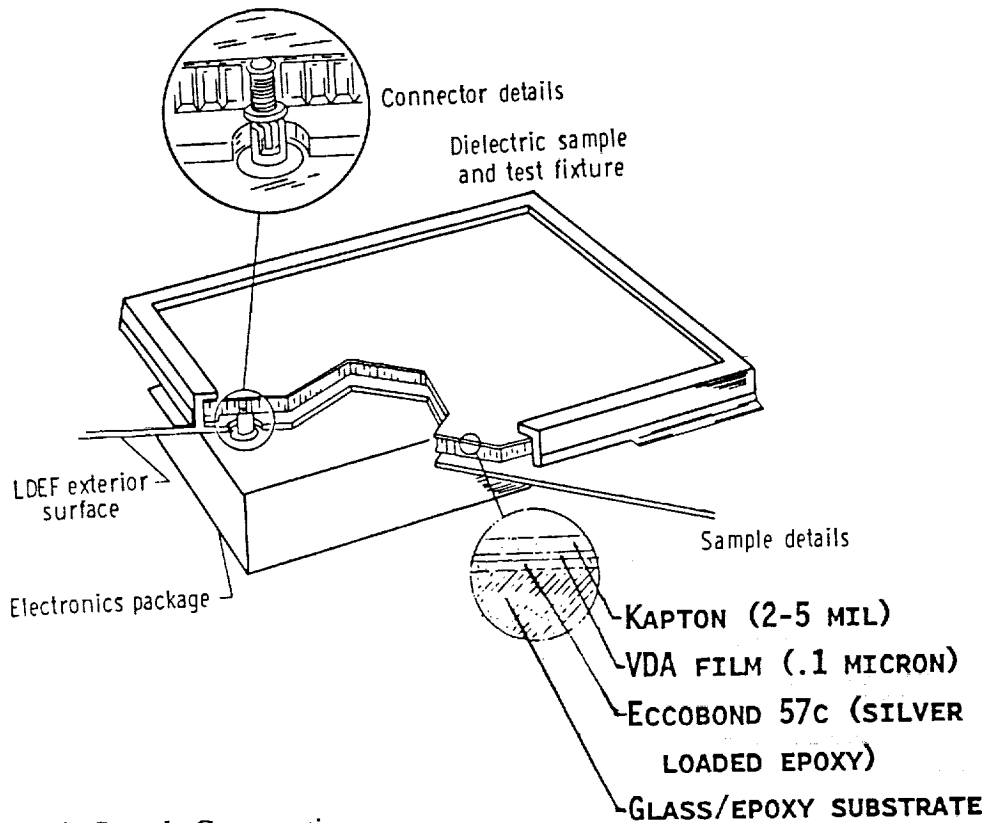
Figure 2. Dielectric Sample Construction

Each tray contained six sets of four dielectric samples, with each set maintained at a different bias voltage (i.e., ±300, ±500 or ±1000 volts). The sets were comprised of various combinations of Kapton/VDA film in one of three thicknesses (i.e., 2 mils, 3 mils, and 5 mils) bonded to the fiberglass/epoxy substrate with a 60 wt% silver loaded epoxy. Thus, the long-term average leakage current and resistivity were determined by using a matrix of dielectric samples of different thicknesses and biases comprising 22 dielectric samples per tray. The adhesive and the VDA (Vapor Deposited Aluminum) served as conducting layers of the dielectric stack for collecting leakage current. The layered construction of the dielectric stacks is shown in Figure 2. Both trays also contained two solar cell modules, one maintained at +300 and the other at -300 volts bias. Each cell module consisted of three solar cells in a closed loop circuit with a load resistor.

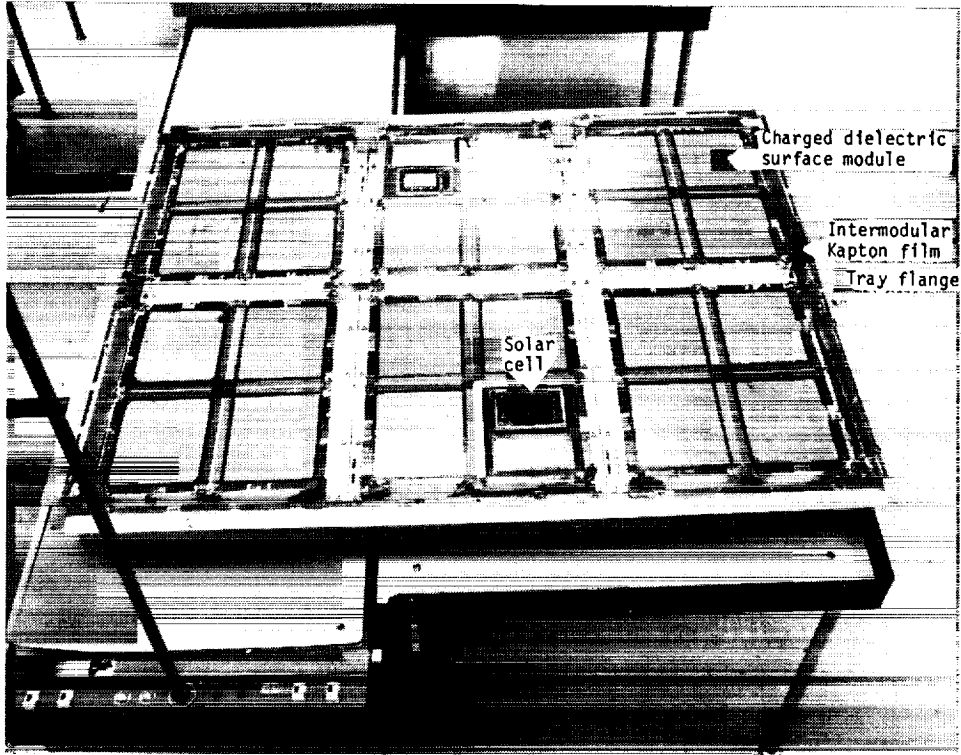
Figure 3. Leading Edge SP-HVDE Tray (Post Flight)

The striking contrast in the post-flight condition of the leading and trailing edge trays is evident in Figures 3 and 4. The trailing edge tray appears essentially the same as it did when the LDEF was deployed, but the leading edge tray shows the result of exposure to an atomic oxygen fluence of 7.88x10<sup>21</sup>/cm<sup>2</sup>. Of course the complete erosion of the Kapton material radically changes the dielectric properties of the experiment, but over the intended functional period of the experiment, approximately 1.5 mils of Kapton were eroded by the action of energetic atomic oxygen. Leakage current data, taken during the 233 day design life of the SP-HVDE, are presented below.

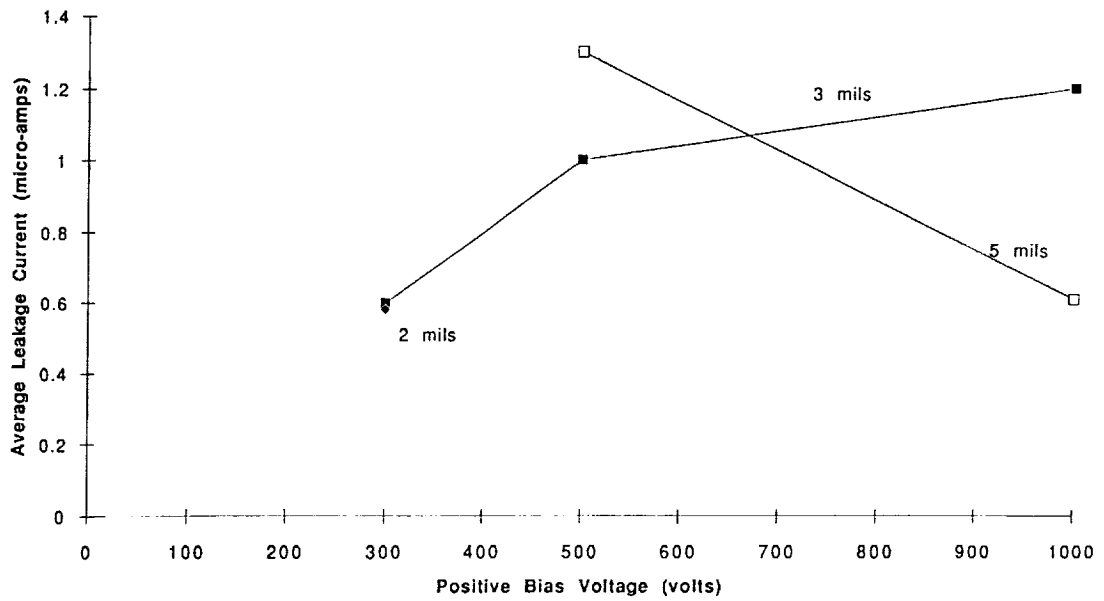
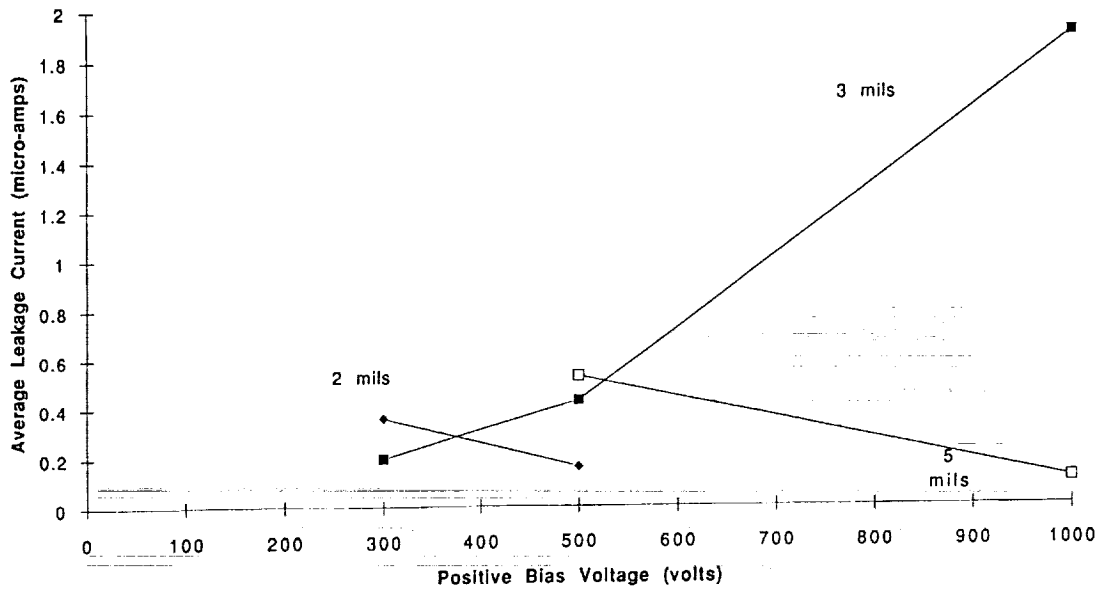
Figure 5. Average Leakage Current Data for Positive Bias Voltage Samples

Ground simulations predicted leakage current to increase with positive bias voltage and decrease with greater dielectric sample thickness. Figure 5 shows the leakage current data for positively biased samples on the leading and trailing edge trays. The data show that only the 3 mil samples followed the predicted trend and that the 5 mil samples showed an unexpected decrease in leakage current over the 500 to 1000 +volt range. The limited data obtained for the 2 mil samples also seems to follow the atypical trend, although the 2 mil sample did demonstrate an expectedly larger leakage current compared to the thicker samples at the 300 +volt bias.

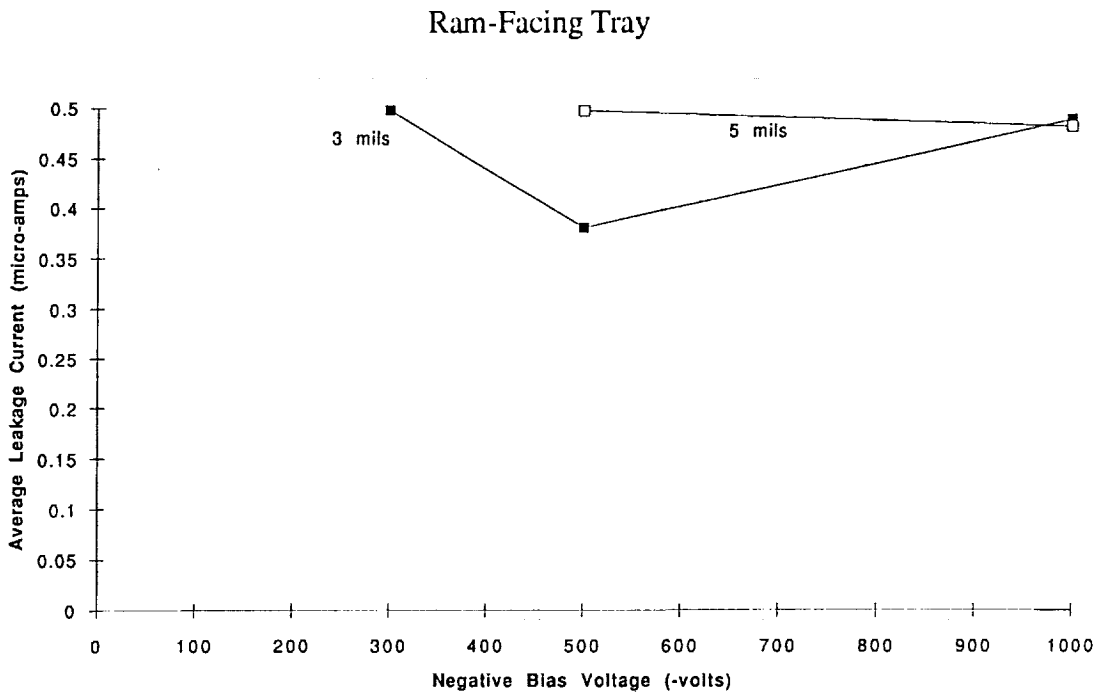
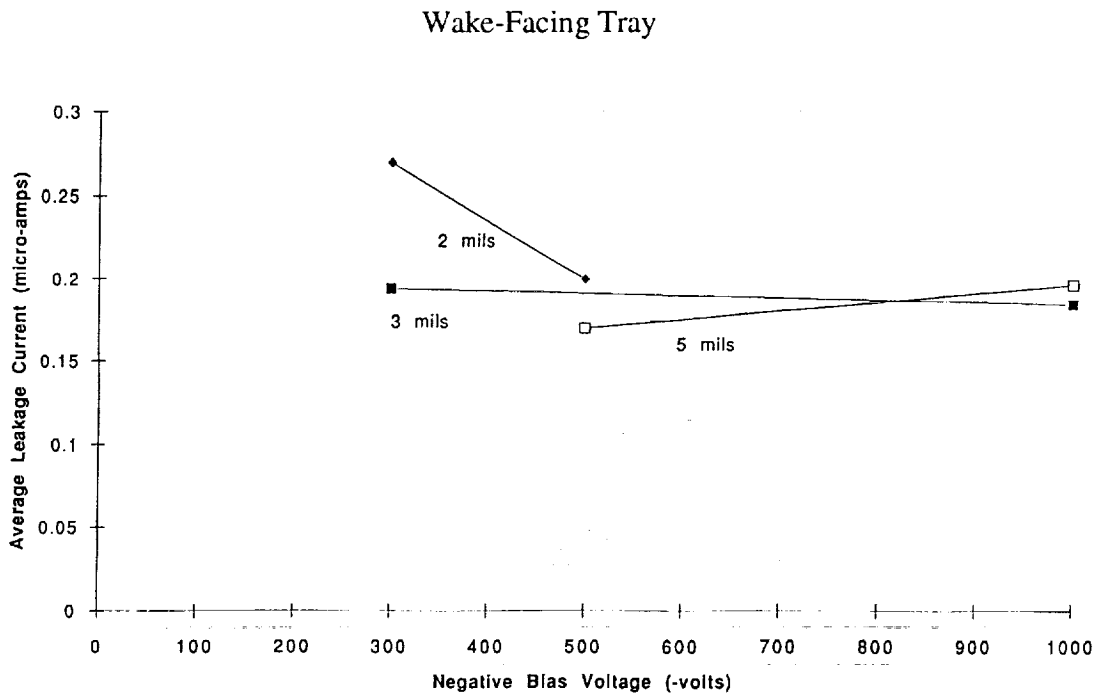
Figure 6. Average Leakage Current Data for Negative Bias Voltage Samples

Leakage current data shown in Figure 6, for negatively biased samples, are distinctly different compared to those for positively biased samples. For the negatively biased condition, the leakage currents obtained are lower than those measured for the positive bias condition by a factor of three. Also of significance is the smaller change in leakage current across the voltage range. It is speculated that for the negatively biased surfaces even the lowest voltage (*i.e.*, -300 volts) is beyond the threshold at which interaction with the space plasma results in localized but intense electrodischarge events. The occurrence of such discharges is consistent with the lower post-flight average leakage currents measured and also consistent with work performed by Thiemann, et al. (ref. 4) which reported greater numbers of discharges for negatively biased surfaces during ground simulations. The reason for the dip in the leakage current at -500 volts for the 3 mil sample on the leading edge tray is unclear at this time, but it should be noted that a similar phenomenon was seen in the data from the PIX-I experiment (see ref. 1).
