Space Shuttle Orbiter Thermal Protection System Design and Flight Experience

NASA Technical Memorandum 104773

Donald M. Curry
Lyndon B. Johnson Space Center
Houston, Texas

Presented at the
First ESA/ESTEC Workshop on Thermal Protection Systems
Noordwijk, the Netherlands, May 5-7, 1993

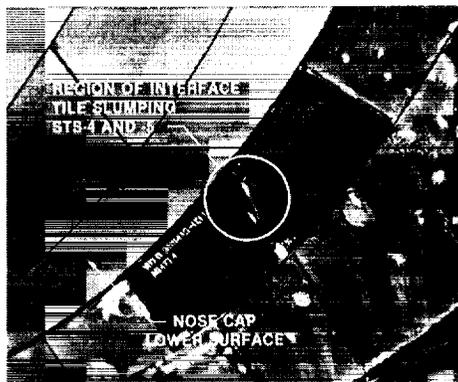
FIGURE 23: NOSE CAP LOWER SURFACE, INTERFACE DAMAGE, STS-5

Tile-to-tile gap heating has occurred in a number of locations and is usually observable from external inspection as slight tile shrinkage and/or slumping, filler bar charring, and gap filler degradation/breaching. An example of tile slumping and gap filler breaching is shown in figure 22. The use of higher density tiles and an improved gap filler design has significantly reduced the damage. An example of extensive damage as a result of gap heating, tile slumping, gap filler degradation, subsurface flow, and localized aluminum melting was found after STS-5 at the RCC nose cap/tile interface (figure 23). This area was subsequently redesigned with stiffer support structure and replacement of the tiles with an RCC panel, known as the chin panel.

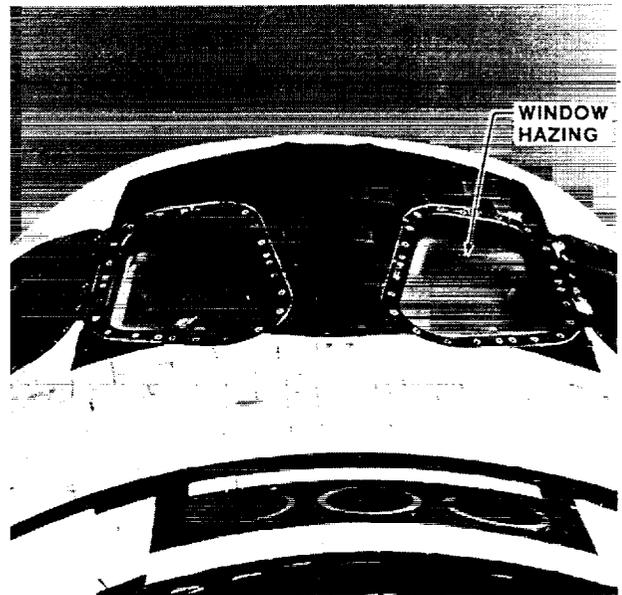
FIGURE 25: ORBITER WINDOW CONTAMINATION

Another critical area on the Orbiter, not generally considered part of the TPS, is the window system. As shown in figure 25, the Orbiter has 11 windows (6 forward, 2 overhead, 1 side hatch and 2 rear view). The forward windows consist of three panes each:

thermal, redundant, and pressure. Hazing or contamination (mainly from SRB separation) of the outer thermal pane occurs during each flight (figure 25). A cleaning procedure has been developed to remove the haze and maintain required visibility. The outer panels are also subject to impact, and very detailed inspections are performed after each flight to ensure structural integrity of the glass. Through flight STS-54, a total of 35 window panels have been replaced, 34 due to impact damage and 1 due to hazing.
