# THE X-15 AIRPLANE—LESSONS LEARNED

William H. Dana\*  
NASA Dryden Flight Research Facility  
Edwards, California

The X-15 rocket research airplane flew to an altitude of 354,000 ft and reached Mach 6.70. In almost 200 flights, this airplane was used to gather aerodynamic-heating, structural loads, stability and control, and atmospheric-reentry data. This paper describes the origins, design, and operation of the X-15 airplane. In addition, lessons learned from the X-15 airplane that are applicable to designing and testing the National Aero-Space Plane are discussed.

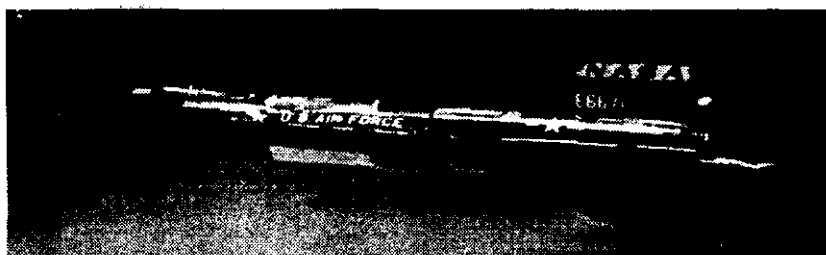
Fig. 12 The X-15A airplane.

The ramjet engine which was planned to be tested on the X-15A was the most interesting X-15 follow-on experiment. Figure 12 shows the X-15A which was rebuilt from the X-15 airplane that rolled on its back after the previously discussed landing gear failure. The fuselage was lengthened 29 in. to make room for a hydrogen tank which was to provide fuel for an air-breathing ramjet engine to be mounted on the ventral fin. The ramjet shown in Fig. 12 was a boilerplate dummy engine used to obtain performance and stability data before installation of a working ramjet. Similar to the lower ventral fin, the ramjet had to be jettisoned before landing.
