N.A.C.A. STALL-WARNING INDICATOR

By F. L. Thompson  
Langley Memorial Aeronautical Laboratory

TECHNICAL NOTE NO. 670

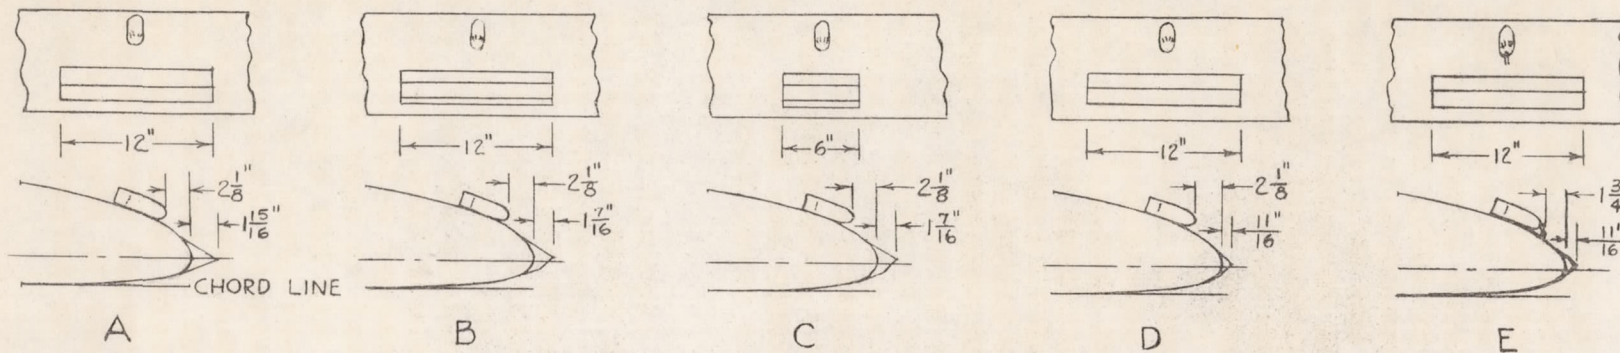
TABLE I.- TESTS OF STALL WARNING DEVICE - ARRANGEMENTS TESTED AND RESULTS.

A  
Satisfactory with  
flaps up.  
Not tried with flaps  
down.

B  
Satisfactory.

C  
Unsatisfactory.  
Insufficient  
and erratic  
warning.

D  
Unsatisfactory.  
Insufficient  
warning with  
flaps up.

E  
Satisfactory.

F  
Satisfactory.

G  
Unsatisfactory.  
Insufficient  
warning, par-  
ticularly with  
flaps up.

H  
Satisfactory.

It appears from a study of the results given in table I that the functioning of the stall-warning device is adjustable through a considerable range by means of alterations of the shape and size of the sharp edge and of the nose of the head. It appears to be very important that the dynamic opening of the head be close to the wing surface in order to avoid the necessity for a large, sharp edge. With the dynamic opening above the wing surface about one-half inch as it was with the original nose piece, satisfactory results were obtained only with the large, sharp edges of arrangements A and B. With the dynamic opening brought down close to the surface, satisfactory results were obtained with the sharp edge reduced to a length of 6 inches in a spanwise direction and an extension of  $11/16$  inch in a chordwise direction (arrangements F and H). A further reduction in size might have been possible but appeared to be unnecessary in view of the apparent insignificance of the alteration of the wing contour.

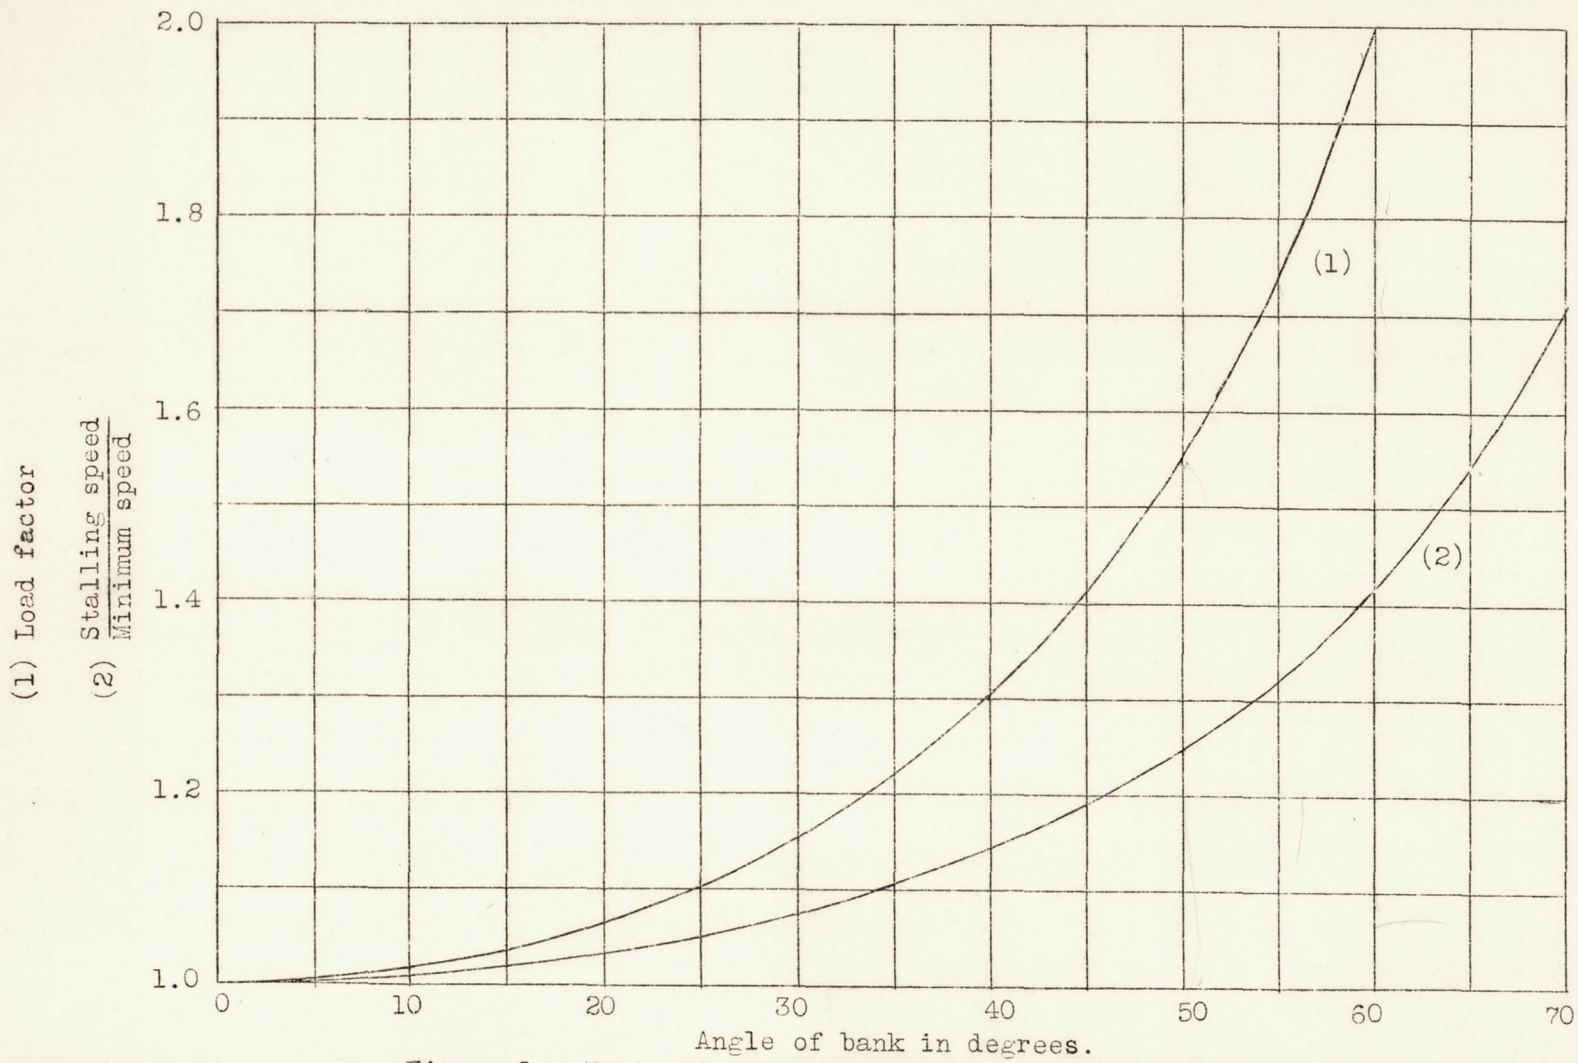
Figure 1.- Variation of load factor and ratio of stalling speed to minimum speed with angle of bank in horizontal turns.

The load factor and the ratio of  $V_{\text{stall}}$  to  $V_{\text{min}}$  in turns are plotted in figure 1 to show how these quantities vary with angle of bank. The curve of stalling speed is an ideal one that does not take into account the influence of errors in the air-speed meter reading. In general, such errors will further complicate the situation because calibrations made in steady flight will not apply in accelerated flight unless the correction for position error of the air-speed head is negligible. If an instrument is to be used to give a warning of the stall, therefore, it appears desirable that its functioning should be dependent on angle of attack rather than air speed. Furthermore, it seems desirable in order to avoid the necessity for watching the instrument continuously that it be arranged to give a warning signal when a safe limit has been reached.

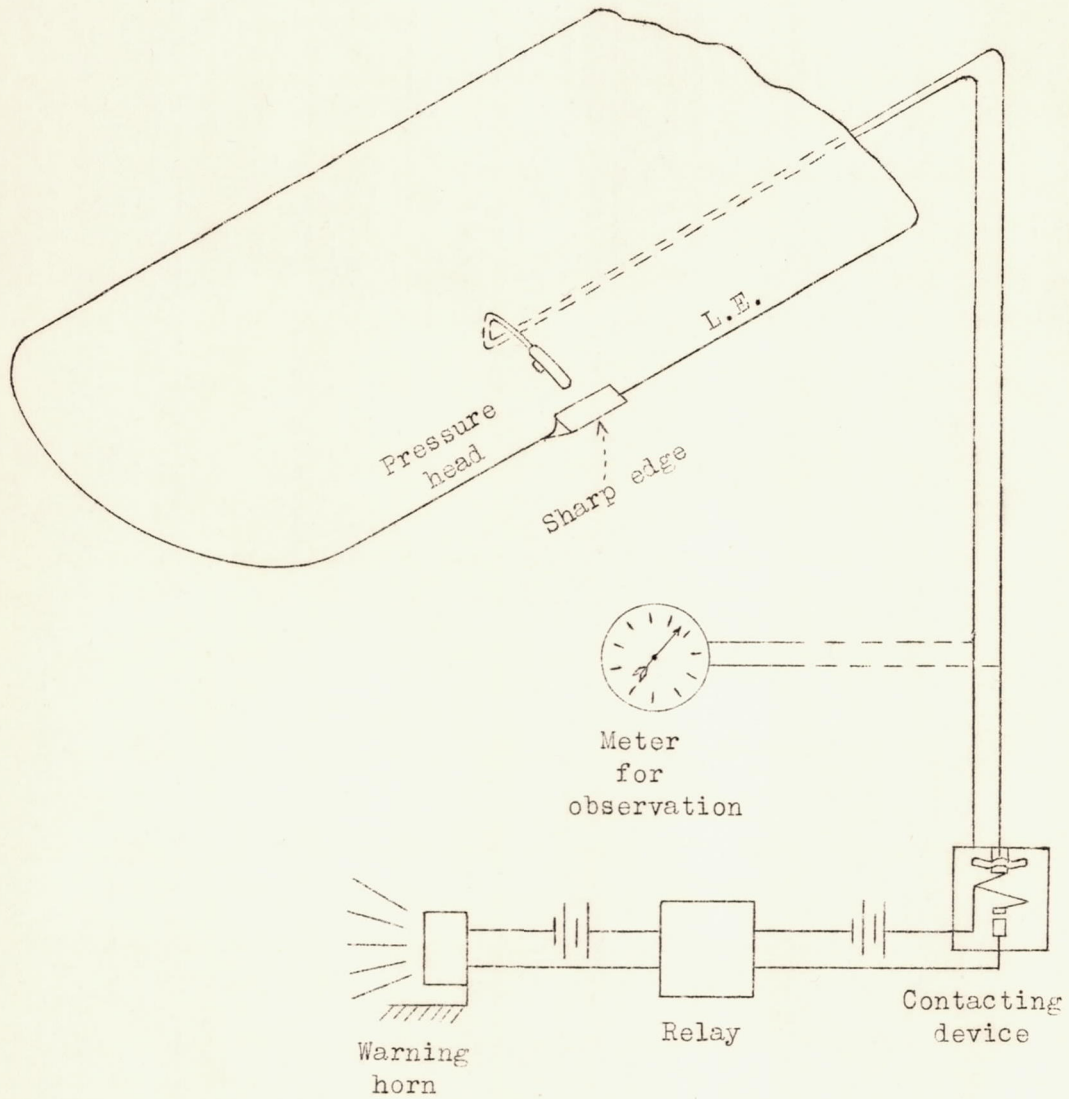
Figure 2.- Diagram of stall warning device.

A stall-warning device developed by the National Advisory Committee for Aeronautics is shown diagrammatically in figure 2. It makes use of a modified type of pitot-static head set close to the wing surface in a region wherein stalling occurs (or is made to occur) at an angle of attack considerably below that at which the main portion of the wing stalls. This head is connected to a pressure cell fitted with electrical contacts and for observations during tests it may also be connected to a conventional air-speed meter. When the air flow in the region in which the head is located breaks away from the wing surface, that is to say, when local stalling occurs, the pressure indicated by the head drops sharply to zero. When this occurs the electrical contacts close a circuit that operates a warning signal. The signal as used in flight tests of this device was a horn such as that used with retractable landing gears, but of course any suitable type of warning may be used.

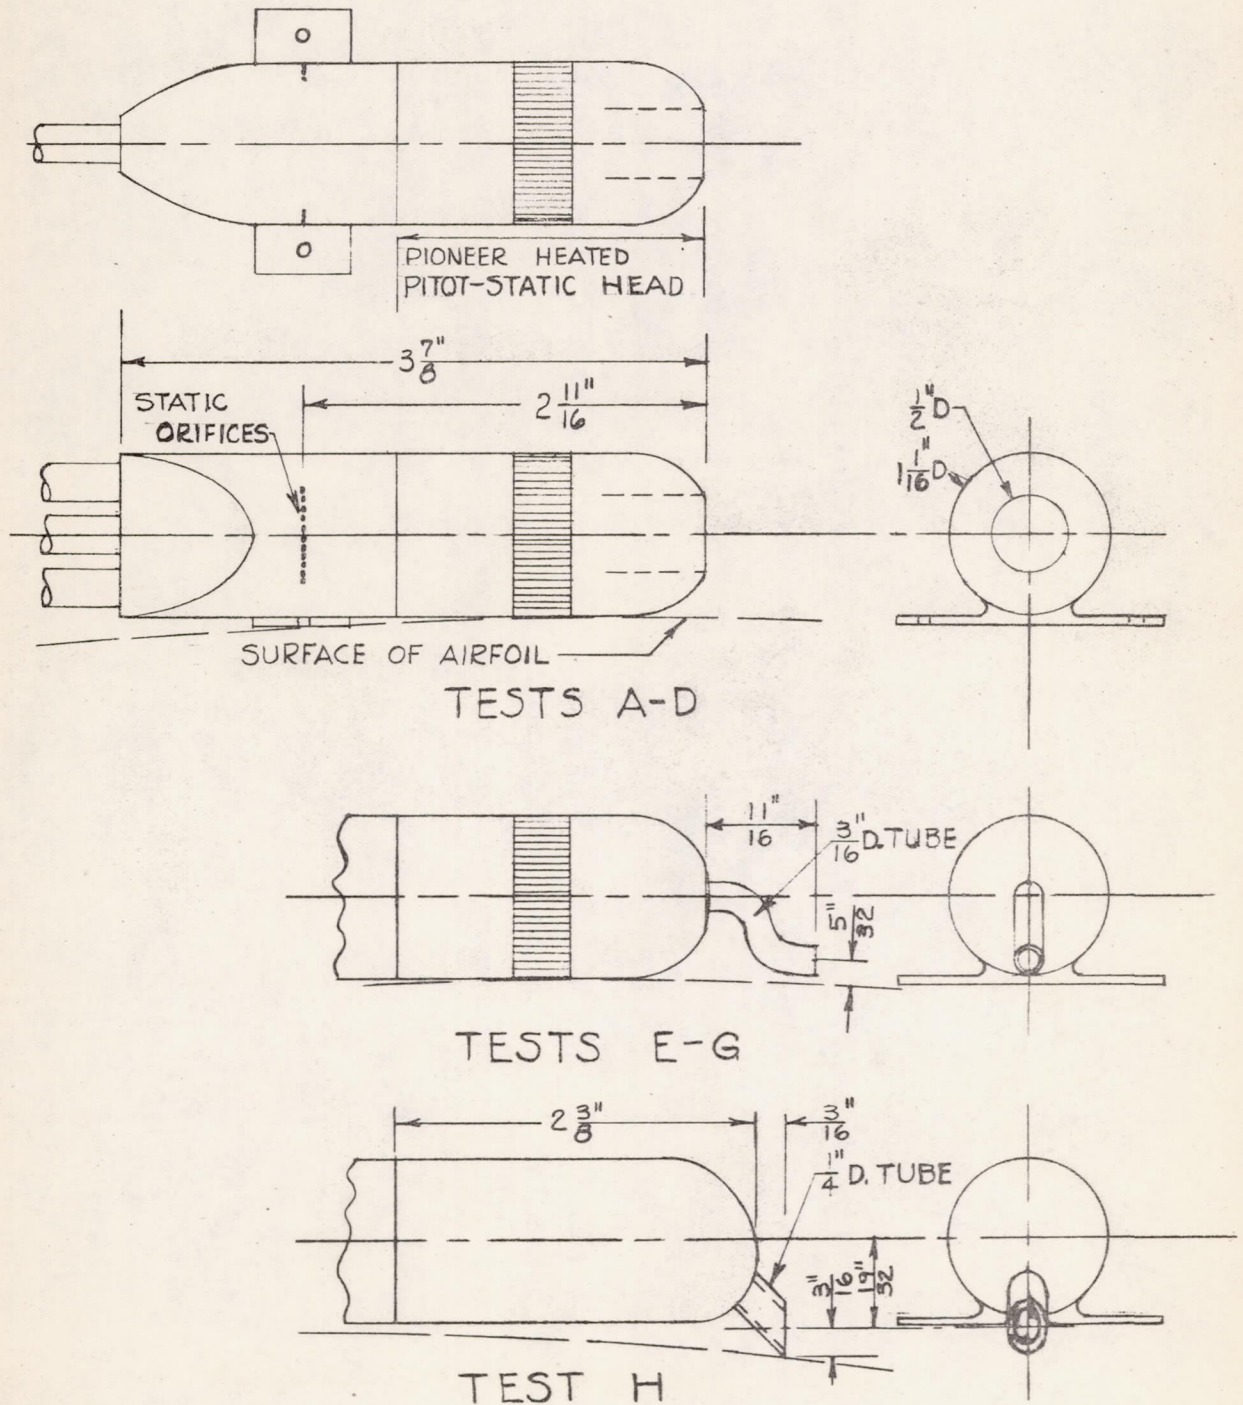
FIGURE 3.- PRESSURE HEADS USED WITH STALL WARNING DEVICE.

The head used in the experiments with different nose pieces is shown in figure 3. Table I shows the various arrangements of sharp edge and head that were tested and figure 4 shows photographs of combination H. For the tests the contacting device was set to operate when the local air speed as indicated by the stall-warning device dropped below 70 miles per hour. As will be shown later, this setting was appreciably below what would normally be the local velocity over the curved portion of the leading edge of the wing at the minimum speed of the airplane on which the tests were made. A considerable variation of this setting, however, would not have altered the results appreciably.

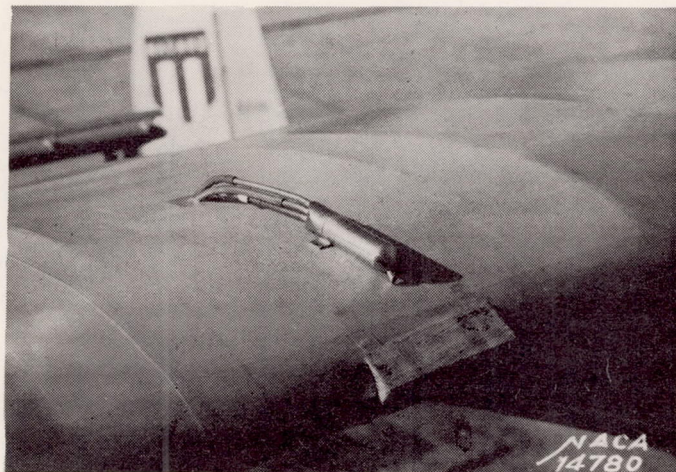
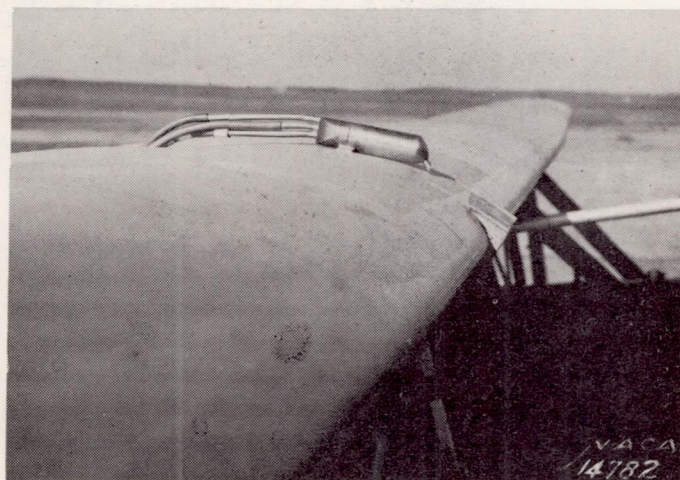
Figure 4.- Stall-warning device installed on wing of Fairchild 22 airplane.

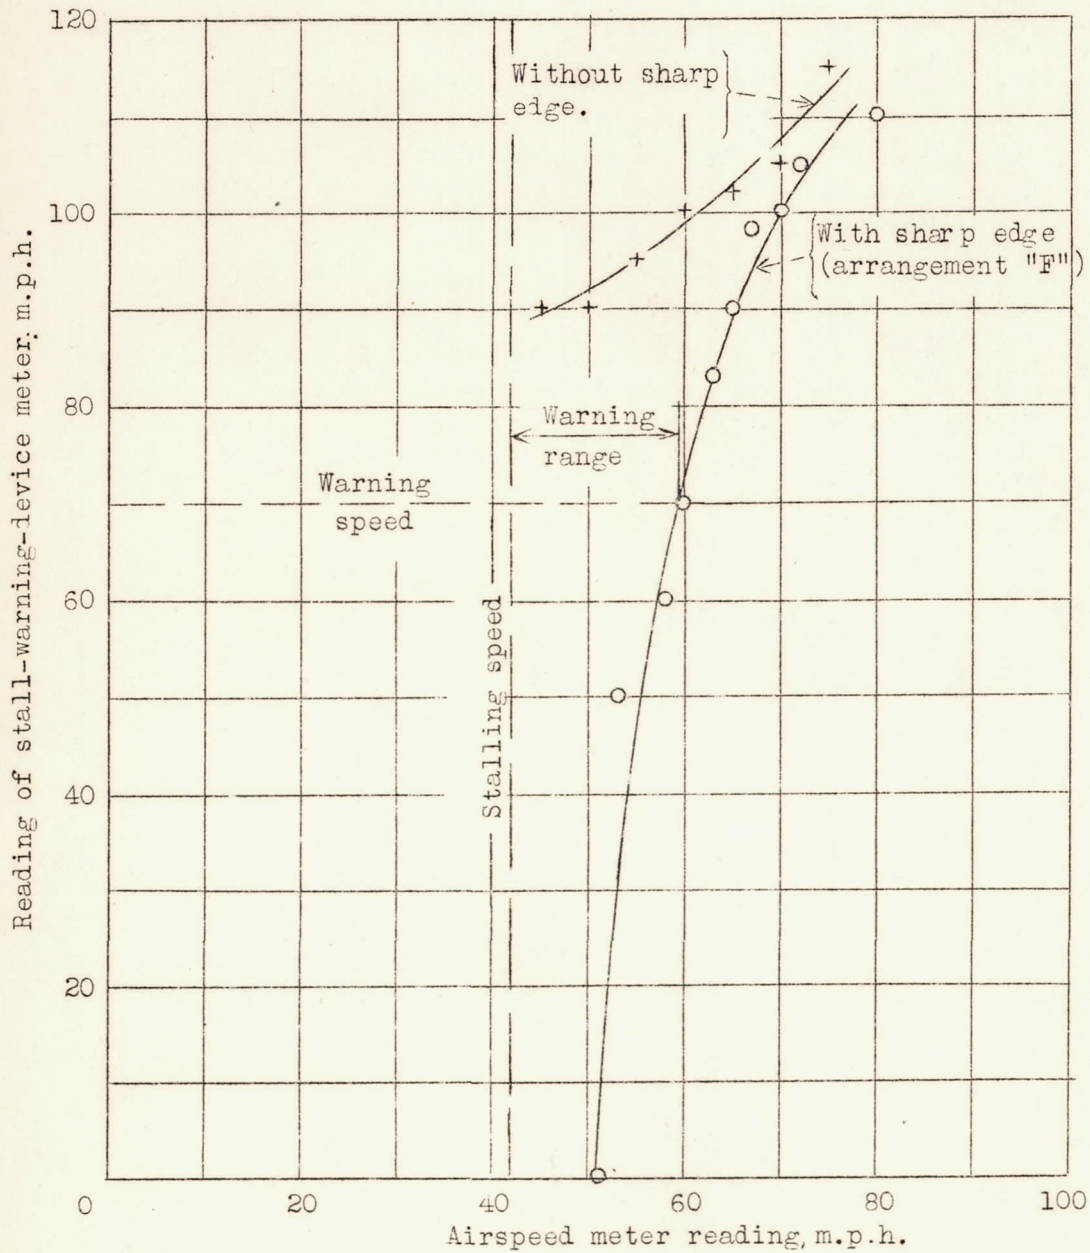
Figure 5.- Characteristics of stall-warning device for typical case.

Before a comparison is made of the results obtained with different arrangements, it seems advisable to describe the general characteristics of the behavior of the device by reference to figure 5. This figure shows the readings of the meter connected to the stall-warning head plotted against the readings of the air-speed meter of the airplane with arrangement F and also with the sharp edge removed. The results shown in this figure for arrangement F are typical of arrangements considered to be satisfactory. It will be noted that whereas the reading of the air-speed meter of the airplane at minimum speed is 42 miles per hour, the warning is obtained at about 59 miles per hour, the speed at which the local velocity falls below 70 miles per hour. Without the sharp edge the local velocity over the leading edge of the wing does not fall below 90 miles per hour. It may also be noted that, although the device was set to warn when the local velocity reached 70 miles per hour, a change of setting of several miles per hour in either direction would not have greatly altered the airplane speed at which the warning occurred. In other words, the adjustment of the contacting device was not critical. One other point of practical interest brought out by figure 5 is that in the normal flight range the local velocity is considerably greater than the air

speed of the airplane, so that the pressure unit used in the contacting device must be rugged enough to withstand pressures much larger than the dynamic pressure corresponding to the maximum speed of the airplane relative to undisturbed air.
