NACA TN 1249

A STUDY OF PISTON-RING FRICTION

By James C. Livengood and Chapin Wallour

Massachusetts Institute of Technology

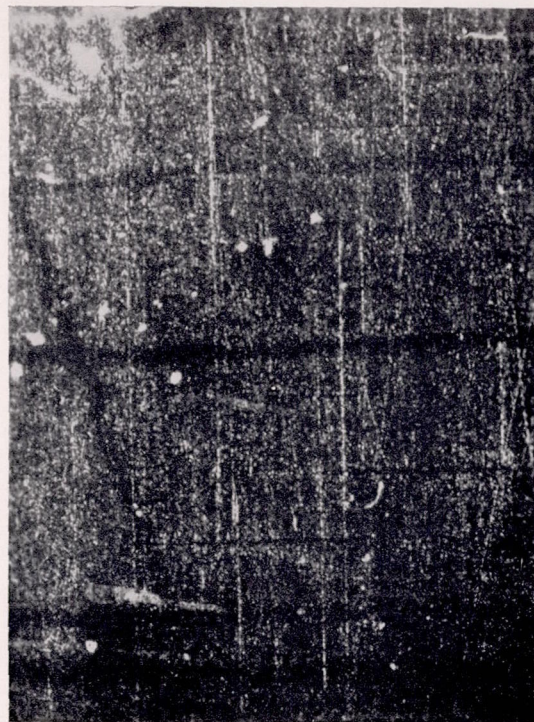
Figure 26.—Photomicrographs of surface replicas of SAE 4140 cylinder used in run B. (25 $\times$ ).

Figures 24 to 31 are photomicrographs made from replicas of the ring and barrel materials used in the tests. These show the condition of the surfaces at the beginning, after 1 hour, and after 10 hours of running. The ragged edges of the ring photographs do not represent the edge conditions of the ring, but are due to slight tearing of the lacquer film when it was lifted from the surface.

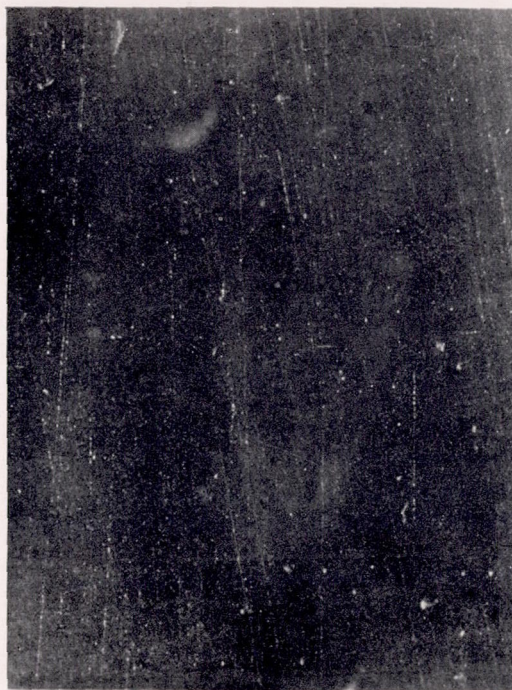
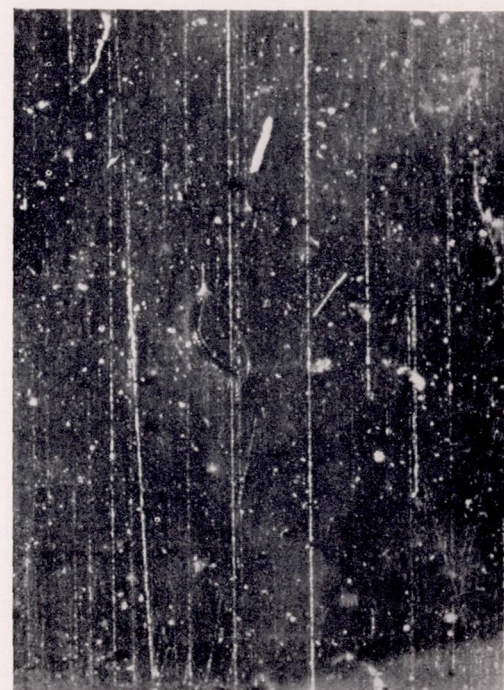
Figure 30.—Photomicrographs of surface replicas of SAE 4140 cylinder used in runs D, E, and F. (25 $\times$ ).
