TECHNICAL NOTE

No. 1492

AN INVESTIGATION OF FRETTING CORROSION UNDER  
SEVERAL CONDITIONS OF OXIDATION

By B. W. Sakmann and B. G. Rightmire

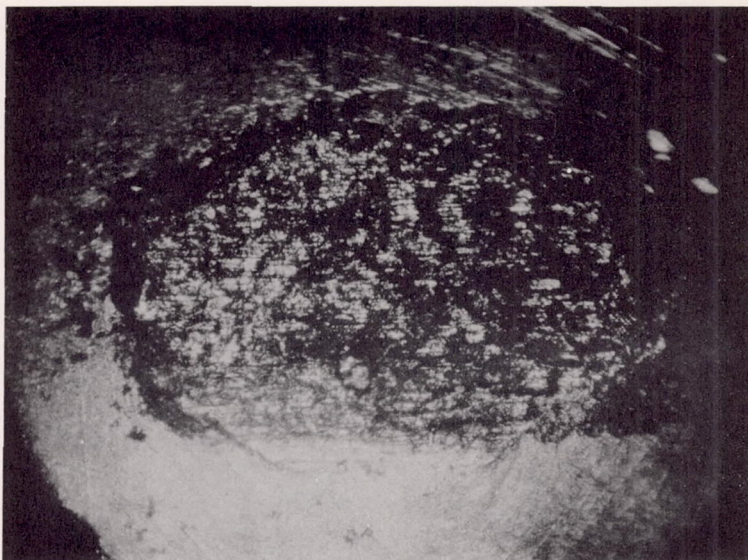
Figure 7.- Tin hemisphere run against SAE 1020 steel flat in air and vacuum. Magnified 50 times.

(a) Tin hemisphere after test in air of atmospheric pressure. Most of the debris is on the flat.

(b) Tin hemisphere after test in vacuum. Wear spot is highly polished.

In the next run, in which a tin hemisphere was run against a steel flat, the difference between the damage in air and in vacuum was even greater than with the preceding combination of phosphor-bronze on steel. Figures 7(a) and 7(b) show the damage to the tin hemisphere after the two tests. It is evident from figure 7(a) that this damage was very severe after the test in air. As in the preceding test with phosphor-bronze, the surface of the tin hemisphere was highly reflecting after the test in vacuum; this indicated that a clean tin surface was formed. There was no indication of any oxidation of the abraded surface after the test in vacuum. Figure 8 shows the damaged areas on the steel flat. It is evident from figure 8(a) that a large amount of debris was formed during the test in air. Only part of the fragments produced is visible in figure 8(a). Figure 8(c) shows a corroded spot of another test under the same conditions of load and slip. The debris was easily removed from the steel flat by wiping. Inspection of the damaged spots of figures 8(a) to 8(c) makes it apparent that corrosion damage was very serious. In table I the combination of tin and steel was classified as having a low corrosion resistance. This classification is in good agreement with the fact that tin oxide is considerably harder than copper oxide, having a hardness value between 6 and 7 on Moh's scale.

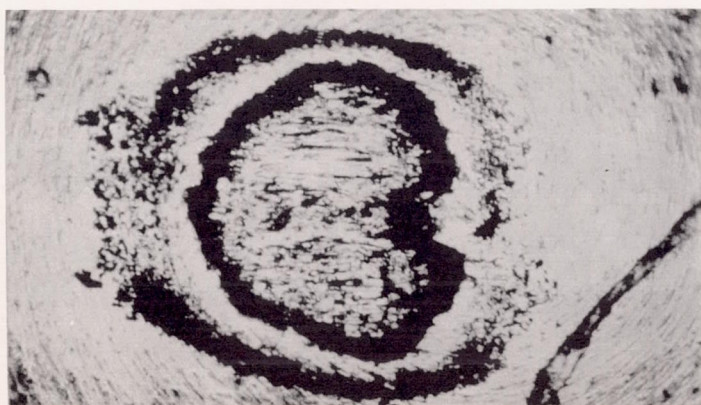
Figure 9.- Aluminum hemisphere run against aluminum-alloy flat in air and vacuum. Magnified 100 times.

(a) Aluminum hemisphere after test in air of atmospheric pressure. Before wiping.

(b) Aluminum hemisphere after test in air of atmospheric pressure. After wiping.

(c) Aluminum hemisphere after test in vacuum. Before wiping.

(d) Aluminum hemisphere after test in vacuum. After wiping.

As the third pair of materials in the first group, an aluminum hemisphere was run against a flat of aluminum-silicon alloy. Table I shows that the combination of aluminum on aluminum has a low corrosion resistance. This classification is borne out by the severe damage shown in figures 9(a), 9(b), 10(a), and 10(b). This low corrosion resistance is probably due to the fact that aluminum oxide is one of the hardest metal oxides, having a hardness value of 9 on Moh's scale. After the test in air, a large amount of debris was found on both hemisphere and flat. The results of the test in vacuum are illustrated in figures 9(c), 9(d), and 10(c). It is evident that the damage under these conditions was much less severe than in air and that fewer fragments were formed.

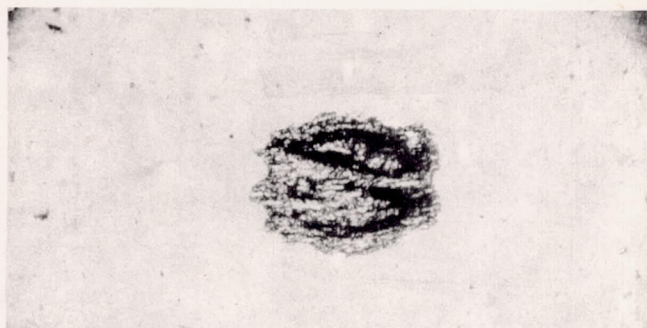
Figure 13.- Steel against steel in air and vacuum. Chromium-steel sphere against SAE 1020 steel flat. Magnified 100 times. Mating steel flats are shown in figure 14.

(a) Steel sphere after test in air.  
Corroded spot looks brownish.

(b) Steel sphere after test in vacuum.

(c) Steel sphere after test in vacuum  
with degassed specimens.

The second group of runs was devoted entirely to pairs of materials with a low corrosion resistance and particularly to the combination of steel on steel. Because of its general importance in engineering problems, more tests were made with this combination than with any so far discussed. In one respect, the combination of steel on steel behaved differently from the other materials tested. The degassing of the specimens in an electric discharge had a pronounced influence on the corrosion resistance, but with the other materials described in this report degassing did not seem to change the corrosion resistance. For tests in vacuum with steel specimens, the damage of degassed corrosion samples was less severe under otherwise identical conditions of pressure. This point is illustrated in figures 13 and 14. Figure 13(a) shows the corroded spot on the steel sphere after a corrosion test in air under atmospheric conditions. Figure 13(b) shows the damage to the steel sphere after a test in vacuum, and figure 13(c) shows the damage to a degassed steel sphere tested in vacuum. Figure 14 shows the corresponding spots on the steel flats, which are mirror images of the spots on the spheres. Comparison of figures 13 and 14 makes it evident that the greatest amount of damage was done to the specimens run in air at atmospheric pressure, whereas the degassed specimens run in vacuum showed the least damage. Figures 15 and 16 show the same corrosion spots at different magnifications. These photographs show that not only the area of the corroded
