TECHNICAL NOTE 2812

EFFECTS OF CYCLIC LOADING ON MECHANICAL BEHAVIOR
OF 24S-T4 AND 75S-T6 ALUMINUM ALLOYS
AND SAE 4130 STEEL

By C. W. MacGregor and N. Grossman
Massachusetts Institute of Technology

October 1952

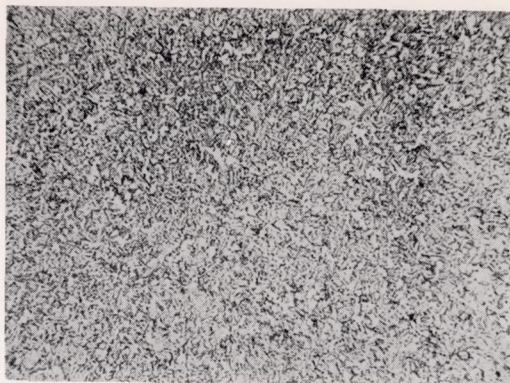
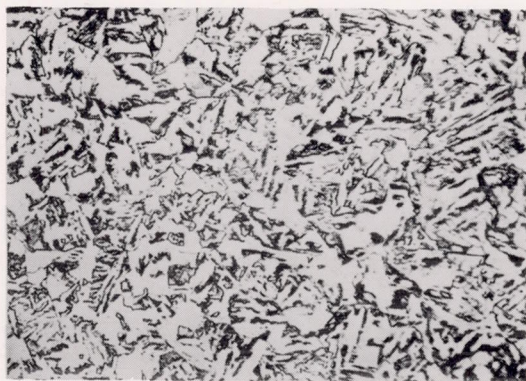
Figure 1.- Photomicrographs of SAE 4130 steel tested.

(a) Transverse. X100.

(b) Longitudinal. X100.

(c) Transverse. X500.

(d) Longitudinal. X500.

Two commercial aluminum alloys (24S-T4 and 75S-T6) and an aircraft quality alloy steel (SAE 4130) were used in the present investigation. The rods were obtained in 1/2-inch-diameter stock from the Aluminum Company of America and the Carnegie-Illinois Steel Corp., respectively. Table I lists the chemical analyses and mechanical properties; figures 1 and 2 show the photomicrographs.

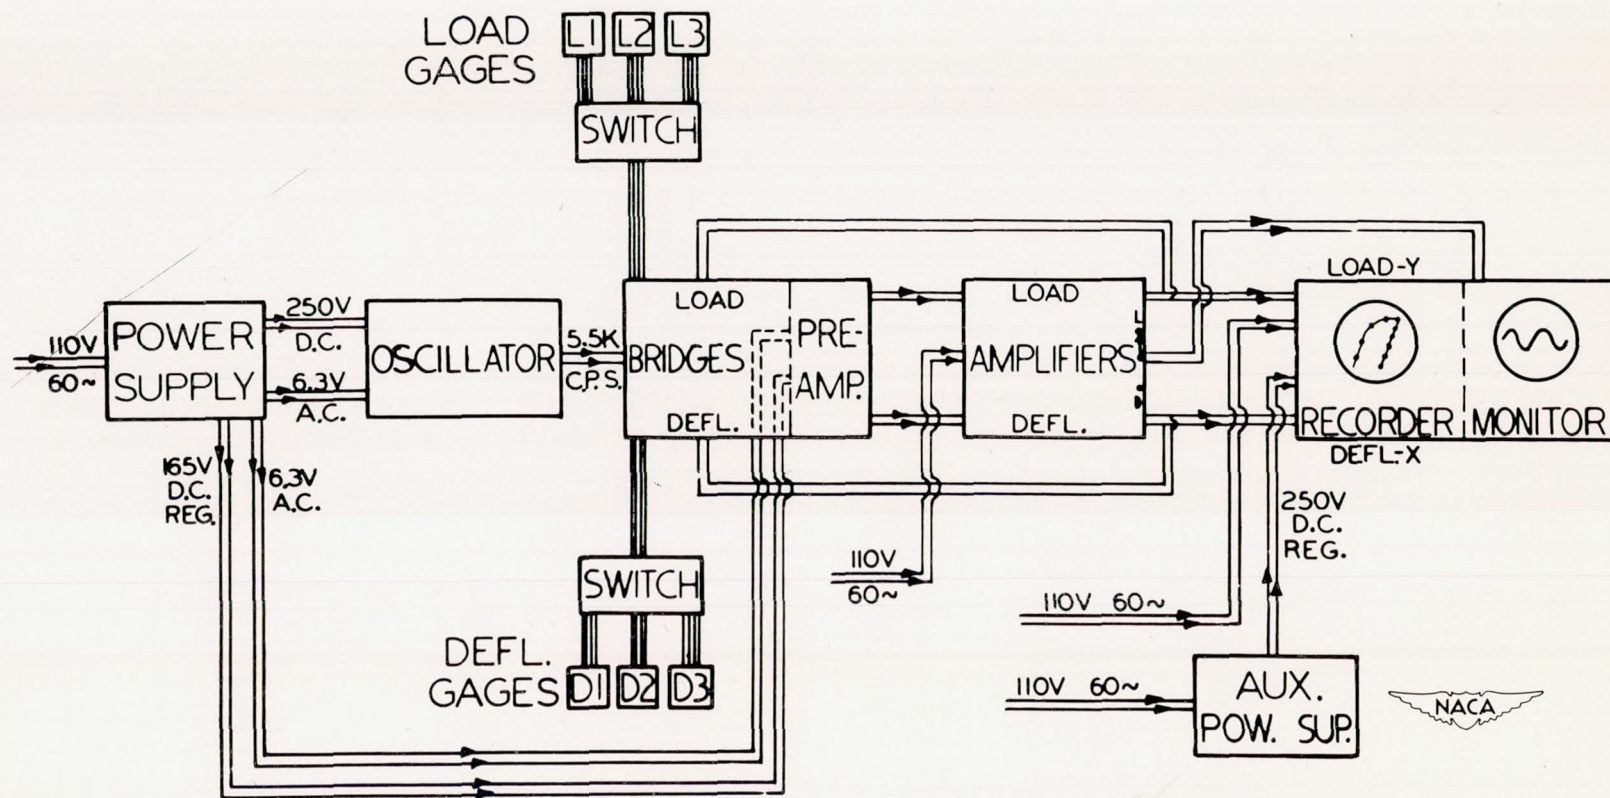
Figure 6.- Panel connections for electronic recorder with alternating-current bridge.

Slow-bend tests at constant deflection rates and temperatures were employed to determine the effects of the prior cycles of fatigue stressing on the mechanical properties. The testing equipment is designed to load a specimen in simple bending at a constant speed and temperature and to supply a load-deflection record of the test. Type AB 7 SR-4 electric strain gages connected in a bridge circuit are used to measure both the load and the deflection. The integral parts of the apparatus include the loading machine with strain gages, a thermocouple and millivoltmeter, a stop watch, electronic recorder, and still camera. The over-all picture of the test cabinet and electronic recorder is shown in figure 4. Figure 5 depicts the loading equipment and the electronic-recorder panel connections are illustrated in figure 6.

An alternating-current bridge system is employed whereby a 5500-cycle-per-second voltage is introduced into the load bridge and the deflection bridge with the resulting unbalance from loading or deflecting detected, amplified, and transmitted to a 5LPI tube. A record is made with a still camera. The load bridge and the deflection bridge contain a type AB 7 SR-4 strain gage in each of the four arms.

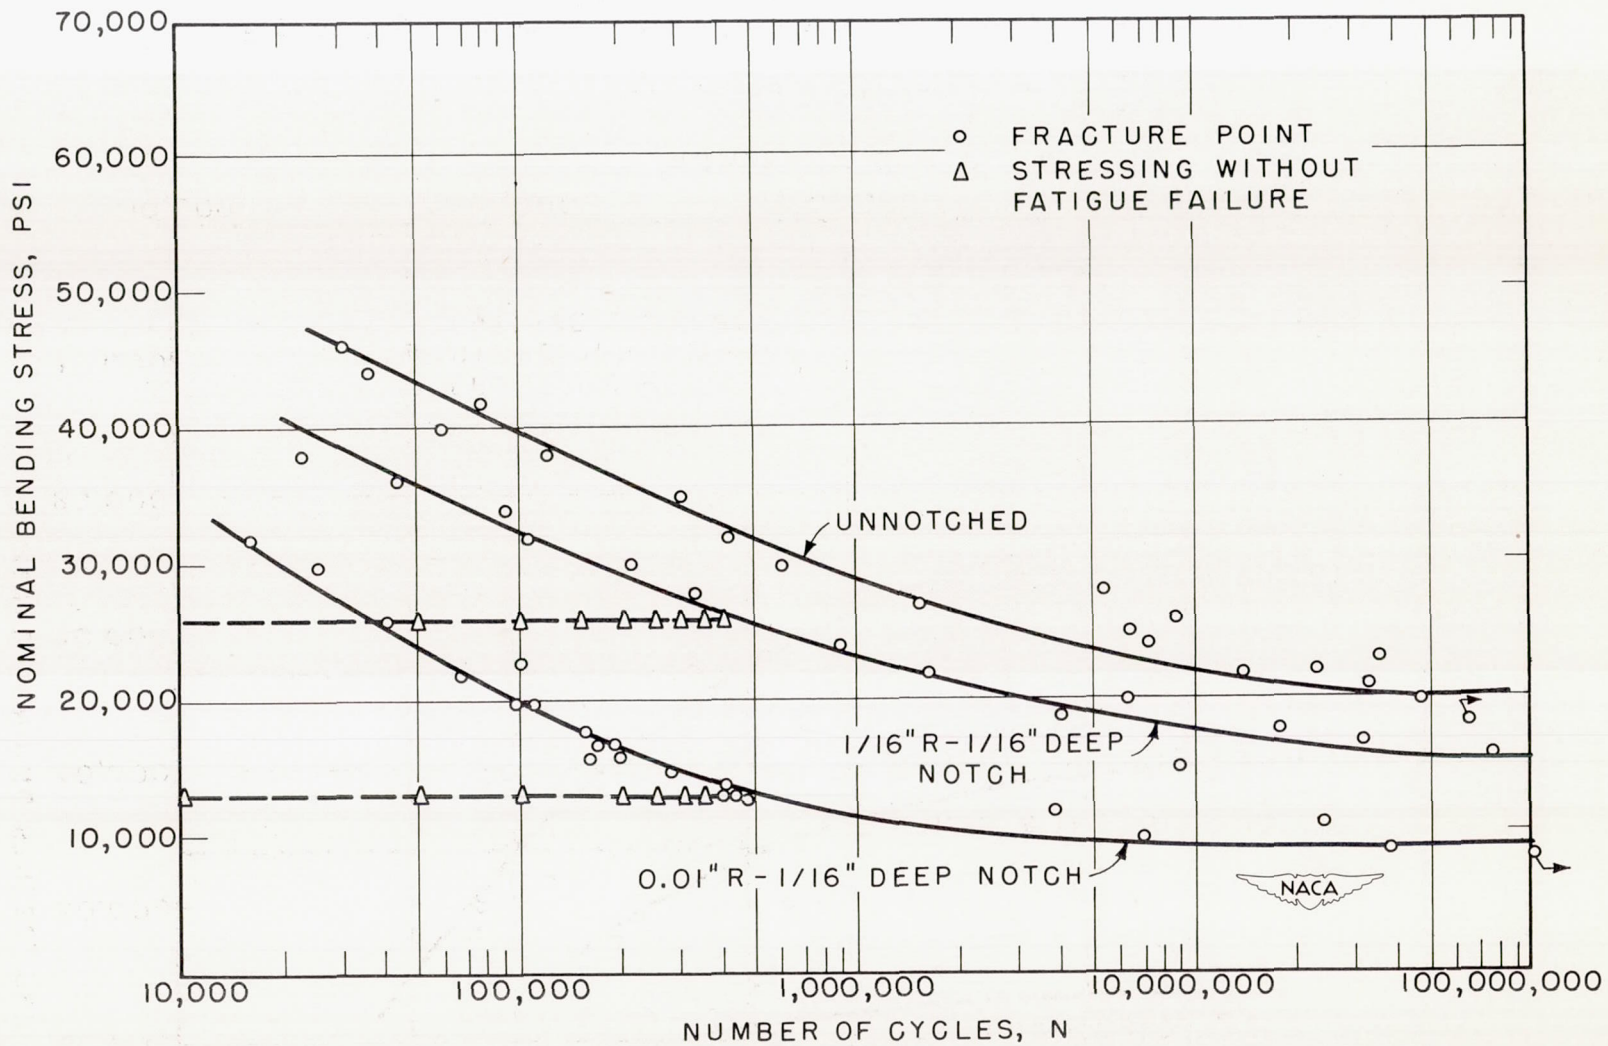
(a) For SAE 4130 steel.

Figure 7.- S-N curves showing location of prior cycles of fatigue for brittle temperature tests.

(b) For 24S-T4 aluminum alloy.

(c) For 75S-T6 aluminum alloy.

The S-N curves for completely reversed bending were first established for the three materials tested in the as-received condition. Three

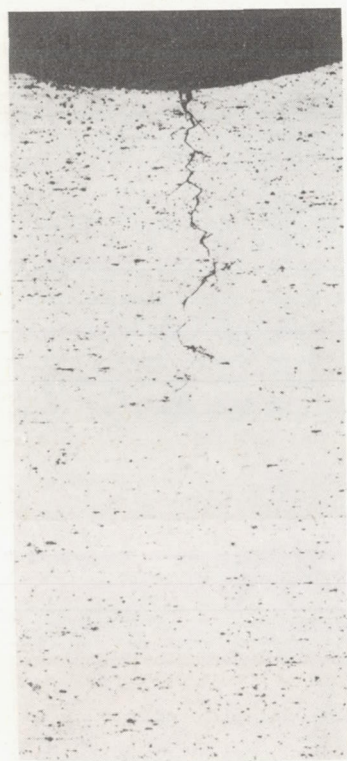
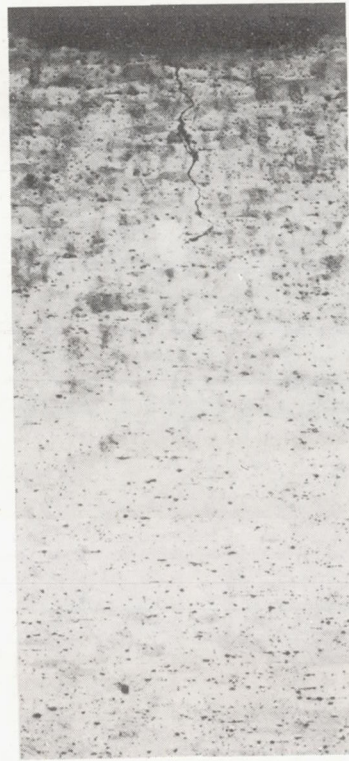
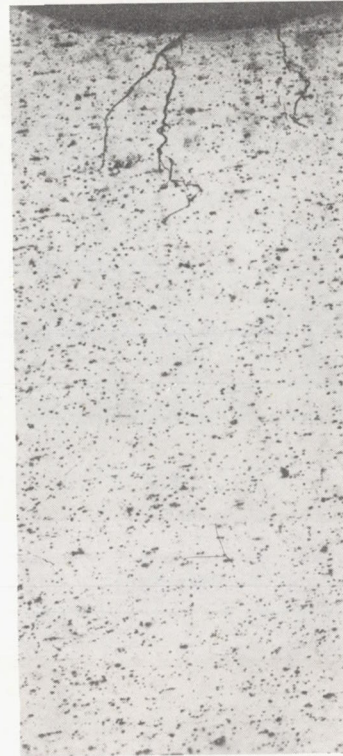
(a) SAE 4130 steel; nominal fatigue bending stresses indicated.

Figure 9.- Longitudinal sections of U-notched specimens showing cracks after various numbers of cycles of fatigue stressing. Notch, 1/16 inch deep with 1/16-inch radius.

(b) 24S-T4 aluminum alloy; nominal fatigue bending stress, 26,000 psi.

It was deemed important, therefore, to determine whether this was a peculiarity of mild steel or whether this phenomenon occurred in other metals as well. Consequently, crack studies were made of specimens subjected to prior fatigue cycles for all three of the metals discussed here for stresses below and above the endurance limits. The technique used was described earlier under "Testing Procedure." Figures 8 to 10 show typical longitudinal sections revealing fatigue cracks for the three metals stressed above the notched endurance limit for different numbers of cycles. Figures 8(a) to 8(c) are for V-notched specimens; figures 9(a) and 9(b), for U-notched specimens; and figures 10(a) and 10(b), for unnotched bars. This method yielded erratic results because the circumferential cracks which originated at the root of the notch and penetrated radially inward were not necessarily symmetrical about the axis of rotation of the specimens. Thus, it was found satisfactory to photograph the stressed and subsequently fractured specimens which showed two clearly distinguishable areas, an outer ring due to the slowly penetrating cumulative "cracks" and the inner "core" which was suddenly fractured. Figures 11

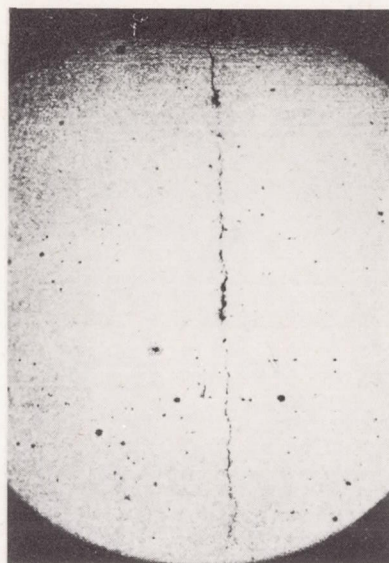
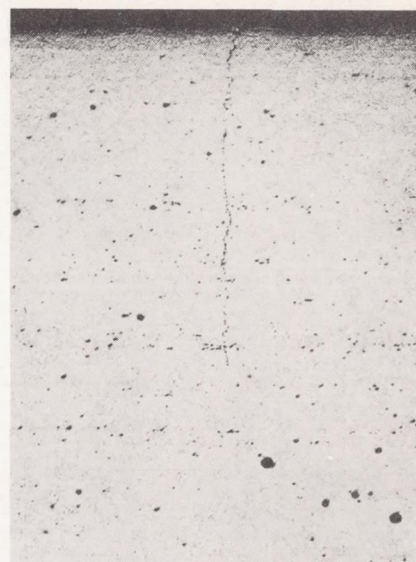
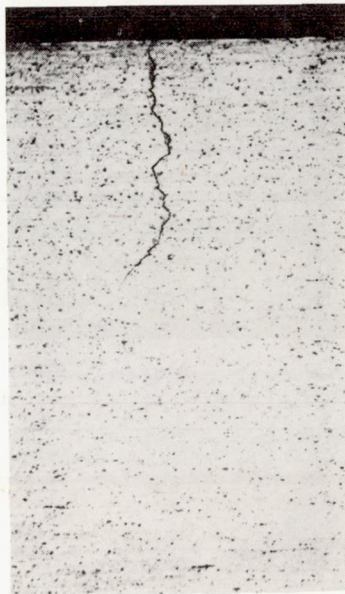
(a) SAE 4130 steel; nominal fatigue bending stress, 60,000 psi.

Figure 10.- Longitudinal sections of unnotched specimens showing cracks after various numbers of cycles of fatigue stressing.

(b) 24S-T4 aluminum alloy; nominal fatigue bending stress, 37,000 psi.

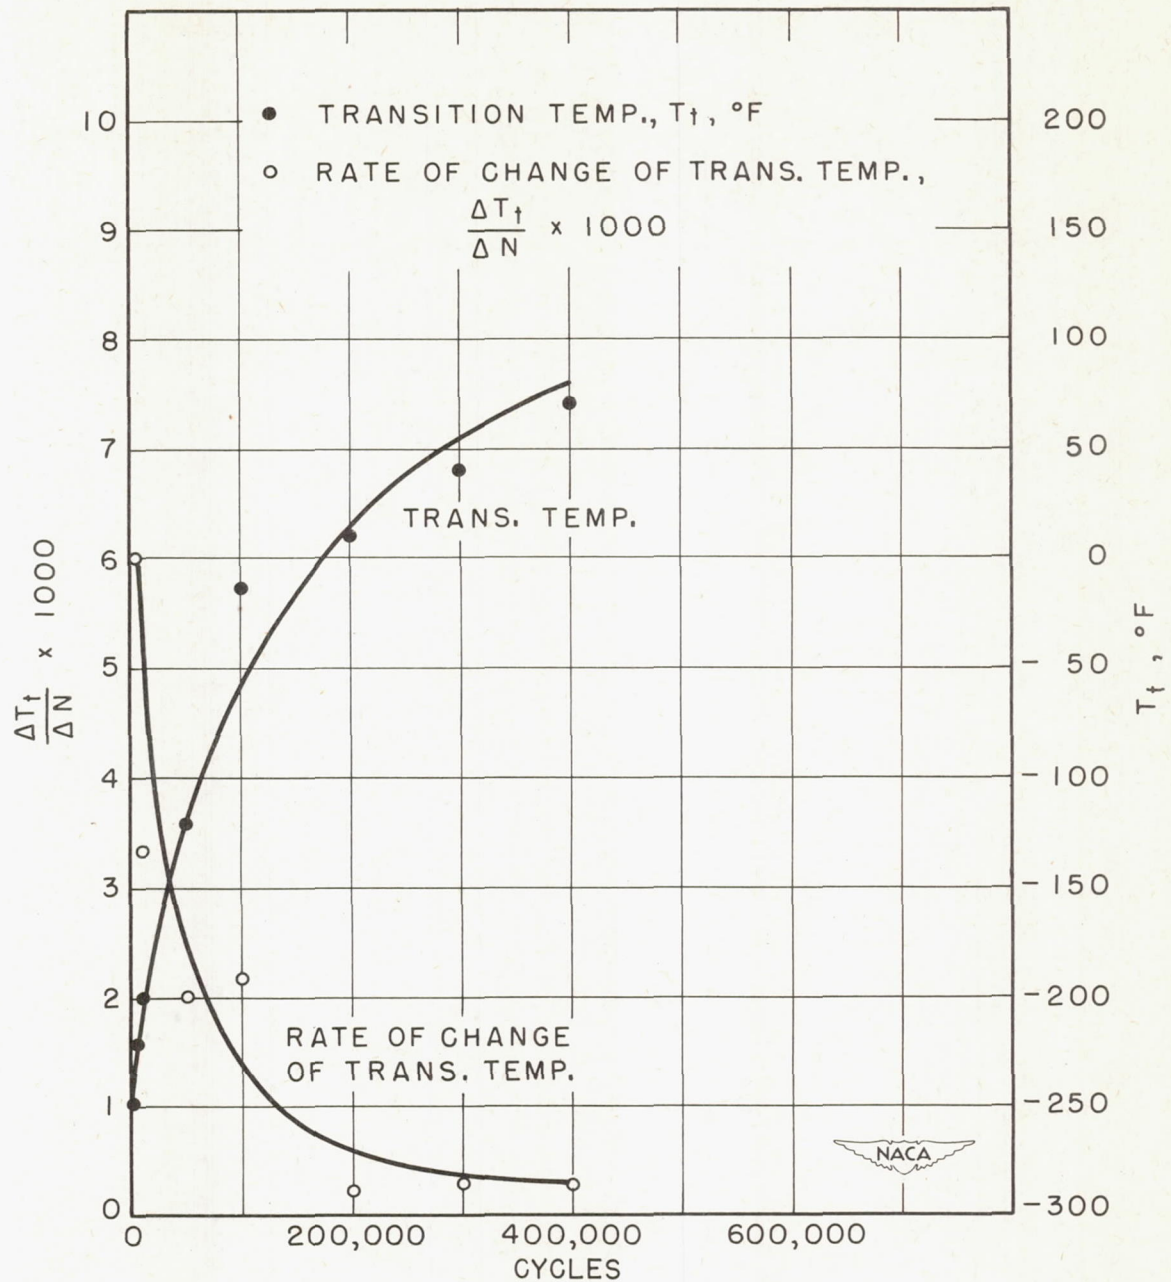
(a) V-notched specimens. Notch, 1/16 inch deep with 0.01-inch radius.

Figure 14.- Transition-temperature values for SAE 4130 steel after various prior cycles of fatigue stressing.

(b) U-notched specimens. Notch, 1/16 inch deep with 1/16-inch radius.

The SAE 4130 steel when subjected to prior cycles of stress above the notched endurance limit showed a steady increase in transition temperature with prior cycles. Table III provides the numerical data for figure 14. Figure 14(a) shows the transition temperature plotted against the number of prior cycles for sharp V-notched specimens, including the rate of change of transition temperature with cycles. The prior stress level was 33,000 psi. It is seen that the transition temperature increased to room temperature at the end of its fatigue life. The rate of change of transition temperature continuously decreased with prior cycles. The U-notched specimens (fig. 14(b)), subjected to prior fatigue stress levels of 46,000 psi (which gave a life of 450,000 cycles, about the same as for the V-notched specimens at a stress level of 33,000 psi), showed a similar increase in transition temperature with prior cycles, although it required about 200,000 cycles before much change took place. After this, the rate of change of transition temperature for the next 200,000 cycles was about the same as that for the first 200,000 cycles for the V-notched specimens.

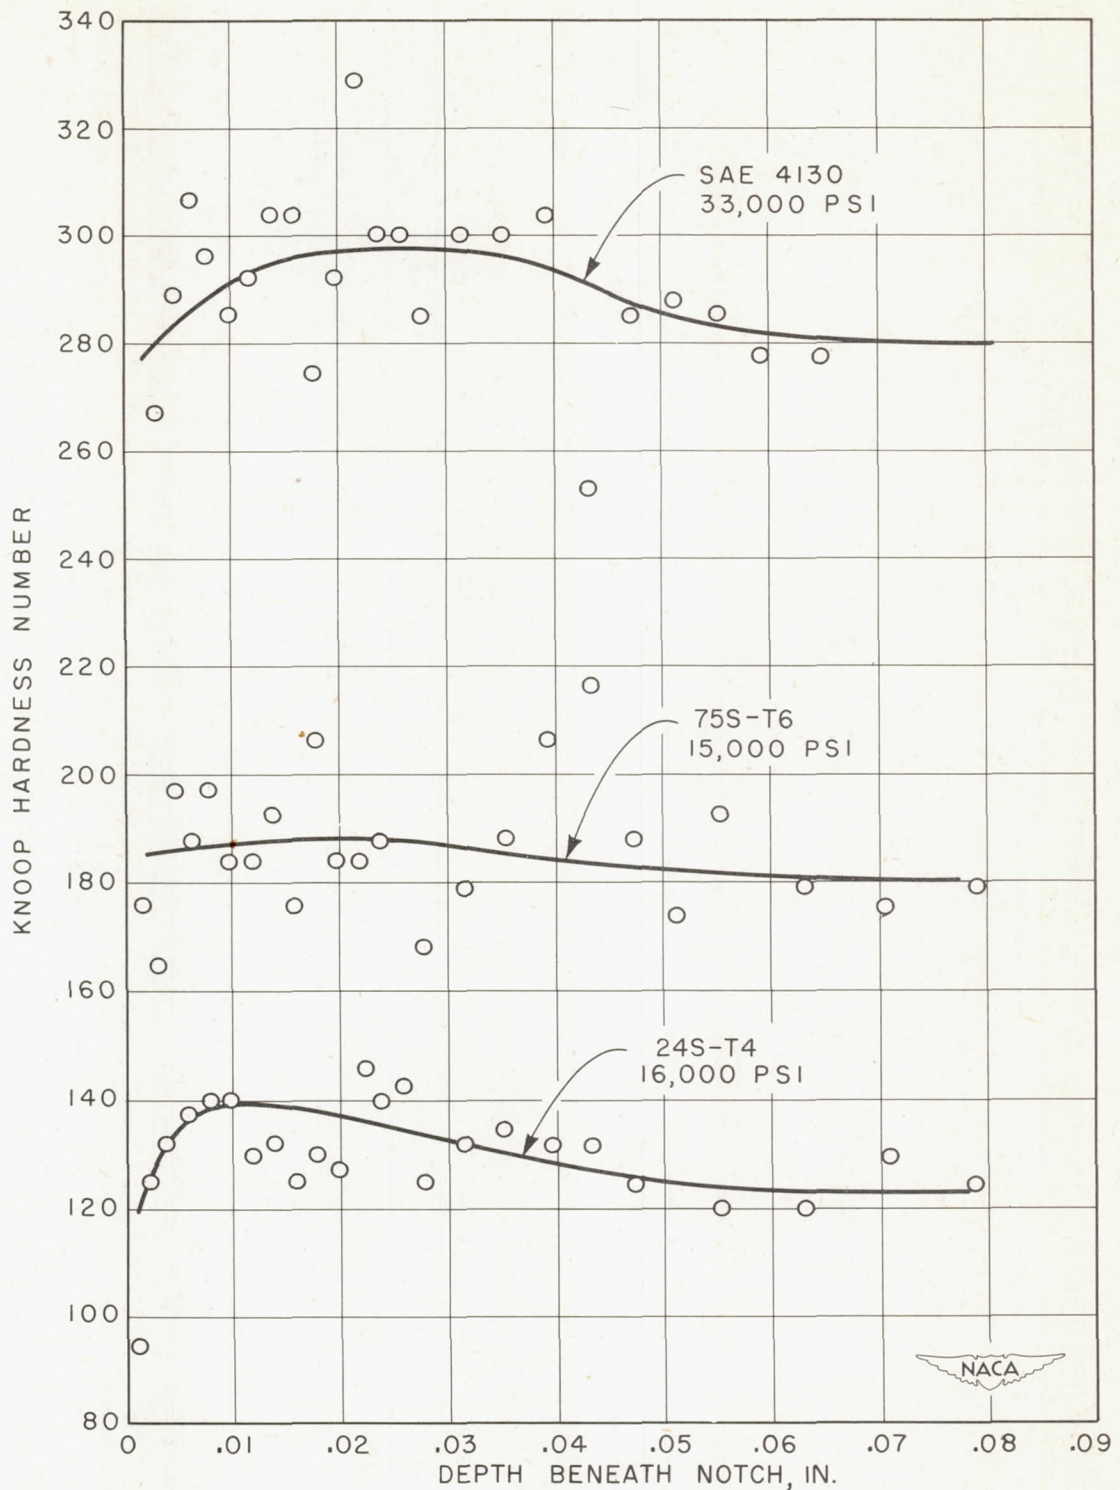
Figure 20.- Microhardness survey of V-notched fatigue specimens subjected to 100,000 cycles of stressing. Approximate fatigue life, 450,000 cycles at respective stress levels. Notch, 1/16 inch deep with 0.01-inch radius.

A microhardness survey with the Tukon tester made on V-notched specimens, fatigued for 100,000 cycles and sectioned longitudinally, showed as illustrated in figure 20 that the hardness within 0.002 inch of the notch bottom was somewhat less than the original matrix. It then increased for a depth of about 0.02 inch and leveled off to the hardness of the matrix.
