TECHNICAL NOTE 2991

ACCELERATIONS AND PASSENGER HARNESS LOADS MEASURED  
IN FULL-SCALE LIGHT-AIRPLANE CRASHES

Lewis Flight Propulsion Laboratory  
Cleveland, Ohio

August 1953

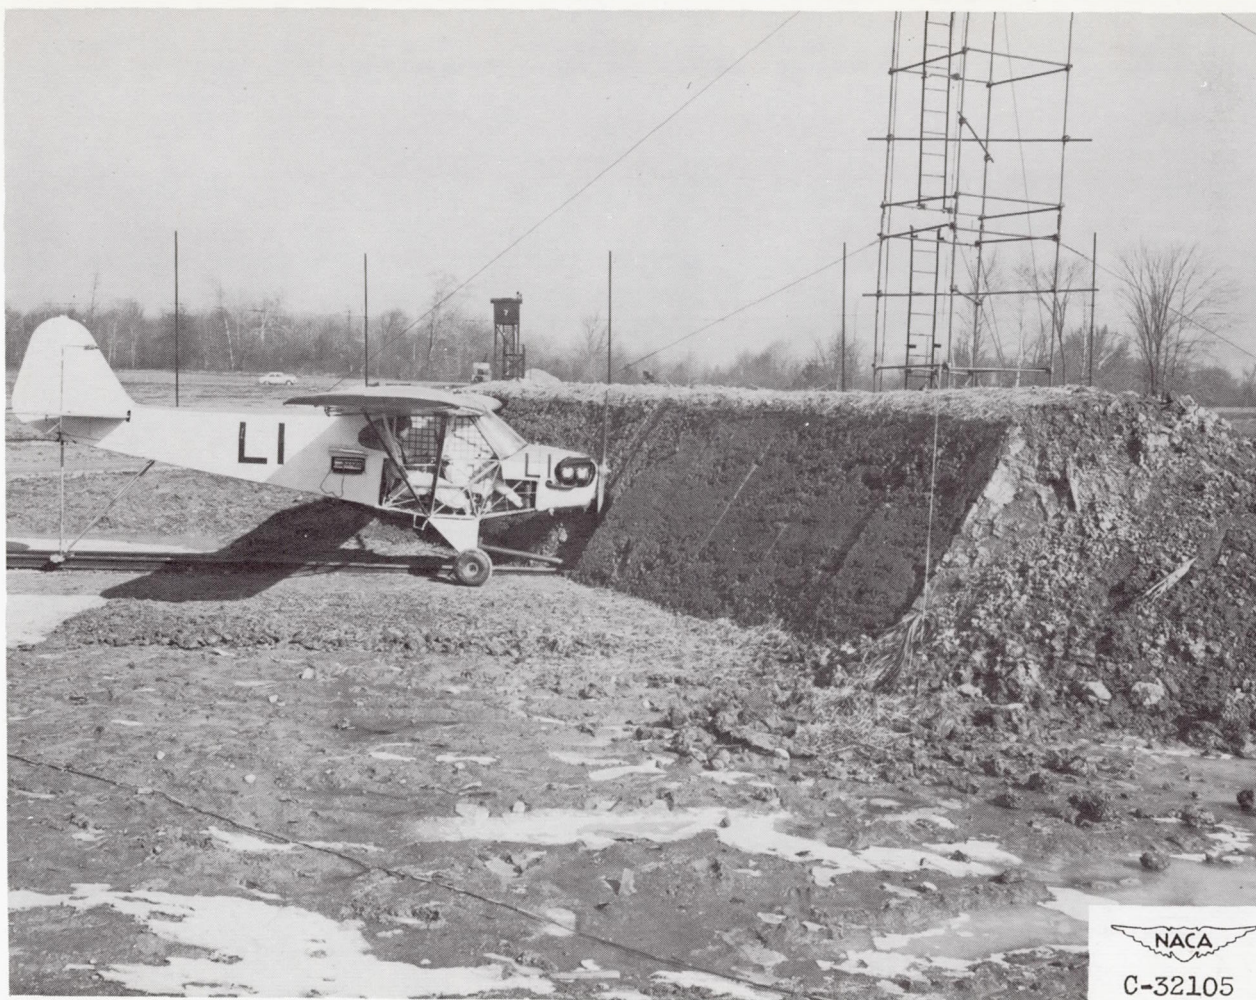
(a) Photograph of two-seat tandem airplane used in investigation, showing relation of airplane engine and left wing to front edge of earthen crash barrier.

In a crash, the airplane was propelled by its own power along a guide rail toward the crash barrier. A slipper, located at the end of a tongue, guided the airplane to the crash barrier. This guide slipper was designed to fit around the top flange of the guide rail (fig. 1(b)) in such a manner as to prevent the slipper from leaving the rail in either a vertical or a lateral direction. In order to prevent the slipper and tongue assembly from transmitting forces to the airplane structure during the crash, a 12-inch-diameter steel tube (fig. 1(c)) was installed at the end of the rail to allow the slipper and the tongue assembly to pass underneath the crash barrier. The momentum of the slipper and tongue assembly carried it into the steel tube upon airplane impact with the crash barrier. The rear of the tongue was pinned to the airplane with a 3/32-inch-diameter pin (fig. 1(d)) that sheared under a load of 150 pounds.

The earthen crash barrier (fig. 1(a)) located at the end of the guide rail was constructed of dirt compacted to have a bearing pressure of 5900 pounds per square foot on the front surface into which the airplane crashed. This bearing pressure corresponds to the local undisturbed clay turf soil. The barrier was 50 feet long,  $9\frac{1}{2}$  feet high, and 22 feet thick at the base, sloped at an angle of  $55^{\circ}$  to the vertical axis, and oriented  $66^{\circ}$  to the axis of the rail, as shown in the sketch in figure 2.

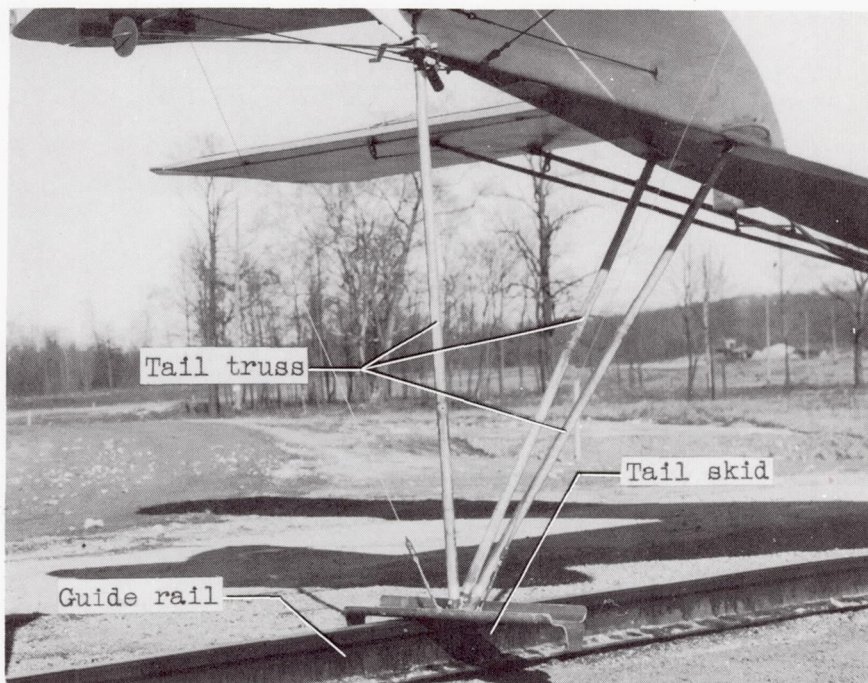
(e) Extended tail-truss support for holding airplane in flight attitude.

In order to support the airplane in flight attitude as it proceeded unmaned down the runway, a tail truss was bolted to the tail-wheel attachment bracket (fig. 1(e)), the tail-wheel assembly having been removed. A 1/8-inch aluminum plate that was flush-riveted to the bottom of the tail truss slid along on top of the guide rail. This tail truss weighed approximately  $2\frac{1}{2}$  pounds more than the tail-wheel assembly that it replaced. The gross weight of each airplane was 1200, 1013, and 1261 pounds, respectively, for the crashes at 42, 47, and 60 mph. The Civil Aeronautics Administration certified maximum weight of the airplane is 1220 pounds.

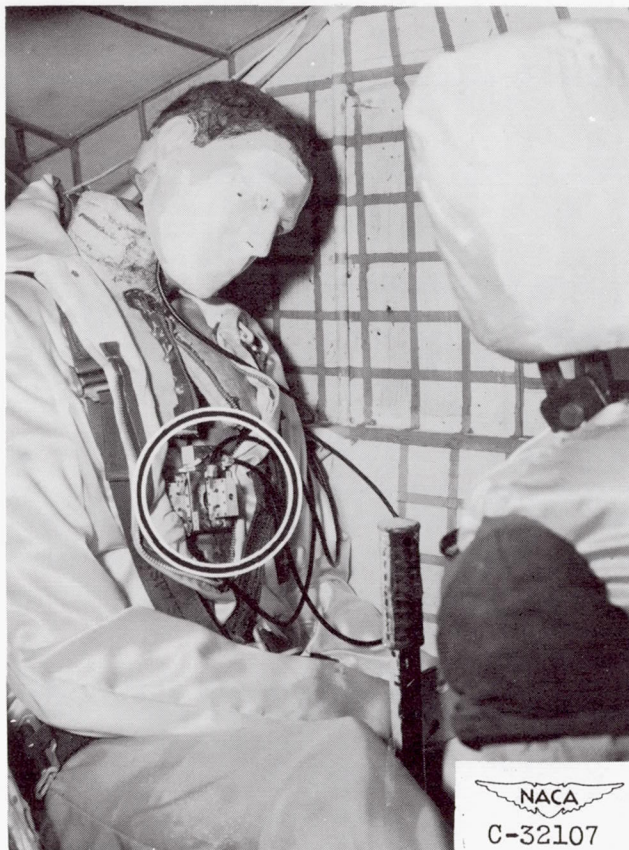
(e) Accelerometers installed on chest of rear dummy.

| Channel | Measured quantity | Direction | Location | Figure | Range |
|---|---|---|---|---|---|
| 2 | Acceleration | Vertical | Chest of dummy | 4(e) | -91 to 42g |

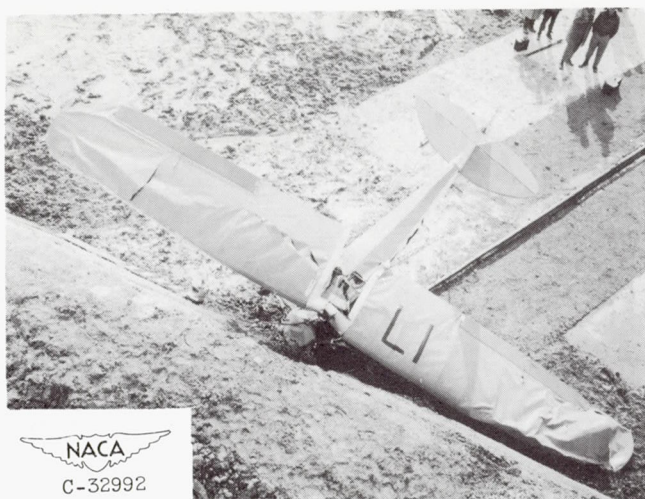
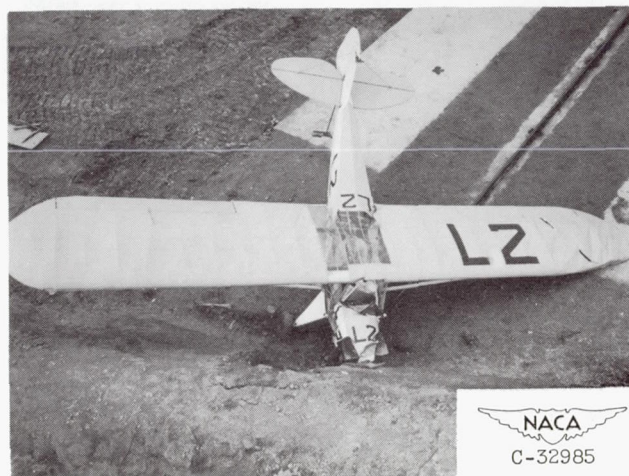
Figure 8. - Damage to wing and fuselage of airplane resulting from impact with crash barrier.

In the 60-mph crash, the fuselage crumpled to such a degree as to allow the leading edge of the wings to come in contact with the crash barrier, and the resulting damage to the wing structure is shown in figure 8(a). This impact of the wings with the barrier undoubtedly aided in reducing the decelerative force that was transmitted to the fuselage because part of the mass of the wings was decelerated by direct

contact with the barrier. Very little damage occurred to the wings in the 47- and 42-mph crashes, as shown in figures 8(b) and (c). Since the maximum fuselage-floor deceleration for the three crashes did not vary appreciably, the duration of the decelerations increased with increasing impact speed consistently with the higher airplane momentum at impact. A measure of this duration can be obtained by noting the time of the last major peak (fig. 7). This peak for the 60-mph crash occurred at 0.124 second after impact. The last peak deceleration for the 47-mph crash occurred at 0.076 second after impact, and the last peak for the 42-mph crash occurred at 0.061 second after impact. The average rate of onset of deceleration of the fuselage floor for the 42- and 47-mph crashes was approximately 2400g per second and 4600g per second, respectively.

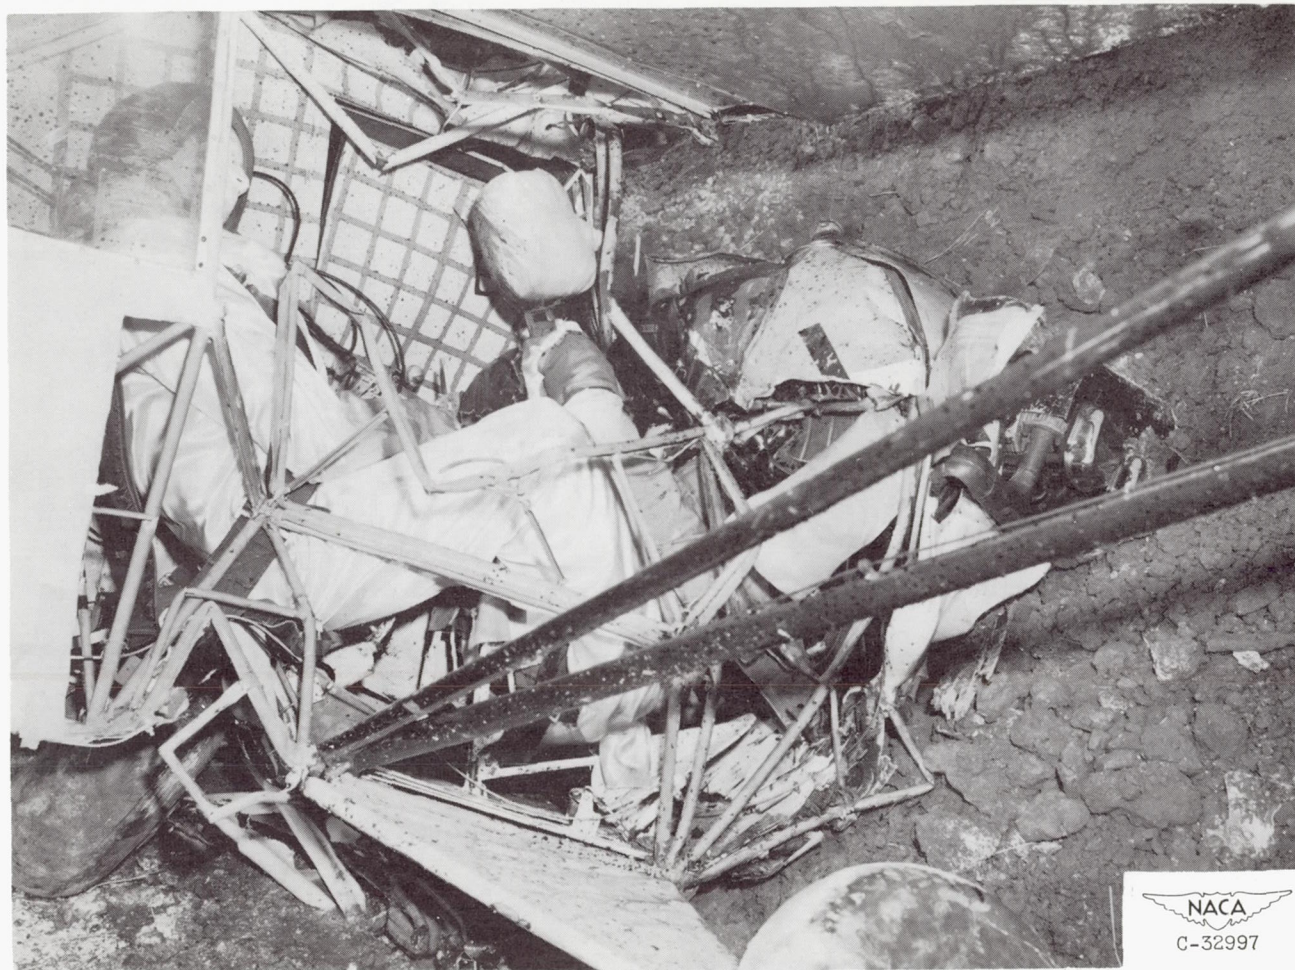
Figure 19. - Crash damage to airplane structure.

Collapse of cabin structure. - Potential injury of the occupants due to inward-collapsing cabin structure is indicated by comparison of the extent of the collapse of the cabin structure in figure 19. The figures show photographs of the cabin area following the 42-, 47-, and 60-mph crashes. As indicated by comparison of these photographs, an increase of speed at impact with the barrier caused a corresponding reduction of the volume enclosed by the cabin structure. Figure 19(a) shows that, during the 42-mph crash, deformation of the cabin was minor. Appreciable reduction in cabin volume was noticeable with an increase of impact speed to 47 mph. During this crash, the cabin volume was reduced by the rearward displacement of the instrument panel, as may be detected by comparing the position of the upper, forward, right-side diagonal brace in figure 19(b) with its undistorted position after the 42-mph crash, figure 19(a). With an impact speed of 60 mph, considerable reduction in cabin volume resulted. This reduction resulted from (1) rearward movement of the instrument panel nearly to the front dummy's chest and (2) collapse of the longerons under the rear seat (fig. 19(c)). Distortion of the cabin structural tubing during cabin deformation may increase the probability of injury to the occupants. An example of this distortion is shown by the upper cabin members projecting into the proximity of the heads of both dummies in figure 19(c). It is evident from inspection of figure 19 that, if occupants of an airplane during a crash are to be protected from the additional hazard of striking the deformed cabin structural members collapsing around them, the cabin structure itself must be strong enough to resist the decelerative forces occurring at impact.
