NACA TN 3775

TECHNICAL NOTE 3775

CRASH INJURY

By Gerard J. Pesman and A. Martin Eiband

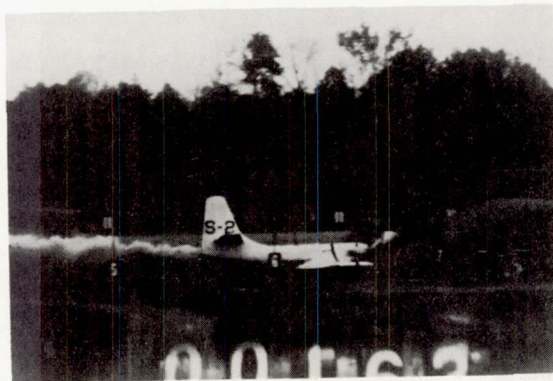
Figure 1. - Crushing of nose and cockpit structure in fighter airplane crash.

the airplane's trajectory and the ground surface). The airplane speed at the instant of impact was about 110 miles per hour. The photographs of figure 1, reproduced from a motion picture of the incident, show a succession of steps in the crushing action. Figures 1(a) to (c) show that the fuselage structure was not strong enough to noticeably deflect the airplane from its original path; the fuselage crushed continuously. When the stronger wing and engine support structure struck the ground (fig. 1(d)), the airplane's path was changed until the airplane was moving parallel to the ground and the crushing action stopped. By that time, however, every part of the fuselage structure ahead of the wing, including the cockpit, had been crushed. If the angle of impact and impact speed are great enough, any airplane will crush in a similar manner. Survival under such circumstances is improbable.

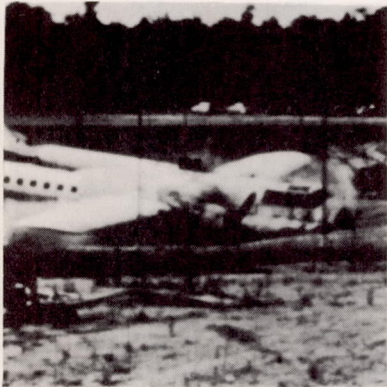
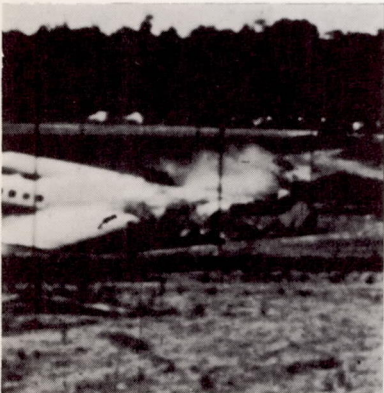
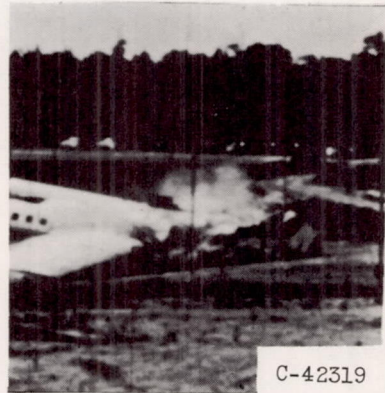
Figure 2. - Hinging action of crew compartment.

The action of this cargo airplane structure during a crash impact is shown by the sequence of photographs in figure 2. When the nose of the airplane struck the ground, the weak understructure crumpled until the floor of the crew compartment was reached (figs. 2(a) to (c)). The strong floor structure prevented further crumpling. Instead, the crew compartment hinged upward, lifting at the front and hinging at a point near the wing leading edge (fig. 2(d)). The hinging action lifted the compartment so that it was not in the direct line between the main mass of the airplane and the ground. The compartment thus was not subjected to the total force decelerating the airplane and consequently was not crushed.

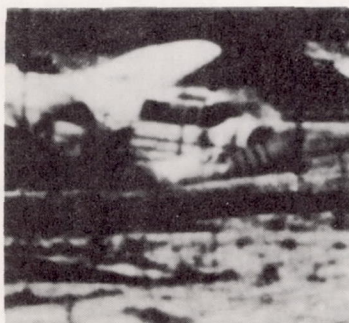
Figure 4. - Successive stages of fuselage structure being pulled under sliding airplane.

Although hinging action would help to protect the occupants during the initial impact, there is an additional problem. As the airplane slides along, it tends to ride up and over the crumpling lower structure. Since the lower structure is fastened to that above, the upper structure is also pulled down and under the sliding hulk. In the crash of the cargo airplane, however, the strong floor structure of the crew compartment combined with the weaker lower structure allowed the metal to tear at the floor line. Consequently, the crew compartment was not pulled down and under as was expected. The undertow and tearing action are apparent in figure 4. Figure 4(a) shows the nose of the airplane just before it touched the ground. Soon after the first impact (fig. 4(b)) a large wrinkle had formed in the fuselage skin (point A), and the parallel lines painted on the nose were bent showing that the nose structure was being pulled down. An instant later (fig. 4(c)), the understructure had been crushed up to the bottom of the Y painted on the side of the fuselage. The nose structure had separated from the main bulkhead (point B). Crushing of the understructure and pulling under of the nose structure progressed rapidly (fig. 4(d)) until the understructure was crushed and torn away almost up to the floor level (point C, fig. 4(e)). The nose section had been pulled completely under the sliding hulk.

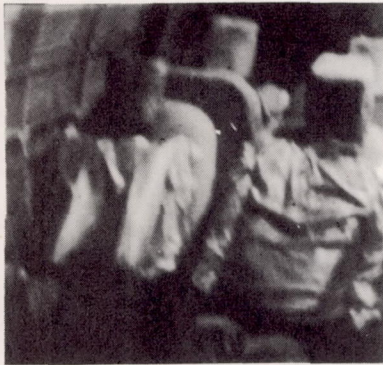
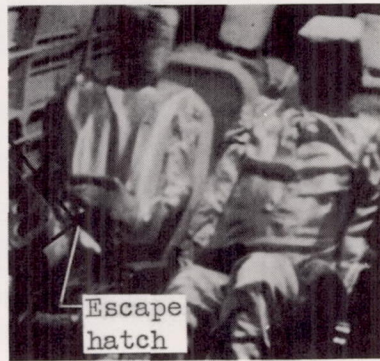
Figure 11. - Escape hatch striking dummy.

Even though the crash forces to which an airplane is exposed are not large enough to crush the structure, the forces may still be large enough to break the attachment fittings for equipment like fire extinguishers. Such detached equipment or other loose articles become missiles inside the cabin because of their inertia. In one of the experiments, when motion pictures were being taken inside the cabin while the airplane was crashing, a record was obtained of such an event. Figure 11 shows several frames from this motion picture. An escape hatch is shown being thrown across the cabin by the impact and striking a dummy.

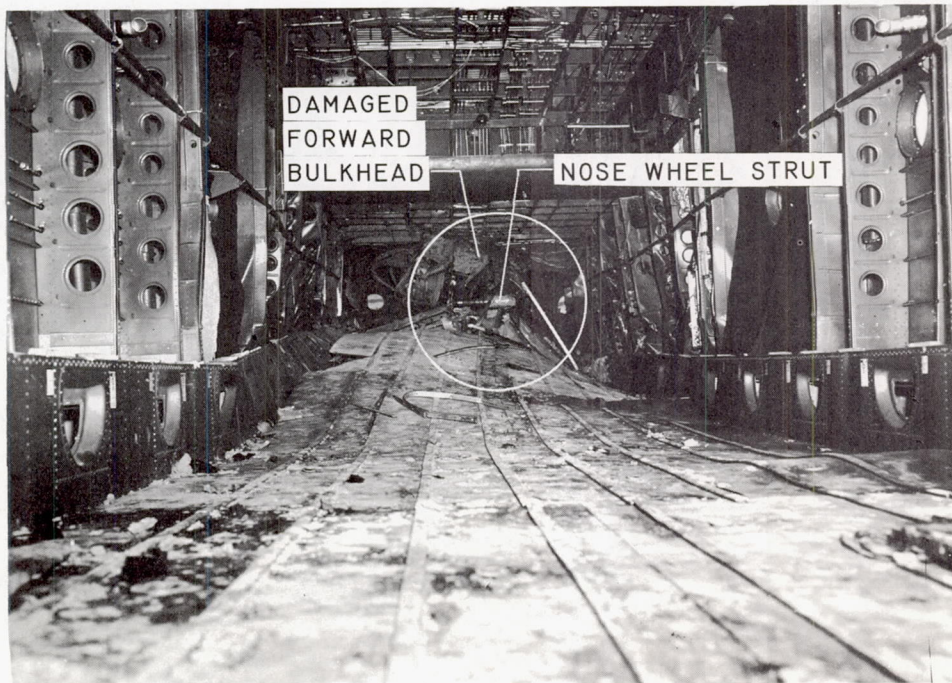
Figure 13. - Nose gear driven into cabin.

The front landing wheel assembly and the propellers can also produce missiles that may enter occupied zones. If a nose wheel is torn off by an obstacle, it can be driven back into the airplane, or it may be tangled with the debris under the belly and work its way through the floor. The results of such an incident can be seen in figure 13. This view was taken looking forward in the fuselage. The nose gear entered the fuselage a few feet behind the main forward bulkhead. The nose wheel strut can be seen protruding from the floor.

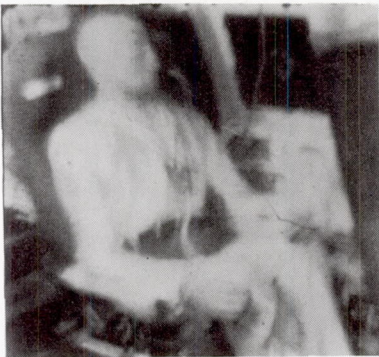
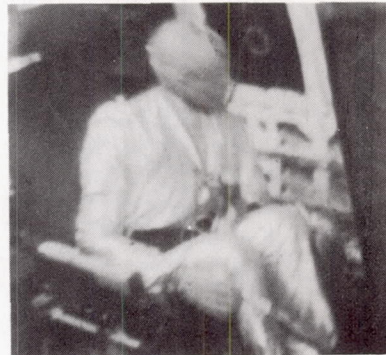
Figure 19. - Flailing action of dummy.

Thus far the hazard of occupants being struck by flying objects has been considered. Injury is also possible if the people themselves move. During a crash, a person held by a seat belt alone flails about and strikes objects near him. His hands, feet, and upper torso swing forward; his chest strikes his thighs; and then his head snaps down. This flailing action is shown by a sequence of photographs taken during an experimental crash (fig. 19).

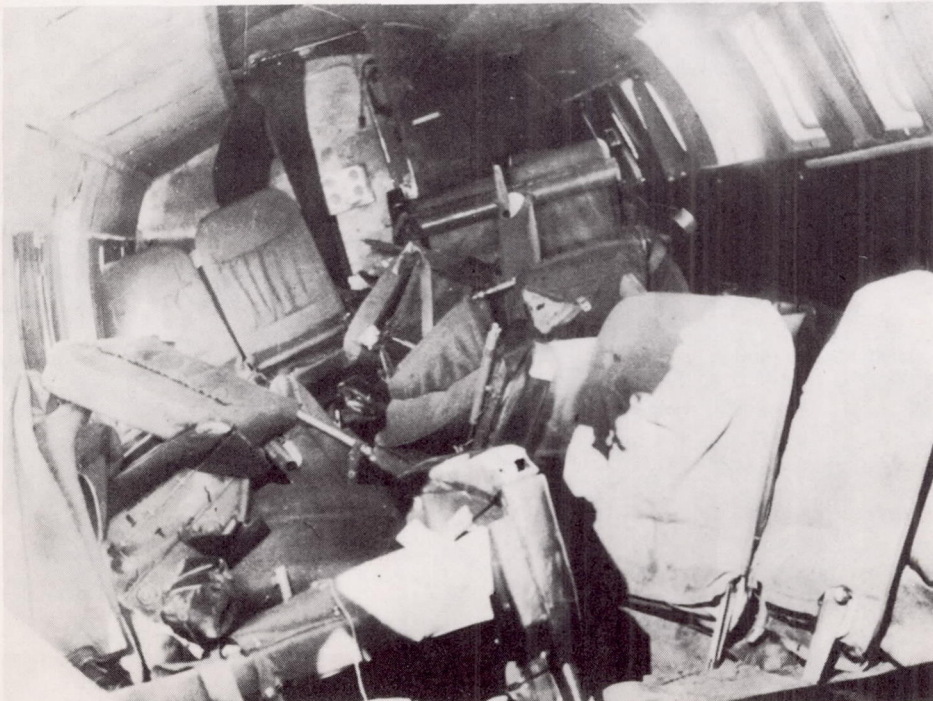
CS-10219

Figure 21. - Failed seats torn loose and piled in front of cabin.

If seat belts fail, or if the seats break loose, then the occupants instead of flailing about become free bodies inside the airplane. When this happens, passengers pile up in the front of the cabin. Figure 21 shows seats piled in the front of an airplane after the passengers were removed.

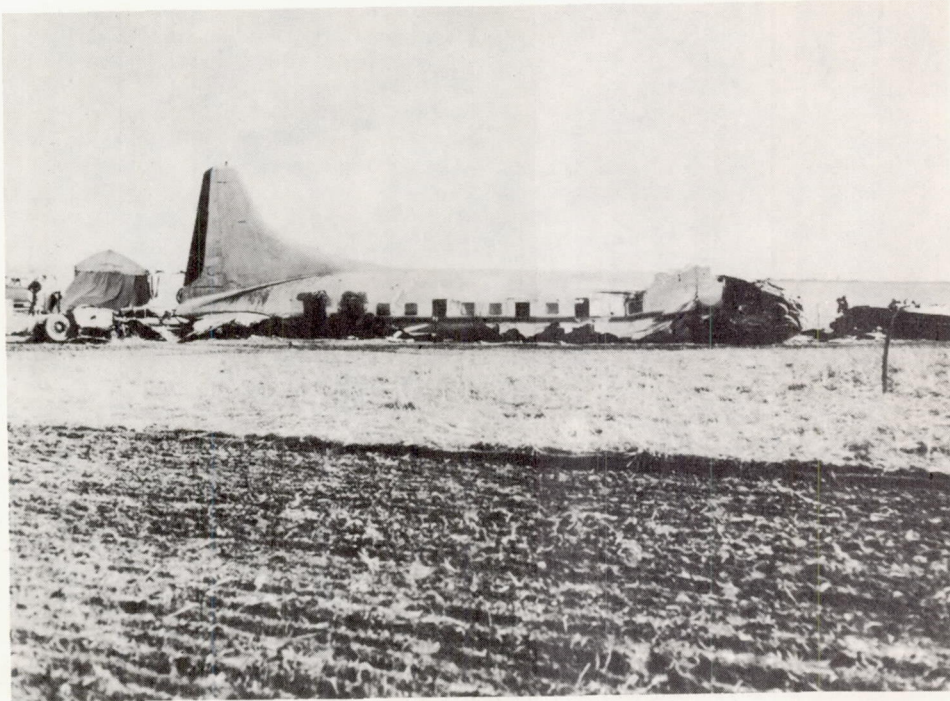
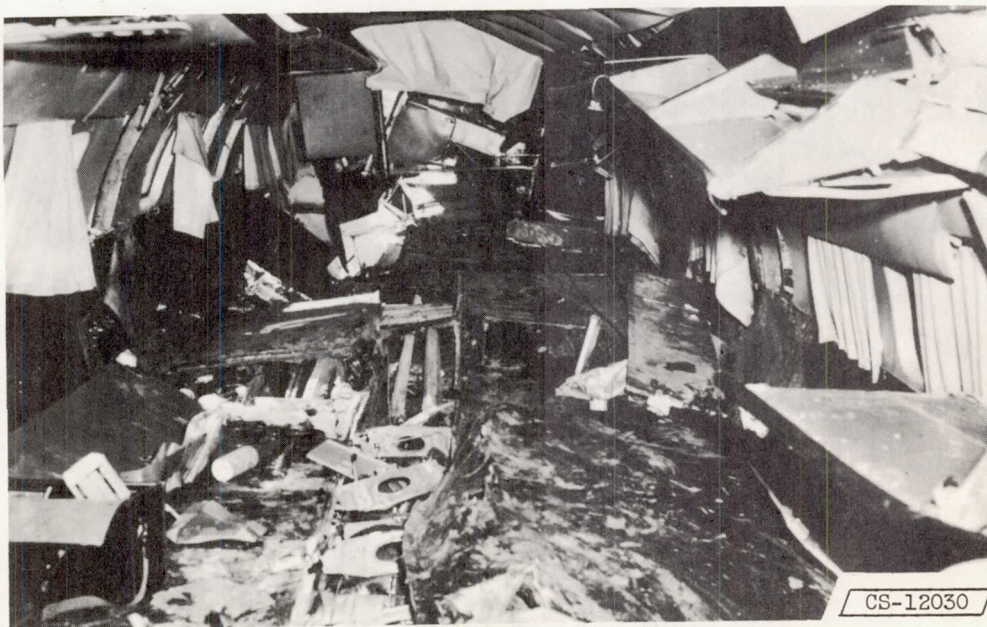
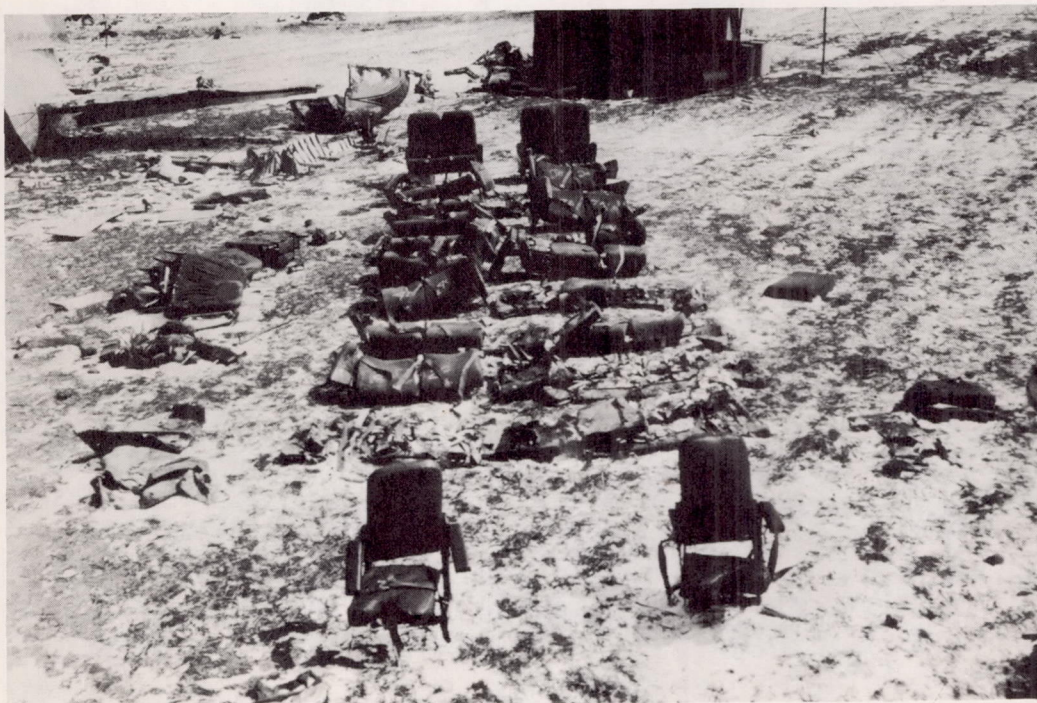
(a) Aft fuselage structure.

(b) Interior view looking forward at cabin floor structure.

Figure 22. - Crash in which impact forces destroyed seat attachment fittings. (Photographs supplied by Aviation Crash Injury group of Cornell University.)

(c) Seat wreckage assembled in original rows.

Wreckage from another accident in which many seats pulled loose is shown in figure 22. Broken seats could have been expected in front of the break in the fuselage (fig. 22(a)) because the fuselage structure was severely damaged. Aft of the break, however, the fuselage structure did not appear severely damaged, and little seat damage would have been expected. After the debris had been removed, the cabin appeared as shown in figure 22(b). The floor was badly deformed, and all the passengers' seats except the aft four had come loose (fig. 22(c)).

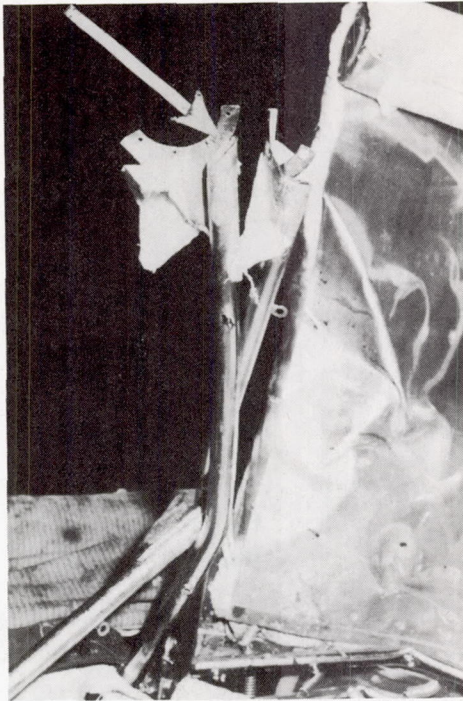
CS-12032

Figure 23. - Spear-like point formed by broken seat back tubing.
(Photograph supplied by Aviation Crash Injury group of Cornell University.)

When people and seats are torn loose and become free bodies in a sliding hulk, they can strike sharp, pointed, or solid obstacles. Broken seat parts are examples of obstacles that can cut and puncture people as they are thrown about. An example of such a spear, a broken tube from the seat back, is shown in figure 23. A similar spear in the same

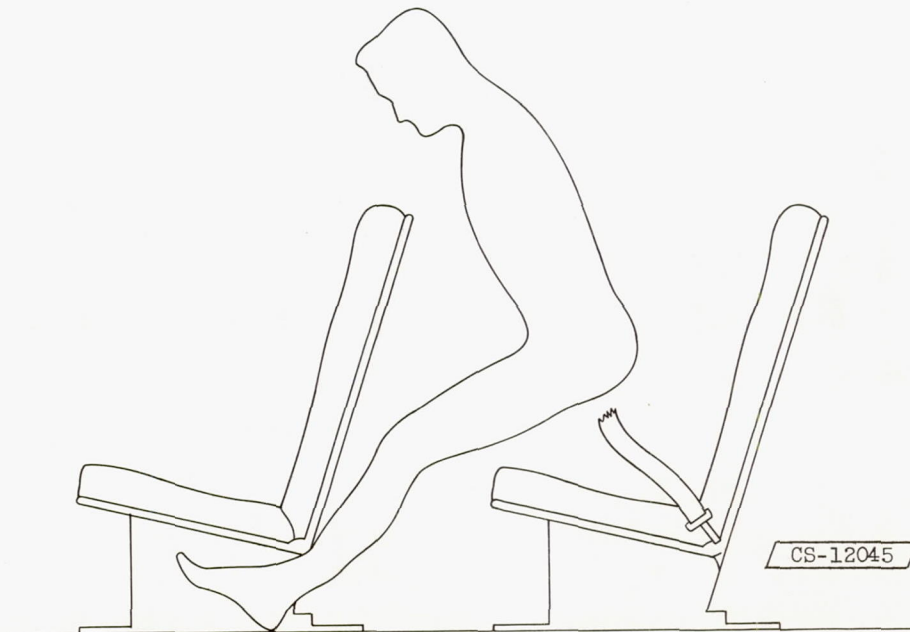
CS-12045

Figure 24. - Shanks broken by lever action.

If the seats remain fixed, but a belt fails, then a person's feet can slide under the seat ahead as shown in figure 24. The inertia of a person's body is applied to his shins with the seat structure as a fulcrum. A lower leg fracture is almost certain. Such injuries have occurred and can be avoided if the seat belts are made as strong as the seats.
