TECHNICAL NOTE 3892

PERFORMANCE OF 110-MILLIMETER-BORE M-1 TOOL STEEL BALL  
BEARINGS AT HIGH SPEEDS, LOADS, AND TEMPERATURES

By William J. Anderson

Lewis Flight Propulsion Laboratory  
Cleveland, Ohio

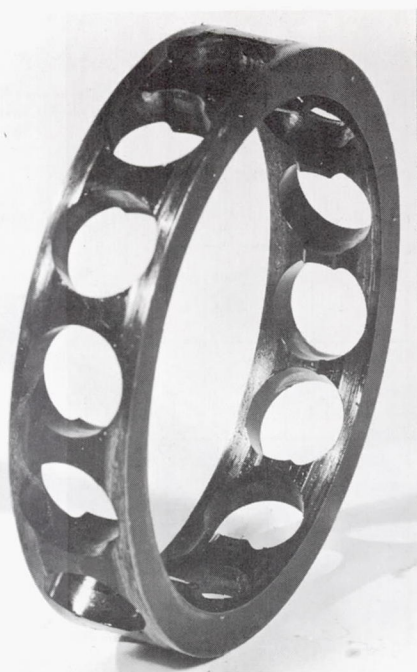
(a) Bearing 1009. Cage wear resulting from several oil-interruption tests.

some 15 hours running time was accumulated at temperatures of 501° to 678° F without the cage incurring any appreciable wear. During several oil-interruption tests, which cumulatively consumed 17 minutes and 22 seconds running time (table III), severe wear of the cage and extremely severe wear of both the inner and outer races occurred. The depth of wear on the cage inside and outside diameters was less than 1/64 inch, but the cage wore the inner and outer races to uniform depths of 7/64 and 1/16 inch, respectively, over the surfaces contacting the cage. A photograph of the cage of bearing 1009 is shown in figure 13(a). The inner race of bearing 1009 is shown in figure 9 and the outer race in figure 14.

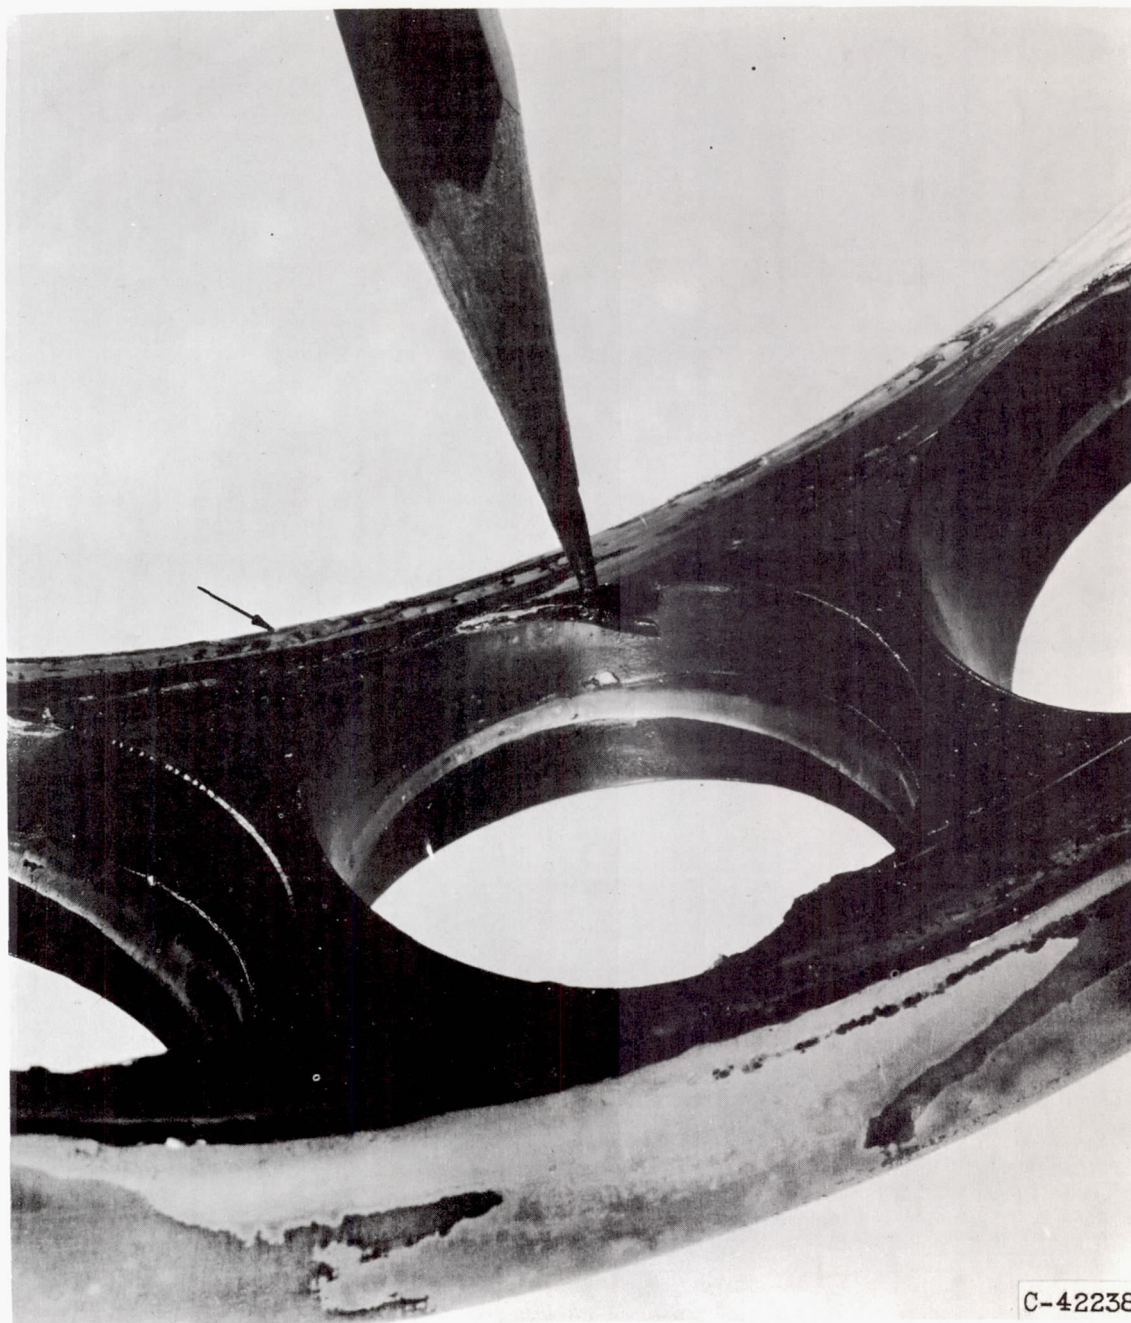
(g) Bearing 1005A. Cage locating surface and pocket wear resulting from an oil-interruption test.
