# RESEARCH MEMORANDUM

FLIGHT MEASUREMENTS WITH THE  
DOUGLAS D-558-II (BuAero No. 37974) RESEARCH AIRPLANE

LOW-SPEED STALLING AND LIFT CHARACTERISTICS

September 5, 1950  
Declassified May 8, 1957

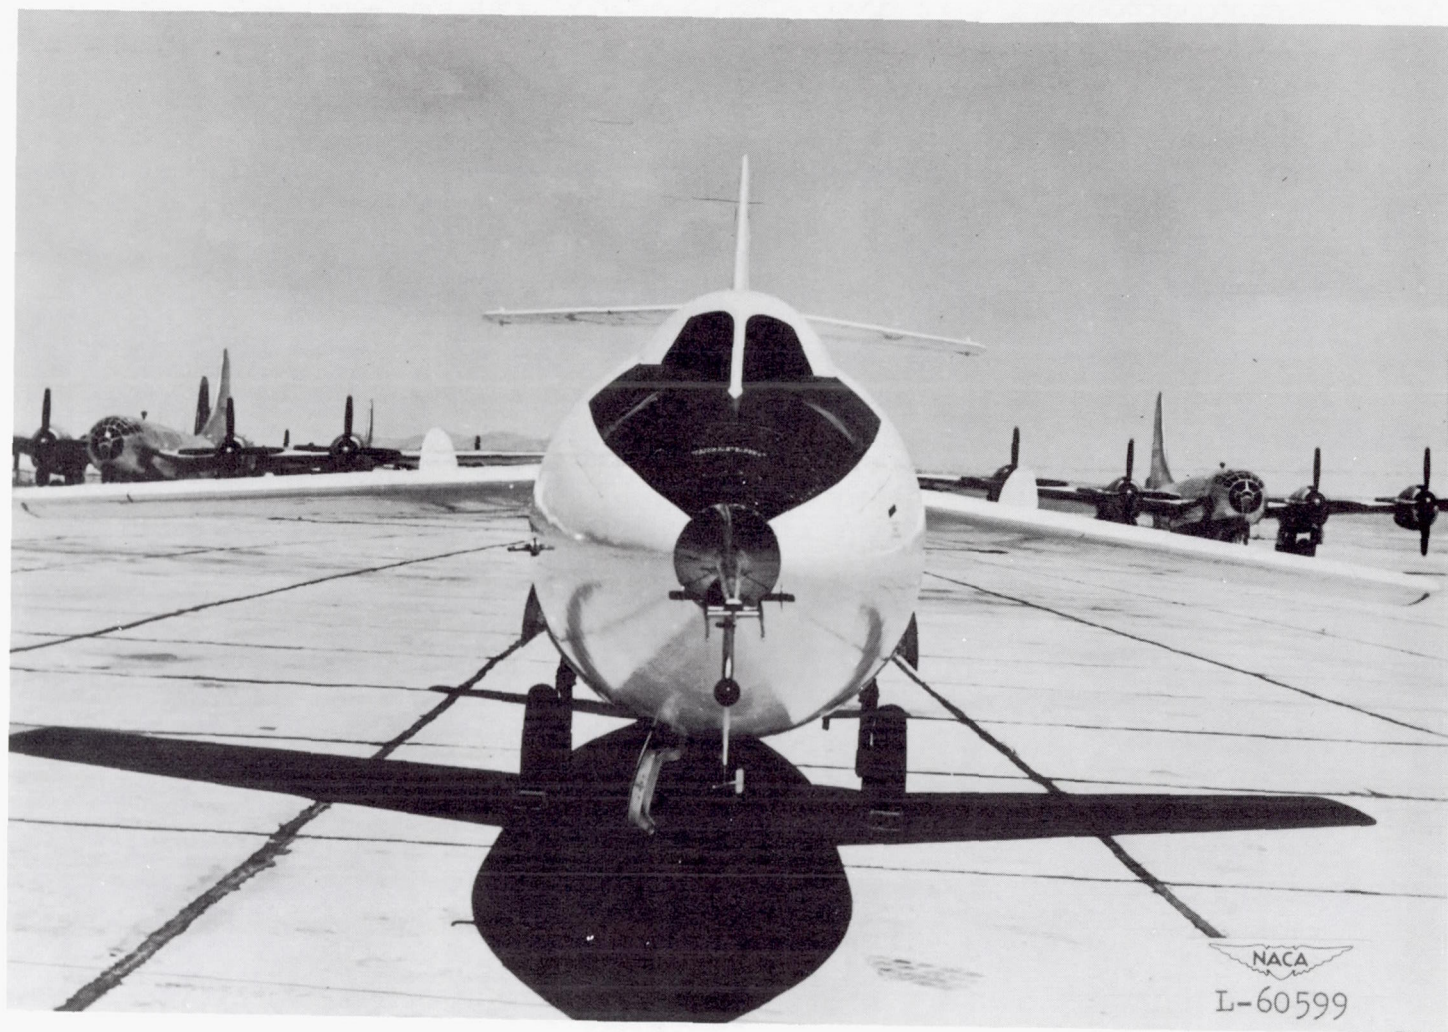
Figure 1.- Front view of Douglas D-558-II (BuAero No. 37974) research airplane.

a J-34-WE-40 turbojet engine which exhausts out of the bottom of the fuselage between the wing and the tail. Photographs of the airplane are shown in figures 1 and 2 and a three-view drawing is shown in figure 3. Pertinent airplane dimensions and characteristics are listed in table I.

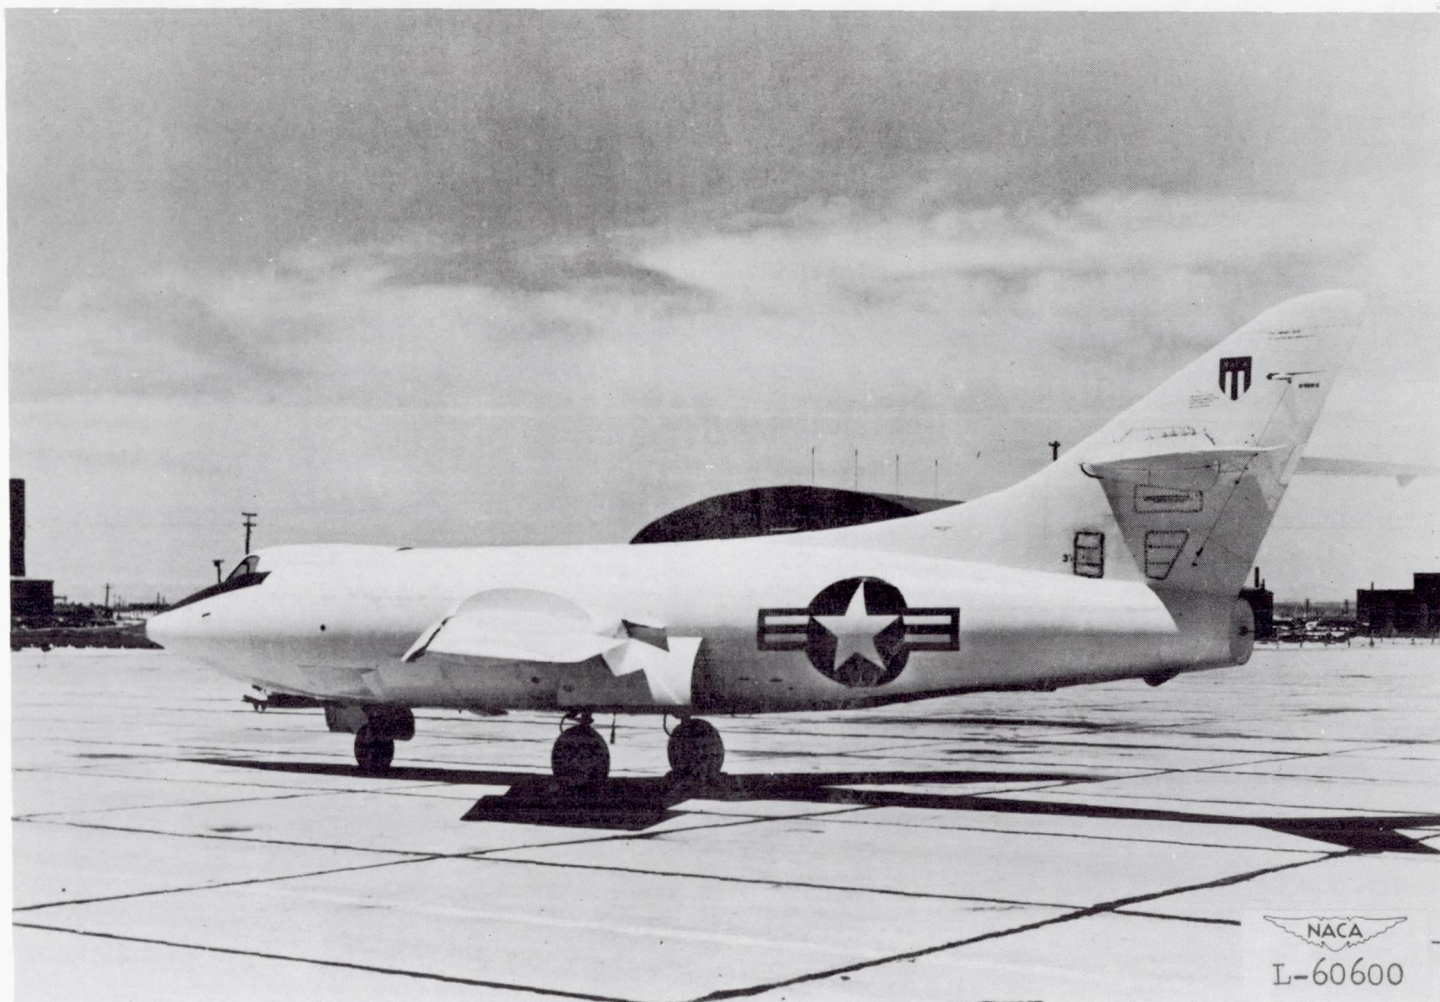
Figure 2.- Three-quarter rear view of Douglas D-558-II (BuAero No. 37974) research airplane.

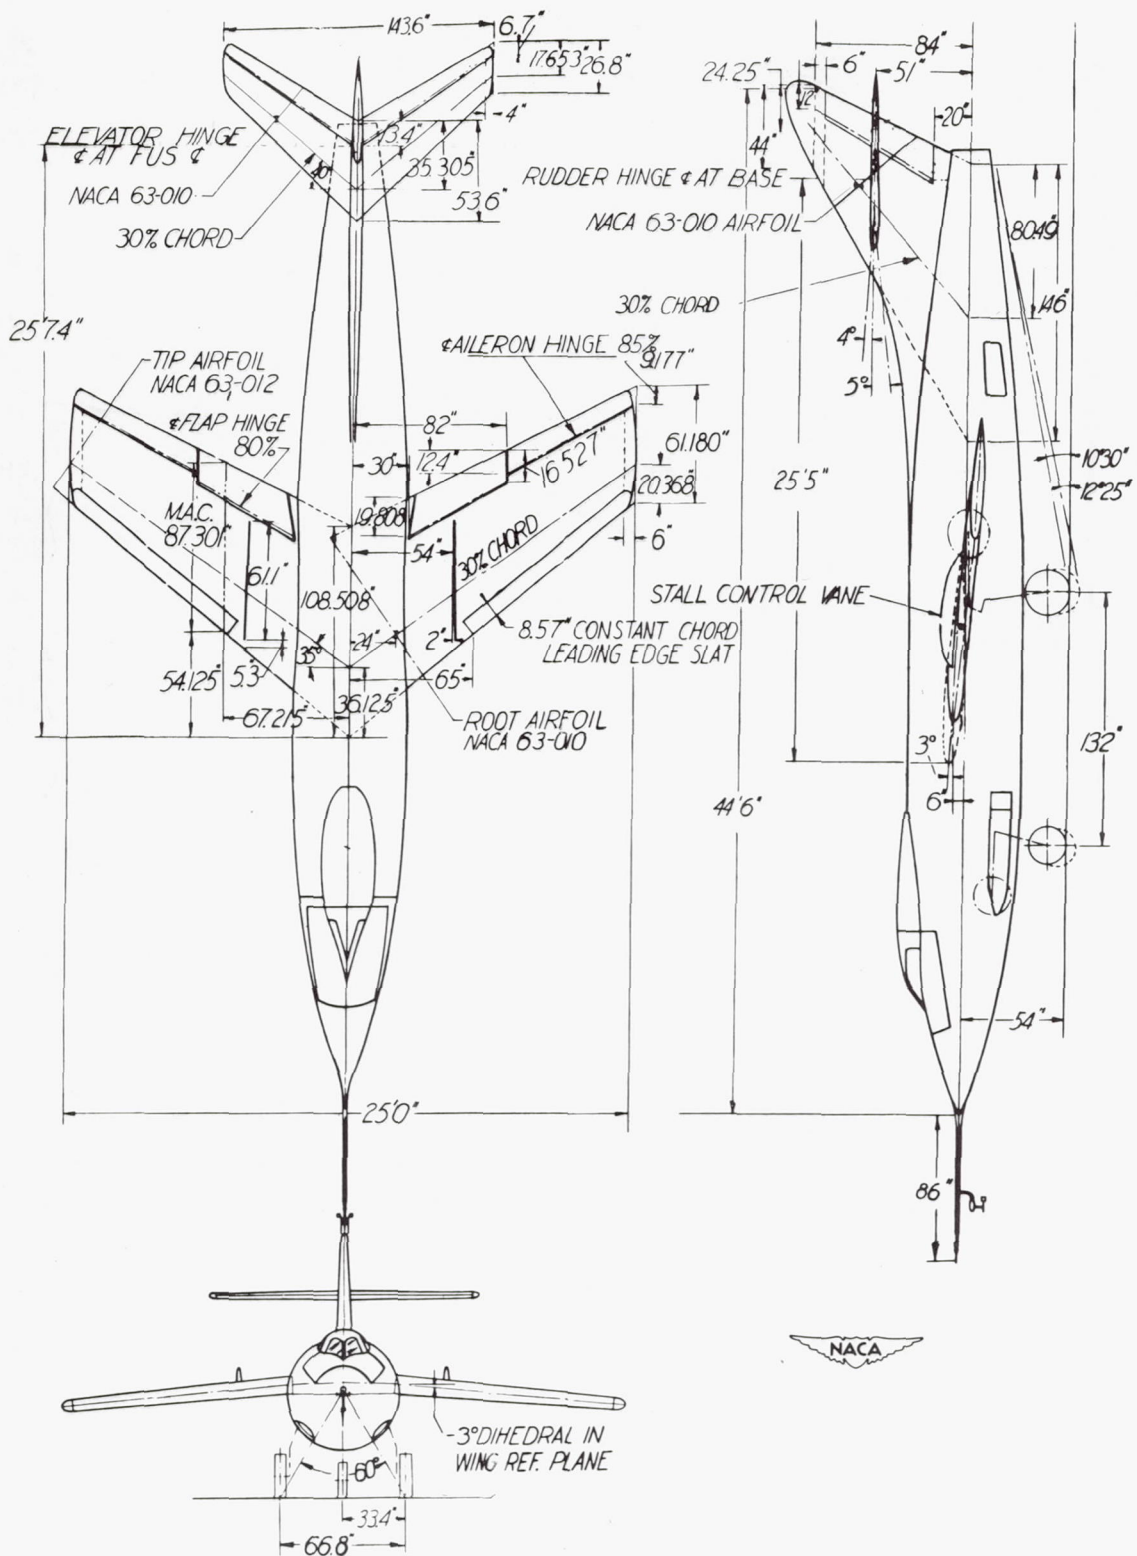
Figure 3.- Three-view drawing of the Douglas D-558-II (BuAero No. 37974) research airplane.

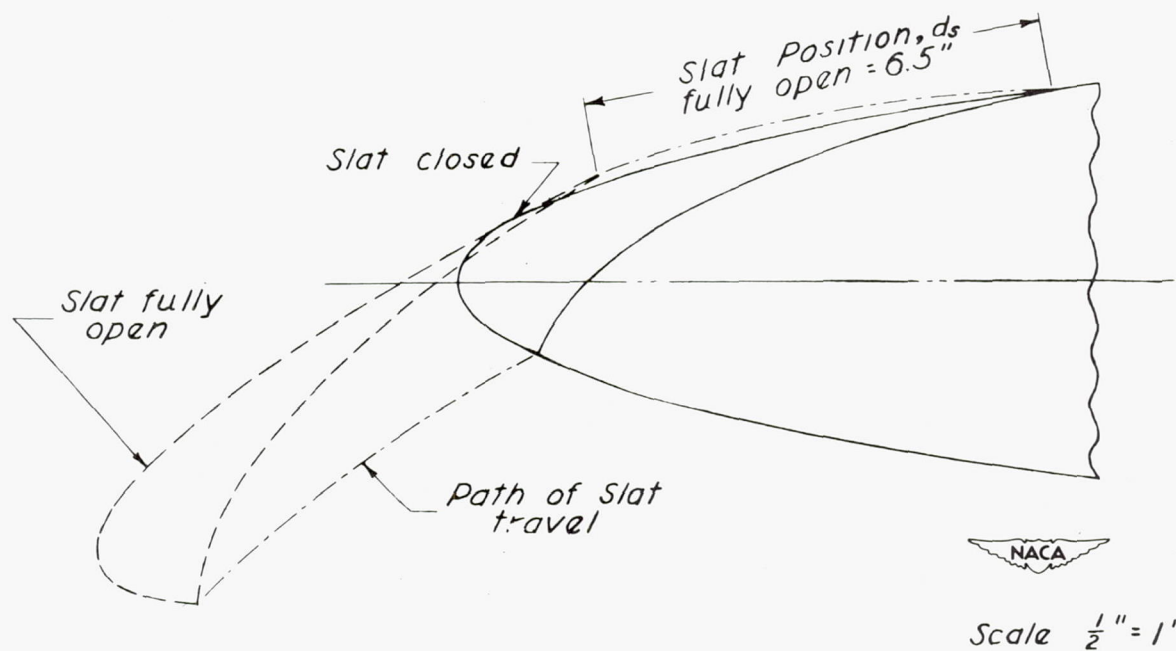
Figure 4.- Section of wing slat of Douglas D-558-II (BuAero No. 37974) research airplane perpendicular to leading edge of wing.

Both slats and fences are incorporated on the wing of the airplane. The wing slats can be locked in the closed position or they can be unlocked. When the slats are unlocked, the slat position is a function of the angle of attack of the airplane. Also, the slats on the left and right wings are interconnected and therefore, at any time, have the same position. A section view of the slat and the forward portion of the wing showing the motion of the slat with respect to the wing is shown in figure 4.

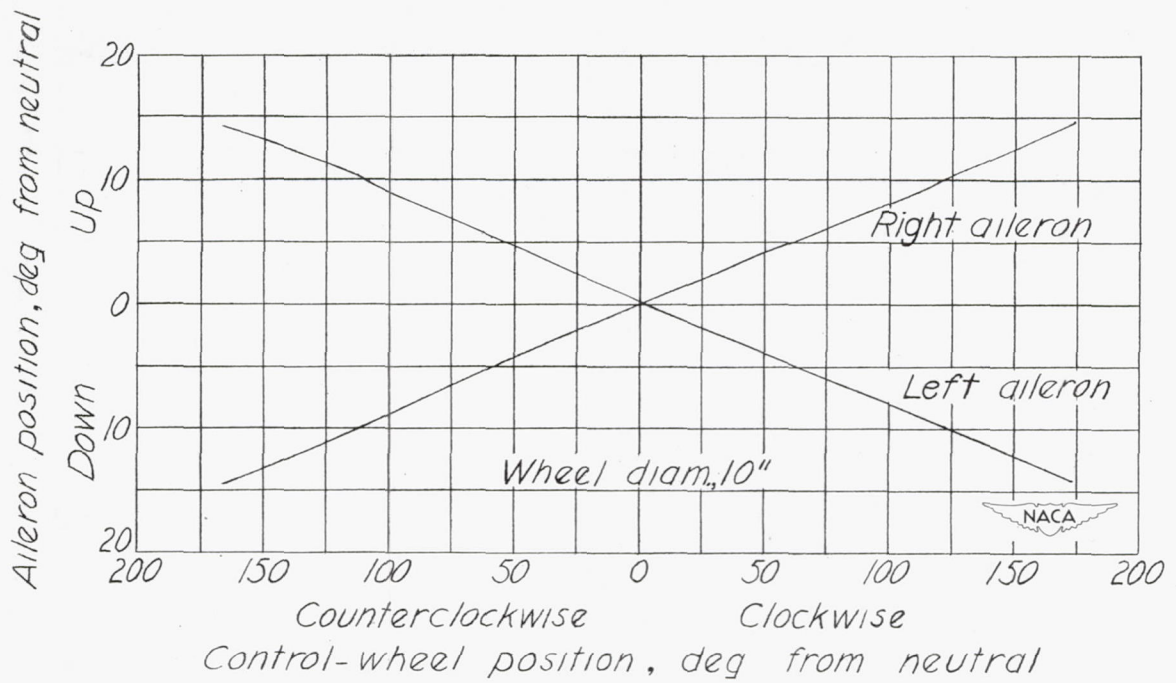
Figure 5.- Variation of left and right aileron positions with control-wheel position. No load on system.

The variations of aileron and elevator position with control-wheel position are shown in figures 5 and 6 and the variation of rudder position with right rudder pedal position is shown in figure 7. The friction in the control systems as measured on the ground under no load is shown in figures 8, 9, and 10. The friction measurements were obtained by measuring the control position and the control force as the controls were deflected slowly. The rate of control deflection was sufficiently low so that the control force resulting from the hydraulic dampers in the control system was negligible.

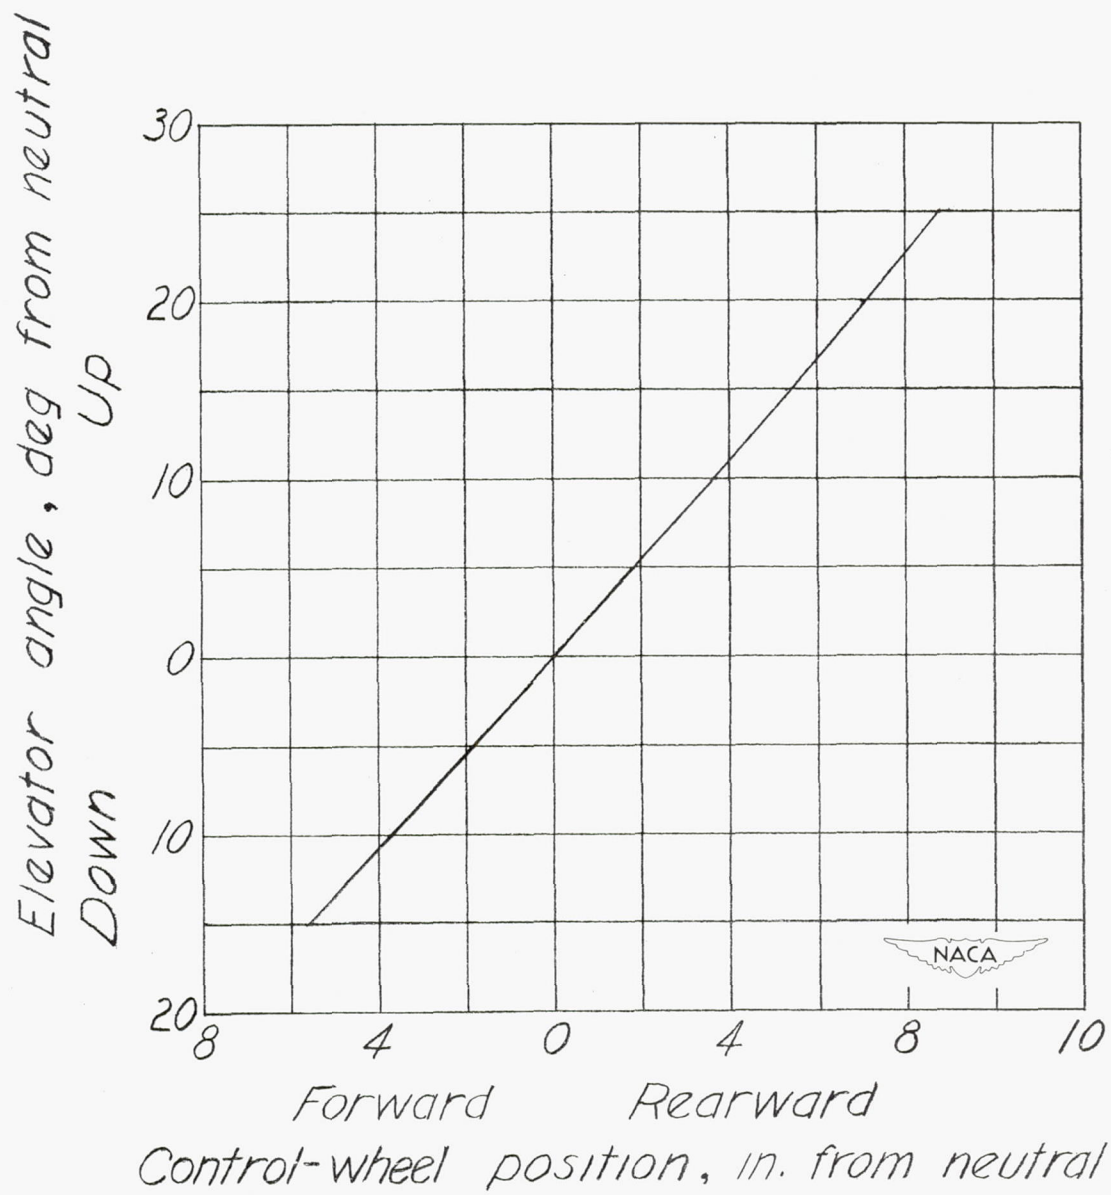
Figure 6.- Variation of elevator position with control-wheel position.  
No load on system.

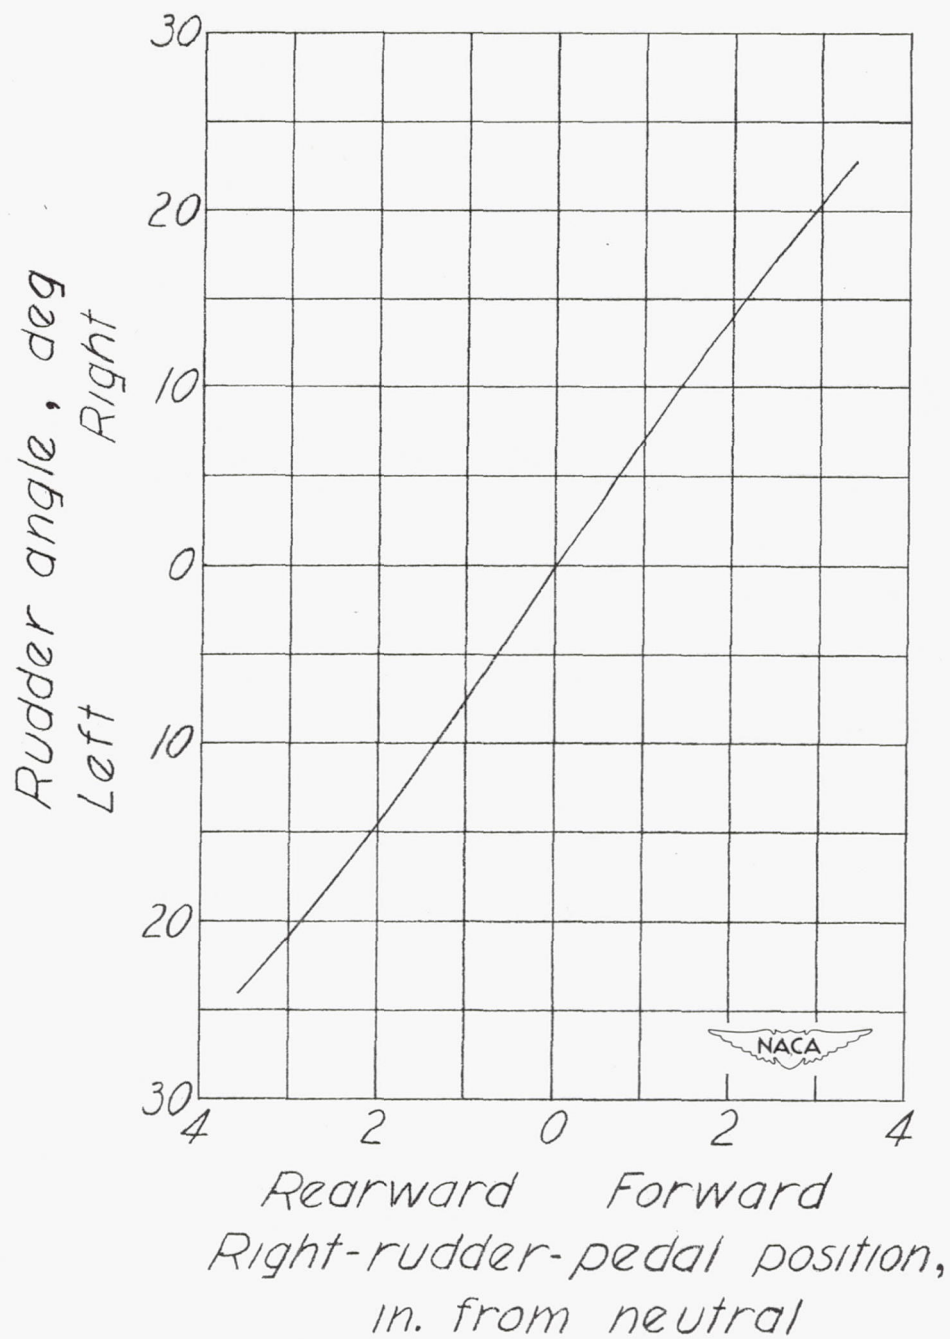
Figure 7.- Variation of rudder position with right-rudder-pedal position.  
No load on system.

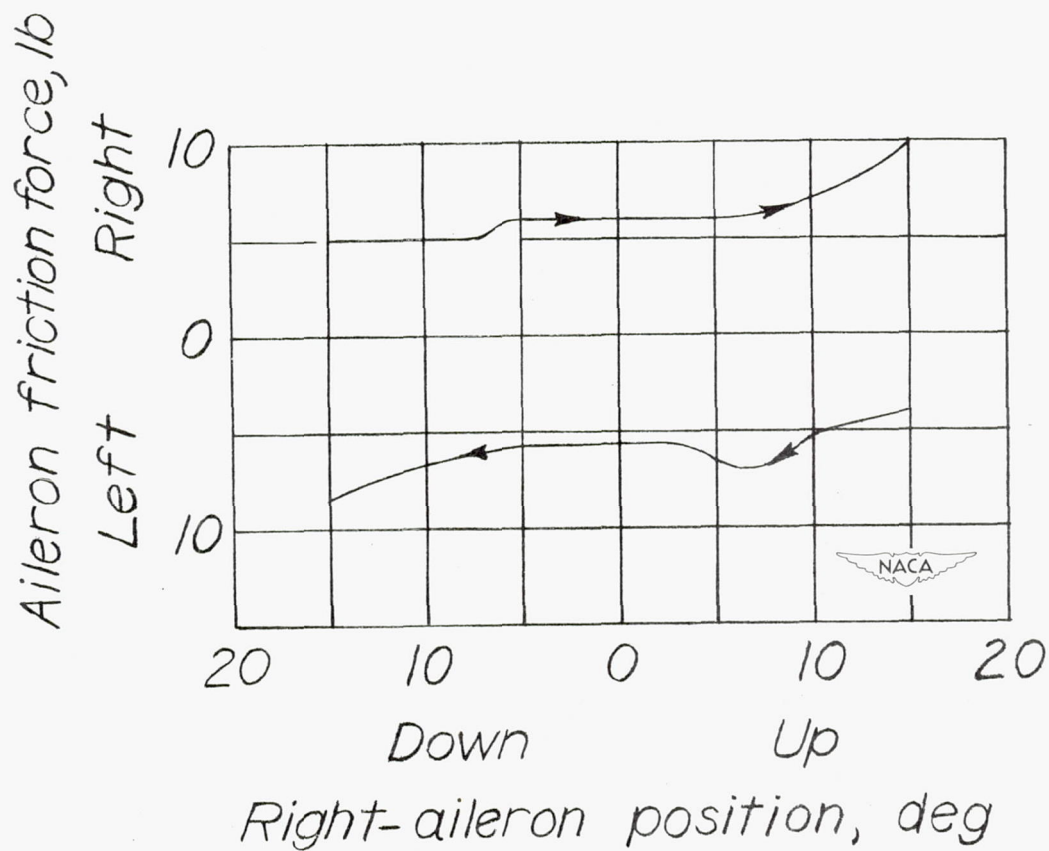
Figure 8.- Aileron-control force required to deflect ailerons on the ground under no load.

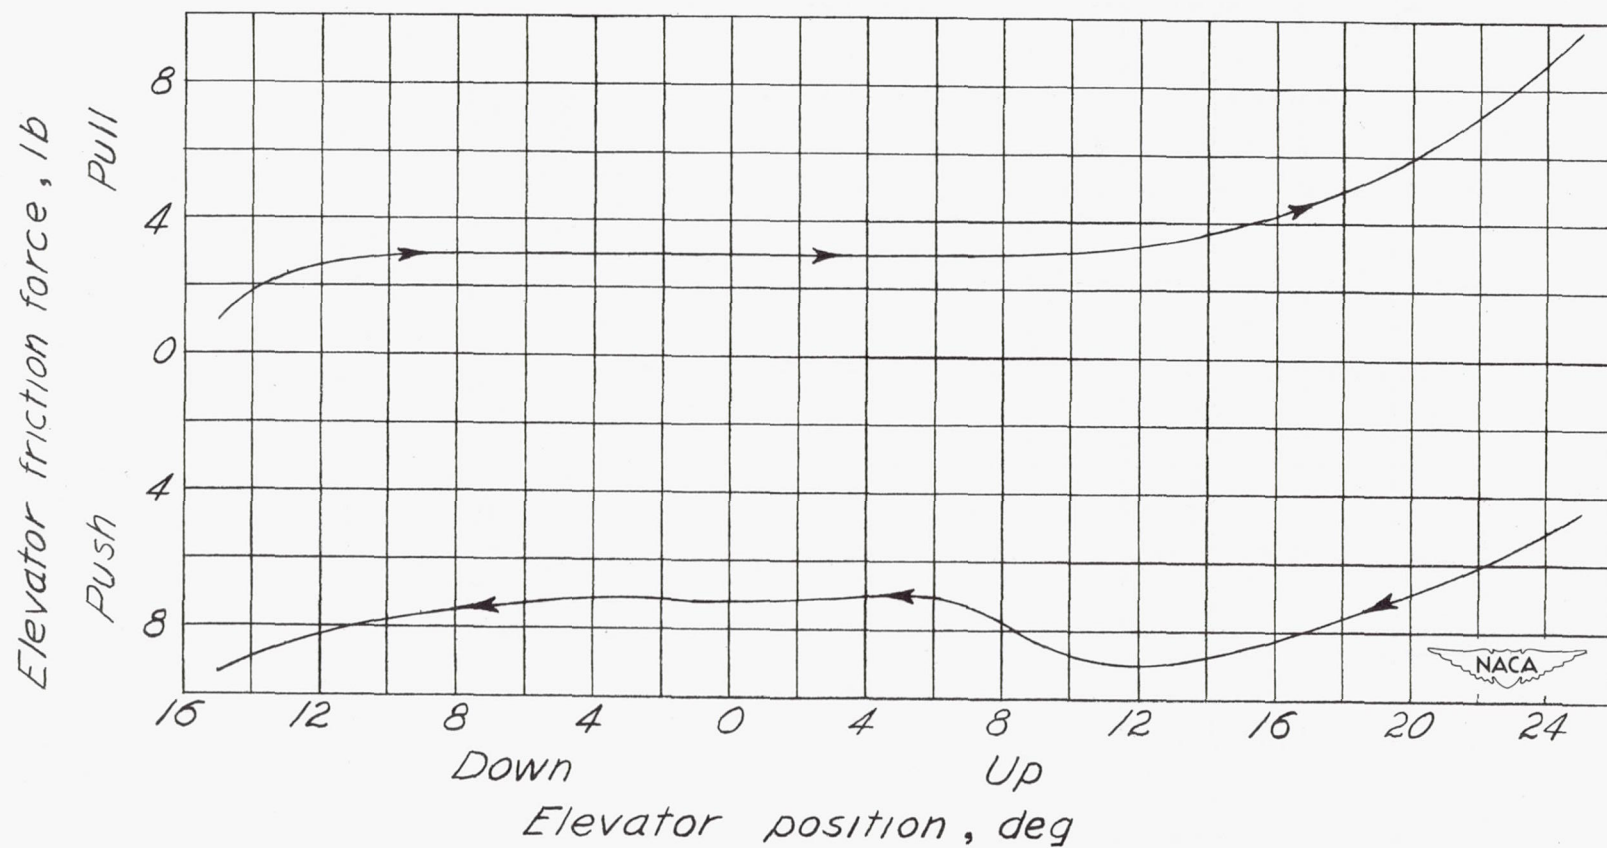
Figure 9.- Elevator-control force required to deflect elevator on the ground under no load.

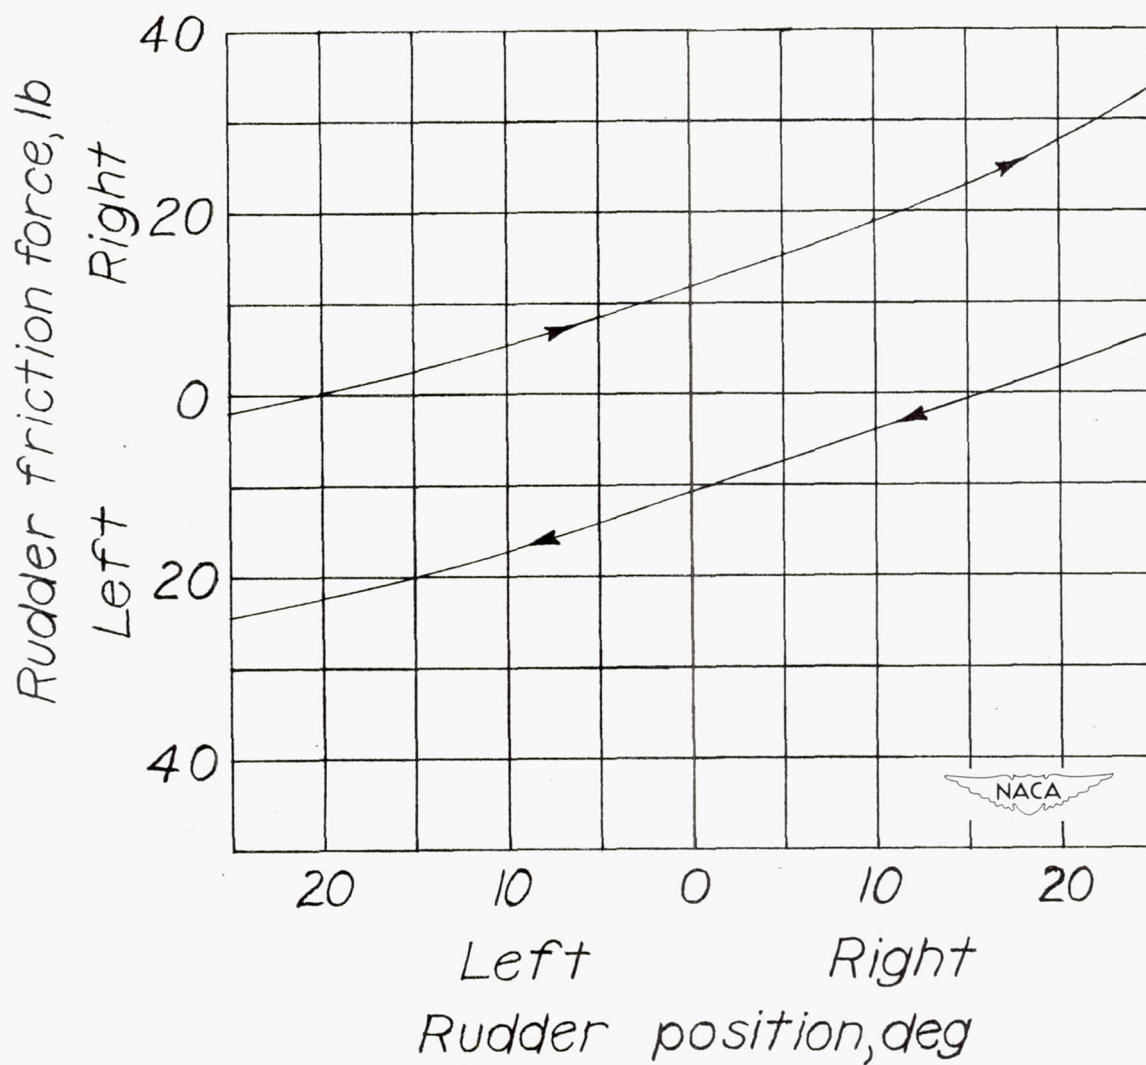
Figure 10.- Rudder-control force required to deflect rudder on the ground under no load.

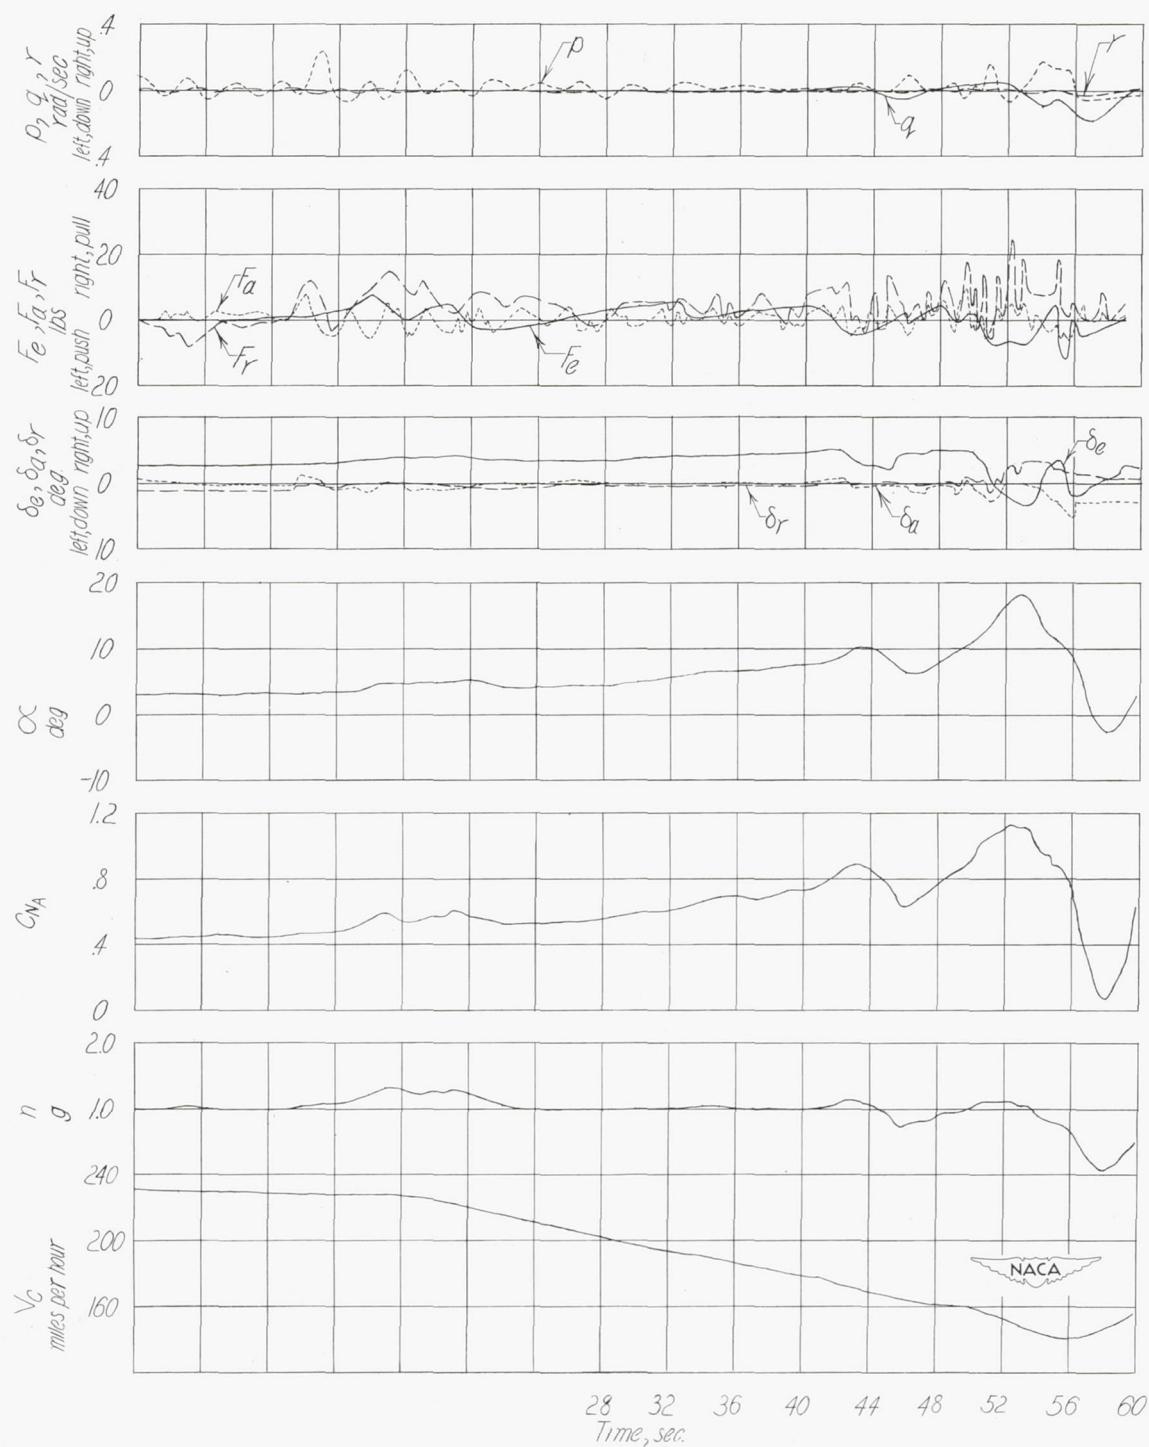
(a) Time history.

Figure 11.- Stall data for the Douglas D-558-II (BuAero No. 37974) research airplane. Flaps up; landing gear up; slats locked; inlet-duct flaps closed; stabilizer setting  $1.95^\circ$ ; center of gravity at 26.5 percent mean aerodynamic chord.

Flaps up, landing gear up, inlet-duct flaps closed, slats locked.- A time history of a stall in this configuration is presented in figure 11(a). Presented in figure 11(b) are photographs of tufts on the wing at various times during the stall. The black lines on the wing are parallel to the airplane center line and are located at intervals of 25 percent of the semispan of the exposed wings. The times listed in figure 11(b) correspond to the times of figure 11(a). The run was started at an indicated airspeed of about 230 miles per hour and the minimum speed reached was about 142 miles per hour. A lateral oscillation, which was predominantly a rolling motion, persisted throughout the run. The data indicate that the airplane became longitudinally unstable

at a normal-force coefficient of 0.8 and an angle of attack of about  $9^\circ$  which, for 1 g flight, corresponds to an airspeed of about 165 miles per hour. When the airplane became unstable the pilot was required to use large down-elevator deflections to control the pitching. In figure 11(a) at times between 50 and 53 seconds, the elevator was moved from  $5^\circ$  up to  $3^\circ$  down but the angle of attack increased from  $11^\circ$  to  $18.2^\circ$ . The highest normal-force coefficient reached was 1.13 at an angle of attack of about  $17.5^\circ$ .

The pilot objected to the characteristics of the airplane near the stall in this configuration because of the tendency for the airplane to pitch up abruptly. In some cases, particularly in maneuvering flight, the pilot did not check the pitch up as soon as in the run presented in figure 11(a). In these cases the angle of attack increased very rapidly and when the high angles of attack were reached the airplane performed violent rolling and yawing motions.

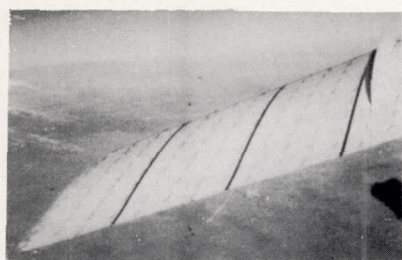
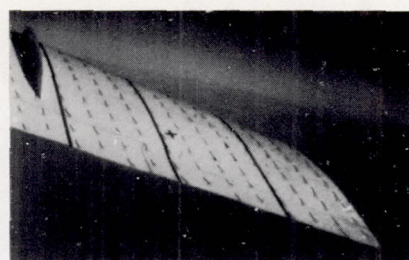
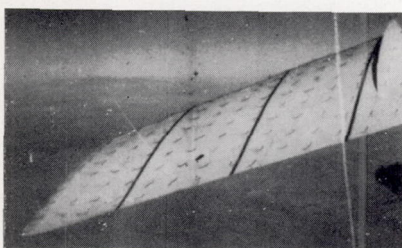
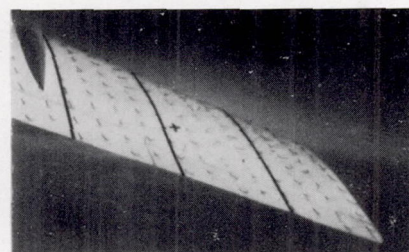
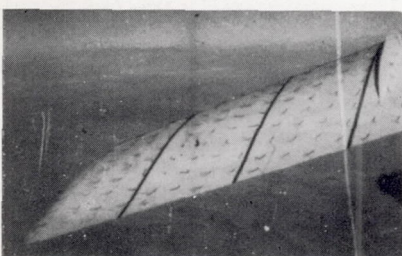
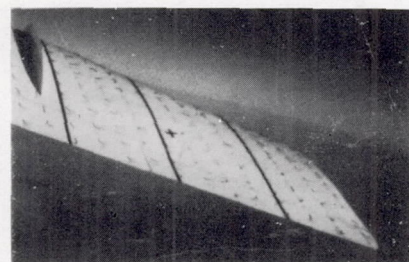
(b) Tuft pictures.

Time = 38  
 $C_{NA} = 0.69$   
 $\alpha = 7.2^\circ$

Time = 43  
 $C_{NA} = 0.88$   
 $\alpha = 10.2^\circ$

Time = 50  
 $C_{NA} = 0.91$   
 $\alpha = 11.0^\circ$

Time = 52.4  
 $C_{NA} = 1.13$   
 $\alpha = 17.5^\circ$

Time = 53  
 $C_{NA} = 1.12$   
 $\alpha = 18.2^\circ$

Inspection of the tuft pictures of figure 11(b) shows that separation first occurs on the right wing between the 50- and 75-percent semi-span stations. At the same time there is a marked outflow on both wings outboard of the wing fences. As the angle of attack increases, the separation spreads over both the left and right wings and at the highest angle of attack reached,  $18.2^\circ$ , the entire wing appears to be stalled.

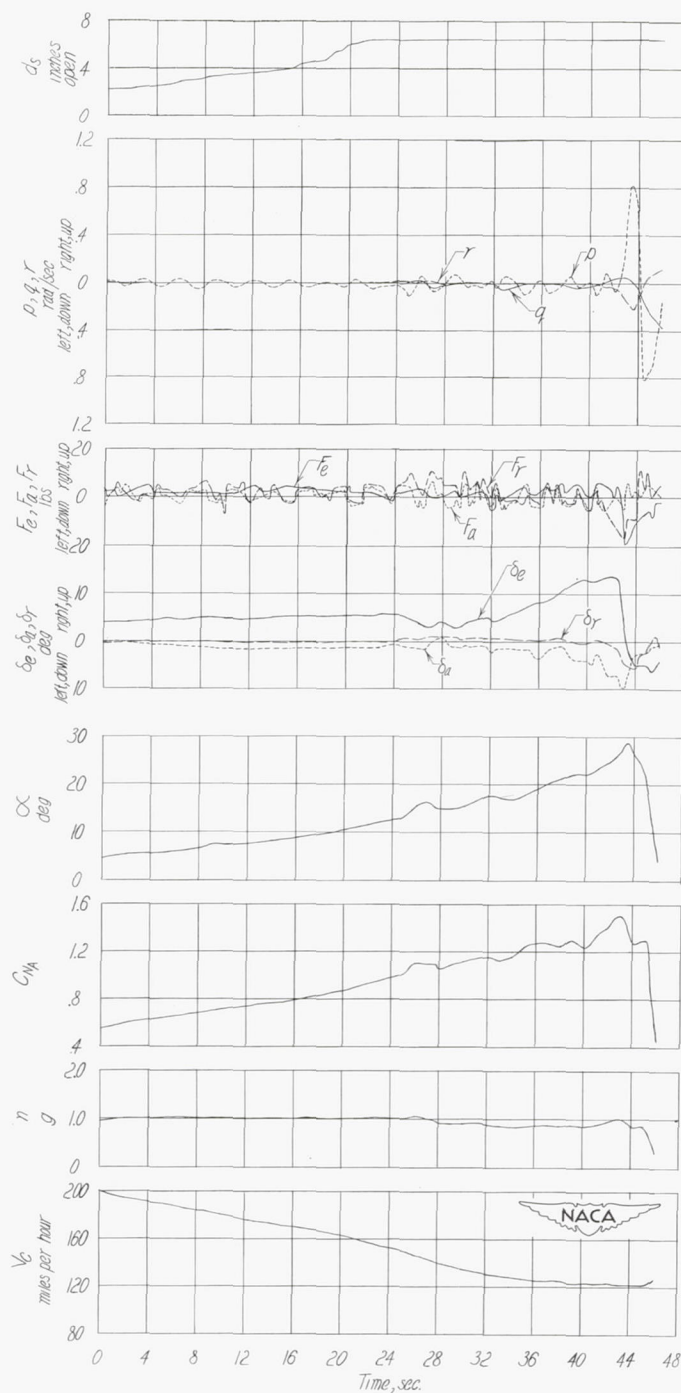
(a) Time history.

Figure 12.- Stall data for the Douglas D-558-II (BuAero No. 37974) research airplane. Flaps up; landing gear up; slats unlocked; inlet-duct flaps closed; stabilizer setting  $1.95^\circ$ ; center of gravity at 26.6 percent mean aerodynamic chord.

Flaps up, landing gear up, inlet-duct flaps closed, slats unlocked.-  
A time history of a stall in this airplane configuration is presented as figure 12(a) and tuft pictures at various times during the stall are shown in figure 12(b). The approach to the stall was started at about 200 miles per hour and the minimum speed reached was about 122 miles per hour. At times between 24 and 29 seconds (in the speed range from 155 to 140 miles per hour), the data indicate that the airplane was slightly unstable longitudinally since the up-elevator deflection required for trim decreased as the angle of attack and normal-force coefficient increased. The pilots did not have any serious objections to the slight instability present in this speed range. From 140 miles per hour down to a speed slightly above the minimum speed reached (122 miles per hour), the airplane was stable longitudinally. Near the minimum speed or at the higher angles of attack ( $23^\circ$  to  $28.5^\circ$ ) the data indicate that the airplane was again unstable. At 42.5 seconds the elevator was quickly moved down but between 42.5 and 43.5 seconds the angle of attack increased from  $26^\circ$  to  $28.5^\circ$ . A rolling and yawing motion was present when the airplane was unstable at the high angles of attack. These motions were objectionable to the pilots and were much more noticeable than the longitudinal instability. Recovery from the stall was accomplished by moving the elevator down.

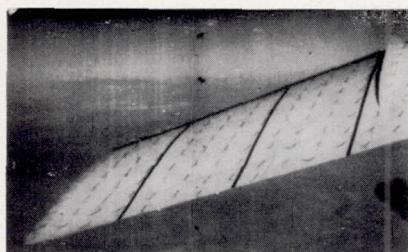
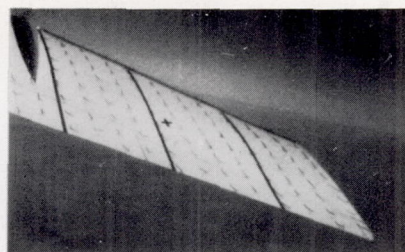
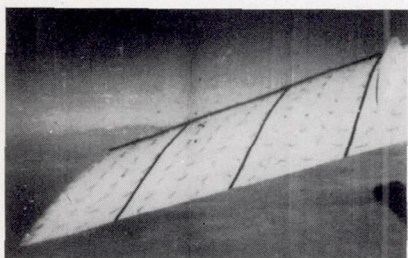
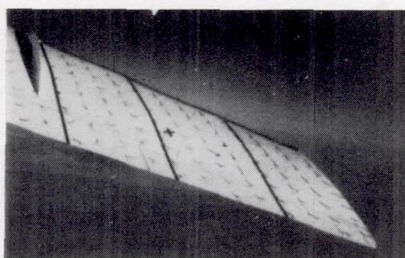
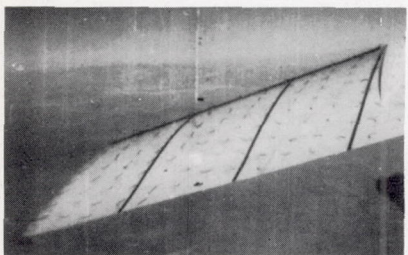
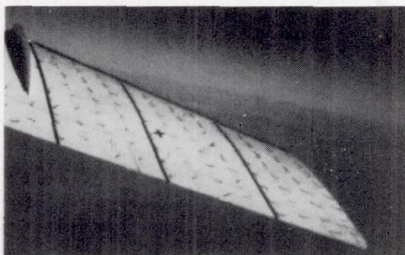
(b) Tuft pictures.

Time = 20  
 $C_{N_A} = 0.87$   
 $\alpha = 10.5^\circ$

Time = 30  
 $C_{N_A} = 1.12$   
 $\alpha = 15.5^\circ$

Time = 37  
 $C_{N_A} = 1.27$   
 $\alpha = 20.4^\circ$

Time = 43  
 $C_{N_A} = 1.51$   
 $\alpha = 27.2^\circ$

Time = 43.5  
 $C_{N_A} = 1.40$   
 $\alpha = 28.6^\circ$

The tuft pictures of figure 12(b) show the wing first stalls between the fuselage and the 50 percent wing semispan. At the same time

there is outflow over the outer part of the wing panel. As the angle of attack increases, the stall spreads outboard over both wings. The tuft pictures for the time 43 seconds in figure 11(b), (the slats-locked configuration), are for about the same angle of attack and airplane normal-force coefficient as the tuft pictures of the time 20 seconds in figure 12(b). Comparison of these tuft pictures indicates that the slats are effective in delaying separation since at 43 seconds in figure 11(b) the tufts show an appreciable separation but at 20 seconds in figure 12(b) the flow appears to be smooth.

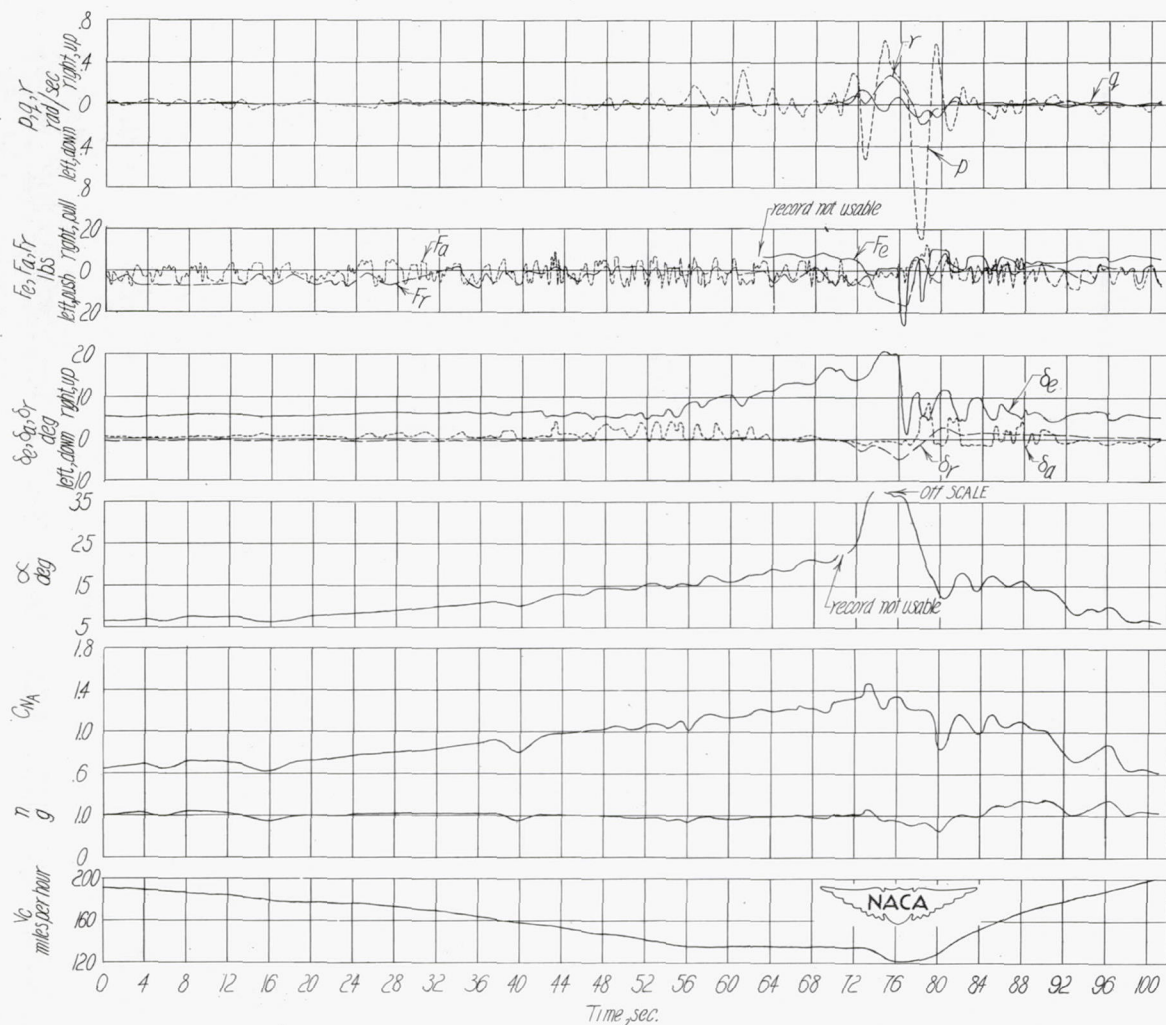
Figure 13.- Time history of a stall with the Douglas D-558-II (BuAero No. 37974) research airplane. Flaps up; landing gear up; slats unlocked; inlet duct-flaps closed; stabilizer setting  $1.72^\circ$ ; center of gravity at 26.7 percent mean aerodynamic chord.

The stall presented in figure 13 shows the same characteristics as that in figure 12(a), except that recovery was made after the airplane had reached a higher angle of attack. (The range of the angle-of-attack recorder was exceeded at  $38^{\circ}$ .) The approach to the stall was started at 190 miles per hour and recovery was made at 122 miles per hour. At the higher angles of attack the airplane was longitudinally unstable. At times between 70 and 72 seconds the elevator is moved down, but at the same time the angle of attack increases rapidly. Also at times between 72 and 75 seconds when the elevator is being moved up, the angle of attack is leading rather than lagging the elevator motion. The highest normal-force coefficient reached was 1.47 at an angle of attack of about  $36^{\circ}$ . Recovery from the stall was accomplished by moving the elevator down. The longitudinal instability which occurred in this airplane configuration at angles of attack greater than about  $23^{\circ}$  was not nearly so objectionable to the pilots as the instability which occurred in the slats-locked configuration previously discussed. With the slats locked the instability occurred at a much lower normal-force coefficient or angle of attack and the pitch-up was more rapid.

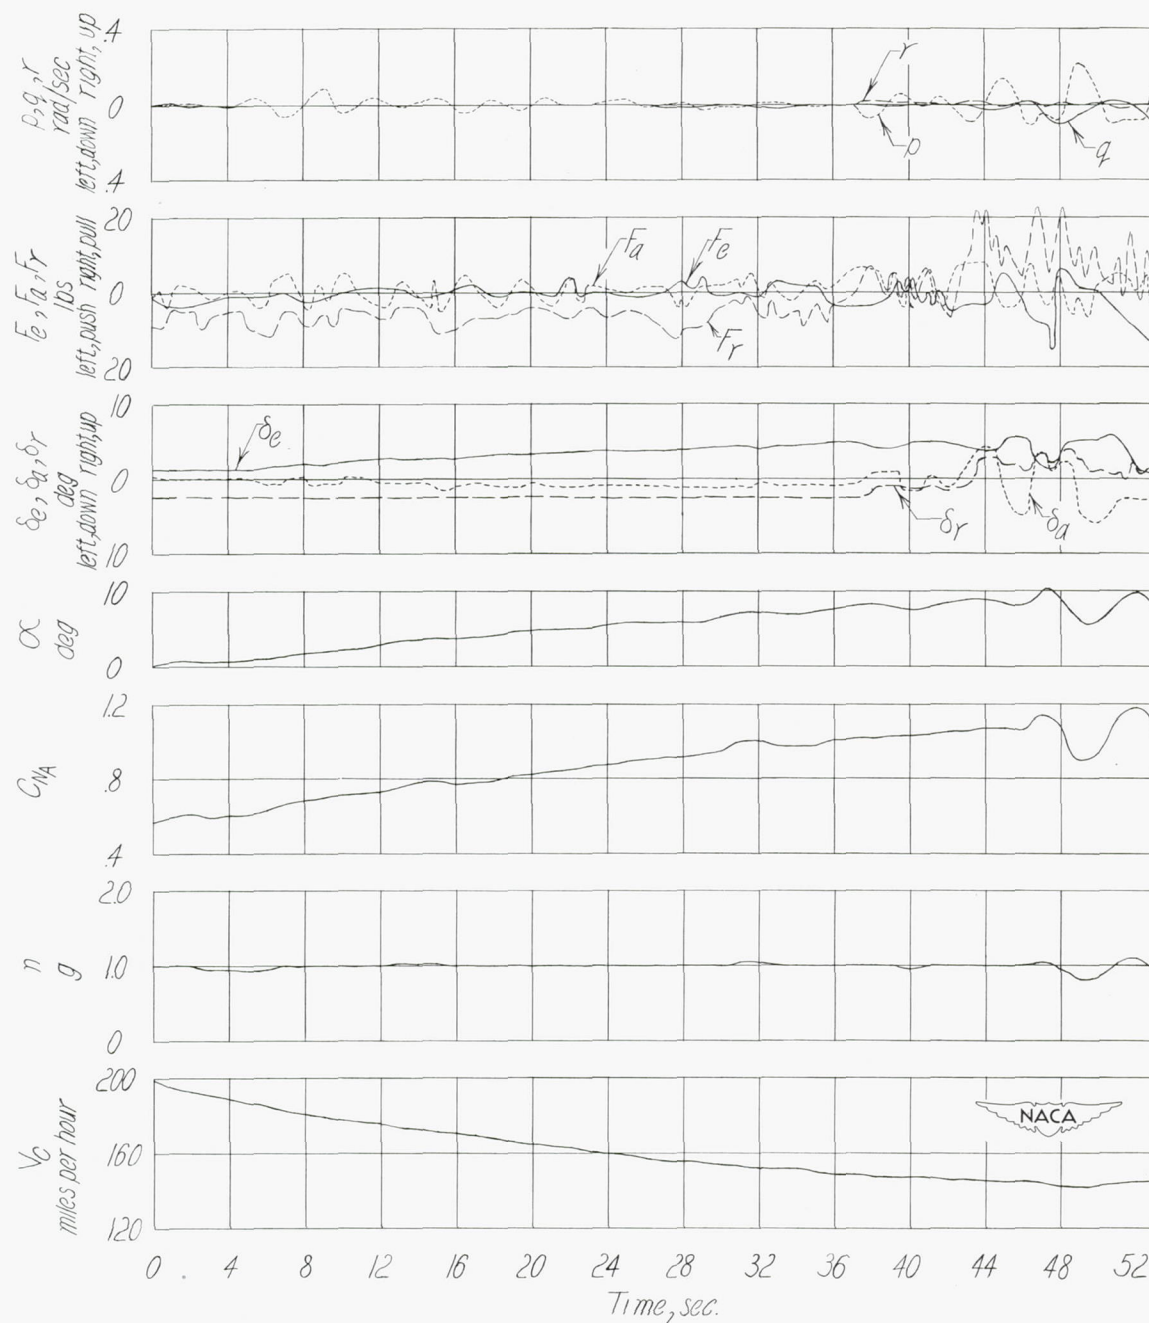
(a) Time history.

Figure 14.- Stall data for the Douglas D-558-II (BuAero No. 37974) research airplane. Flaps down; landing gear down; slats locked; inlet-duct flaps open; stabilizer setting  $2.2^\circ$ ; center of gravity at 26.1 percent mean aerodynamic chord.

Flaps down, landing gear down, inlet-duct flaps open, slats locked.-  
Figure 14(a) presents a time history of a stall approach in this airplane configuration. The tuft pictures are presented as figure 14(b). The stall approach was started as an indicated airspeed of about 200 miles per hour and the minimum speed reached was about 142 miles per hour. As will be shown in a later time history, figure 15, considerably lower speeds and higher angles of attack have been reached in this airplane configuration in other runs, and therefore in the time history presented as figure 14(a) the airplane was not completely stalled. The tuft pictures of figure 14(b) also show that the wing of the airplane was only partially stalled at the highest angles of attack reached. A rolling oscillation of small amplitude was present throughout most of the run. The airplane was neutrally stable or slightly unstable longitudinally in the speed range from about 150 to 142 miles per hour. Inspection of the tuft pictures shows that stalling first occurred on the flaps. The tuft pictures at 47, 49, and 52 seconds show parts of the left and right wings to be alternately stalled and unstalled. The alternate stalling and unstalling of the wings appear to be associated with the rolling motion. When the airplane is rolling to the left at 47 and 52 seconds,
