# RESEARCH MEMORANDUM

FLIGHT MEASUREMENTS WITH THE  
DOUGLAS D-558-II (BuAero No. 37974) RESEARCH AIRPLANE

LOW-SPEED STALLING AND LIFT CHARACTERISTICS

September 5, 1950  
Declassified May 8, 1957

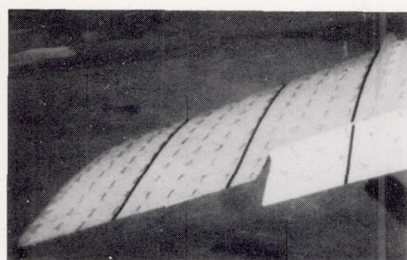
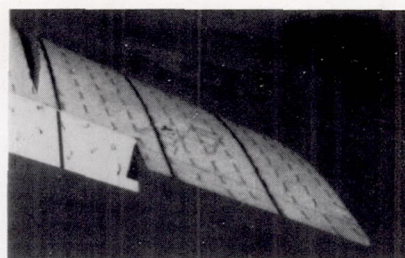
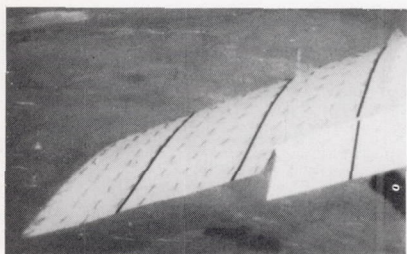
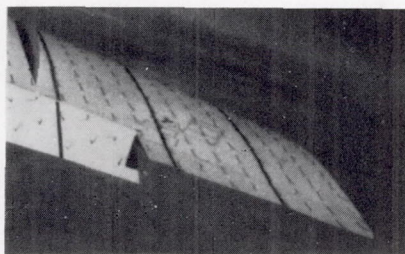
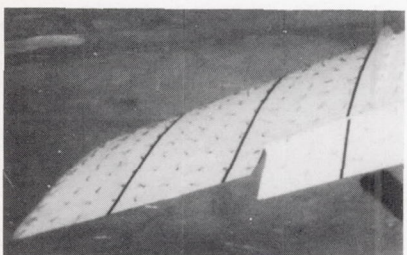
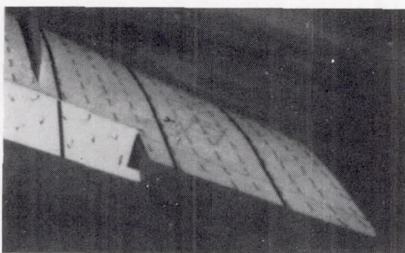
(b) Tuft pictures.

Time = 38  
 $C_{NA} = 1.02$   
 $\alpha = 8.3^\circ$

Time = 45  
 $C_{NA} = 1.07$   
 $\alpha = 8.5^\circ$

Time = 47  
 $C_{NA} = 1.14$   
 $\alpha = 10.0^\circ$

Time = 49  
 $C_{NA} = 0.90$   
 $\alpha = 6.0^\circ$

Time = 52  
 $C_{NA} = 1.18$   
 $\alpha = 9.7^\circ$

Flaps down, landing gear down, inlet-duct flaps open, slats locked.-  
Figure 14(a) presents a time history of a stall approach in this airplane configuration. The tuft pictures are presented as figure 14(b). The stall approach was started as an indicated airspeed of about 200 miles per hour and the minimum speed reached was about 142 miles per hour. As will be shown in a later time history, figure 15, considerably lower speeds and higher angles of attack have been reached in this airplane configuration in other runs, and therefore in the time history presented as figure 14(a) the airplane was not completely stalled. The tuft pictures of figure 14(b) also show that the wing of the airplane was only partially stalled at the highest angles of attack reached. A rolling oscillation of small amplitude was present throughout most of the run. The airplane was neutrally stable or slightly unstable longitudinally in the speed range from about 150 to 142 miles per hour. Inspection of the tuft pictures shows that stalling first occurred on the flaps. The tuft pictures at 47, 49, and 52 seconds show parts of the left and right wings to be alternately stalled and unstalled. The alternate stalling and unstalling of the wings appear to be associated with the rolling motion. When the airplane is rolling to the left at 47 and 52 seconds,

part of the left wing is stalled; when the airplane is rolling to the right at 49 seconds, a part of the right wing is stalled.

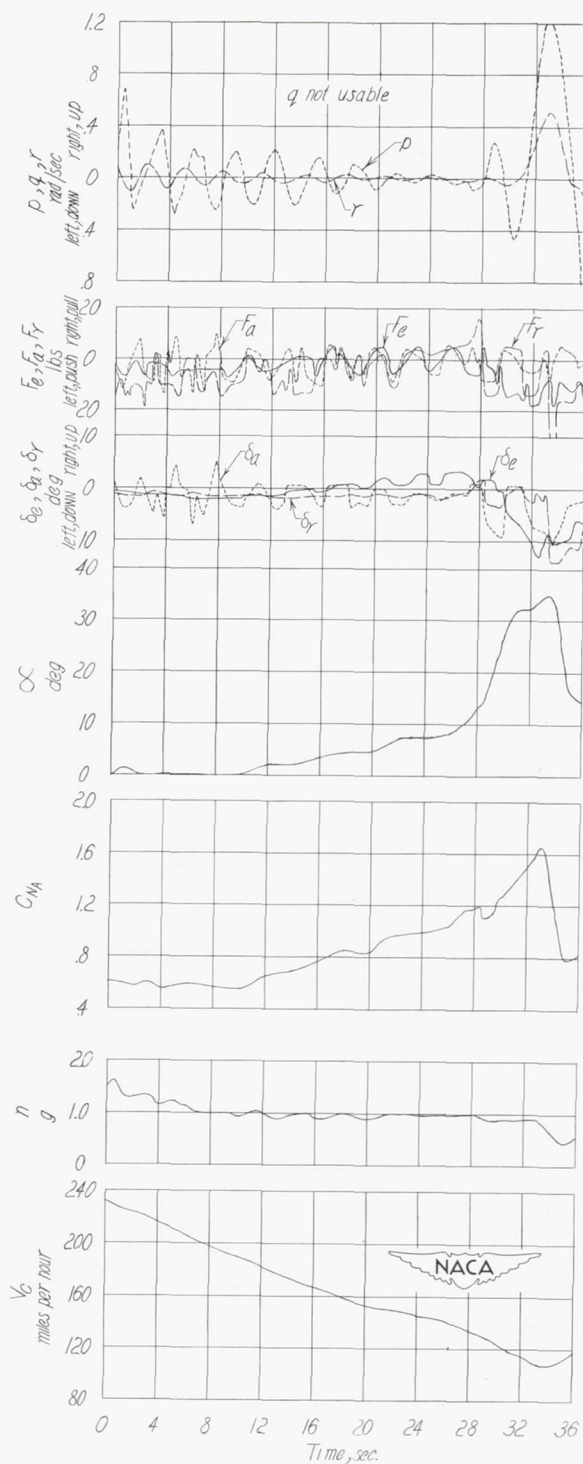
Figure 15.- Time history of a stall with the Douglas D-558-II (BuAero No. 37974) research airplane. Flaps down; landing gear down; slats locked; inlet-duct flaps open; stabilizer setting  $0.7^\circ$ ; center of gravity at 26.6 percent mean aerodynamic chord.

Figure 15 presents a time history of a stall approach and stall in the same airplane configuration during which much higher angles of attack were reached. The data show that at about 140 miles per hour (time 26.5 seconds) the airplane becomes very unstable longitudinally. In the time interval between 26.5 and 32.5 seconds the elevator was moved from  $3.5^\circ$  up to  $12.5^\circ$  down and during the same time the angle of attack increased from about  $9^\circ$  to  $33^\circ$ . The airplane experienced quite high rolling velocities at the higher angles of attack. A rolling velocity of about 1.2 radians per second to the right first occurred followed by a roll to the left. During the left roll the recording instruments were inadvertently turned off. After the rolling oscillation occurred the airplane went into a spin. The pilot was unable to effect recovery from the spin with the flaps and landing gear extended, but when the flaps and landing gear were retracted recovery was accomplished with the ailerons and rudder held against the spin.

The pilots considered the stalling characteristics of the airplane in this configuration very objectionable because of the rapid pitch-up which occurred when the airplane became longitudinally unstable and because of the large rolling motions and the possibility of the airplane's spinning. With the slats locked and the flaps and landing gear either up or down, slight buffeting of the airplane occurred at a normal-force coefficient slightly less than the normal-force coefficient at which the airplane became longitudinally unstable. If the pilot initiates recovery when the airplane buffeting occurs or at the first indication of the instability, the violent uncontrolled-for motions can be avoided.

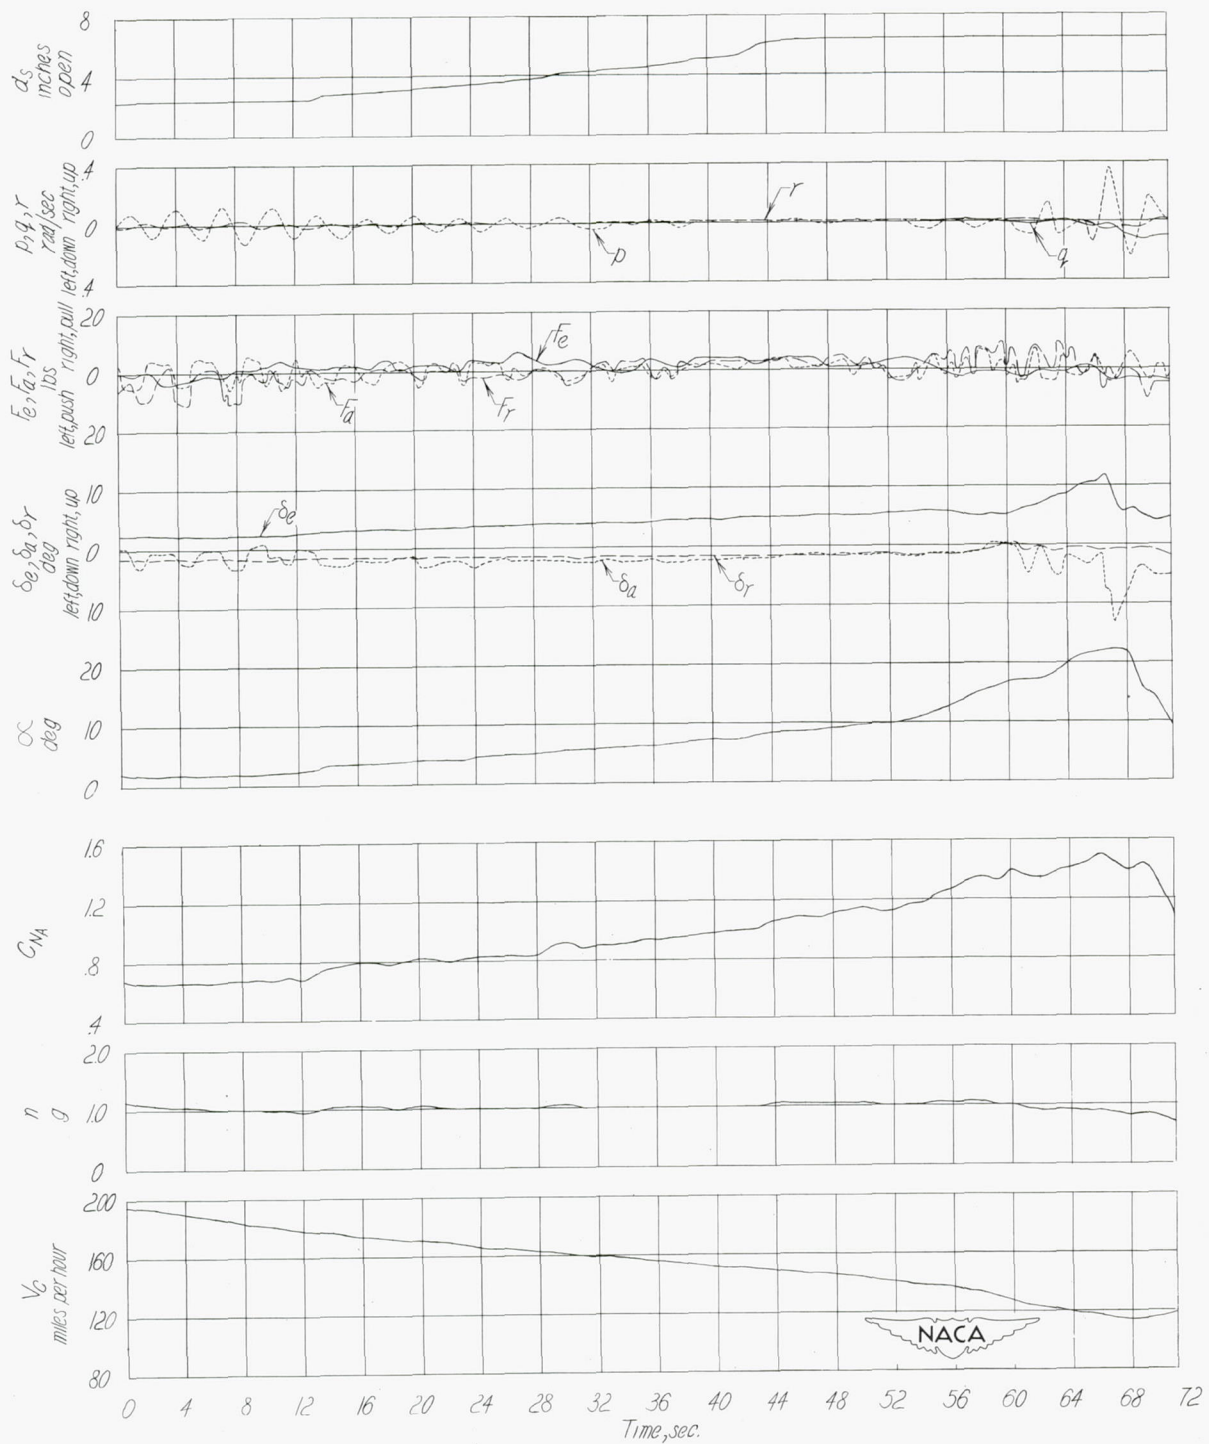
(a) Time history.

Figure 16.- Stall data for the Douglas D-558-II (BuAero No. 37974) research airplane. Flaps down; landing gear down; slats unlocked; inlet-duct flaps open; stabilizer setting  $2.2^\circ$ ; center of gravity at 26.2 percent mean aerodynamic chord.

Flaps down, landing gear down, inlet-duct flaps open, slats open.-  
A time history of a stall approach in this airplane configuration is shown in figure 16(a) and the corresponding tuft pictures are presented in figure 16(b). The run was started at an indicated airspeed of 195 miles per hour and the minimum speed reached was 114 miles per hour. At the higher speeds the airplane performs a Dutch roll oscillation which damps out as the speed is decreased. This has been noted in many flights with the D-558-II airplane. With the flaps down at indicated speeds greater than about 190 miles per hour the pilots have not been able to make precision maneuvers with the airplane because of the poor damping of the Dutch roll oscillations; at speeds between about 150 and 190 miles per hour, the Dutch roll characteristics have not been nearly as troublesome.

The data indicate that the airplane is longitudinally stable in this configuration at indicated airspeeds greater than approximately 140 miles per hour. In the airspeed range from 140 to 130 miles per hour

the airplane has approximately neutral longitudinal stability and at indicated airspeeds less than 130 miles per hour the airplane is very stable longitudinally. The highest angle of attack reached in this run was about  $22^{\circ}$  and the normal-force coefficient at this angle of attack is 1.50. A rolling and yawing oscillation occurred at the higher angles of attack but the airplane motions during the oscillation were mild.

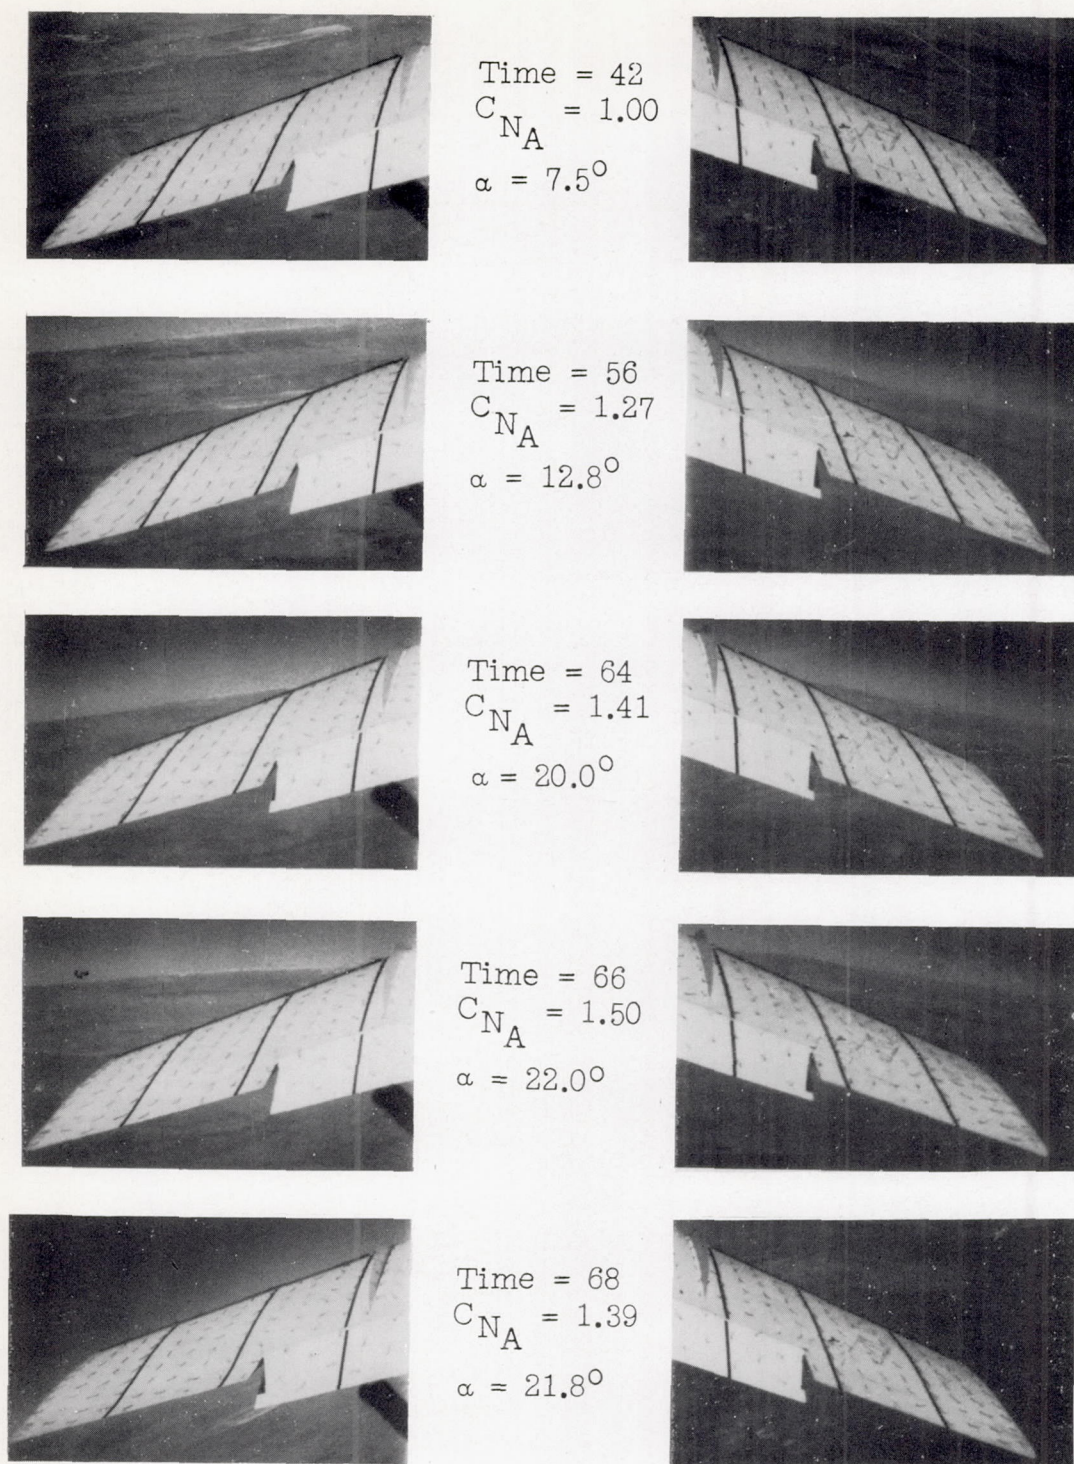
(b) Tuft pictures.

Figure 16.- Concluded.

Figure 16(b) shows that stalling first occurs on the flaps as was also the case with the slats locked (fig. 14(b)). As the angle of attack increases the slats appear to be quite effective in preventing separation as most of the stalling occurs over the inboard 50 percent of the exposed wing semispan. There is considerable outflow over the outer portions of the wing but the flow does not appear to be separated as it is inboard.

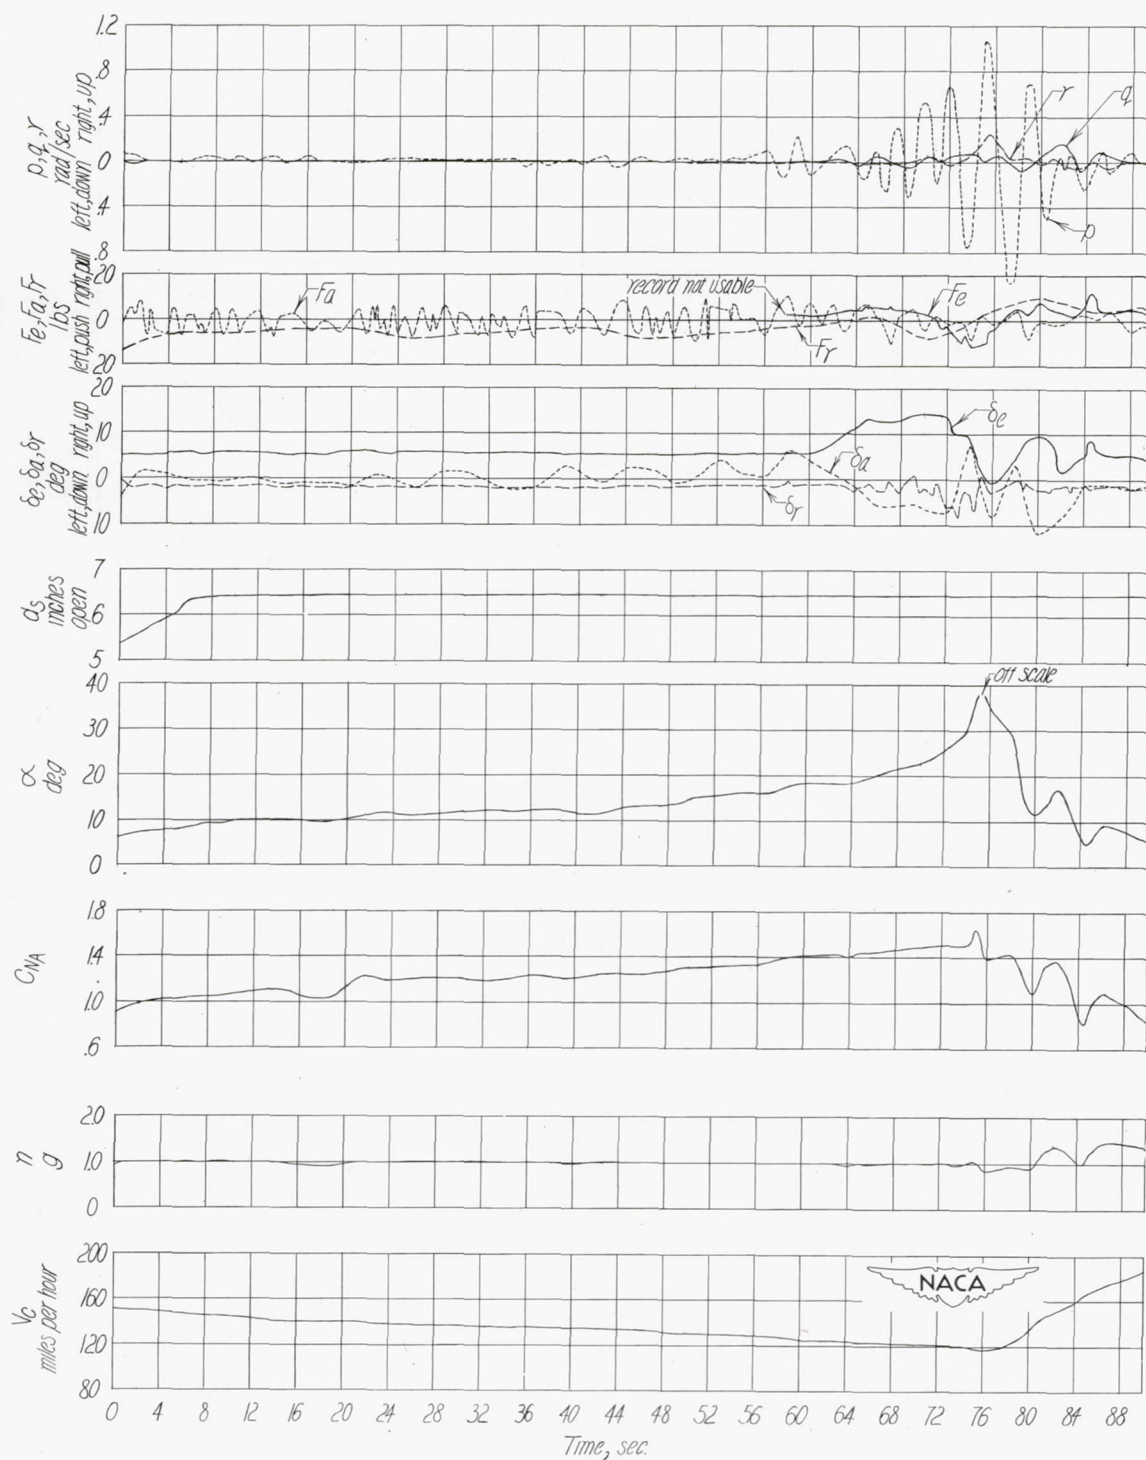
Figure 17.- Time history of a stall with the Douglas D-558-II (BuAero No. 37974) research airplane. Flaps down; landing gear down; slats unlocked; inlet-duct flaps open; stabilizer setting  $1.72^\circ$ ; center of gravity at 26.3 percent mean aerodynamic chord.

A time history of a stall in which considerably higher angles of attack were reached than in the time history presented as figure 16(a) is shown in figure 17. Inspection of figure 17 shows that the airplane is unstable at angles of attack greater than about  $23^{\circ}$ . At times between 72 and 75 seconds the elevator is moved from  $13.5^{\circ}$  up to  $0.5^{\circ}$  down but at the same time the angle of attack increases from  $25.5^{\circ}$  to  $38^{\circ}$ . A rolling and yawing motion involving rolling velocities of the order of 1 radian per second occurred at the high angles of attack. These motions were objectionable to the pilots and were more noticeable than the longitudinal instability. Recovery from the stall was accomplished by moving the elevator down.

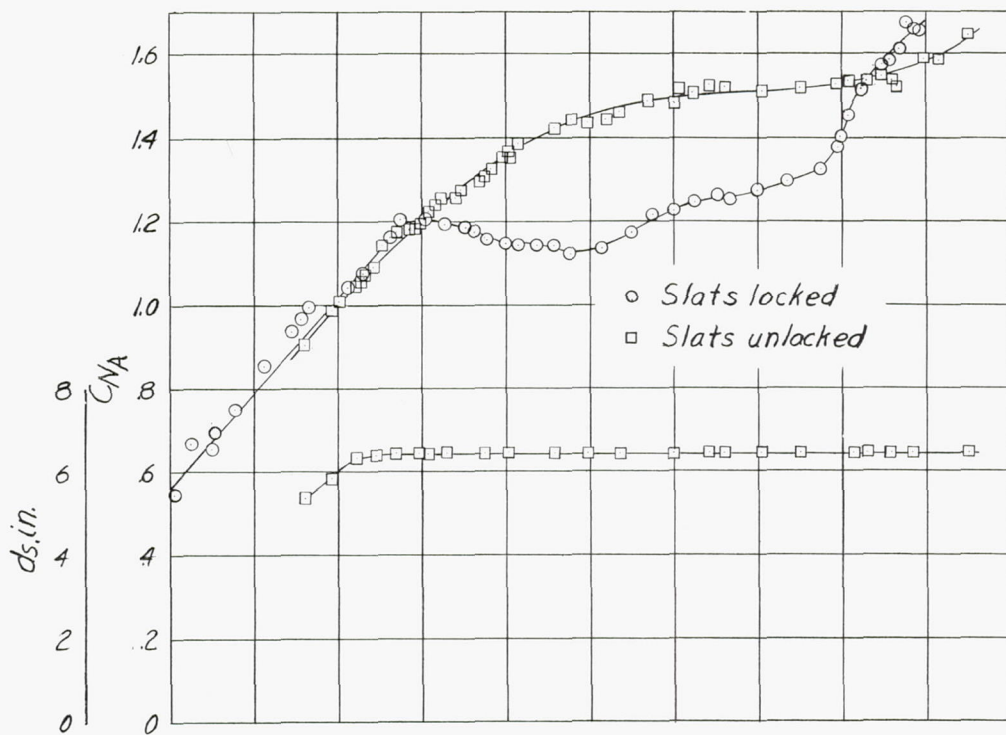
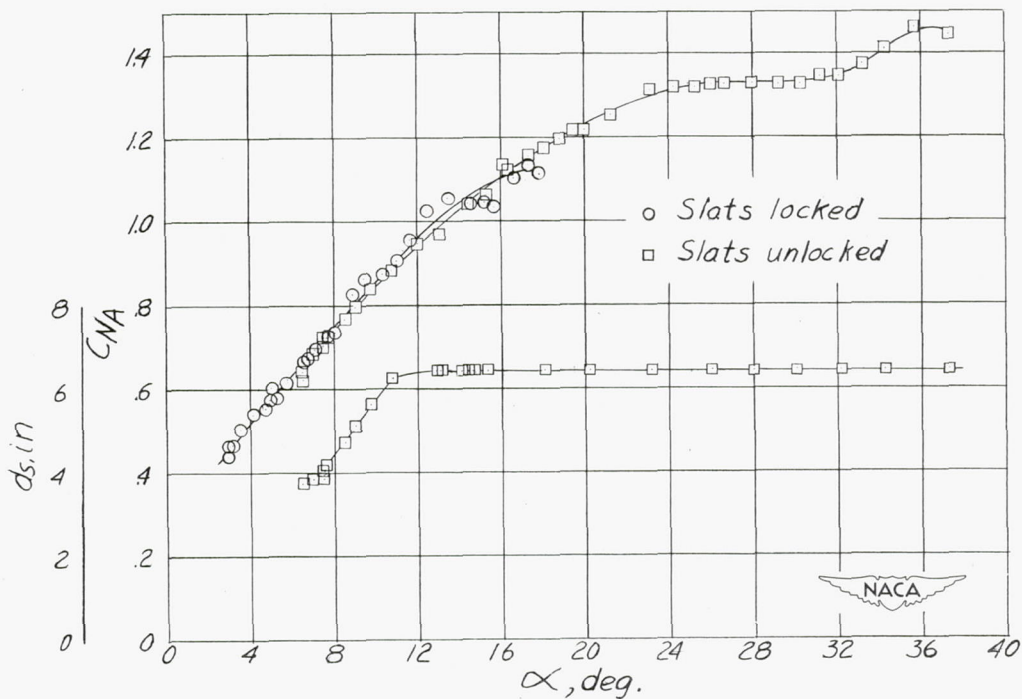
Figure 18.- Variation of airplane normal-force coefficient with angle of attack showing effect of slats.

From some of the runs previously presented as time histories of stalls, the variation of airplane normal-force coefficient with angle of attack was determined for the four different airplane configurations previously discussed. These data are presented in figures 18(a) for the flaps-up configurations and in 18(b) for the flaps-down configurations. The variation of slat position with angle of attack is also presented in figure 18.

At the lower normal-force coefficients, with the flaps up or down, unlocking the slats had no appreciable effect on the angle of attack required to produce a given normal-force coefficient. With the flaps up and the slats locked, the highest normal-force coefficient reached was about 1.13 at an angle of attack of about  $18^{\circ}$ . With the flaps up and the slats unlocked, the highest normal-force coefficient reached was

about 1.46 at an angle of attack of  $36^\circ$ . In the angle-of-attack range from about  $23^\circ$  to  $30^\circ$  the normal-force coefficient has a substantially constant value of 1.32. At the higher angles of attack, the lift coefficient would be considerably lower than the normal-force coefficient because of the large inclination of the normal-force vector with respect to the lift vector.

With the flaps down and the slats locked or unlocked (fig. 18(b)) the highest normal-force coefficient reached was about 1.65. This value of normal-force coefficient was reached at an angle of attack of  $35.5^\circ$  with the slats locked and  $38^\circ$  with the slats unlocked. However, in the angle-of-attack range from  $12^\circ$  to  $32^\circ$ , considerably higher normal-force coefficients can be reached at a given angle of attack with the slats unlocked than locked. For example, at an angle of attack of  $25^\circ$  the normal-force coefficient is about 1.5 with the slats unlocked and 1.25 with the slats locked.

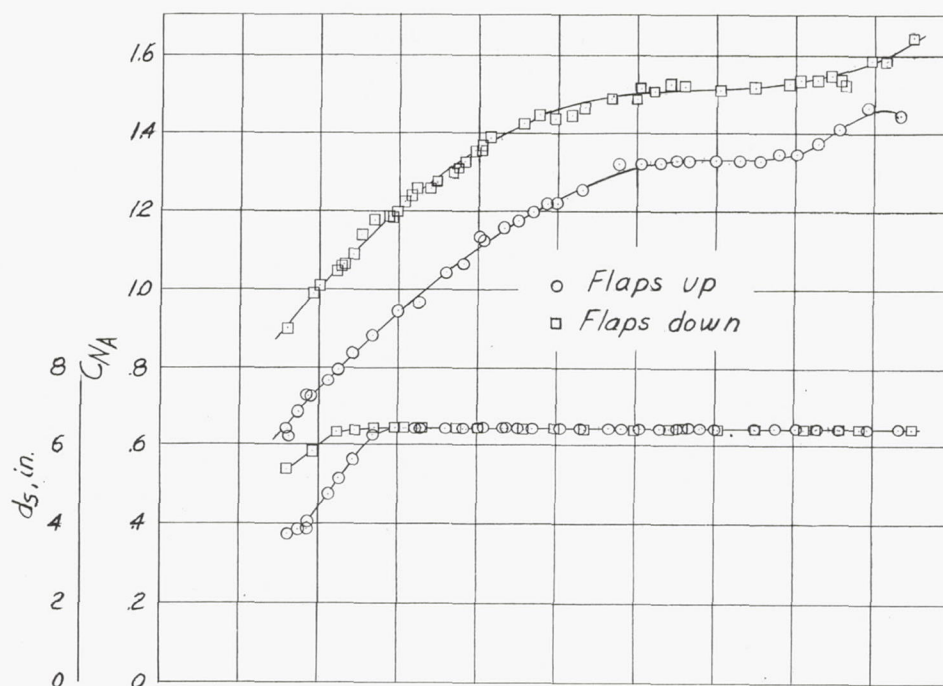
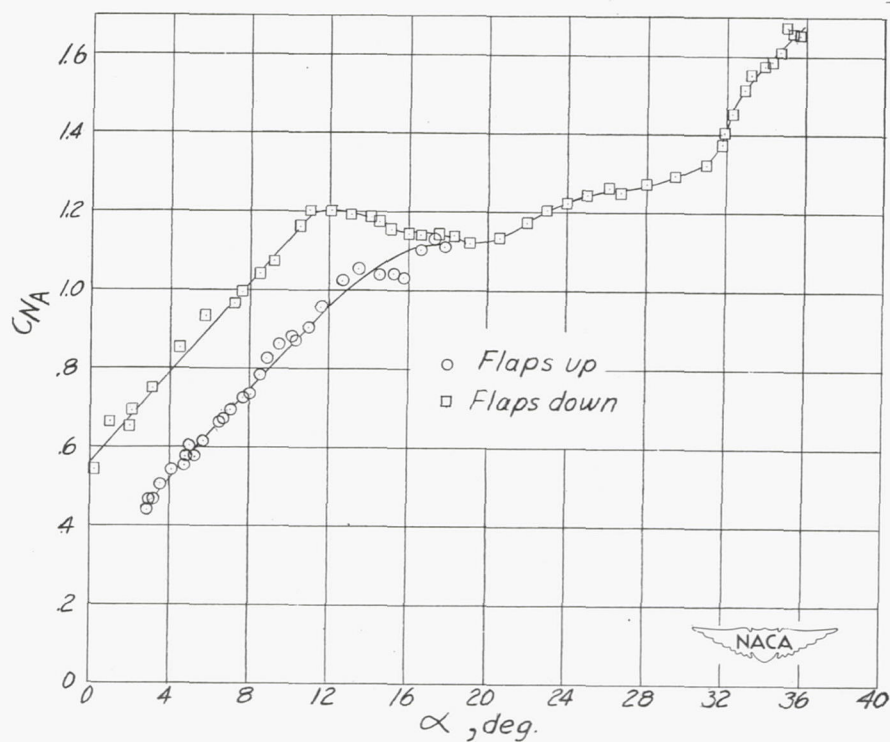
Figure 19.- Variation of airplane normal-force coefficient with angle of attack showing effect of flaps.

In order to show more clearly the effect of flap deflection on the lift characteristics the data of figure 18 have been replotted in figure 19. Figure 19(a) is for the slats-locked configuration and figure 19(b) is for the slats-unlocked configuration. At the lower angles of attack, with the slats locked or unlocked, deflecting the flaps will produce an increment in normal-force coefficient of about 0.26. With the slats locked at an angle of attack of  $17^\circ$ , the normal-force coefficient has approximately the same value, 1.13, with the flaps up or down. With the slats unlocked the flaps produce an appreciable increment in normal-force coefficient throughout the angle-of-attack range.
