# RESEARCH MEMORANDUM

WIND-TUNNEL INVESTIGATION OF THE AERODYNAMIC  
AND STRUCTURAL DEFLECTION CHARACTERISTICS  
OF THE GOODYEAR INFLATOPLANE

By Bennie W. Cocke, Jr.

NATIONAL ADVISORY COMMITTEE  
FOR AERONAUTICS

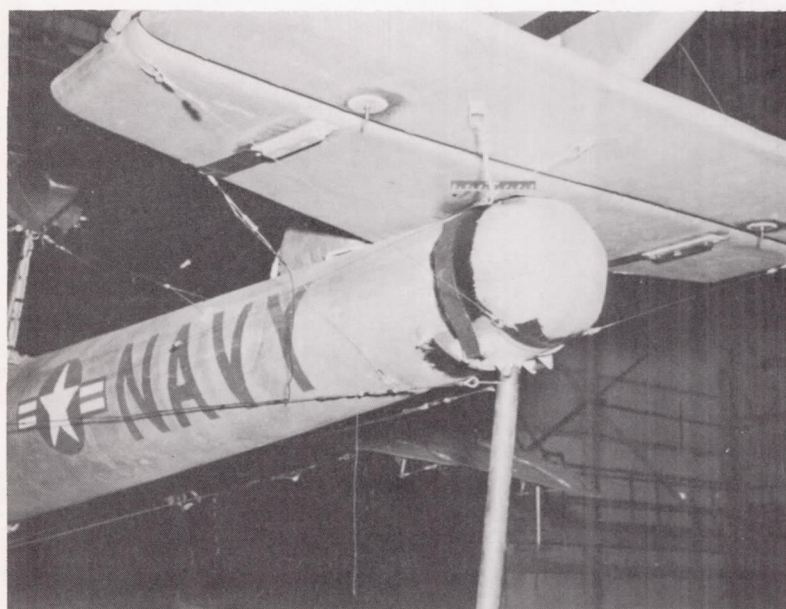
Figure 3.- Inflatoplane mounting arrangement.

(a) General view.

(b) Main support yoke.

(c) Tail support fitting.

The airplane was mounted for tests on the conventional six-component mechanical balance as shown in figure 3. A special yoke (fig. 3(b)) was utilized to mount the airplane so that strut restraining loads were transmitted to the fuselage through strap attachments located beneath the wing quarter-chord point thus leaving the wings free to deflect while being restrained only by the normal wing-fuselage and guy-cable attachments as in flight. The tail strut was attached to a saddle strapped to the rear of the fuselage (fig. 3(c)) and was connected by cables to the front support yoke thus preventing longitudinal tail strut loads from being transmitted into the fuselage.
